AI2005-5

AIRCRAFT SERIOUS INCIDENT INVESTIGATION REPORT

PRIVATELY-OWNED
BEEHCRAFT C-23, JA3683
AREA 6Km NORTH-NORTHEAST OF NAGASAKI AIRPORT
OCTOBER 24, 2004

September 30, 2005

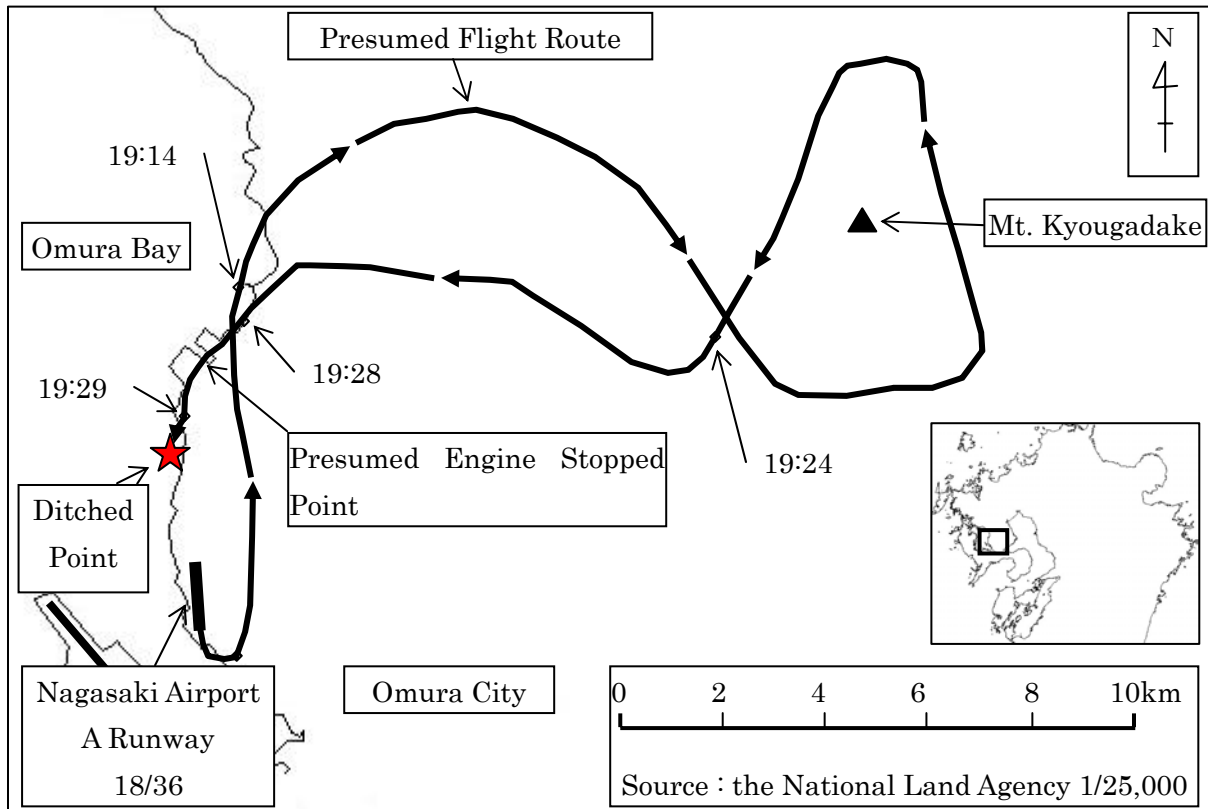
Figure 1 Presumed Flight Route

Position information thought to correspond to the aircraft was recorded in air traffic control radar recordings at four-second intervals between 1910:21–1929:49. The flight course of the aircraft was estimated based on this data.

(See Figure 1)

3.8 Based on the flight course estimated as described in section 2.9, it is estimated that at around 1928:36, the aircraft began to left turn at around 4.3km north of the approach end of the runway-A, at around 1928:48, the aircraft was in a shallow left turn and was on the final approach path to runway-A around 4.1km of the approach end of the runway.

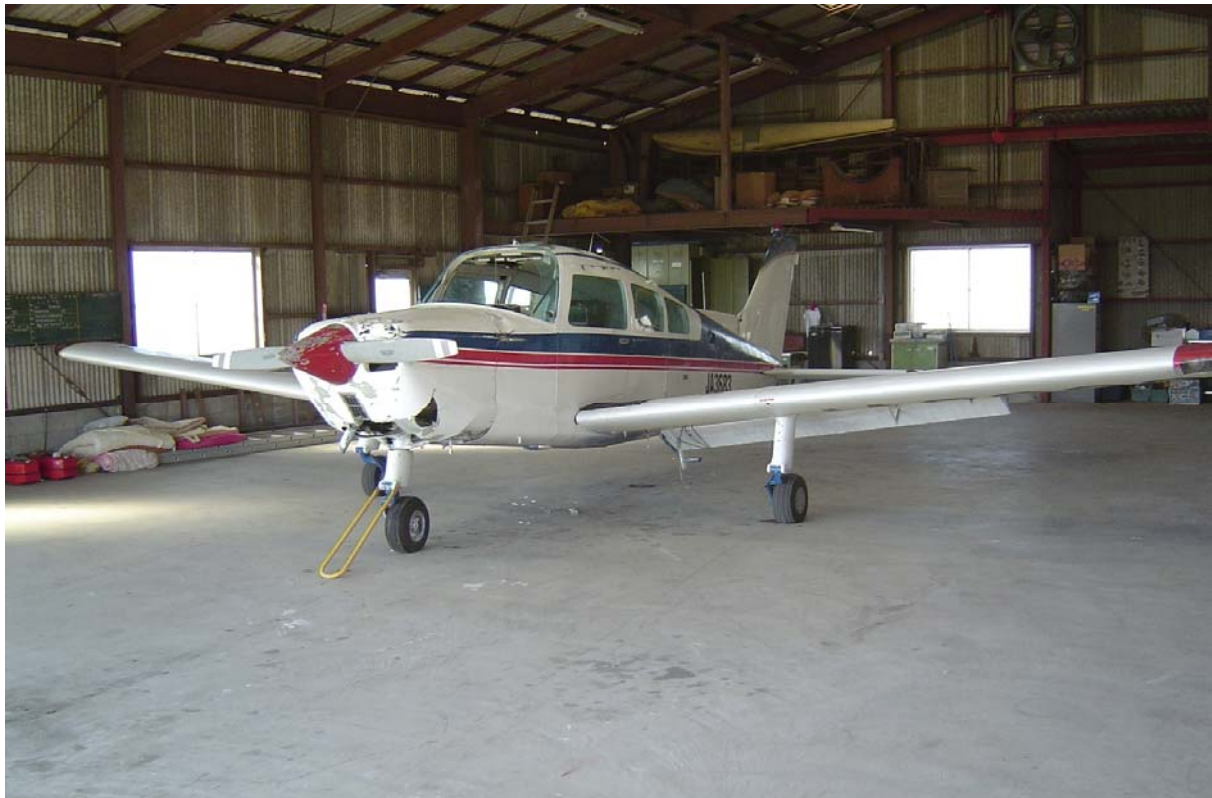
Photograph Serious Incident Aircraft

- | | |

| (1) Aircraft nose lower section and windshield: | damaged |
| (2) Left flap attachment area: | fractured |

(See Photograph)
