**AIRCRAFT SERIOUS INCIDENT  
INVESTIGATION REPORT**

**PRIVATELY OWNED  
JA3842**

## CONTINUOUS LOSS OF ENGINE POWER PRIVATELY OWNED BEEHCRAFT A36, JA3842, AT AN ALTITUDE OF ABOUT 300 M AND 4 KM NORTHWEST OF FUKUI AIRPORT AT ABOUT 15:36 JST, OCTOBER 15, 2017

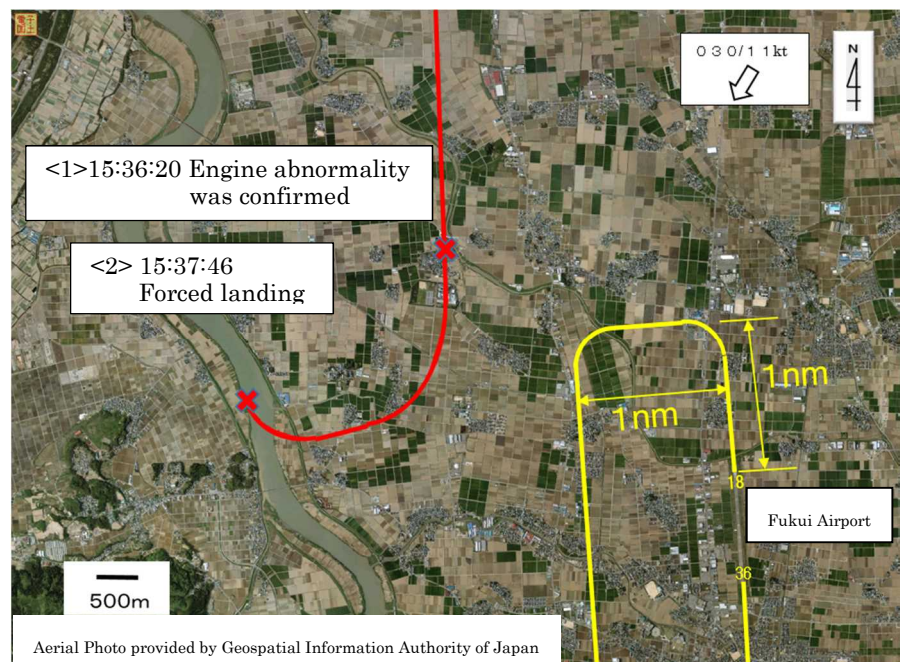
Photo 2 Estimated flight route based on records on the GPS  
(<1> and <2> were what estimated based on records on the drive recorder for vehicles installed in the Aircraft.)

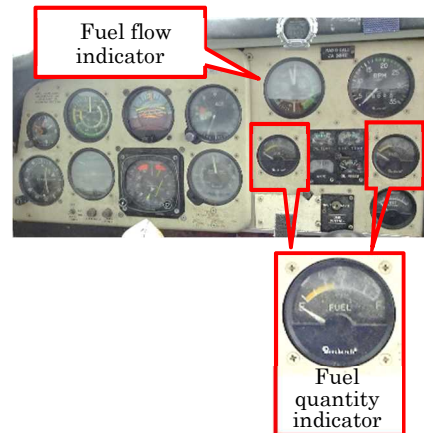
Photo 3 Instrument panel

The Aircraft is equipped with fuel quantity indicators corresponding to the right tank and the left tank respectively in the middle of the instrumental panel, and a fuel flow indicator just above the left fuel quantity indicator.
