**AIRCRAFT SERIOUS INCIDENT
INVESTIGATION REPORT**

**JAPAN COAST GUARD
J A 3 9 3 A**

LOWER PART OF AFT FUSELAGE CONTACT ON RUNWAY
DURING GO-AROUND
JAPAN COAST GUARD
TEXTRON AVIATION 172S, JA393A
KITAKYUSHU AIRPORT, FUKUOKA PREFECTURE
AT 11:30 JST, FEBRUARY 3, 2021

January 7, 2022

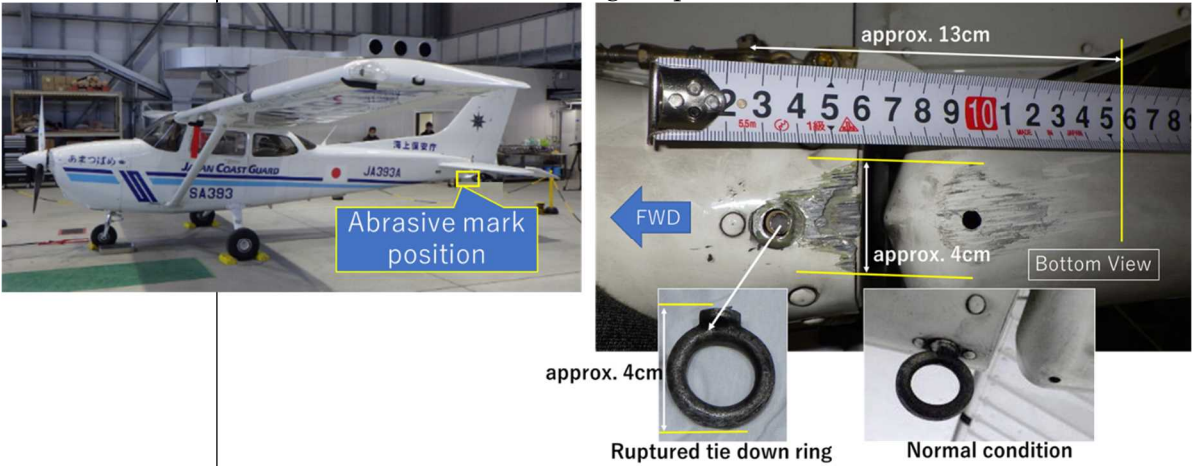
<p>2.2 Injuries to Persons</p>	<p>None</p>
<p>2.3 Damage to the Aircraft</p>	<p>(1) Extent of damage: slightly damaged (2) Damage conditions of the aircraft (see Figure 1)</p> <p>Lower part of the aft fuselage: abrasive marks of approximately 13 cm long and approximately 4 cm wide</p> <p>Tie down ring: Ruptured</p>

<p>Figure 1 Damage conditions of the aircraft</p> <p>(3) Runway conditions</p> <p>Two abrasive marks (approximately : 30 cm and 10 cm long) with approximately 40 cm interval were confirmed on the runway approximately 580 m from runway 36 threshold and approximately 2 m to the right from the centerline (see Figure 2).</p> <p>Besides, the tie down ring of the aircraft was found near the said position.</p>

The aircraft executed go-around because of the instable attitude at a low altitude. The JTSB concludes that it is probable that the tie-down ring contacted on the runway surface and ruptured before turning to climb and the outer skin of the lower part of the aft fuselage subsequently contacted the runway surface that caused two abrasive marks to generate on the runway surface since the aircraft was performing nose-up steering to halt descent and because of the nose-up effect by maximized output during go-around.

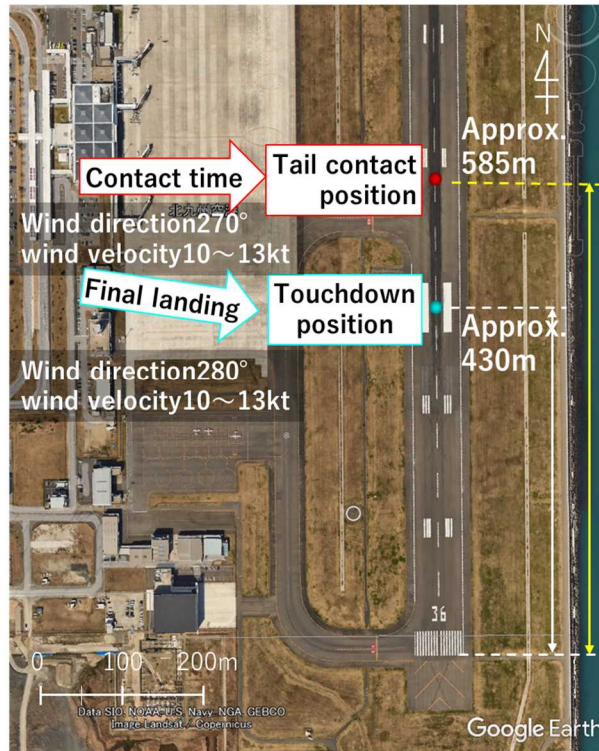
Figure 3 Contact (Touchdown) position

Time (hour)	till 10	till 11	till 12	till 13	till 14																														
Wind direction/velocity (degrees/kt)	250/10	310/13	310/13	310/13	310/13																														
Crosswind component of the runway (kt)	9	8	8	8	8																														
Time of observation (time: minute)	10:00	11:00	12:00																																
Wind direction (degrees)	250	290	300																																
Wind velocity/maximum instantaneous wind velocity (kt)	10	13	14/24																																
Prevailing visibility (km)	10 or more																																		
<p>2.7 Additional Information</p>	<p>(1) Record of flight data in the integrated flight deck</p> <p>The aircraft was installed with the integrated flight deck (GARMIN G1000) that can display and record various flight data. Flight data logging function of the system recorded flight data (hereinafter referred to as “the Data”) since April 2017.</p> <p>Besides, the Data were recorded every second.</p> <p>(i) Contact position of the approach when the lower part of the aft fuselage contacted on the ground (hereinafter referred to as “the Contact Time”) recorded in the Data was approximately 585 m from runway 36 threshold, and touchdown position at the final landing time (hereinafter referred to as “the Final Landing Time”) was approximately 430 m from runway 36 threshold (see Figure 3).</p>

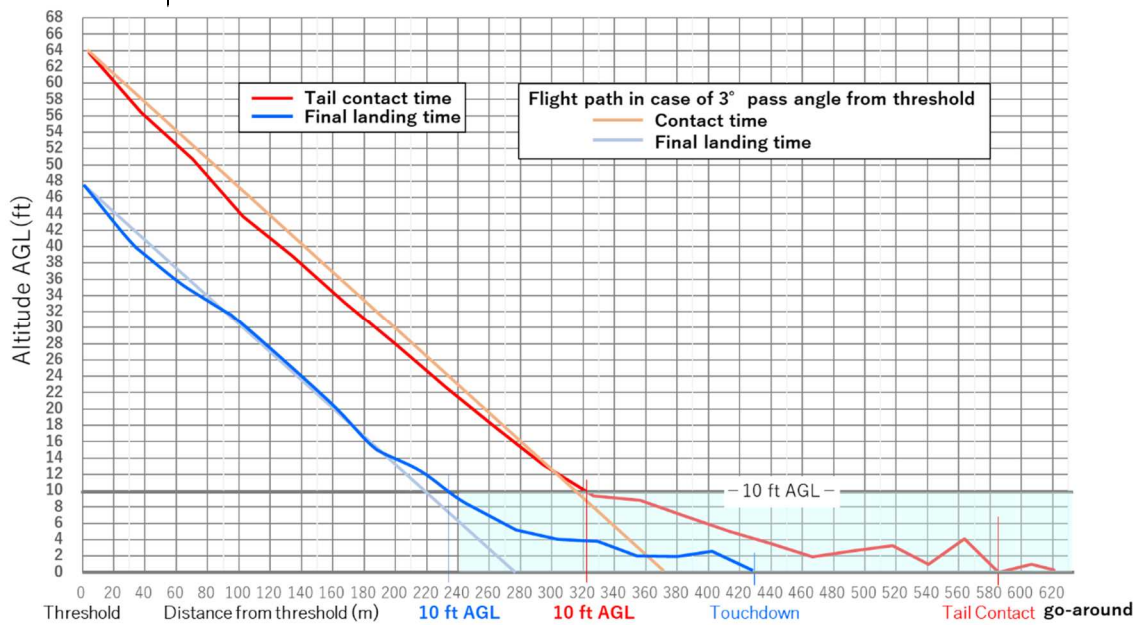
Figure 4 Comparative flight paths from the threshold to the contact (touchdown)

(ii) Comparative flight paths from the runway threshold to the contact (touchdown) between the Contact Time and the Final Landing Time recorded in the Data were as shown in Figure 4. Flight paths at the path angle of 3° of the aircraft from each AGL of the runway threshold were added as a reference (see Figure 4).

<p>Figure 4 Comparative flight routes from runway threshold to the contact (touchdown)</p>	<p>1. From threshold to 10 ft AGL</p> <p>The aircraft passed threshold at approximately 16 ft higher AGL at the Contact Time than the Final Landing Time and approached along the path angle of approximately 3° at both times.</p> <p>2. After 10 ft AGL</p> <p>At the Contact Time, the path angle temporarily became shallow after the aircraft had passed at approximately 10 ft AGL. It is highly probable that this is response of the aircraft to the nose-up control inputs since the Trainee stated that he or she confusedly performed nose-up maneuvering by pulling control column because the aircraft was shaken by the winds at approximately 10 ft AGL and sunk.</p> <p>Flying distance from 10 ft AGL to the contact (touchdown) was approximately 260 m at the Contact Time and approximately 200 m at the Final Landing Time, respectively. Besides, the path angle was instable with an altitude fluctuating up and down after approximately 520 m from threshold at the Contact Time.</p>

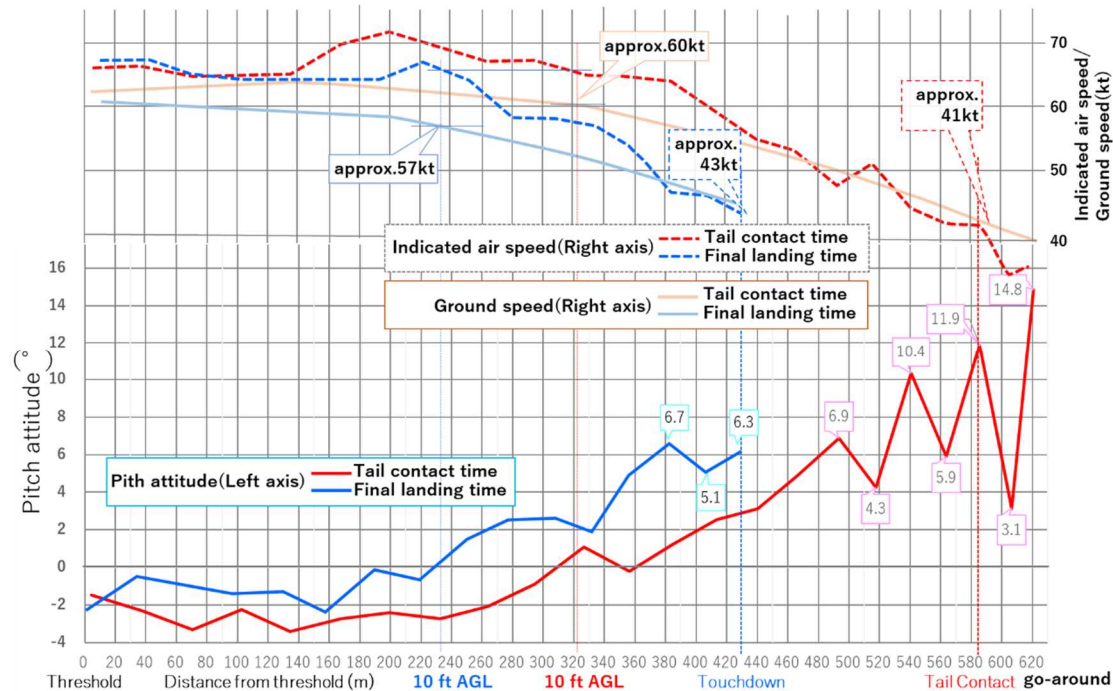
Figure 5 Comparison of pitch attitude (°), indicated air speed and ground speed

(iii) Comparative pitch attitude, indicated air speed, ground speed, roll attitude and vertical acceleration from the runway threshold to the contact (touchdown) between the Contact Time and the Final Landing Time recorded in the Data were as shown in Figures 5, 6 and 7.

Besides, the records of the fuel flow rate and rotational speed of the engine revealed that the go-around commenced approximately one second before the contact. Stall speed at the time of flap full-down was 40 kt indicated air speed.

Pitch attitude at the Contact Time suddenly turned to nose down from the previous nose up at the position of approximately 490 m from threshold, which was then followed by diverging the fluctuation of nose up and nose down repeatedly.

It is highly probable that the aircraft encountered the turbulence just before touchdown, and it is large nose up maneuver performed under the influence of the turbulence caused the pitch angle of the aircraft to diverge and the speed to decrease since the Trainee stated that he or she performed nose-up maneuvering by pulling control column as the aircraft was shaken by the winds and sunk, subsequently maneuvered further nose-up because the aircraft did not stop sinking. Besides, it is possible that the turbulence was induced by the effect of hangar wave (described later) that generated by the westerly winds passing over buildings such as the hangar, etc. located in the west side of the runway.

While indicated air speed at the time of passing through at 10 ft AGL was approximately 65 kt at both times, ground speed was 60 kt at the Contact Time and 57 kt at the Final Landing Time. In the case of wind velocity of 13 kt notified by the Kitakyushu Tower, wind direction at 10 ft AGL computed by ground speed and wind velocity was 295° at the Contact Time and 310° at the Final Landing Time, which indicated that

<p>it is possible that wind direction at the Contact Time was more westerly than the Final Landing Time.</p> <p>Besides, indicated air speed at the Contact Time was 41 kt, less than indicated air speed (43 kt) at the Final Landing time, both of which, however, maintained stall speed or higher.</p>
	Figure 6 Roll attitude	<p>At the Contact Time, left roll became large forming left roll angle of 9° immediately before contact. Then, rapid roll to the right occurred and contacted. Roll rate at that time was as high as 8° /second, which is probable to have been difficult to be corrected by instantly steering.</p> <p>The right roll is likely to have generated by relative increase of the ratio of crosswind component from the left against air speed as a result of the decreased air speed.</p> <p>At the Final Landing Time, approach was conducted with left wing-low method in response to left crosswind.</p>

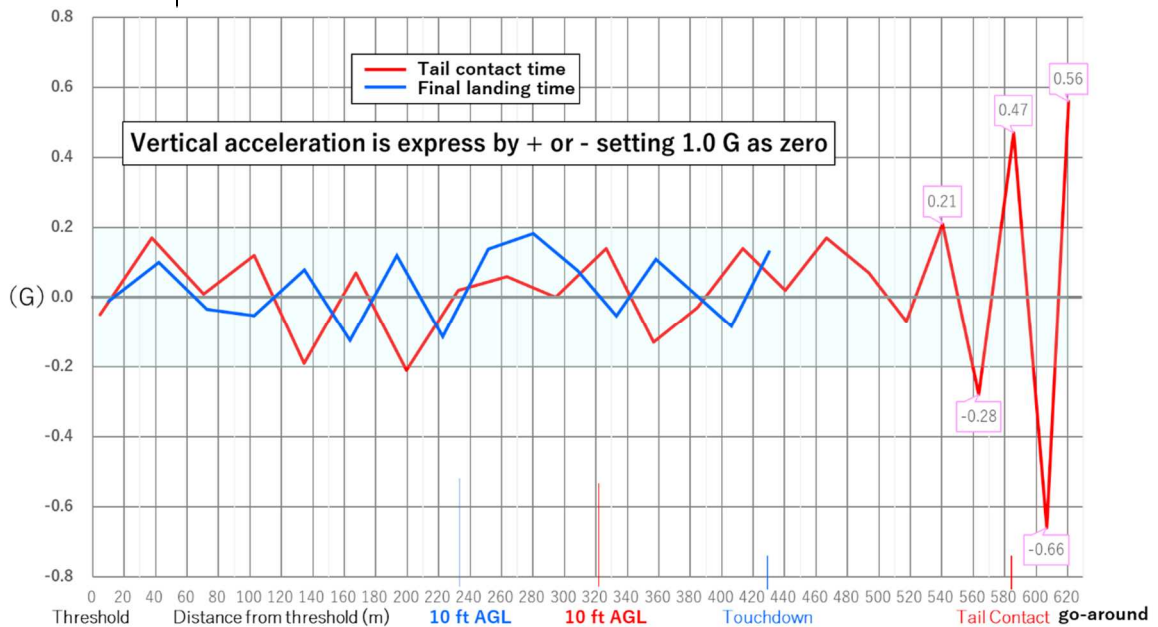
Figure 7 Comparative vertical acceleration (G)

Focusing on the change in vertical acceleration before landing shown in Figure 7, the Final Landing Time within plus or minus 0.2G, but the Contact Time exceeded plus or minus 0.2G, with a maximum of 0.47G and a maximum rate of change was 0.75G per second.

Figure 7 Vertical acceleration	<p>At the Contact Time, vertical acceleration tends to diverge in conjunction with the pitch attitude and fluctuated from plus to minus.</p> <p>At the Final Landing Time, vertical acceleration was stable staying within 0.18 G.</p>

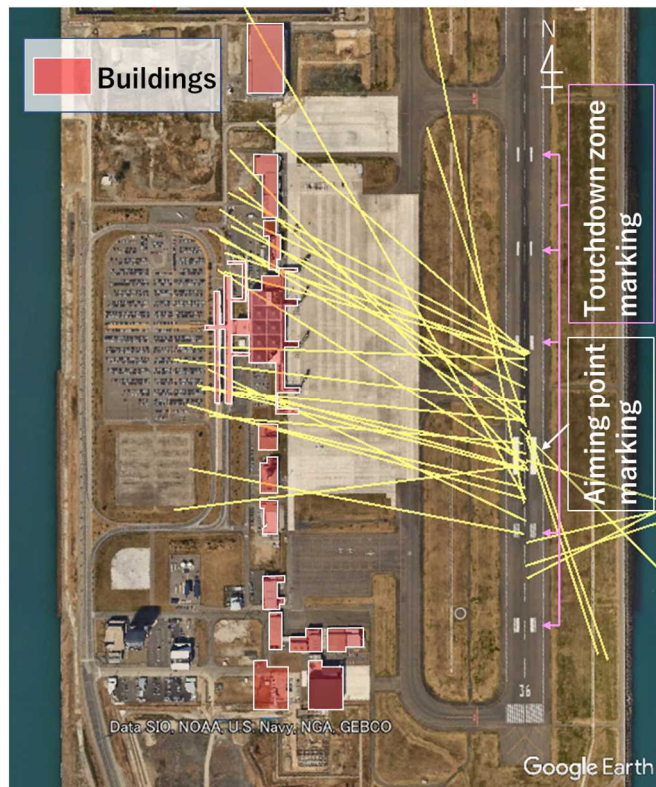
Figure 8 Positions and relevant wind directions of the cases of vertical acceleration exceeding plus or minus 0.2 G before landing

Positions and relevant wind directions of these 34 cases with fluctuations of vertical acceleration exceeding plus or minus 0.2 G before landing are drawn in the aerodrome map (see Figure 8).

(ii) From Figure 8, in the case of shaking by vertical acceleration exceeding plus or minus 0.2 G before landing in the touchdown zone of runway 36, northwesterly winds blowing from the west were dominant.

In the case of the winds from between west to northwest, it is possible that the touchdown zone that was on the leeward of the buildings was influenced by the hangar wave since the airport building and hangar were located in the said direction. Besides, the positions where aircraft shook varied even in the same wind direction. It is probable that this was due to the extent, which was influenced by the hangar wave, widely ranged from north to south since the buildings were also located widely ranging from north to south at the airport.
