**AIRCRAFT ACCIDENT
INVESTIGATION REPORT**

**PRIVATELY OWNED
JA3989**

CRASH INTO THE VICINITY OF THE MOUNTAINTOP

CESSNA 172P, JA3989

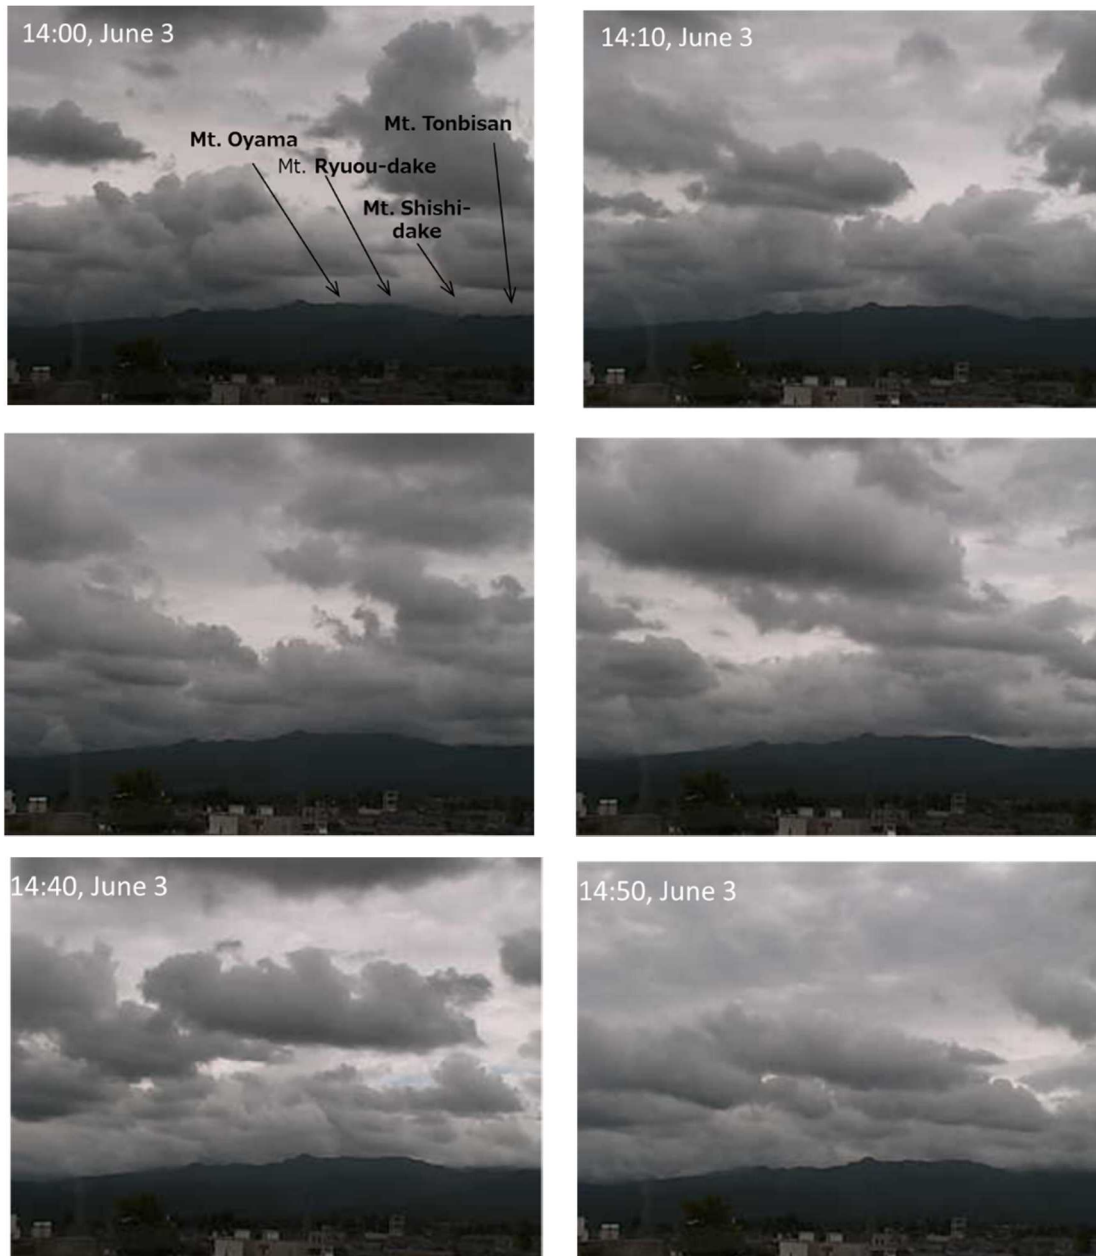
Photo 1: Images of the Tateyama Mountain Range taken by the Live Camera at Tateyama Town Hall (Position A in Figure 1)

time period when the accident occurred, and there did not seem to be any space between the mountaintop and the cloud base as shown in Photo 1.

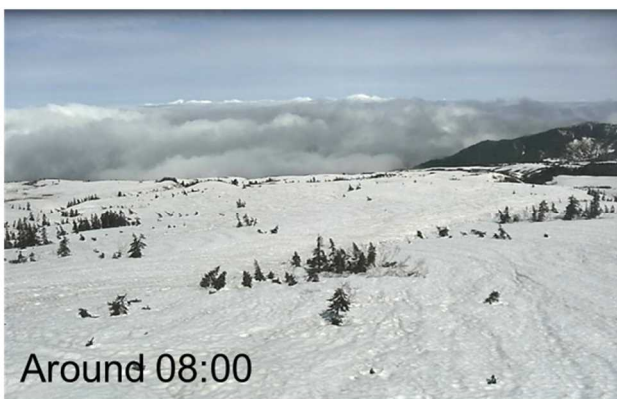
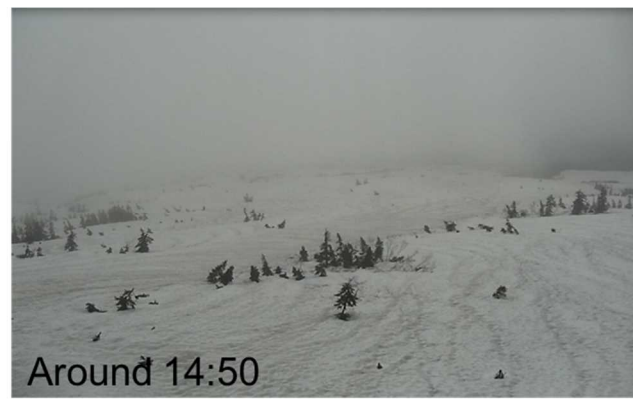
Photo 3: Images taken by the Live Camera at Midagahara (Position C in Figure 1)

It was confirmed that the Tateyama Mountain Range, Midagahara and the Tateyama Caldera²¹ were covered with clouds during the time period when the accident occurred by checking the live camera images in Photo 2 (taken at Tateyama Ashikura Hometown Exchange Center: Position B in Figure 1), those of Midagahara in Photo 3 (taken at Midagahara at an elevation of about 2,300 m: Position C in Figure 1), and the live camera images of the Tateyama Caldera in Photo 4 (taken at the Tateyama Caldera Observatory at an elevation of about 2,015 m: Position D in Figure 1), respectively.

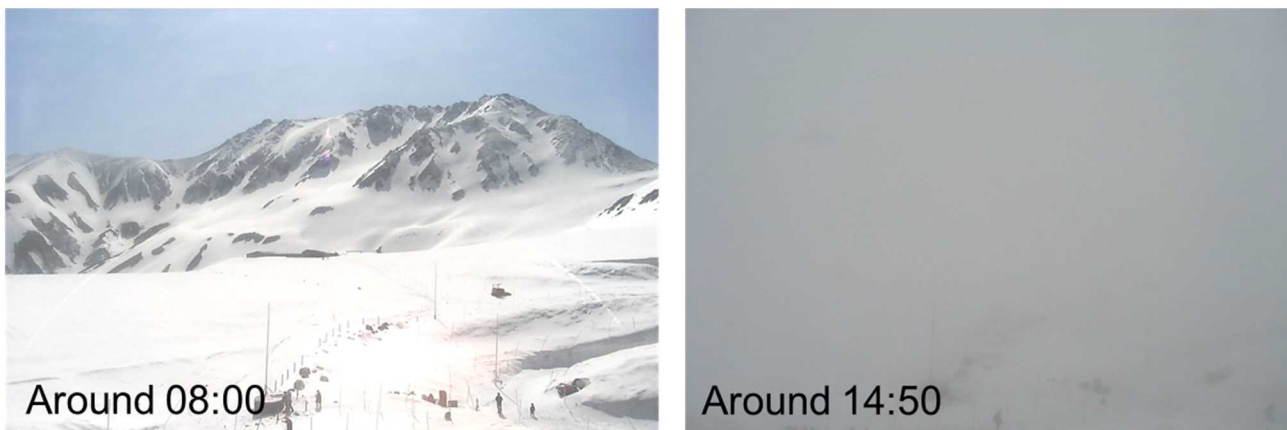
Photo 5: Images taken by the Live Camera
at Murodo (Position E in Figure 1)

With Photo 5 showing the images taken by the live camera at Murodo at an elevation of about 2,450 m (Position E in Figure 1), it was confirmed that the weather conditions in the Tateyama Mountain Range were good in the morning of the day of the accident, however, in the afternoon, clouds were gradually generated and clouds filled the entire screen during almost all the time including the time when the accident occurred.

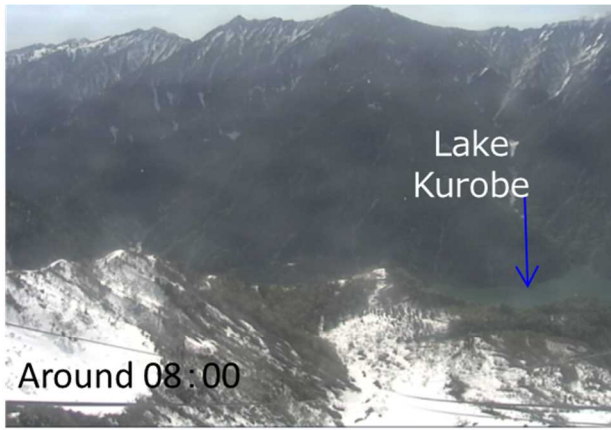
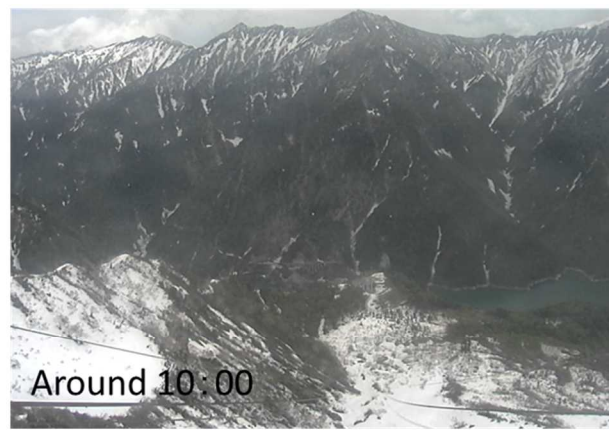
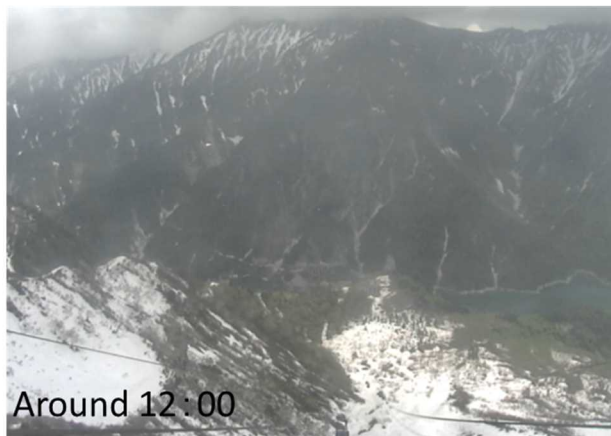
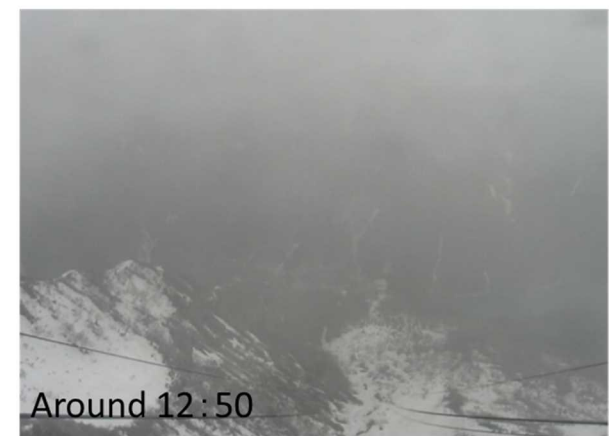
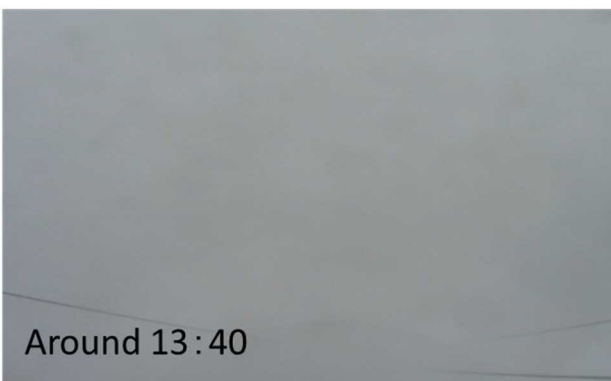
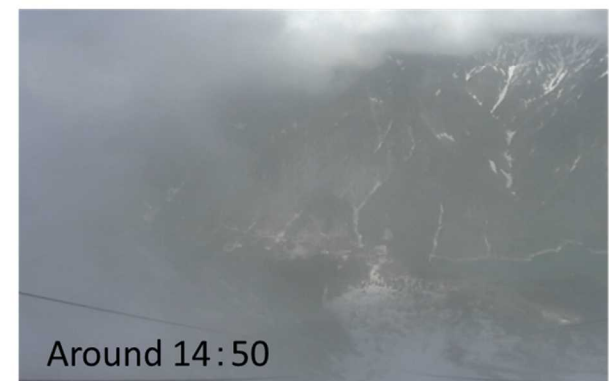
Photo 6: Images of the eastern part of the Tateyama Mountain Range taken by the Live Camera at Daikanbou (Position F in Figure 1)

Besides, in Photo 6 showing the images taken by the live camera at Daikanbou at an elevation of about 2,316 m (Position F in Figure 1), it was confirmed that the weather conditions in the eastern part of the Tateyama Mountain Range were also good in the morning of the day of the accident, however, visibility rapidly deteriorated in the afternoon.

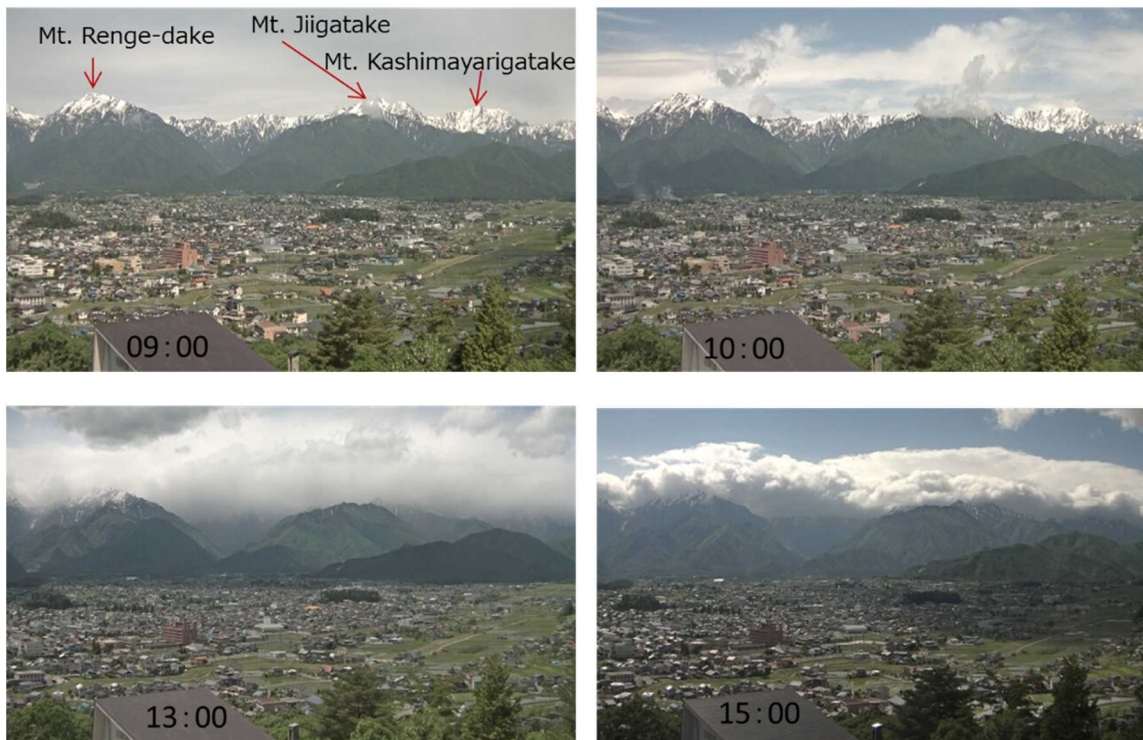
Photo 7: Images of the Ushiroateyama Mountain Range taken by the Live Camera at the Mountain Museum in Omachi Town, Nagano Prefecture

In the images (Photo 7) of the Ushiroateyama Mountain Range²², which consists of Mt. Kashimayarigatake, Mt. Jiigatake and Mt. Renge-dake, taken by the live camera at the Mountain Museum in Omachi City, Nagano Prefecture, it was confirmed that the weather conditions were generally good from 09:00 to 10:00 when the Aircraft flew over Omachi City, however, the mountaintop was covered with the cumulus-like cloud from 13:00 to 15:00.

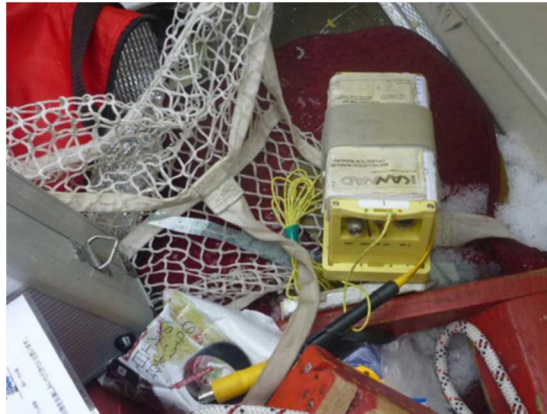
Photo 8: The ELT of the Aircraft when it was found

All the acrylic windows of the Aircraft were broken, the fixed bracket for the right front seat was broken and dislocated from the right position. The right side door was broken and left open and the fixed bracket for the aft seat was completely broken off. The protective net for the luggage area in the back of the seat was detached and got entangled with the ELT that was crashing onto the floor and sounding operating alarm with its switch ON. In addition, the auxiliary antenna for

the ELT was broken with a snap.

When the Aircraft was found, the ELT was lying on the floor under the aft seat with its operation panel switch ON. The auxiliary antenna for the ELT was broken with a snap.

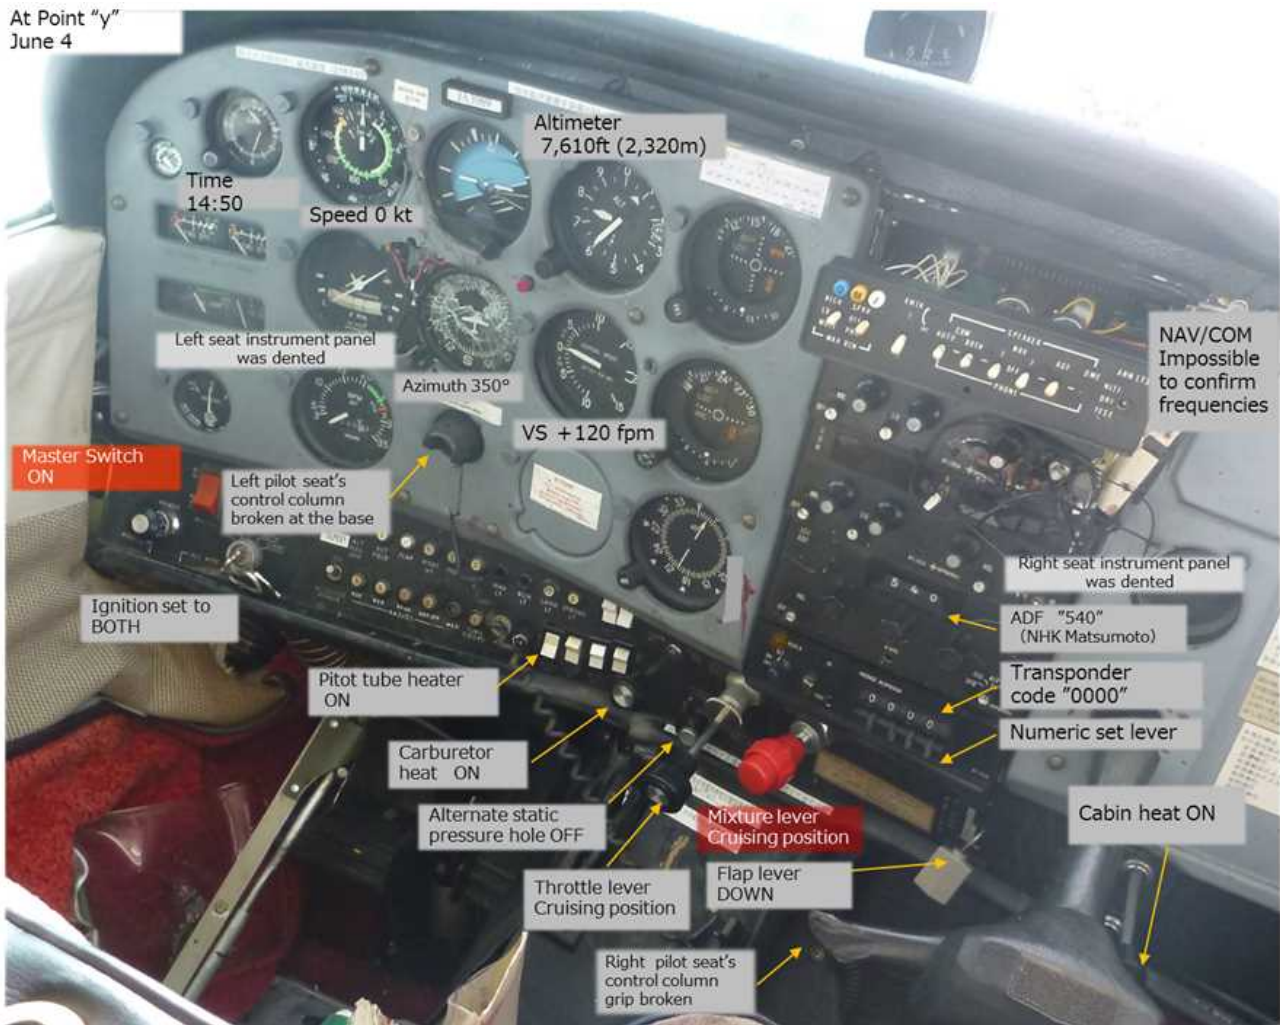
Photo 9: Situation of Cockpit Instrument Panels

- The VHF radio: The settings of the frequencies were not confirmed since it was broken both for communication and navigation.
- Automatic Direction Finder (ADF): It was set to NHK Matsumoto TV Station (540 kHz)

- Transponder Code: 0000 (The numeric set lever was set to Down position.)
- The cabin heat control was set to ON.

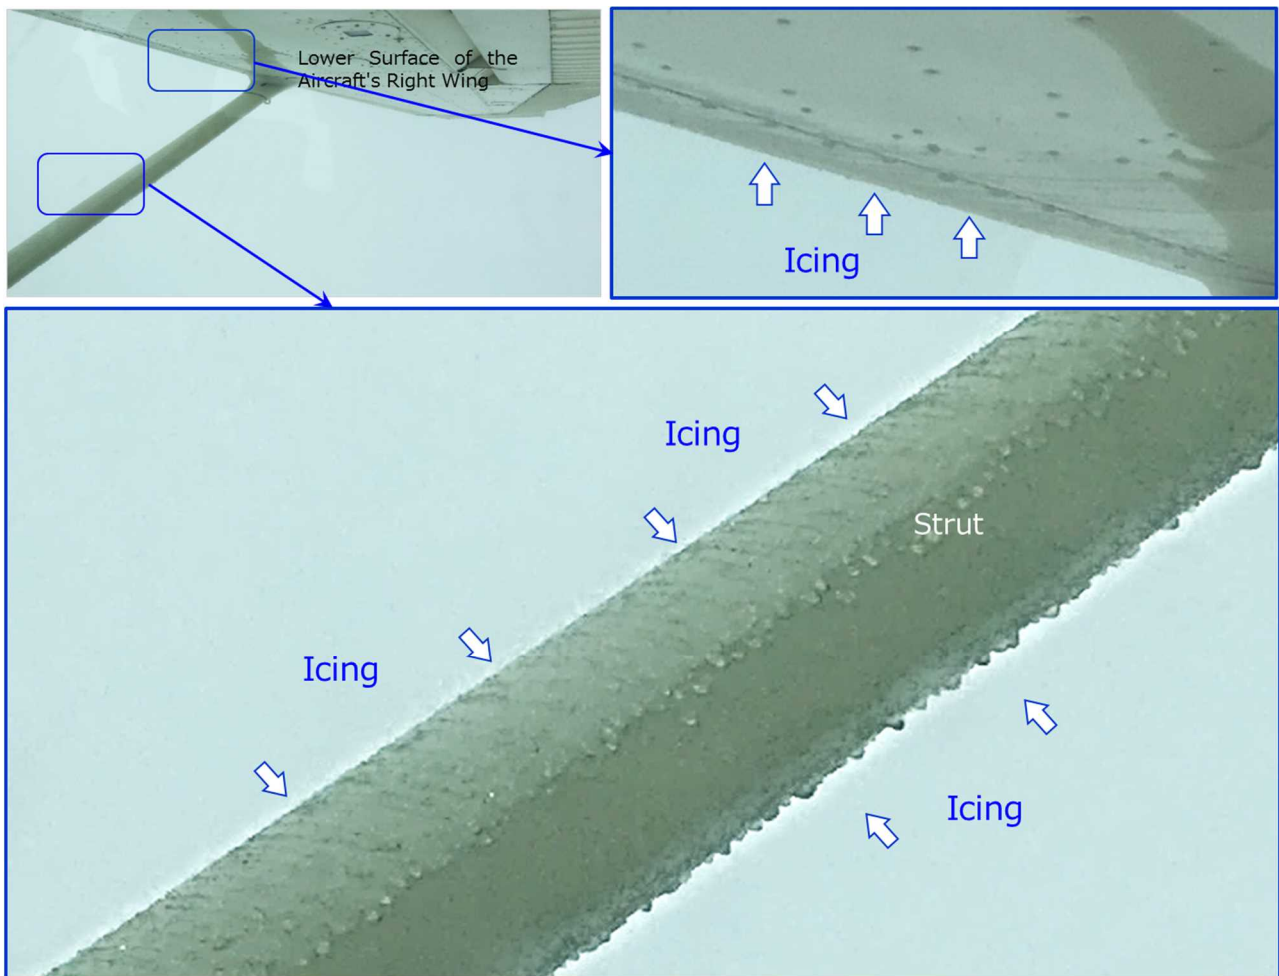
Photo 12: Enlarged Photo of the Leading Edge and Strut of the Right Wing

⁴² Color gradation is provided in the “Enlarged Photo” in order to make clear the icing conditions.

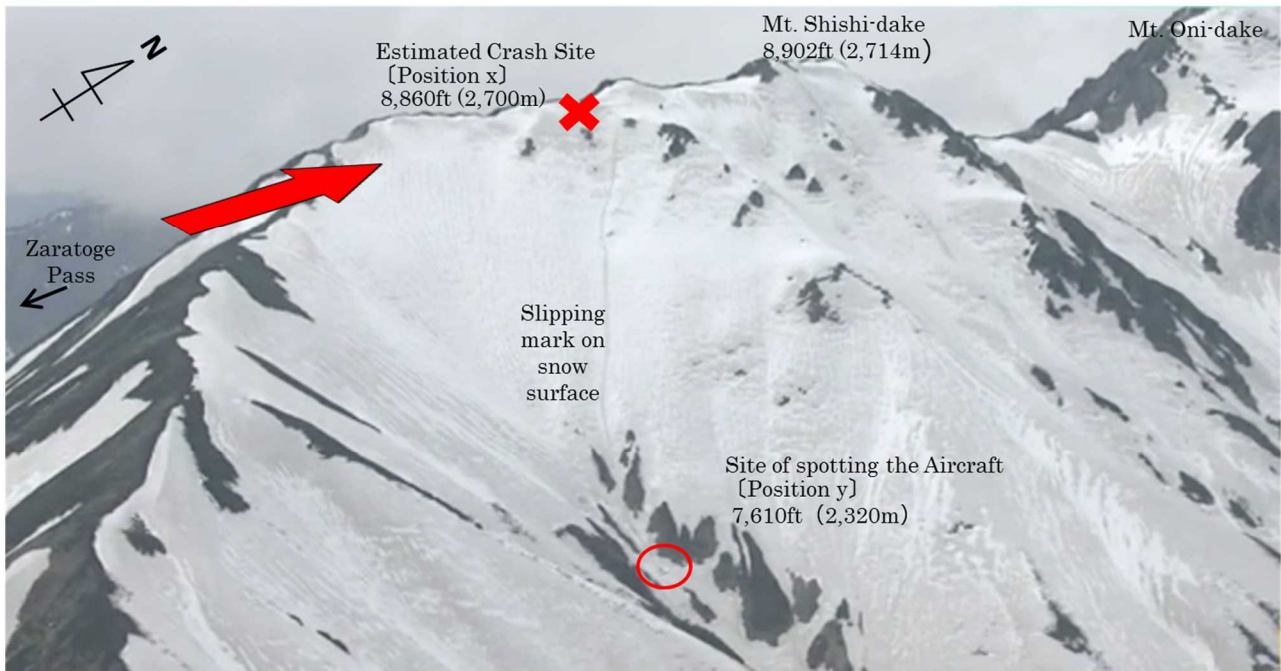
Appended Figure 6: Estimated Crash Site, Marks and Traces

On the south eastern snowy slope about 10 m downhill from the top of Mt. Shishi-dake where plenty of snow remained, there were two marks in parallel with the mountain ridge. (Point x: elevation about 2,700 m). Beside those marks, there were the nose landing gear with its struts equipped, and the left main landing gear beams. Further from that point on, two smartphones for Passenger A and Passenger B were found. Along those marks, there was the rock ridge around where many pieces of the Aircraft such as the left main wheel tire, pieces of the acrylic side windows, the broken control column in the left pilot's seat and others were scattered.

The marks that the Aircraft had slid down the slope were left along the snowy slope from the rock ridge in the vicinity of the mountaintop toward the valley. On this slope, there were also many pieces of the broken Aircraft, its flight manual and others were discovered. Further from that point onto the valley, there were the marks left by the Aircraft that had slid down the slope. A little above the point where the main body of the Aircraft was discovered on June 4 (Point y: elevation about 2,320 m), there was the engine with its propeller equipped. On June 11, the Aircraft was found to have further slid down the slope to the downstream point (Point z: elevation about 1,970 m).

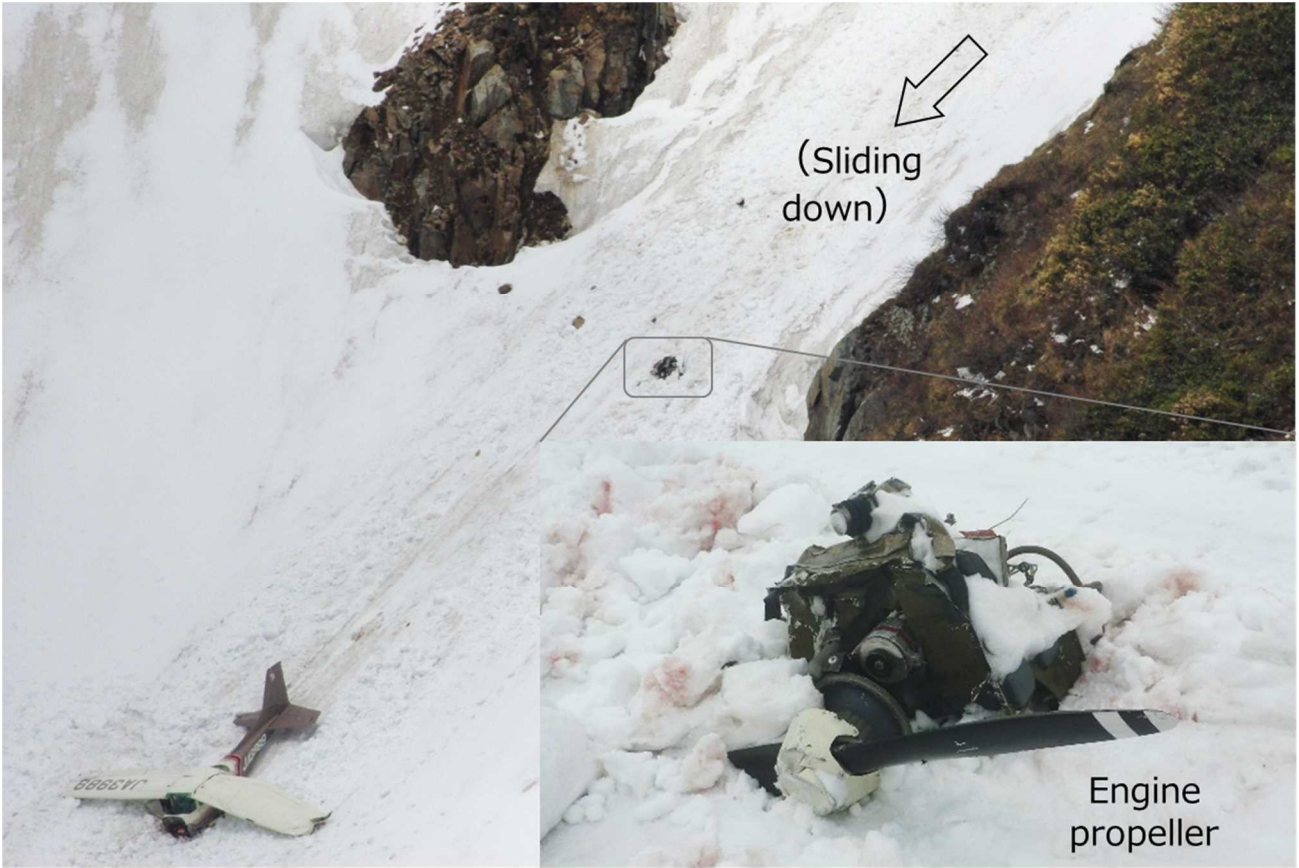
Appended Figure 8: The Aircraft Found at the Accident Site

| (1) Fuselage | Broken |
| (2) Wing | Broken |
| (3) Empennage | Broken |

- (4) Engine Broken, detached from the fuselage
- (5) Propeller Damaged
- (6) Landing gears Broken, detached from the fuselage
