**AIRCRAFT SERIOUS INCIDENT  
INVESTIGATION REPORT**

**J A 4 0 5 8**

**Japan Transport Safety Board**

**PRIVATELY OWNED PIPER PA-46-310P, JA4058  
ON THE TAXIWAY N-2 OF TOKUSHIMA AERODROME  
AT ABOUT 10:58 JST, OCTOBER 11, 2009**

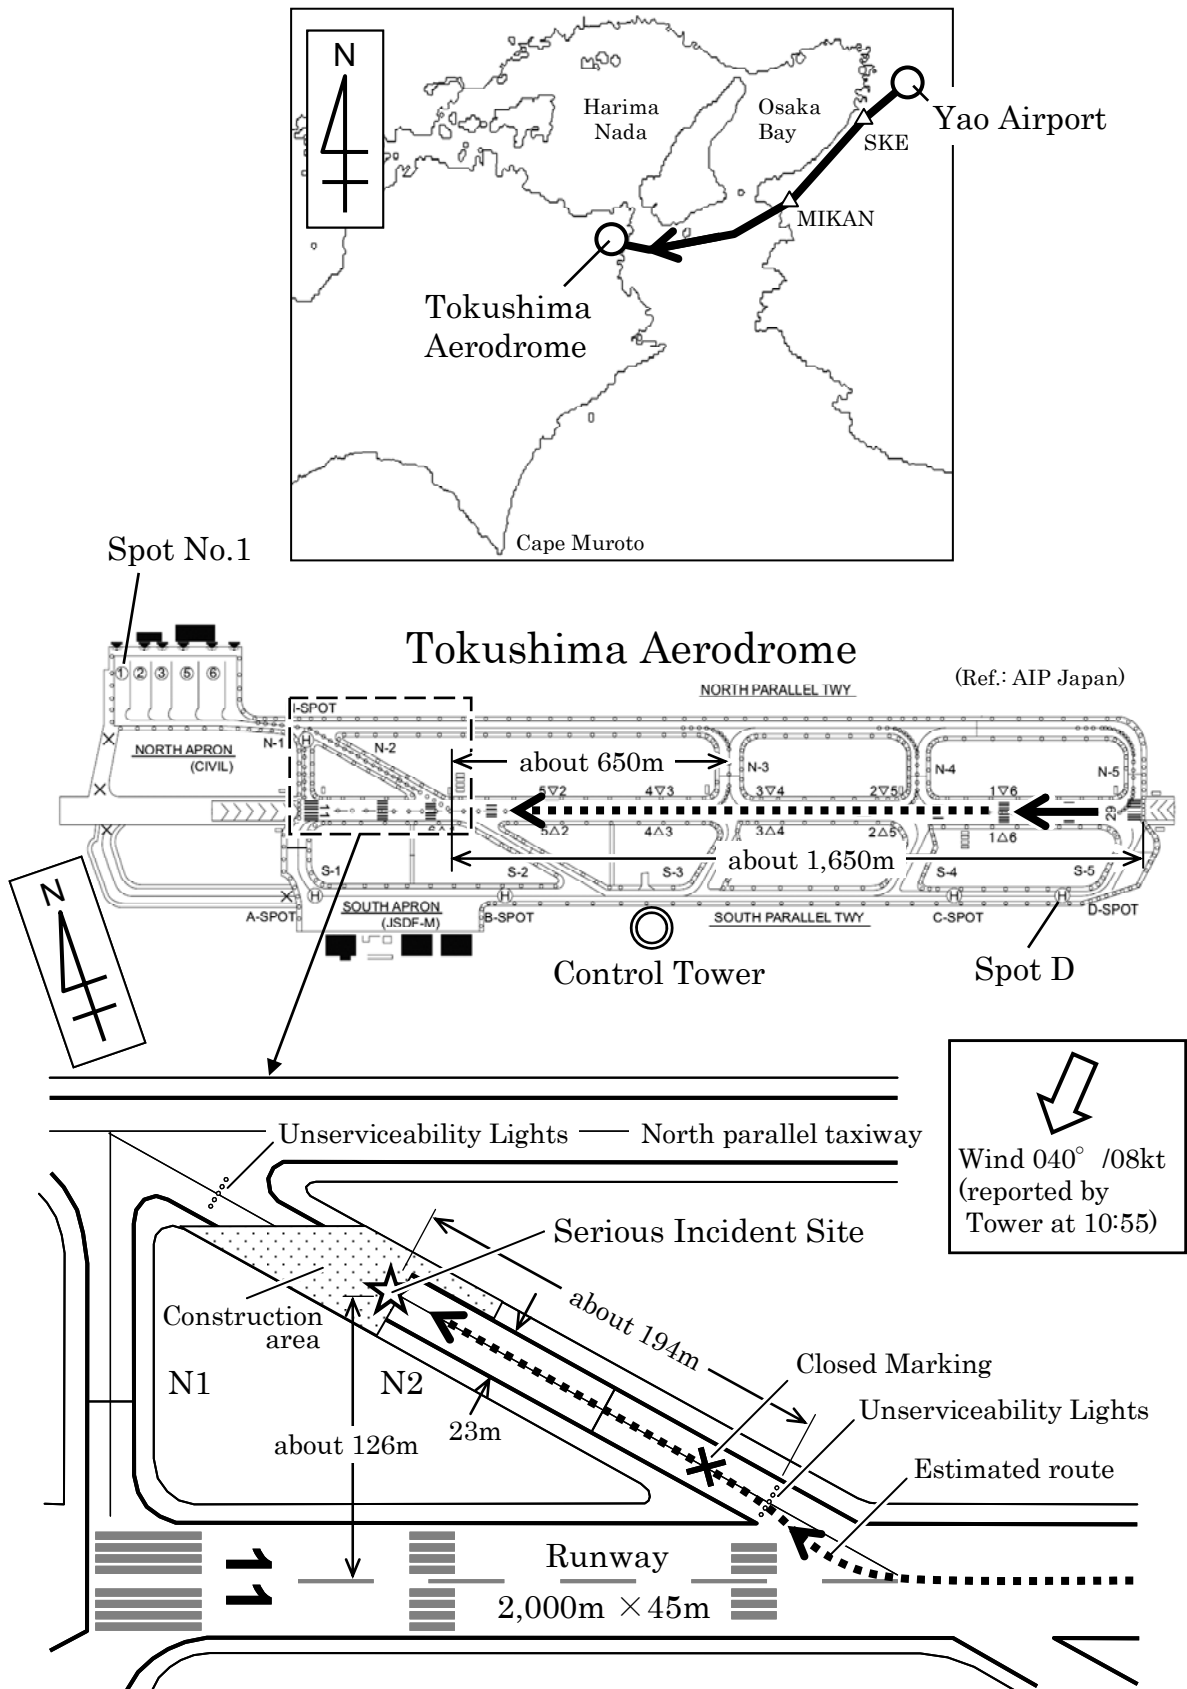
Figure 1 Estimated Flight (Taxiing) Route

As described in 2.9.1, there were no brake marks around the area where the Aircraft stopped by hitting its nose to the ground. In addition, as described in 2.8.3 and Figure 1, it is considered probable that if the Aircraft had entered N2 from the runway, it would have taxied for over 200 meters up to the construction area which would have left enough time to correct the operation of entering N2, slightly overshooting before reaching the construction area, and that if the captain had noticed the construction area ahead, he would have dealt with the situation by stopping immediately or turning around.

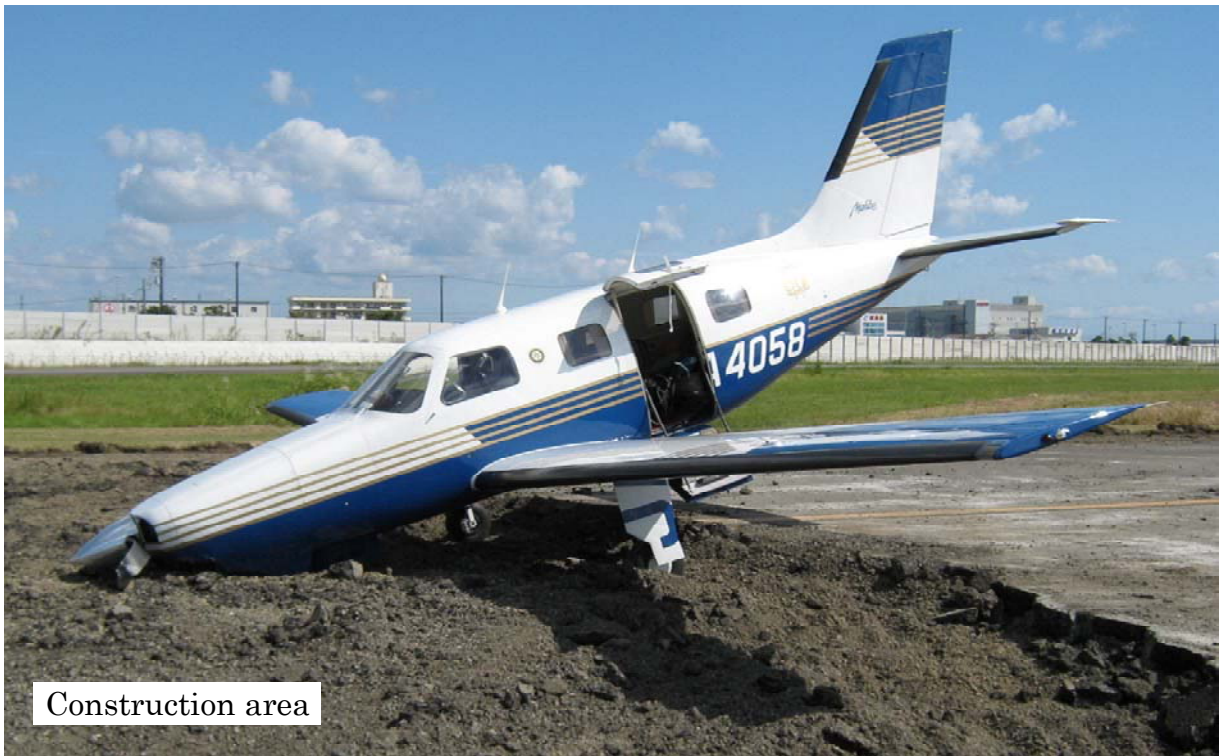
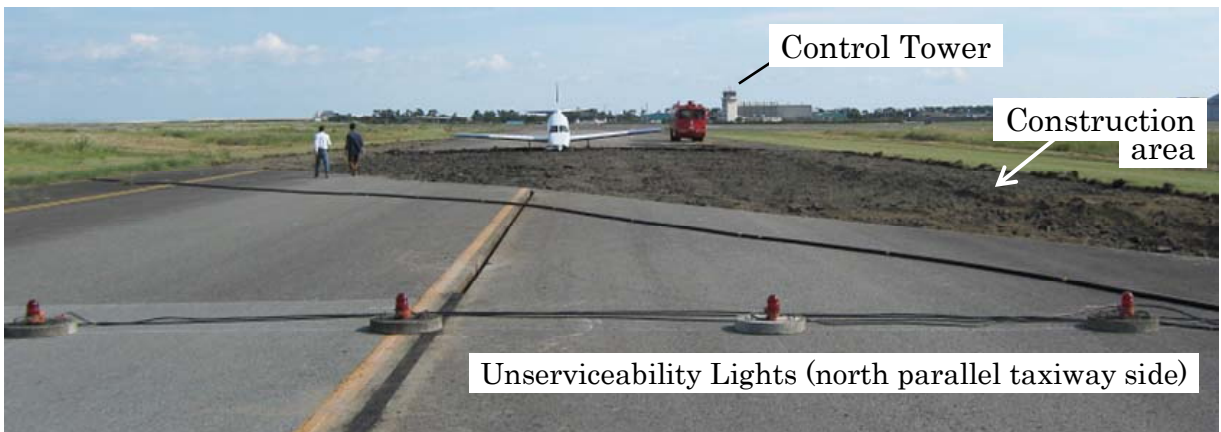
# Photo 1 Serious Incident Site

from the unserviceability lights of the runway side. It was uneven ground, where the paved surface was removed and the gravel was exposed. The ground around where the Aircraft stopped by hitting its nose to the ground was 30cm deep from the paved surface.

The serious incident site was on N2 at the Aerodrome, within the construction area 126m north from the runway centerline. The Aircraft stopped by hitting its nose to the ground on the taxiway centerline with its nose facing the civil apron. There were no brake marks around.

Construction area

The Aircraft

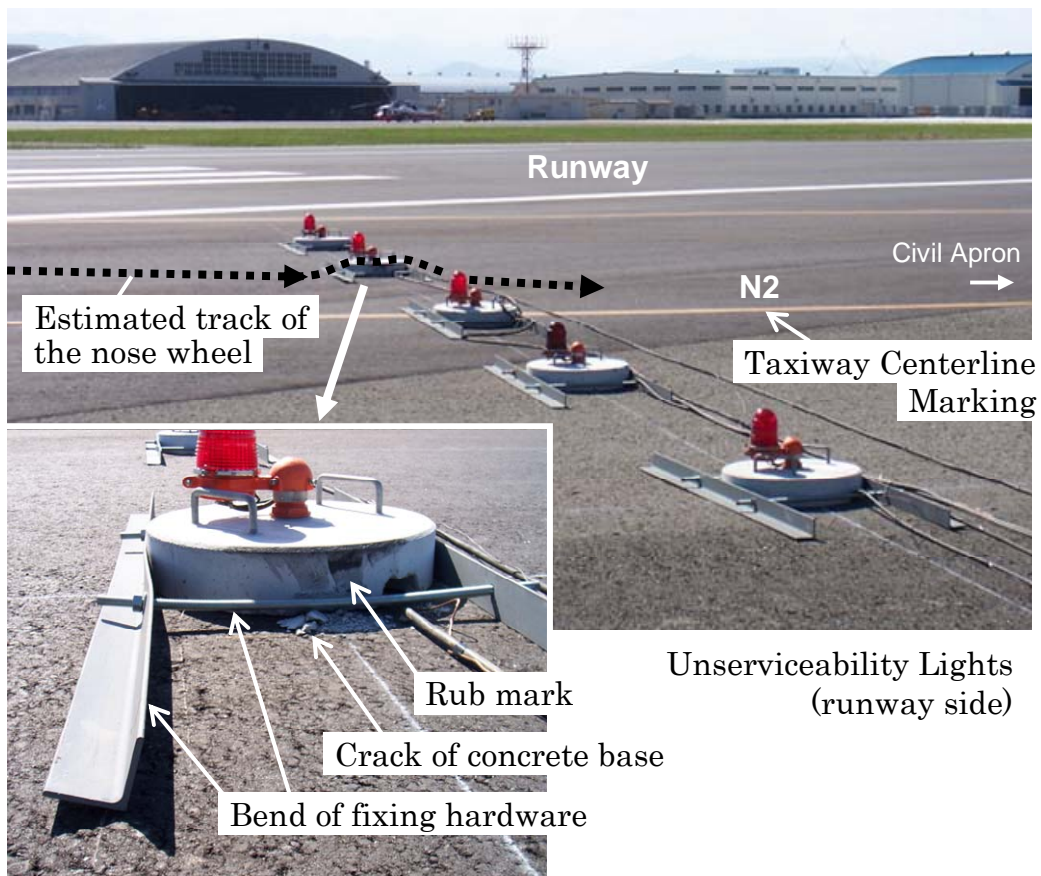
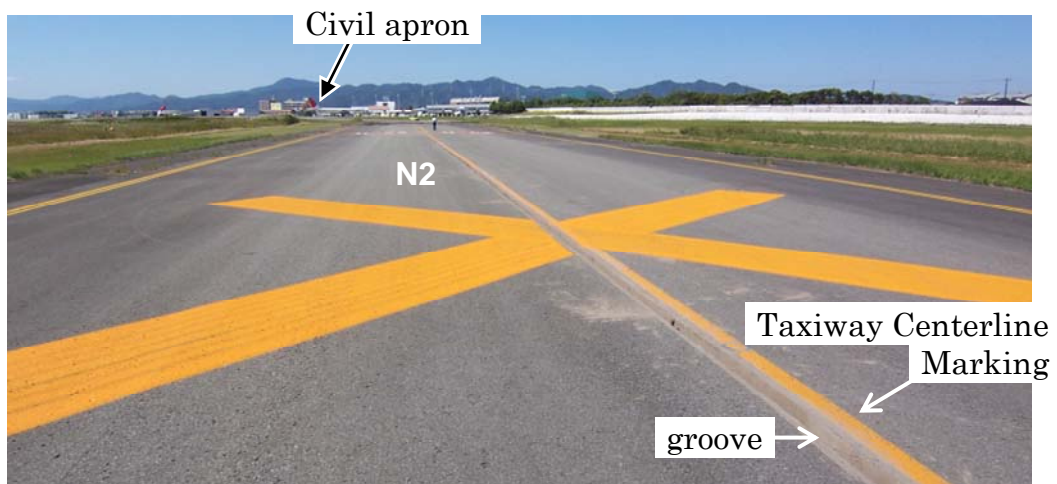
## Photo 2 Unserviceability Lights and Closed Marking

When this serious incident occurred, unserviceability lights (five aeronautical red lights: placed at about 3m intervals), which indicate to the aircrafts the unserviceability area in the aerodrome, were located on the entrance of N2 from the runway side and the entrance of N2 from the north parallel taxiway side. However, the lights were off as it was clear daytime.

The closed marking (yellow “X” mark) was displayed on N2 beyond the unserviceability lights on the runway side.

There was black rub mark at the concrete base of the second left light, as viewed from the runway side, of the unserviceability lights at the entrance of N2 from the runway side. And a part of the concrete was chipped off. The fixing hardware of the base was bent, and position of the base was misaligned.

Unserviceability Lights (north parallel taxiway side)

Closed Marking

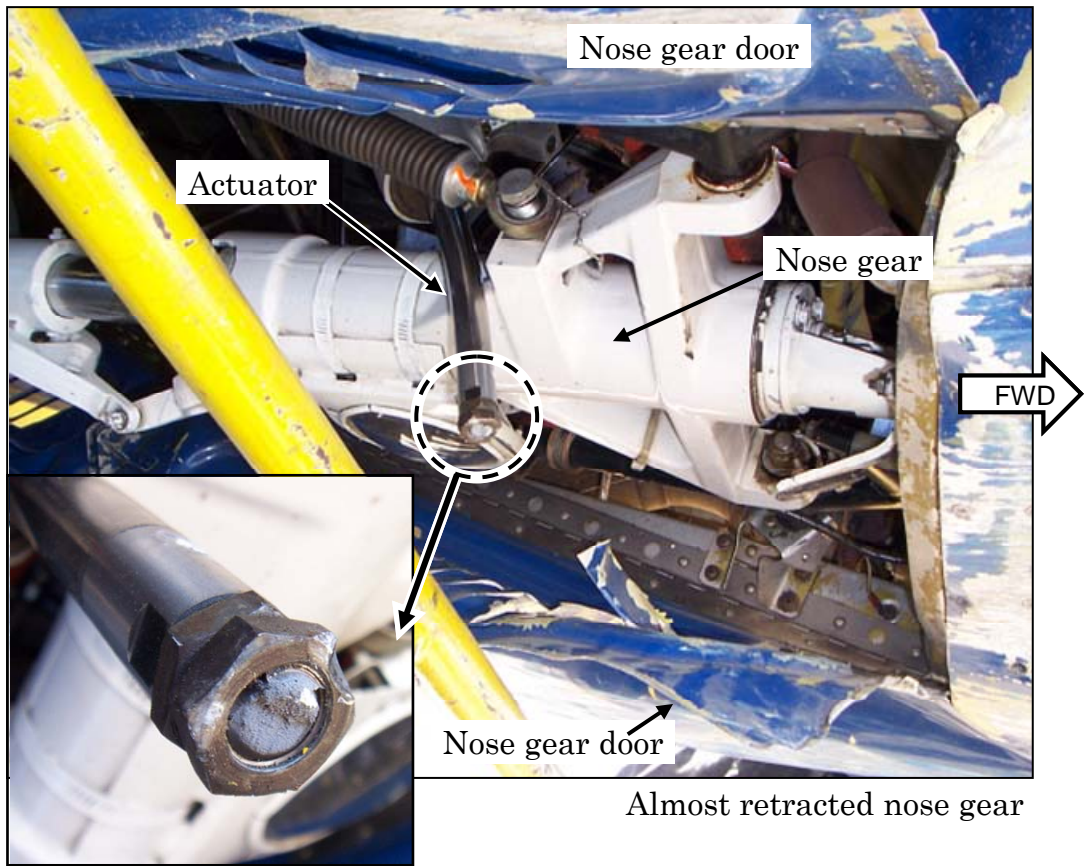
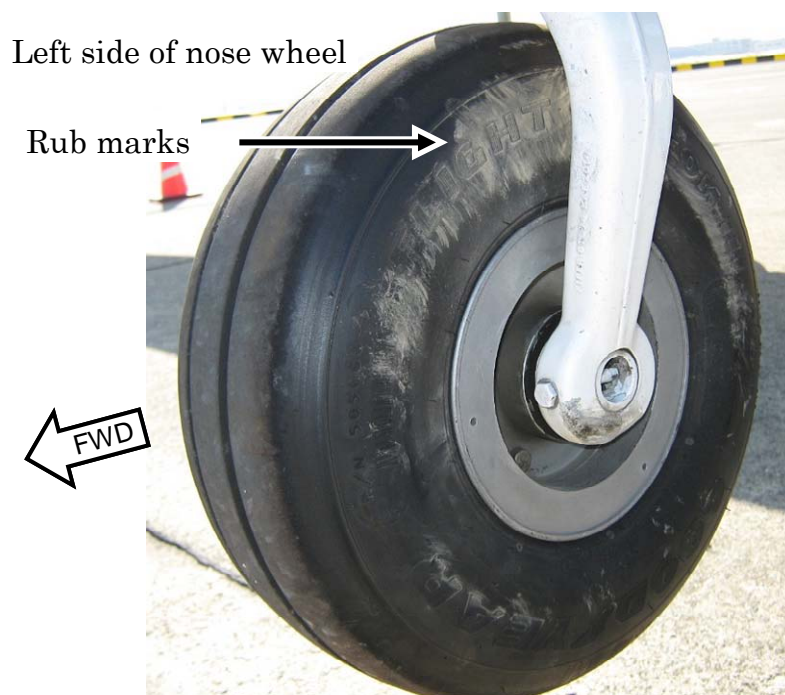
Photo 3 Damage Situation and Rub Marks of the Nose Wheel

Nose Landing Gear                      The actuator was broken.

Fuselage                                      The bottom of engine cowling and the nose landing gear

door were damaged.

The nose landing gear and both of the main landing gears of the Aircraft entered the construction area of N2 from the runway side. The nose landing gear leaned backwards in the retracting direction, and the bottom of the engine cowling touched the gravel. The actuator of the nose landing gear was broken at the mounting point, and the bottom of the engine cowling and the nose gear doors were damaged.

The tips of the two propellers were bent, and one side of the spinner was scarred.

There were white rub marks on the left side of the nose wheel.

Fractured part of the actuator
