**AIRCRAFT ACCIDENT  
INVESTIGATION REPORT**

**J A 4 1 0 6**

**Japan Transport Safety Board**

**PRIVATELY OWNED SOCATA TB10, JA4106  
IN THE SEA, ABOUT 200 METERS EAST  
OF RUNWAY B, NAGASAKI AIRPORT,  
AT ABOUT 17:23 JST, JULY 26, 2008**

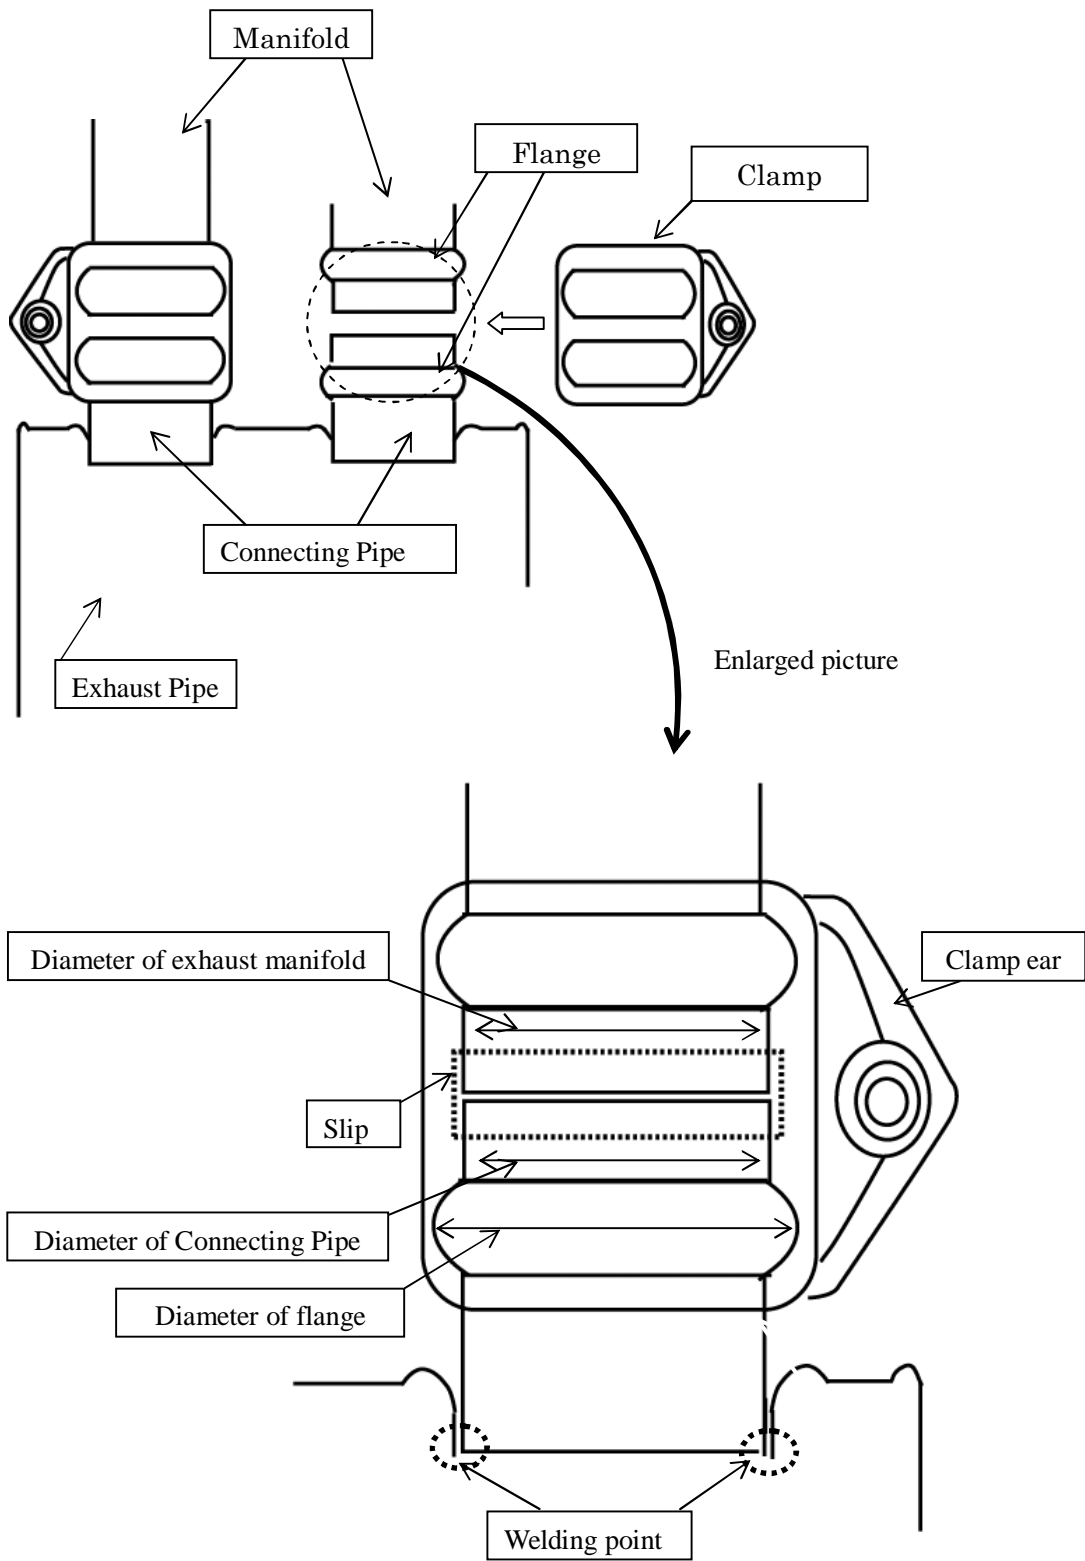
**Figure5 Connecting Pipe of the Exhaust Pipe**

Each Connecting Pipe sustained significant damage in the area corresponding to the gap between the clamp ears. Among the Connecting pipes, the LH Front Connecting Pipe had a part with some material missing, from which a crack extended lengthwise to the welded joint, while the pipe end retained its original roundness and was free of any crushing or other deformation. Further inspection of the three other Connecting Pipes also found the following defects: the Connecting Pipe for the LH rear manifold (hereinafter referred to as “the LH Rear Connecting Pipe”) was deformed with some material missing and was angled forward including its root portion; and both the Connecting Pipe for the RH front manifold (hereinafter referred to as “the RH Front Connecting Pipe”) and the Connecting Pipe for the RH rear manifold (hereinafter referred to as “the RH Rear Connecting Pipe”) were deformed with an outward crest at the location corresponding to the gap between the clamp ears. In addition, all Slips were deformed at their ends while all Connecting Pipes and clamps were corroded.

As described in 2.7.2 (1), each Connecting Pipe sustained significant damage in the area corresponding to the gap between the ears of the clamp. The damage was a crest-shaped deformation on the right-hand Connecting Pipes and missing material and cracks on the left-hand Connecting Pipes. As described in 2.11.6 (2), the ears of every clamp were found touching each other.

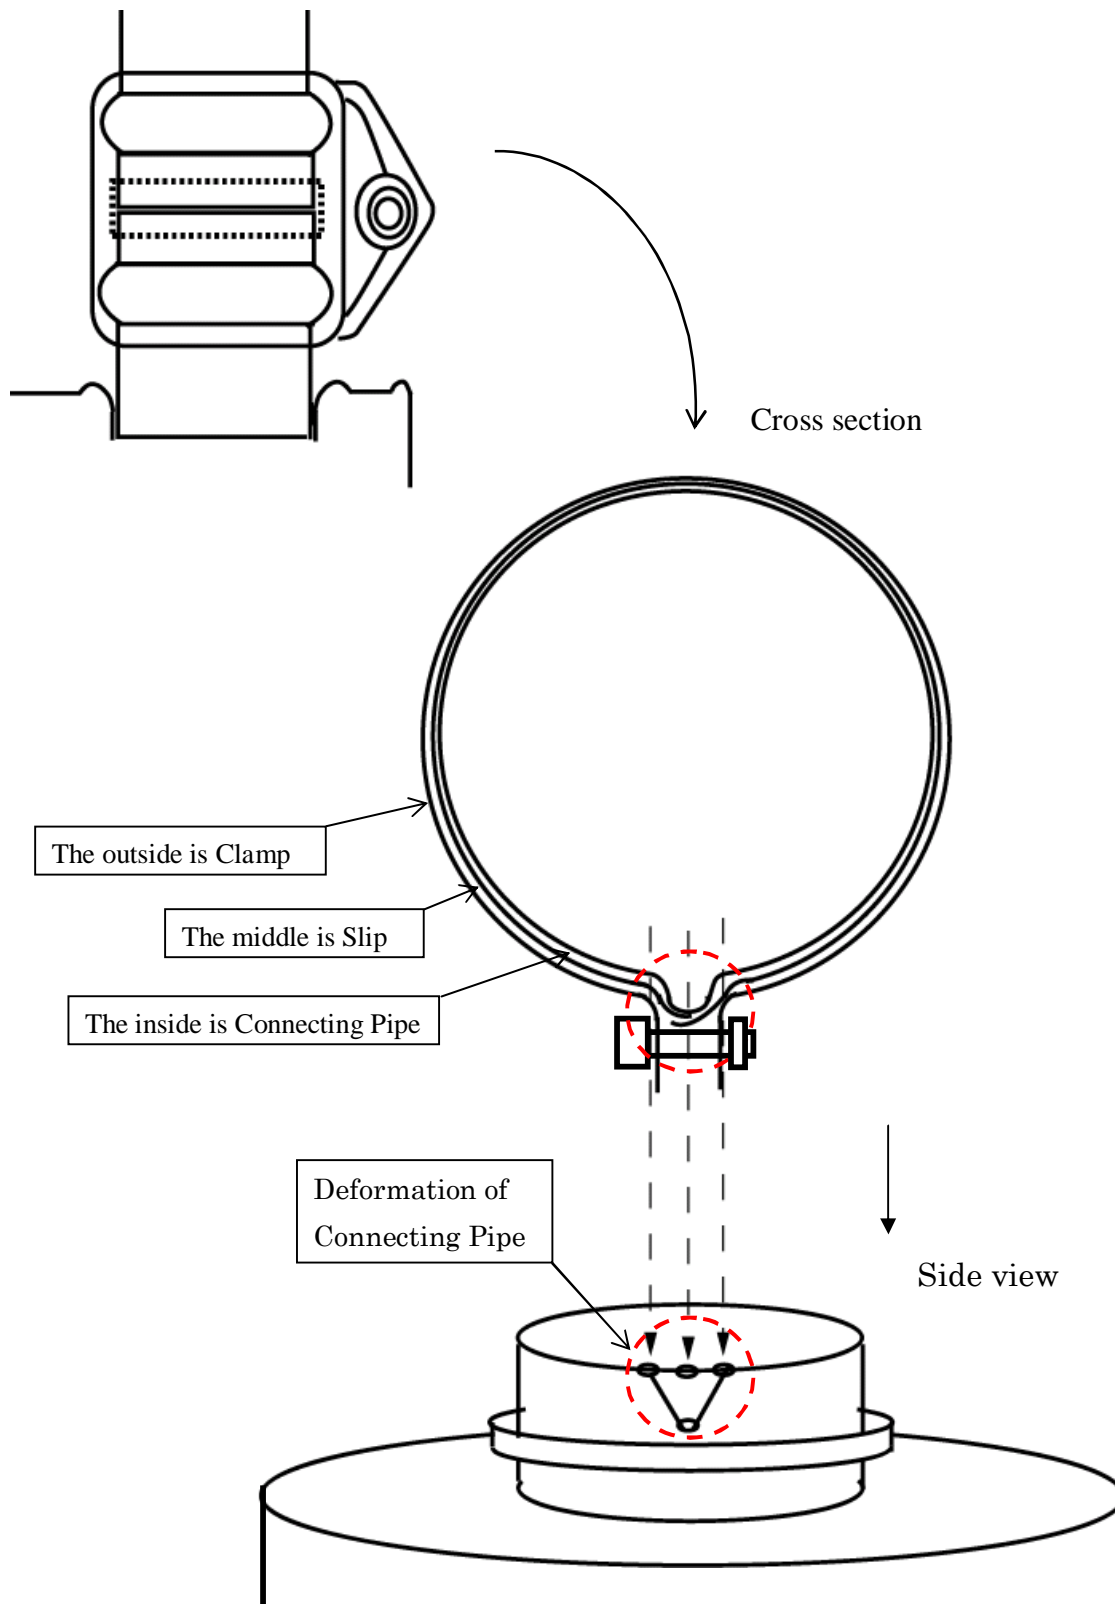
**Figure 6 Deformation of Connecting Pipe by Tightening of Clamp**

As described in 2.11.2 (4) 2, the maintenance manual states in the instructions under the Caution heading that the clamp ears should not be in contact with each other. However, as described in 2.11.6 (2) ①, the ears were found in contact with each other for all the exhaust pipe side clamps. Therefore, it is considered highly probable that the clamps were not tightened respecting this instruction in the maintenance manual. In addition, as described in 2.11.6 (2) ③, despite the fact that a clamp can be installed on the periphery of a Connecting Pipe at any angle as long as the ears do not interfere with other component parts, missing material and deformation were found at only one location on every Connecting Pipe and any damage that would have been caused by excessive clamp tightening was not found in any other areas on the pipe. As described in 2.5.4, the exhaust pipe had been used on the Aircraft for about nine years. Considering that every Connecting Pipe had missing material or deformation in just one location even though three different contractors had worked on the Aircraft for the annual 100-hour and 50-hour checks during that period and the areas in question were inspected a total of 18 times including the parts replacement operation conducted on September 9, 2004, it is considered possible that the procedure in the maintenance manual described in 2.11.2 was not respected.

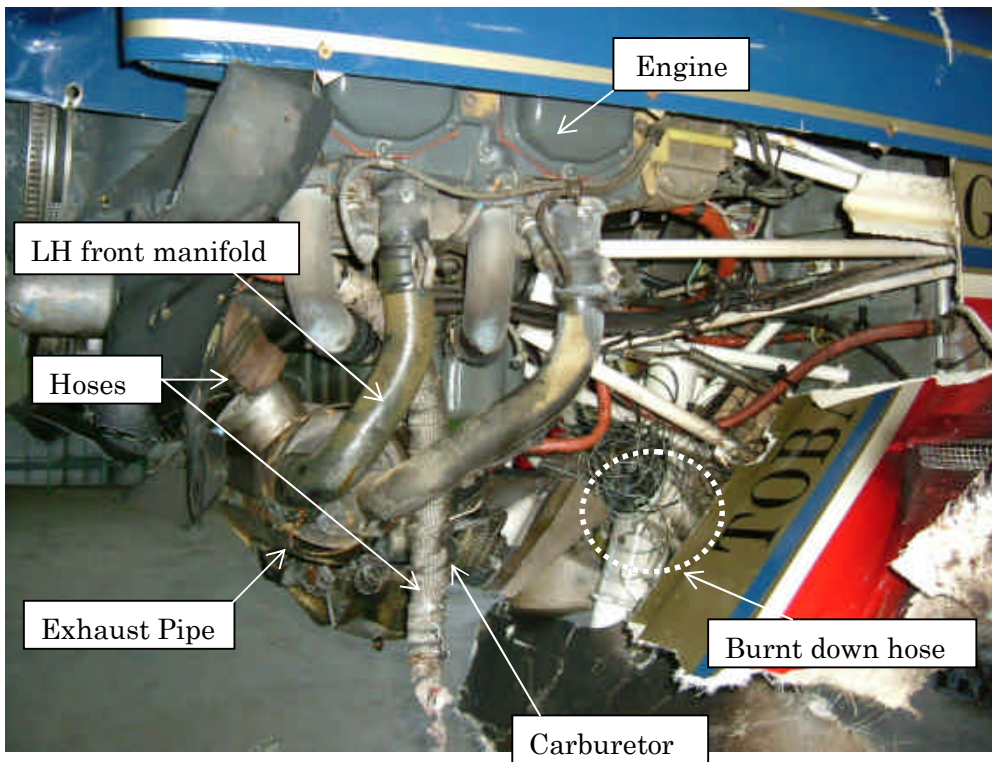
**Photo 2 Lower Left Area of the Burned Engine**

Grayish-white deposits and soot were found on the left side surface of the exhaust pipe and the clamps there. The heat exchanger installed over the exhaust pipe had a dent in the left front area, and the exhaust pipe was found shifted rearward.

The Cowlings were found with significant burn damage, with some portions destroyed by fire, in the areas corresponding to the detached Connecting Pipe. Soot was found adhering to the left side of the airframe in the area extending from the nose towards the left wing. There was a clearance of several centimeters between the sides of the exhaust pipe and the Cowlings. While the Cowlings had been lined with aluminum matting in the areas directly opposite the right and left sides of the exhaust pipe, the left mat together with the surrounding FRP were missing.

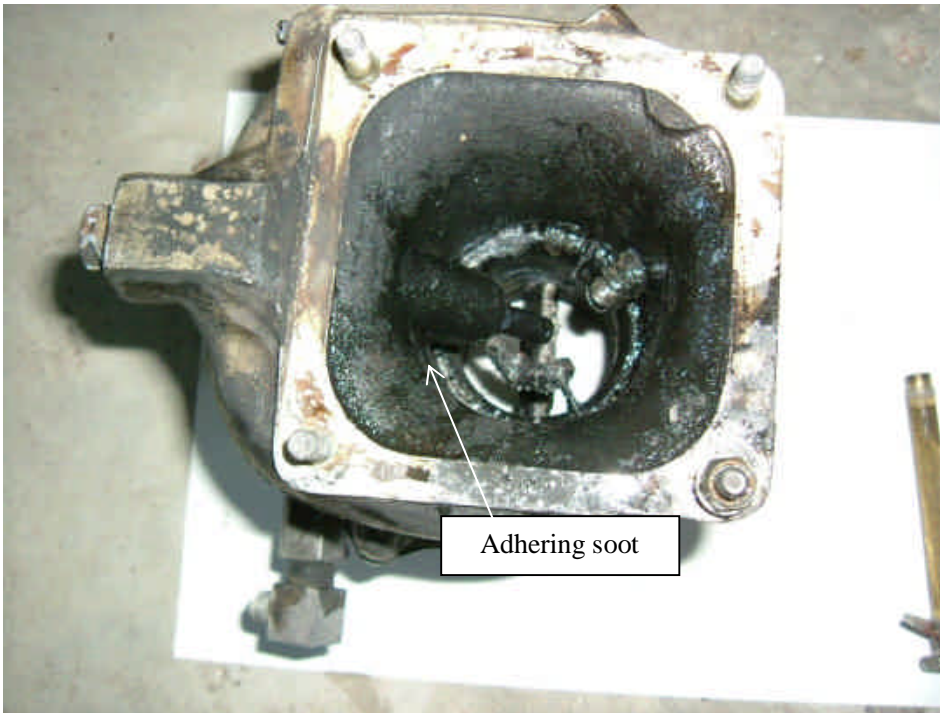
**Photo 4 Carburetor**

Soot was found adhering to the carburetor. The hose for delivering outside air to the carburetor was burned out and the air filter connected to the hose was also burned.

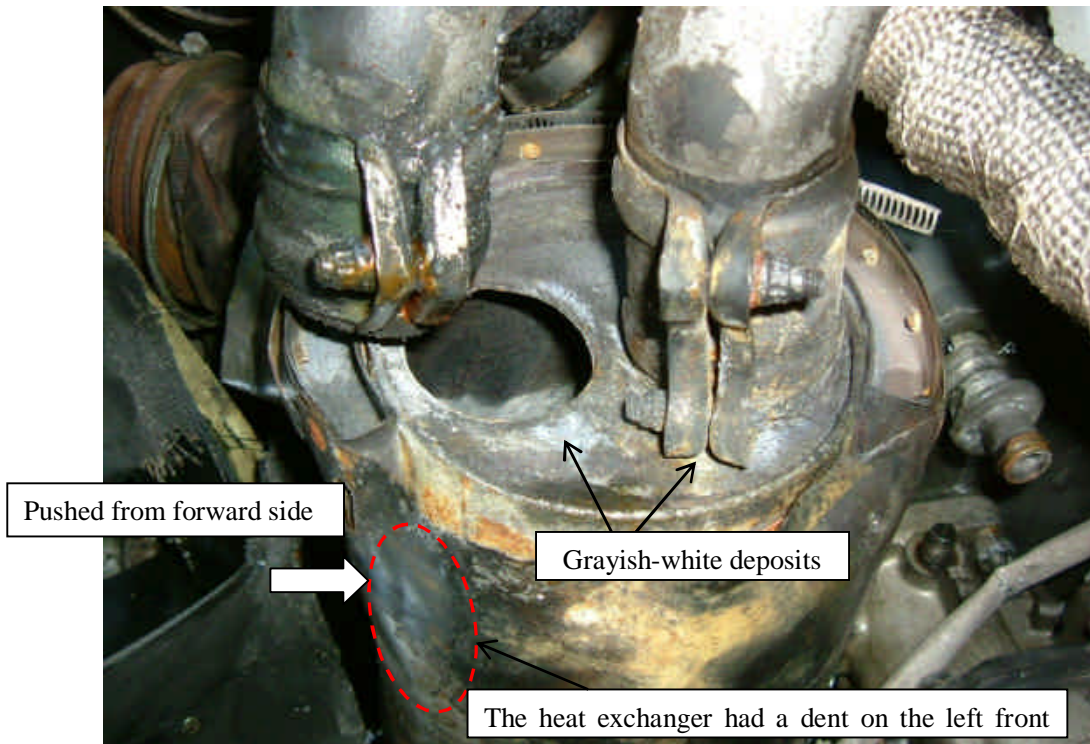
### Photo 6 LH Side of the Exhaust Pipe

The LH front manifold was found detached together with the Connecting Pipe (hereinafter referred to as “the LH Front Connecting Pipe”) from the exhaust pipe. The exhaust pipe was cut open in order to inspect the inside condition of the welded joint between the exhaust pipe and Connecting Pipe. The exhaust pipe and the Connecting Pipe had been welded together where they overlapped each other (hereinafter this area is referred to as “the Base Metal Ends”). Cracks were found in both this welded joint and the LH Front Connecting Pipe, but no abnormal conditions were found in the welded joints for the three other Connecting Pipes.

It is considered highly probable that, the fire on the Aircraft was caused by hot exhaust gases blasted into the engine compartment due to the detachment of the LH front manifold together with the LH Front Connecting Pipe as described in 2.7.2 (1), burning the Cowlings near the left side of the exhaust pipe and the hose leading to the carburetor that was located at the rear of the exhaust pipe. It is also considered highly probable that the Cowlings, lined with heat-resistant aluminum matting in the inside areas near the exhaust manifolds and the exhaust pipe, were burned as blasts of hot exhaust gases extended even to the areas not protected by the heat-resistant aluminum matting.

The LH front manifold was found detached together with Connecting Pipe and Grayish-white deposits.

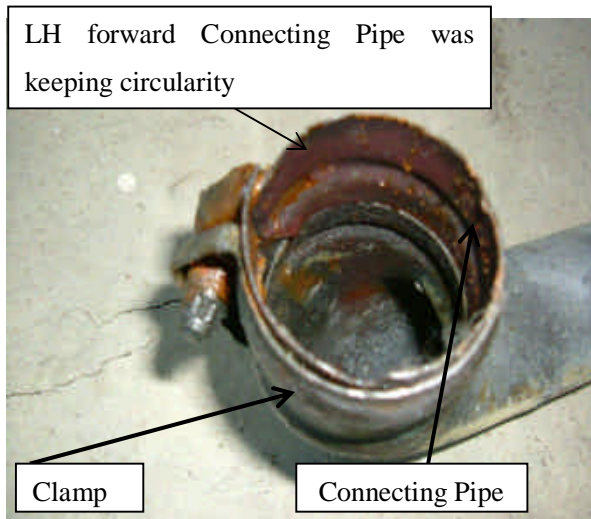
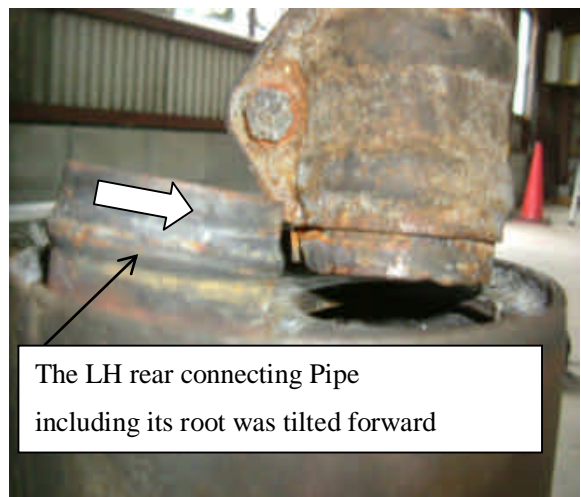
### Photo 7 Fracture Surface of the Connecting Pipe

With regard to the missing material on the ends of the LH Front and LH Rear Connecting Pipes attached to the exhaust pipe, it is considered probable that the missing material on each pipe was the result of the following process: The area that became structurally weak due to fine cracks and other defects caused by the plastic deformation was then subjected to expansion by the heat of the running engine as well as by contraction and vibration, which gradually made the cracks larger and these cracks further progressed under the influence of oxides contained in the exhaust gases resulting from the combustion of sulfur and other substances in the fuel and also of the corrosive action of the humidity and salt contained in atmospheric air, as described in 2.11.5, resulting in the missing material. It is considered highly probable that the missing material area of the LH Front Connecting Pipe was continuously subjected to the forces mentioned above, which caused the cracks to grow further and when the cracks reached the weld surface, cracks ran in the weld surface also; these cracks in the weld surface grew with the clamp tightening forces and under the influence of heat and vibration and gradually covered the entire weld; eventually the LH Front Connecting Pipe became detached from the exhaust pipe.

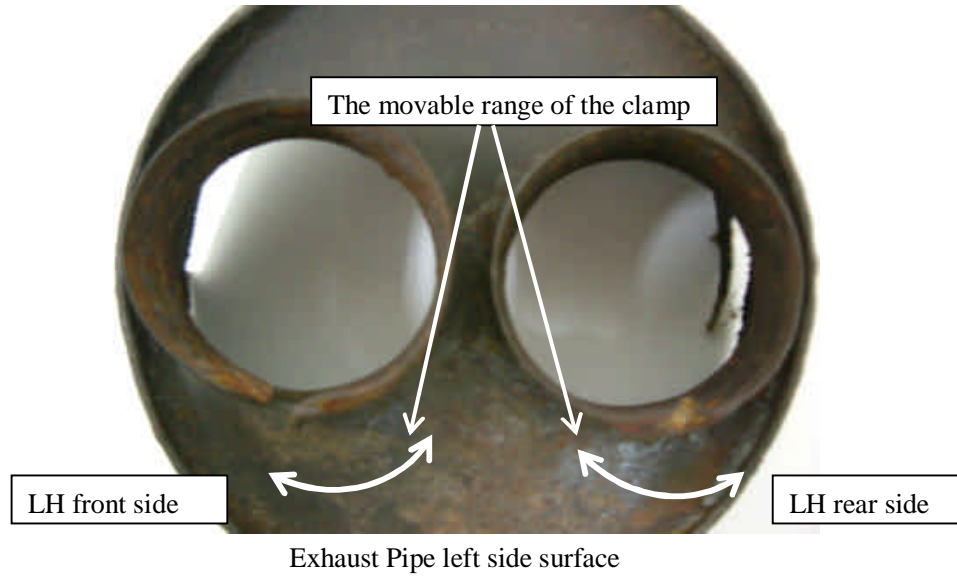
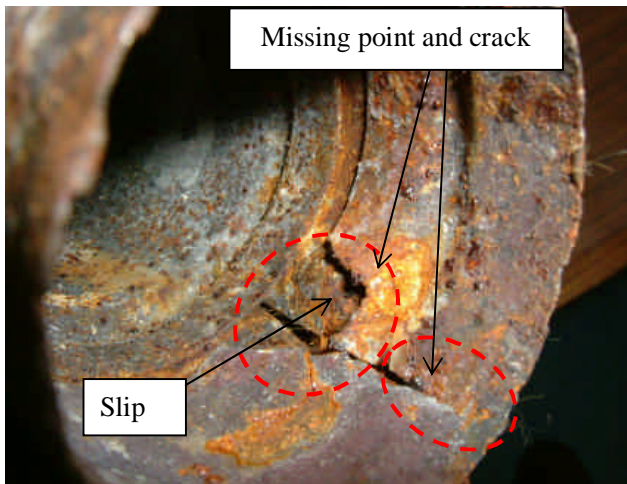
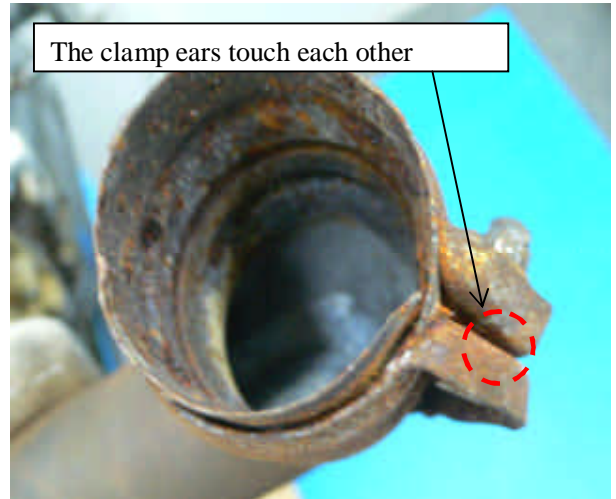
## Photo 8 – Connecting Pipes and Clamps (1)

- ① All the clamps on the exhaust pipe side were found installed with both ears touching each other.
- When the clamps were removed, the clearance between the ears of each clamp measured approximately 3 mm. When each clamp was tightened until its ears touched each other without placing the Connecting Pipe inside, the diameter of the Slip portion measured approximately 44.0 mm.
- Each of the Connecting Pipes had missing material and a crest-shaped deformation.

LH front connection pipe and the state of the clamp

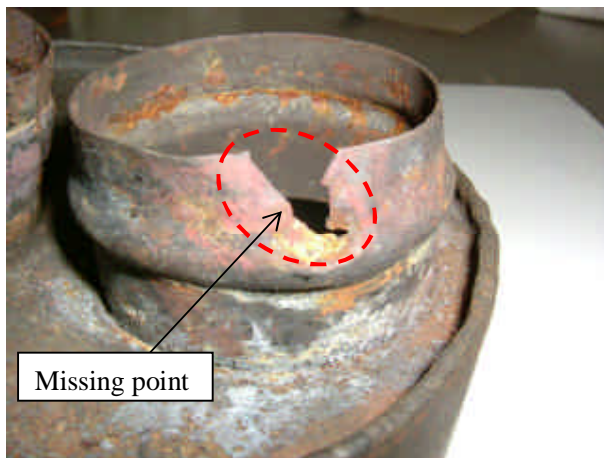
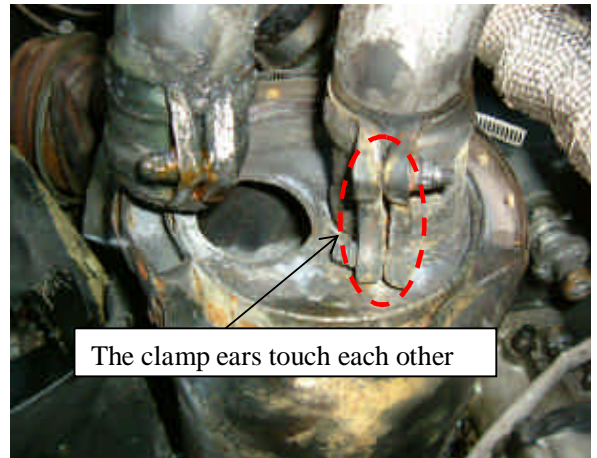
LH rear connecting pipe and the state of the clamp

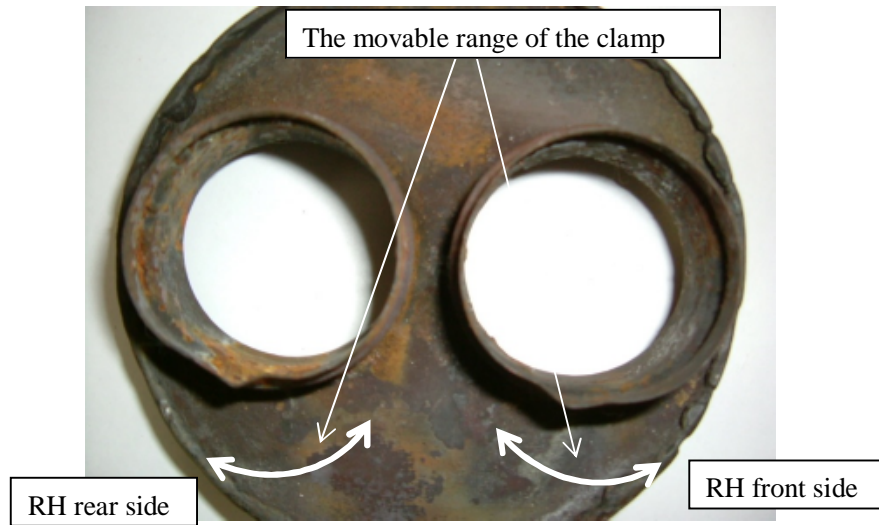
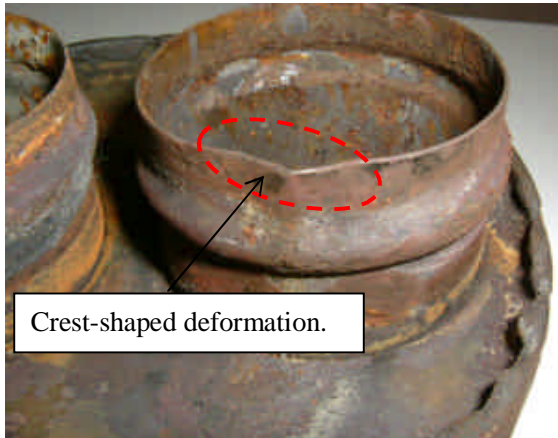
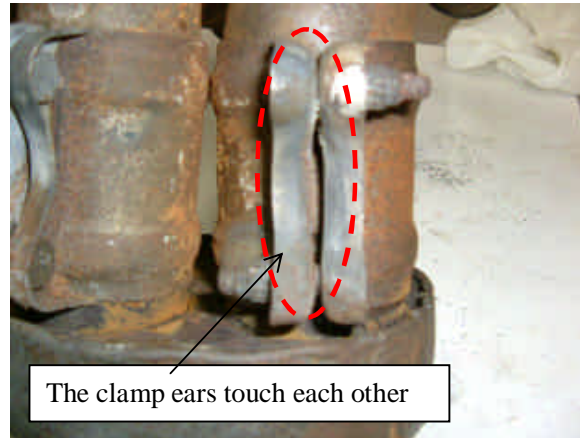
## Photo 8 Connecting Pipes and Clamps (2)

- ④ Both the RH Front Connecting Pipe and RH Rear Connecting Pipe showed no signs of repair for their crest-shaped deformation areas.

Right front connection pipe and the state of the clamp

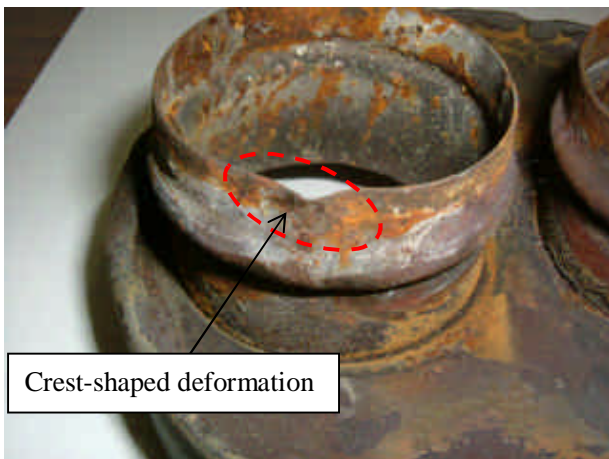
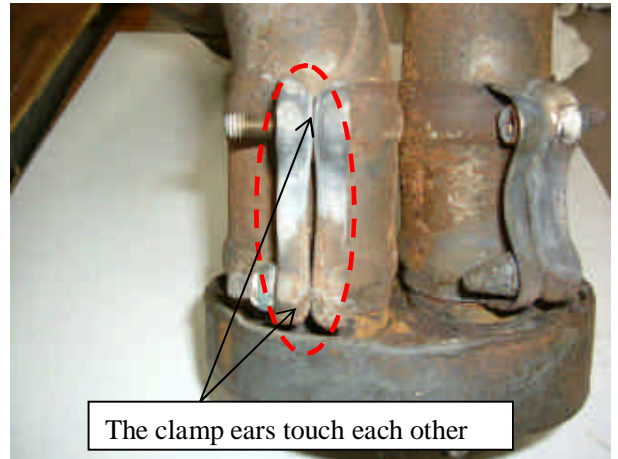
RH rear connecting pipe and the state of the clamp

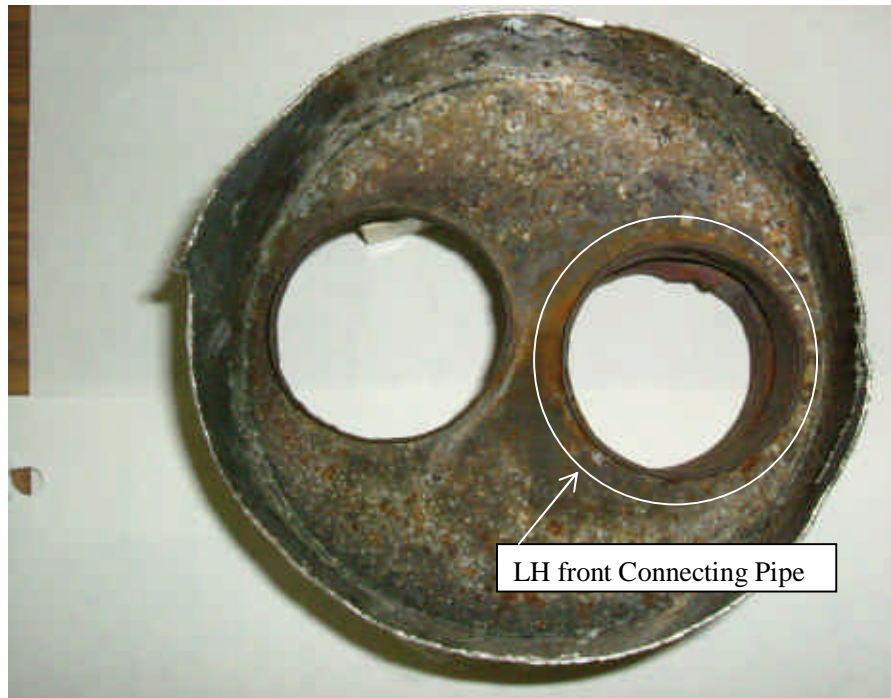
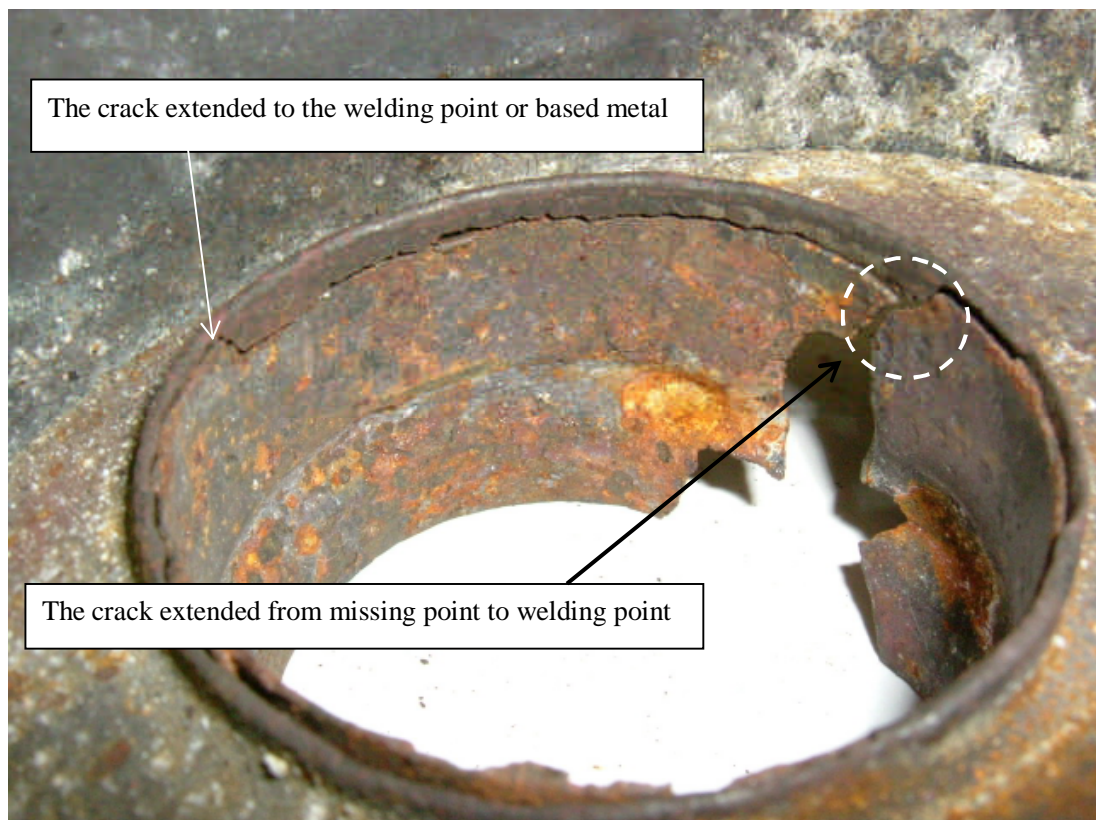
### Photo 10 Deteriorated Weld (Inside)

Connecting Pipe beginning with the occurrence of plastic deformation to the missing material and cracks, it could not be revealed the specific process in a time series. However, judging from the sufficient weld penetration as described in 2.11.4, it is considered probable that there were no abnormalities on the weld surfaces.
