AIRCRAFT ACCIDENT INVESTIGATION REPORT

March 29, 2013

BIRD STRIKE DURING TAKEOFF CLIMB IBEX AVIATION CO., LTD. CESSNA 172P, JA4135 ABOVE RYUGASAKI AIRFIELD RYUGASAKI CITY, IBARAKI PREFECTURE, JAPAN AT 14:40 LOCAL TIME, JUNE 18, 2012

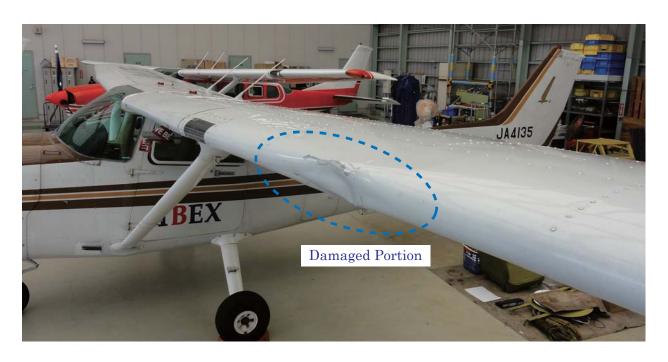
Photo Accident Airplane

2.2	Injuries to Persons	None
2.3	Damage	 Extent of Damage: Substantially damaged Deformation on the skin of the left wing leading edge (with a width of 63 cm and a depth of 2 cm, 146 cm from the wing tip toward inboard) Deformation of two ribs (primary structure components) in the deformed skin area (See Photo)

3.1	Involvement of	None
	Weather	
3.2	Involvement of	None
	Pilots	
3.3	Involvement of	None
	Airplane	
3.4	Analysis of	It is probable that it was difficult for the airplane to avoid the collision
	Findings	with the suddenly emerged bird, as it was in the middle of during takeoff
		climb with insufficient airspeed and altitude in which abrupt attitude
		change should be avoided.
		It is highly probable that the damage to the left wing of it was caused
		by the collision with the bird.
