**AIRCRAFT ACCIDENT
INVESTIGATION REPORT**

OBIHIRO BRANCH SCHOOL OF THE CIVIL AVIATION COLLEGE

J A 4 2 1 5

CRASH INTO THE MOUNTAIN SLOPE
OBIHIRO BRANCH SCHOOL OF THE CIVIL AVIATION COLLEGE,
BEECHCRAFT A36, JA4215
Mt. TSURUGI, MEMURO-CHO, KASAI-GUN, HOKKAIDO, JAPAN
AT ABOUT 09:22 JST, JULY 28, 2011

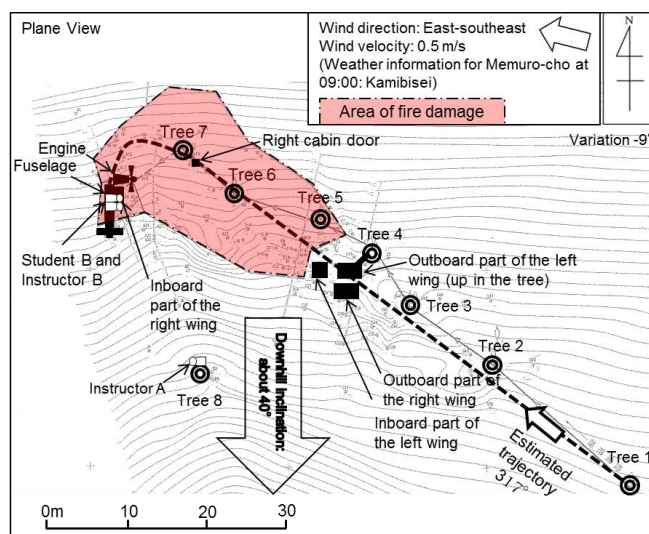
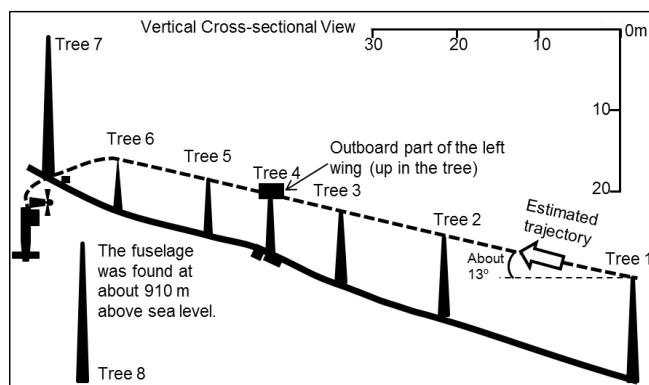
2.8.2 Tree Locations and Damage Caused by the Airplane

About five meters northeast of the airplane’s fuselage there was Tree 7 (as shown in the right figure), and the fragmented wreckage of the airplane scattered around the base of the trunk. The right door was lying about three meters southeast of the Tree 7. Further to the southeast there were Trees 6 and 5. Their tops were damaged and the surface of their trunks was scorched black up to several meters from the ground. On the southeast side of the two trees there was Tree 4 which had no trace of fire. The detached outboard part of the left wing was dangling from the tree with part of it stuck into it. The inboard part of the left wing and the outboard part of the right wing were lying near the base of Tree 4. Southeast of Tree 4 there were Trees 3, 2, and 1, lining up in an almost straight line with their tops broken. These trees had no trace of fire.

Study of each location of Trees 1 to 7 and the height of the tree damage caused by the airplane indicated that Tree 7 stands about 70 meters and 317 degrees from Tree 1. The angle of ascent from Tree 1 to 6 was 13 degrees.

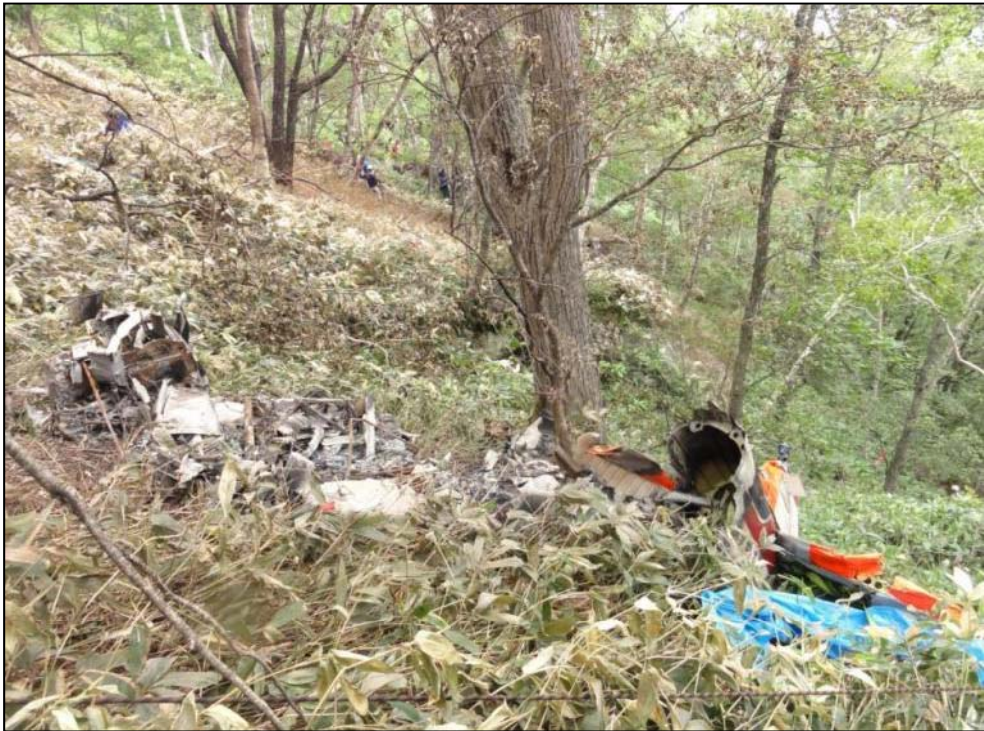
Photo 1: Accident Site

Both wings had come off and had been heavily damaged; besides most of its cabin had been consumed by fire.

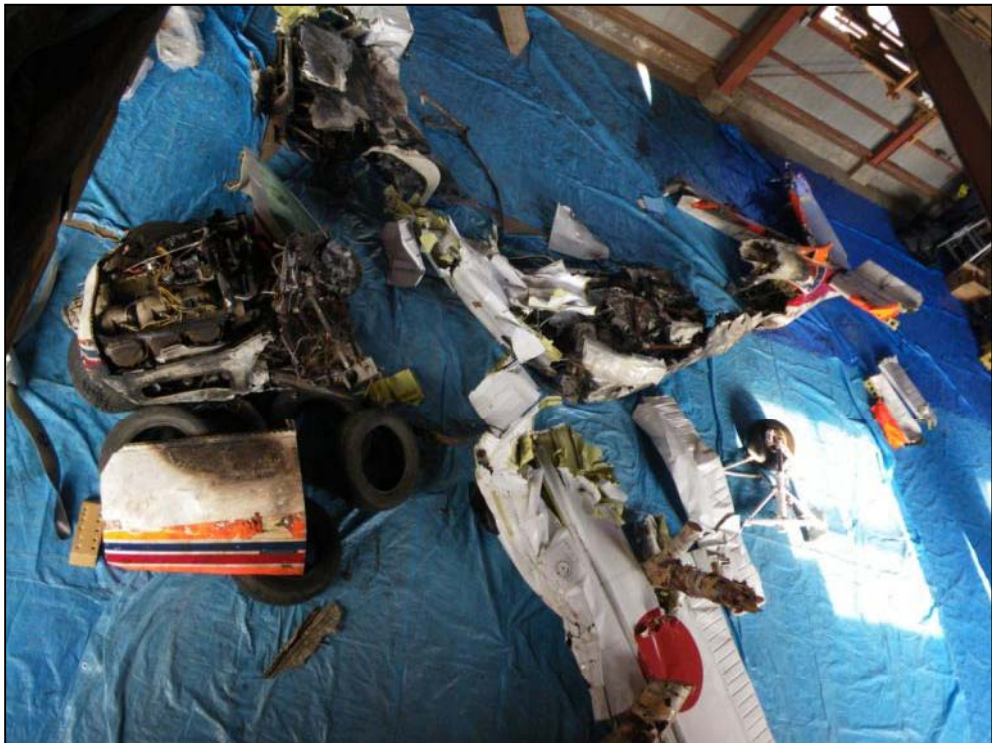
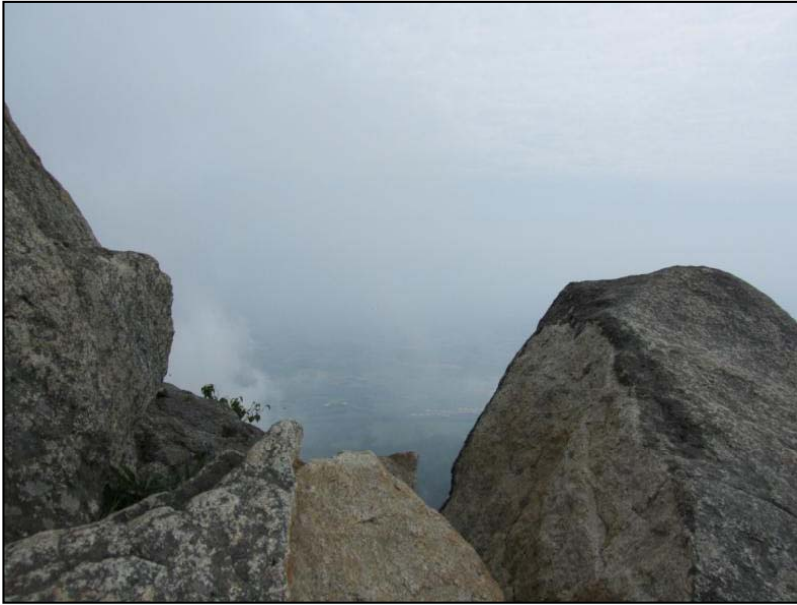
Photo 2: Wreckage of the Airplane

Fuselage:	Separated, broken, and burnout
Wings:	Separated and destroyed
Empennage:	Broken
Engine:	Broken
Propeller:	All three blades were bent backward.

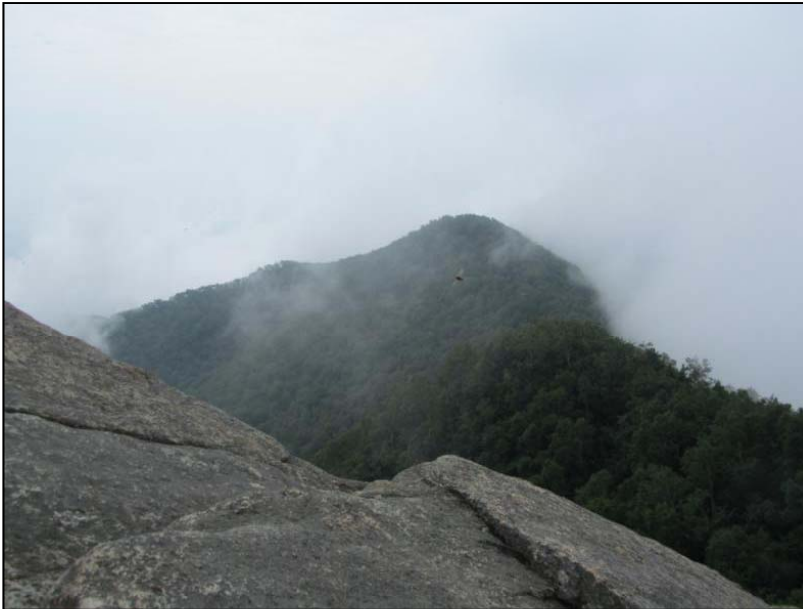
Photo 3: Near the Top of Mt. Tsurugi (1) (taken at about 10:05; by courtesy of a climber of Mt. Tsurugi)

On the day of the accident, the ridges of the mountains were slightly covered with clouds, but the wind was weak, and no unusual meteorological phenomenon was observed.

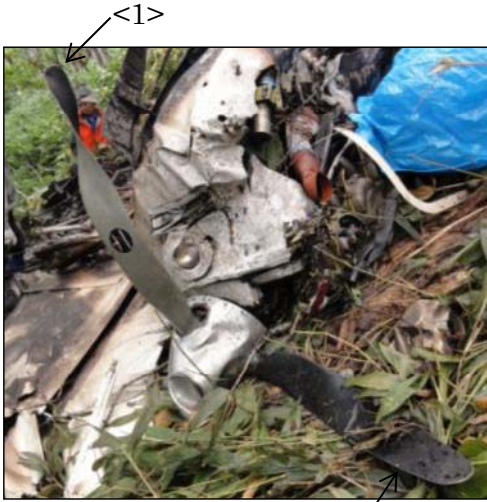
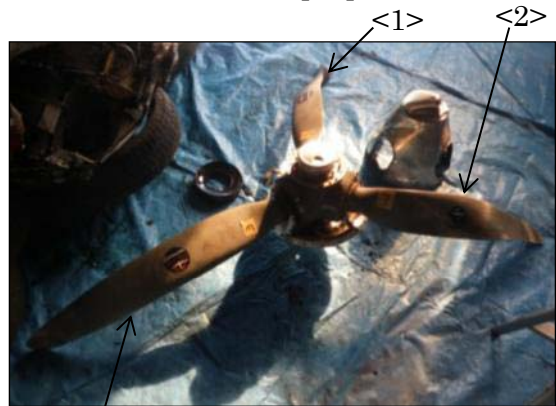
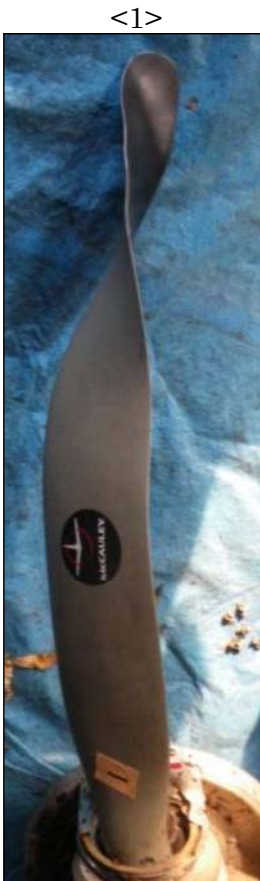
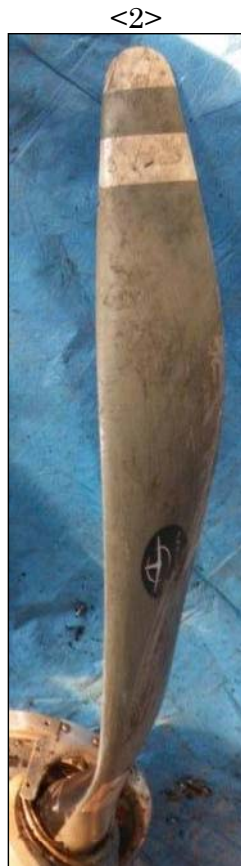
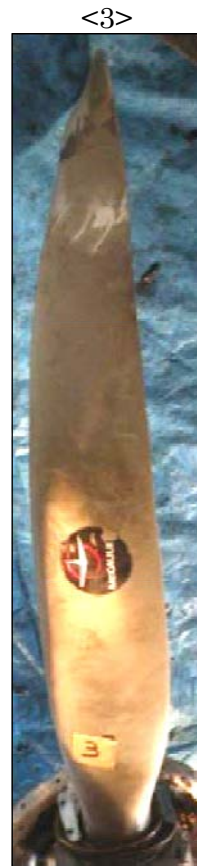
Photo 6: Damage to the Propeller

None of the three propeller blades were broken or destroyed, but all of them were twisted irregularly and bent backward.

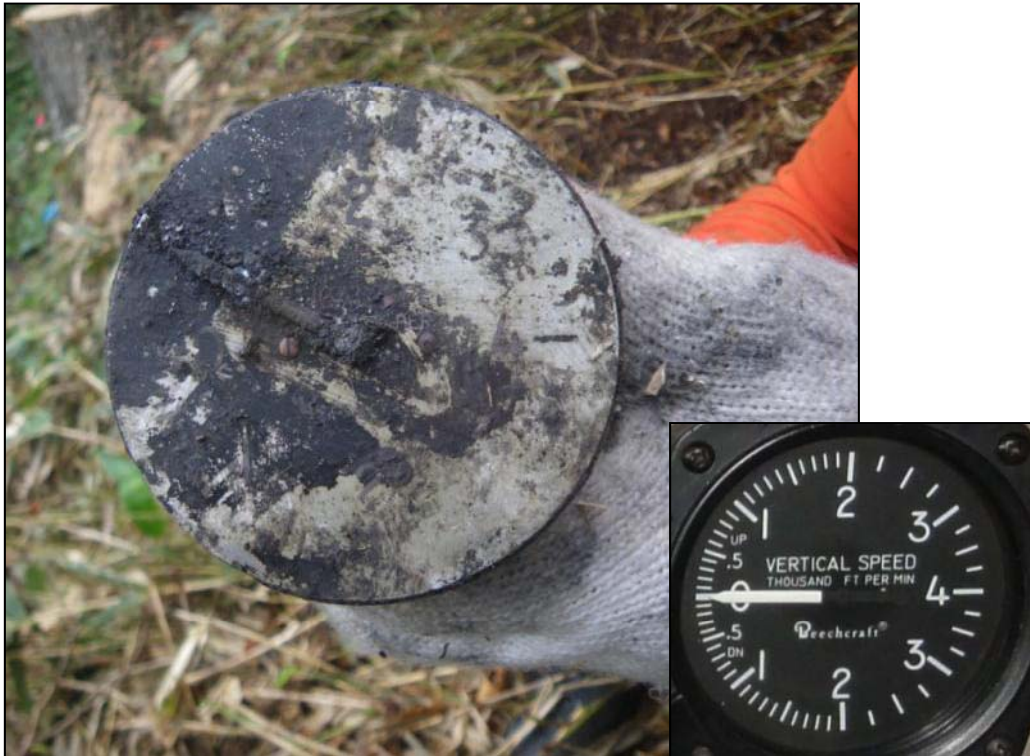
Photo 7: Vertical Speed Indicator

The fire consumed most of the instruments. The fire damaged the vertical speed indicator, but it retained the condition that enabled to confirm that the airplane had been climbing at about 800 ft/min.
