**AIRCRAFT ACCIDENT  
INVESTIGATION REPORT**

**AIRCRAFT DAMAGE DUE TO ROLLOVER AFTER LANDING**

**HIRATA GAKUEN**

**EUROCOPTER AS350 B3 (ROTORCRAFT), JA500H**

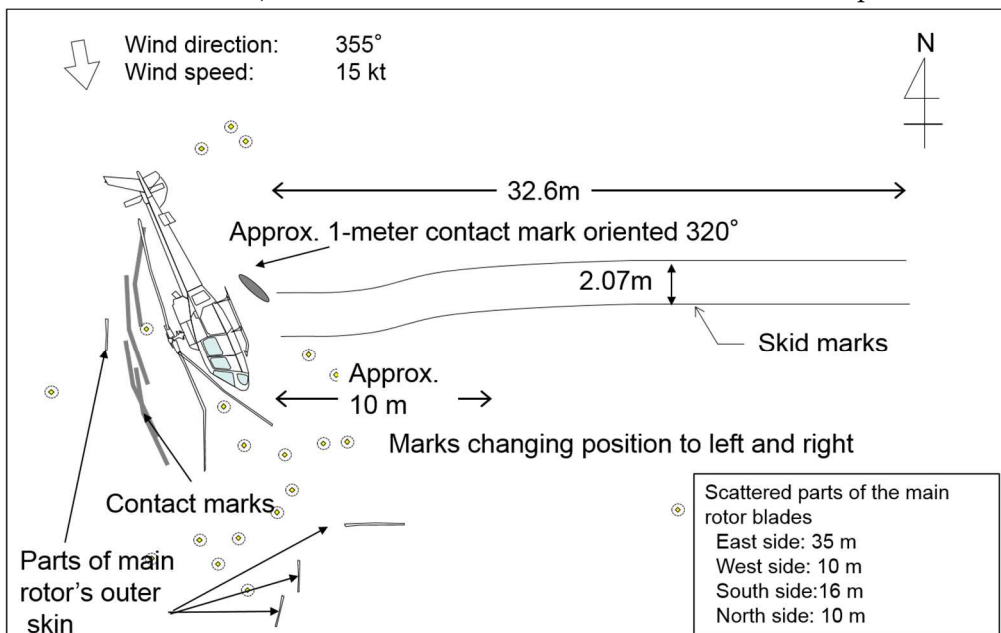
Figure 2 Situation at the Accident Site

- (1) At the time of the accident, the Grass Area was covered with weeds of no more than approximately 10 cm in height and the surface soil was in a slightly soft state.

- (2) As is shown in Figure 2, at the accident site, the Helicopter was rolled over with the nose pointed toward 160 degrees and the fuselage's right side facing down. There were marks made by the skids measuring approximately 2 meters in width, approximately 32 meters in length, and approximately 8 cm in depth running toward the Helicopter on the eastern side of the Helicopter. The marks changed position to the left and right approximately 10 meters before the Helicopter. Additionally, a contact mark of approximately 1 meter in length, where the Grass Area had been lacerated in the direction of 320 degrees, was located near the end of the approximately 32-meter marks. The northwest edge of the mark was deeply gouged and the Grass Area had been turned up. Furthermore, soil that had become attached when the Helicopter slipped laterally remained on the strip surface on the rear of the Helicopter's right skid. Marks where the three main rotor blades contacted the ground when the Helicopter rolled over to the right existed in four locations with lengths of approximately three to four meters near the main rotor blades. Portions of the main rotor's outer skin and inner urethane were scattered in an area measuring 35 meters on the east side, 10 meters on the west side, 16 meters on the south side, and 10 meters on the north side of the Helicopter.

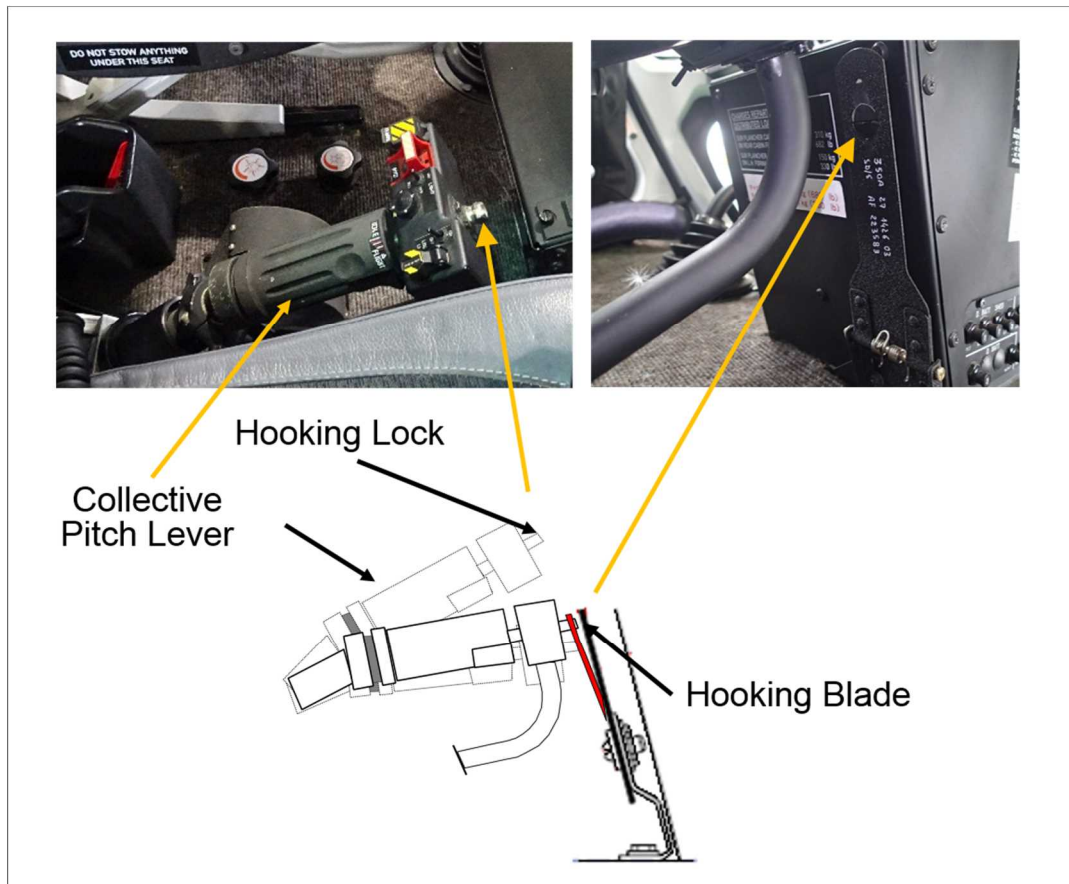
Figure 4 The Lock of Collective Pitch Lever

pitch lever by pushing down on it slightly. If, during a ground operation inspection, the Hydraulic Cut Off switch is set to OFF without locking the collective pitch lever, the collective pitch lever will move up from the neutral position. Thus, it must be confirmed that the collective pitch lever is properly locked.

- (3) Regarding restoration of the hydraulic system after hydraulic system failure training, hold the left collective pitch lever down in its lowest position without using the lock mechanism in order to ensure that the collective pitch lever is securely held as the right-seat pilot operates the Hydraulic Cut Off switch, and then confirm that the flight controls are in the neutral position while restoring the hydraulic system.

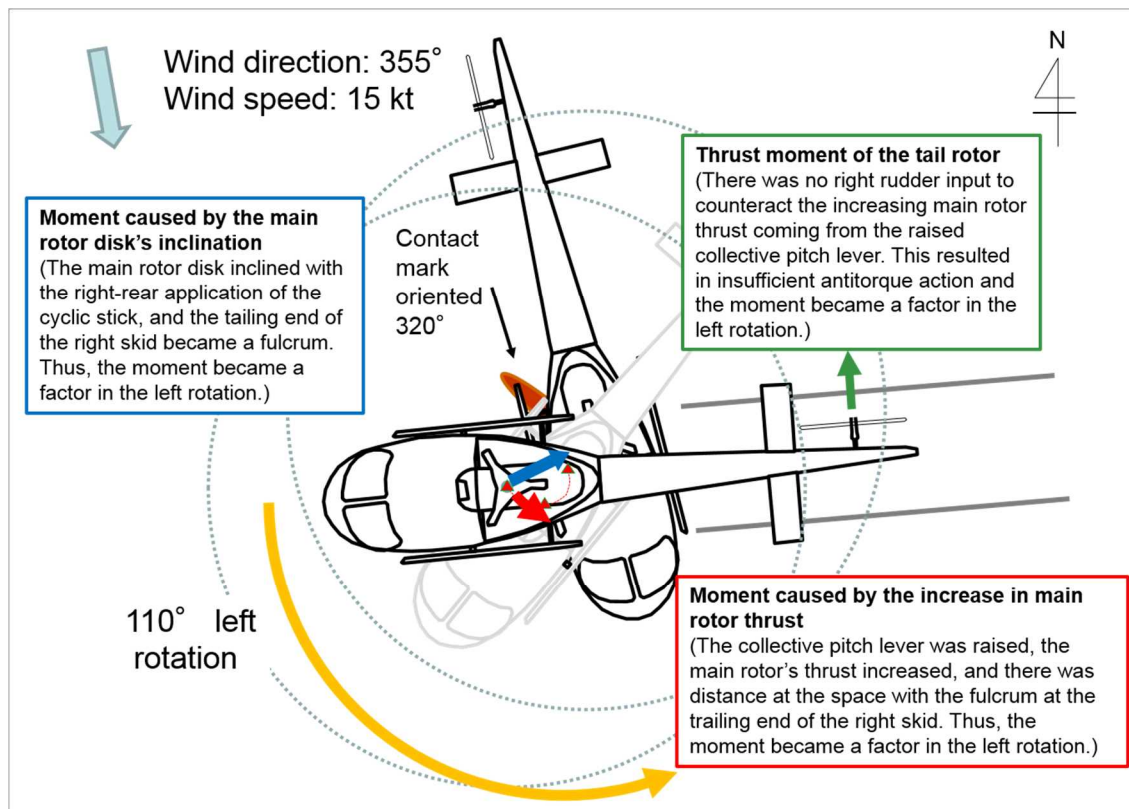
Figure 5 Moments involved in the Left Rotation

to the right rear. Given that the main rotor disk inclined to the right rear and, further, the right rudder was not operated while the main rotor's thrust increased due to the raising of the collective pitch lever described in 3.6.3.1, it is considered probable that the Helicopter rose at the nose and began rotating left while inclining to the right.

Additionally, regarding the PIC's statement that he may have applied the left rudder, as was described in 2.1.2 (1), it is considered probable that the hydraulic pressure had not adequately recovered and therefore the right rudder was not in a state in which it could be easily applied during the time that the collective pitch lever was raised. Moreover, regarding the sudden rise of the nose described in 2.1.2 (1) and (2), based on the fact that there was no mud on the tail skid and on the analysis of the images described in 2.8.2 (2) and 2.11.2, it is considered probable that the PIC confused the Helicopter's rotation to the left while inclining to the right as a sudden rising of the nose.

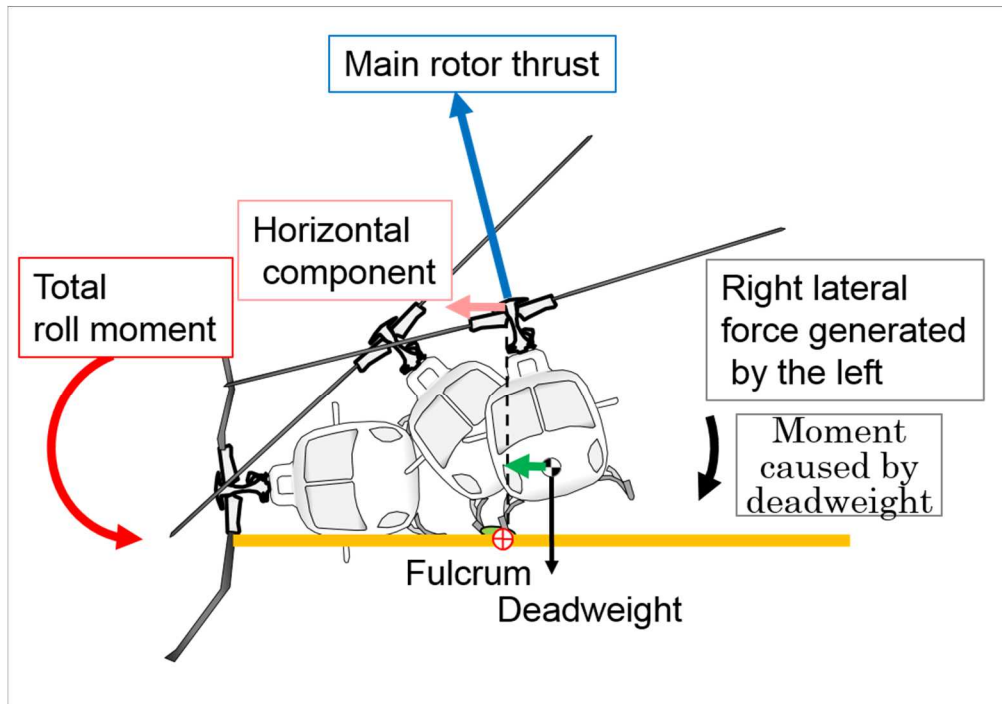
Figure 6 Dynamic Rollover of the Helicopter

Regarding the Helicopter's right rollover, from 3.4.2 and 3.6.3, given that the nose rose, the left rotation continued with a right incline, and there was no lowering of the collective pitch lever, it is considered probable that the right inclination became even larger when the Helicopter rotated 110° to the left and, as is shown in Figure 6, the horizontal component of the main rotor's thrust

and the right lateral force generated by the left rotation caused a roll moment with the strip on the rear part of the right skid serving as the fulcrum, thereby creating a dynamic rollover\*<sup>11</sup> and causing the Helicopter to roll over to the right.

- (3) Provided education on the factors that cause dynamic rollover, and fully implemented reminders and prevention measures.
- (4) Because the accident occurred on a grass area, circulated guidelines for confirming the conditions of Grass Areas prior to conducting running landings and guidelines for taking off and landing on uneven surfaces.

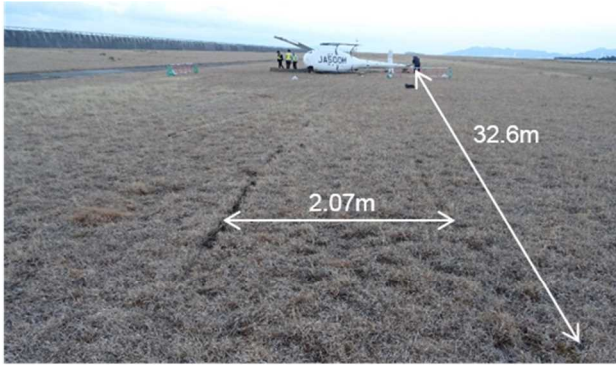
Contact marks from running landing viewed from east side

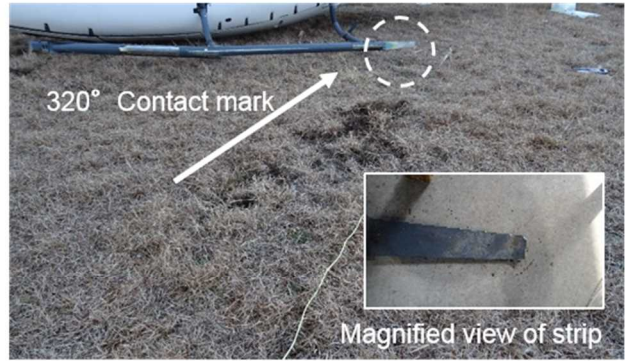
Contact mark made by trailing strip of right skid

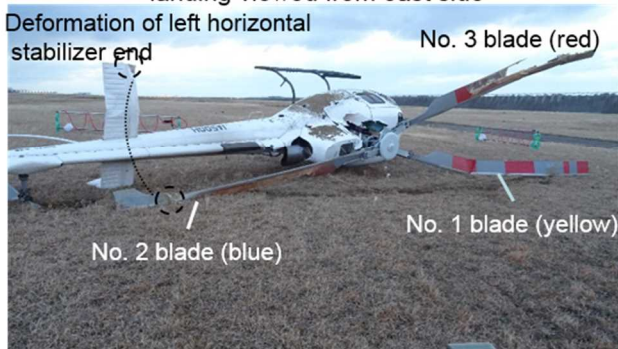
- (1) Fuselage: Damaged and bent
- (2) Tail: Damaged
- (3) Engine: Damaged and deformed
- (4) Rotor system: Damaged and bent
- (5) Control system: Damaged

Damage to aircraft seen from west side

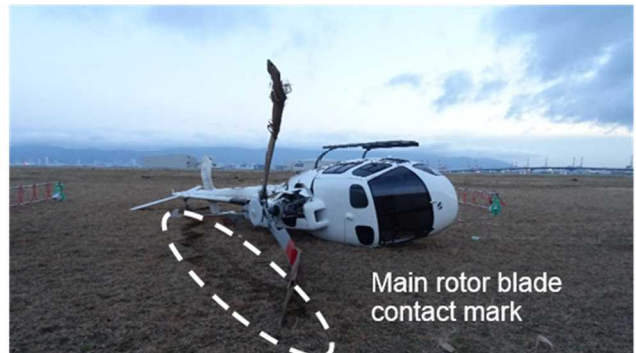
- All of the main transmission's support bars were broken.
- The rotor head's Star Flex was broken inside the sleeve assembly and the entire sleeve assembly was damaged.
- All of the main rotor blades' outer skin was damaged and some parts were scattered throughout the area.
- The tail rotor drive shaft was separated from the engine's output shaft and part of it had fallen onto the ground.

Main rotor blade contact mark

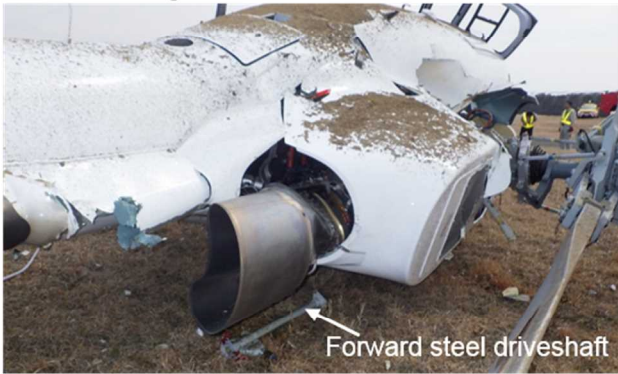
- The outer skin that enclosed the main transmission was damaged and bent.

Damage to top of fuselage

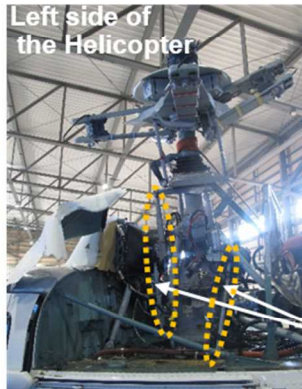
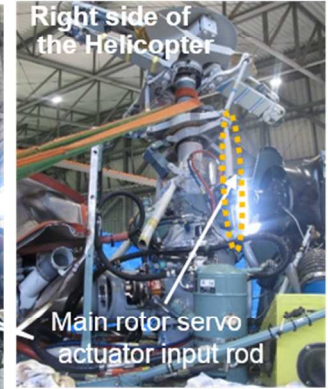
Damage to top of fuselage

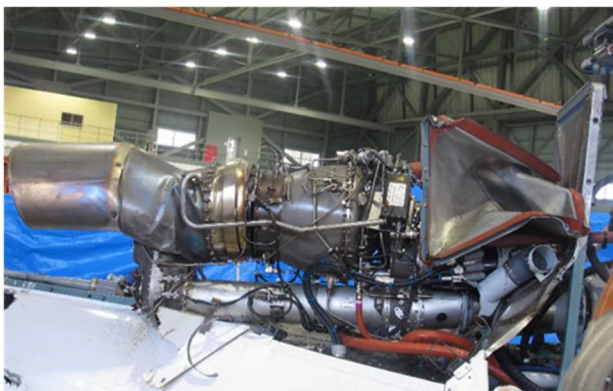
- The engine mount was deformed and/or broken, and the entire engine had shifted to the right.
- Each section was damaged or twisted.

Damage to the engine

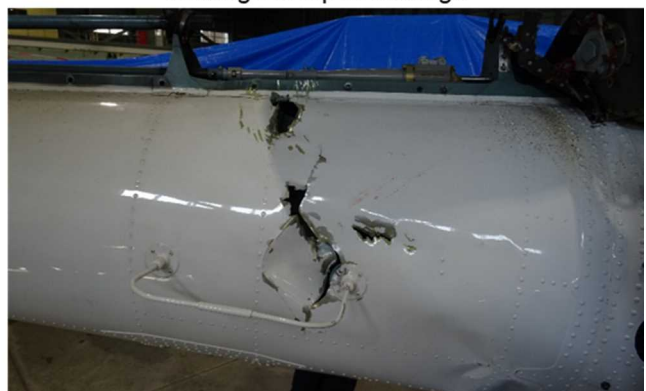
- The outer skin of the right-side forward section and tail drive shaft cover was damaged.
- There was no mud on or damage to the tail skid.

Damage to the right side of the tail
