**AIRCRAFT SERIOUS INCIDENT
INVESTIGATION REPORT**

**ALL NIPPON AIRWAYS CO., LTD.
J A 5 7 A N**

OVERRUN
ALL NIPPON AIRWAYS CO., LTD.
BOEING 737-800, JA57AN
EAST END OF THE RUNWAY AT SHONAI AIRPORT, JAPAN
AT ABOUT 22:26 JST, DECEMBER 8, 2012

August 22, 2014

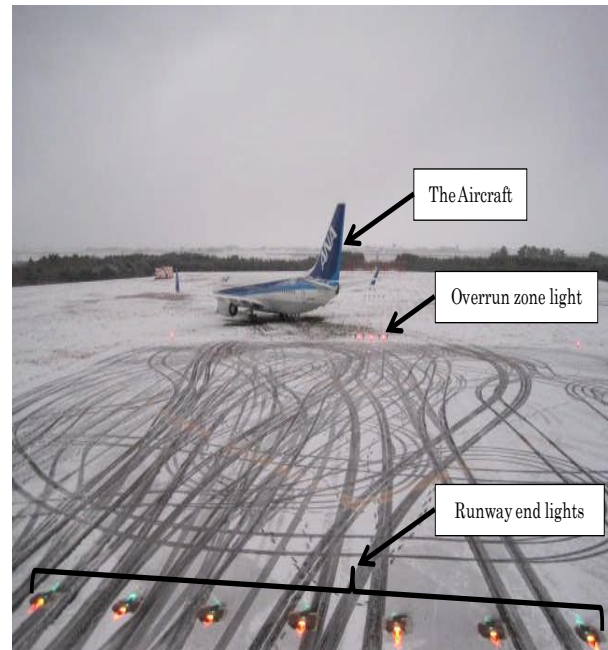
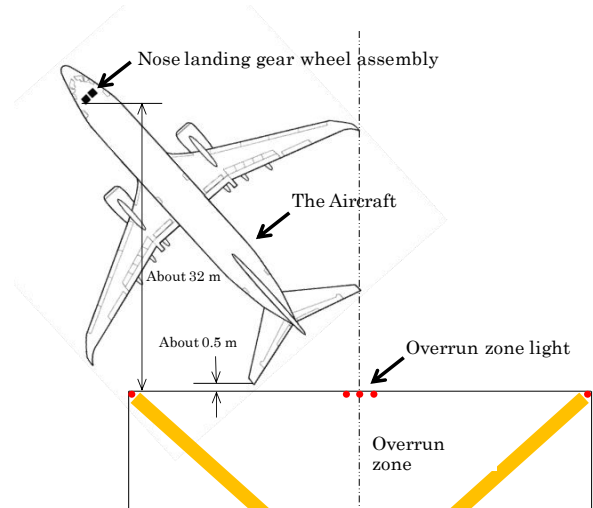
The nose landing gear sank into the ground to a depth equal to about 30% of the wheel diameter—the wheel rim was almost the ground level. The left main landing gear sank into the ground to a depth equal to about 10% of the wheel diameter—part of its side wall was below the surface level. The right main landing gear sank into the ground to a depth equal to about 40% of the wheel diameter—the lower half of the wheel was below surface level.

The Aircraft that made an overrun
(Photographed by the Company in early morning on December 9, 2012)

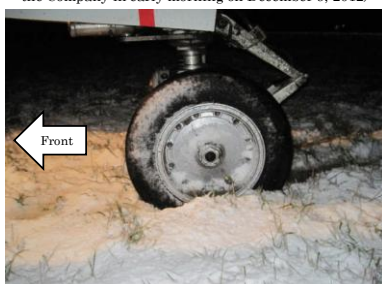
Nose landing gear of the Aircraft (Photographed by the Company in early morning on December 9, 2012)

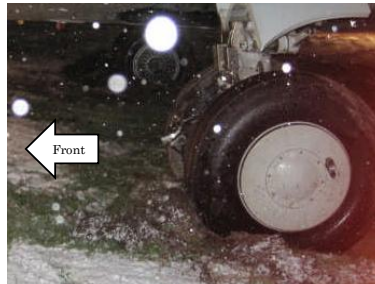
Left main landing gear of the Aircraft (Photographed by the Company in early morning on December 9, 2012)

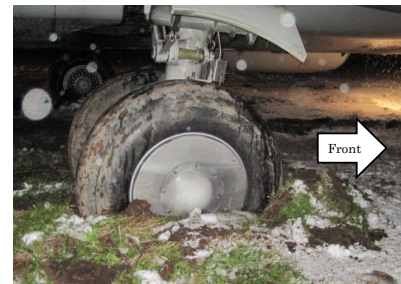
Right main landing gear of the Aircraft (Photographed by the Company in early morning on December 9, 2012)

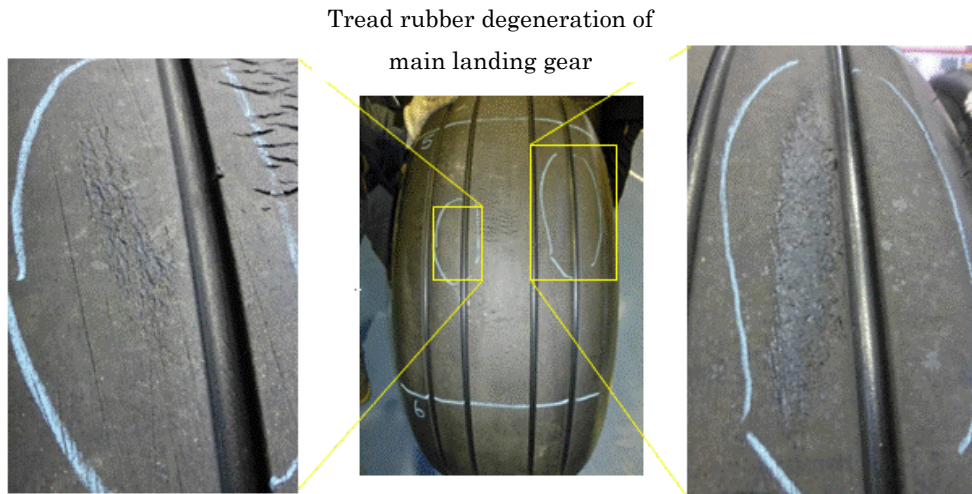
Visual inspections found that all tires from the main landing gears exhibited degraded tire tread as shown in the following photos. No other anomalies were found.

As described in 2.10.3, tread rubber degradation marks were noticed in local portions of tire surfaces of all main landing gear wheel assemblies. It is somewhat likely that these marks were caused by a hydroplaning ^{*8} phenomenon that occurred at an extremely low speed.

As described in 3.6, the slushy runway conditions highly probably degraded the frictional force between the tires and the runway surface. On the other hand, as described in 3.4 and 3.5 (4), degeneration mark were left on the tire surfaces of the main landing gears possibly caused by a hydroplaning phenomenon at extremely low speed.
