**AIRCRAFT SERIOUS INCIDENT
INVESTIGATION REPORT**

TAKE-OFF FROM A RUNWAY BEING USED BY OTHER AIRCRAFT

NOTO AIRPORT

AT ABOUT 10:13 JST, OCTOBER 15, 2022

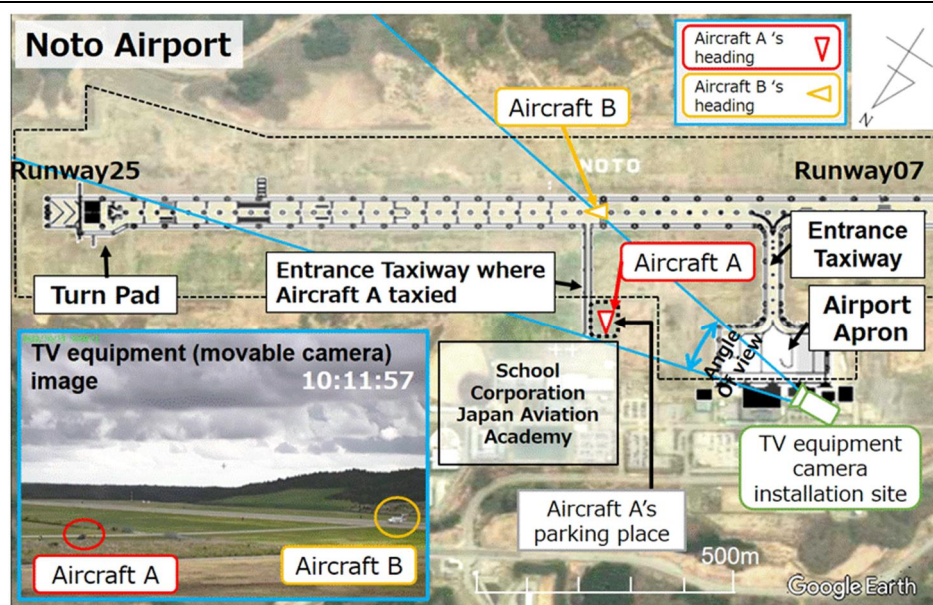
Figure 3: Position Relations before the Serious Incident (at 10:11:57)

At 10:11:54, Noto Radio informed Aircraft B, which had landed on Runway 07, that there was no en-route obstacle for taxiing up to the airport apron. Receiving the information from Noto Radio, Aircraft B continued taxiing toward the turn pad on Runway 25 in order to turn following landing roll.

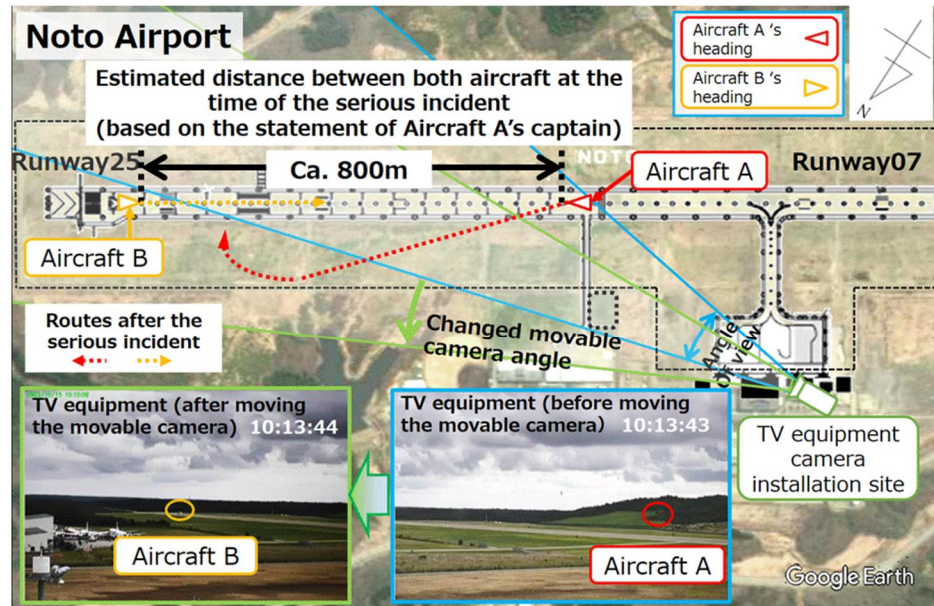
Figure 4: Estimated Position Relations at the Serious Incident (from 10:13:43 to 10:13:44)

At 10:13:23, Aircraft A reported to Noto Radio that it was ready for take-off, and received from Noto Radio "RUNWAY IS CLEAR (see 2.7.(7))." At the position short of entering the runway, Aircraft A confirmed the runway located ahead of its own, entered the runway while turning to the left, and immediately started its take-off climb.

Around the time when completing turn at the turn pad on Runway 25, as Aircraft B heard Noto Radio transmitting "RUNWAY IS CLEAR" over the

radio, visually recognized the helicopter on the runway in front, held position, and then informed Noto Radio that its own aircraft was being still on the runway.

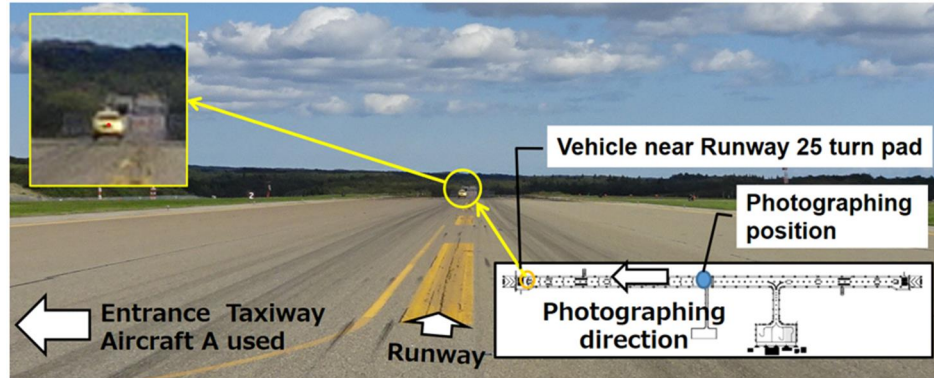
Figure 5: Visual Status from near Take-off Position of Aircraft A

The verification of visual status from near the take-off position of Aircraft A to the direction of the turn pad, where Aircraft B had turned after landing, revealed that it was feasible to visually recognize the vehicle placed near the turn pad even from the position lower than that height, although the actual height of view was different as Aircraft A had been air-taxiing.

From the verification result described in 2.7(4), Aircraft B in the vicinity of Runway 25 turn pad was most likely visible from the position where Aircraft A commenced to take off. However, the captain of Aircraft A had assumed that there would be no other aircraft on the runway, and while the captain of Aircraft A was feeling time pressure to keep the time schedule for the repeatedly continuing sightseeing flights, captain's attention was concentrated on pilot operations and confirmation of the instruments at the time of the take-off, and the captain more likely let Aircraft A take off without fully check of the safety on the runway.

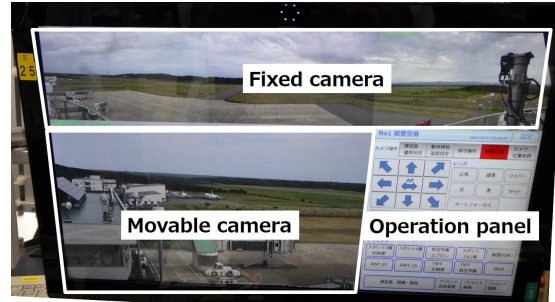
Figure 6: TV Screen

This TV equipment has three fixed cameras enable to oversee the full view of runway (top in Figure 6), and one movable camera (lower left in Figure 6), and the movable camera can be operated by using the functions on the operation panel seen at the bottom right of Figure 6.

Besides, from the time when Aircraft B landed to the time when "RUNWAY IS CLEAR" was notified to Aircraft A, there was no record of movable camera that would check other aircraft on the runway and TV equipment functions to detect or track aircraft movements were not used.

Furthermore, according to the statement of Noto Radio, Noto Radio normally confirms aircraft movements with the movable camera not using TV equipment functions to detect or track aircraft movements, and when Aircraft B landed, Noto Radio also confirmed with the movable camera. However, Aircraft B became away from the mind of Noto Radio as the attention was focused on Aircraft A captured by the movable camera, therefore, Noto Radio failed to notice Aircraft B captured by the fixed camera.

It is necessary that while keeping in mind that flight crew members of aircraft conduct safety checks by using the information provided by AFIS in addition to their own outside watch, those engaged in AFIS shall provide the information "RUNWAY IS CLEAR" after ensuring that there is no relevant aircraft on the runway. In the case where several aircraft use the same aerodrome, it is important for those engaged in AFIS to grasp aircraft movements by communicating with the relevant flight crew members by radio communication, and it is desirable to use TV equipment functions to detect or track aircraft movements, as necessary.
