# SUMMARY OF AIRCRAFT ACCIDENT INVESTIGATION REPORT

ACE HELICOPTER

AEROSPACIAL SA330J, JA6706

WHICH CRASHED DURING APPROACH TO A TEMPORARY  
HELIPAD IN MOUNTAINS, TOYAMA, JAPAN

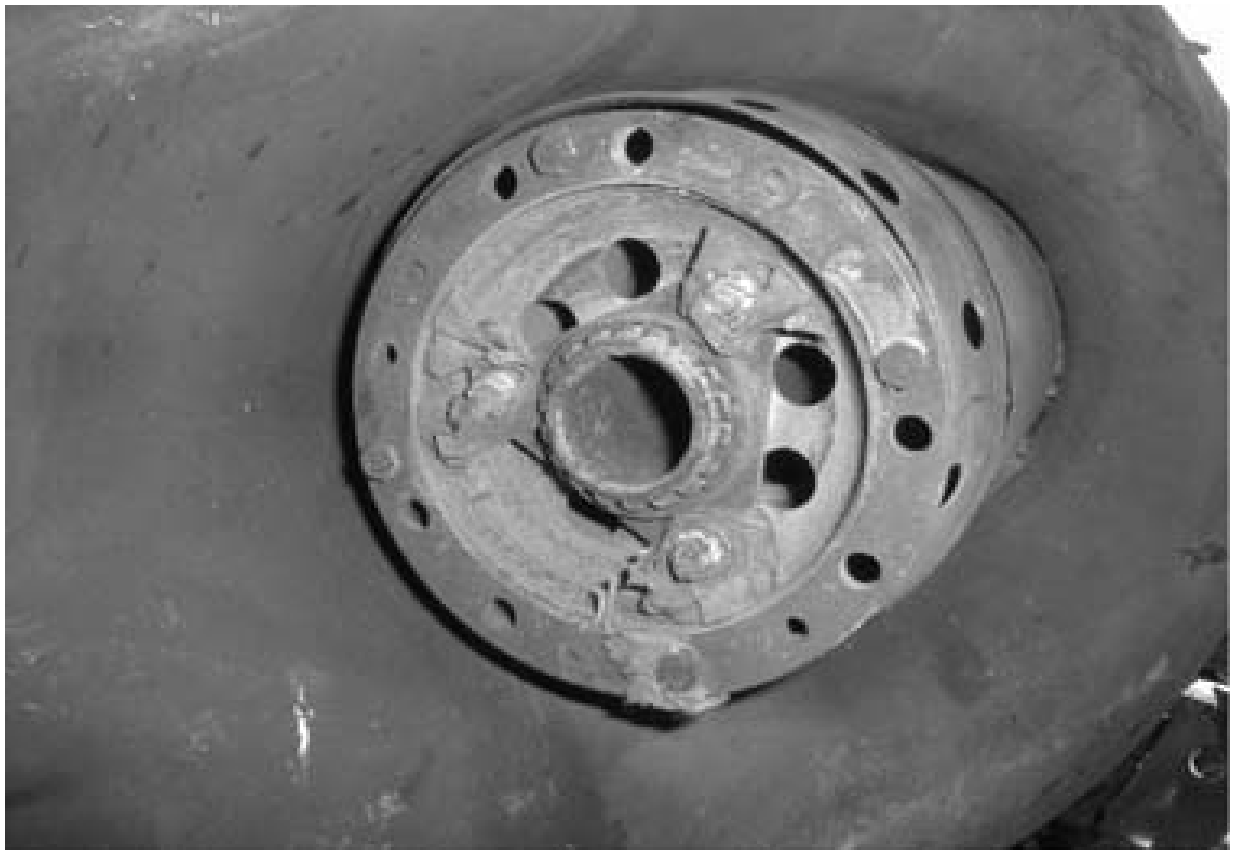
Photograph 5 No.1 Engine  
MGB Power Input (MGB Input Flector)

- ② It is estimated that as the result of the shock of the helicopter's second impact with the ground and the shock caused by the still-rotating main rotor blades (MRB) striking the ground, a excessive misalignment occurred in the transmission shaft linking the No. 1 engine to the main gearbox (MGB) between the free turbine shaft and the MGB input section that could not be absorbed by the transmission shaft's MGB input flector, and this severed the flector. The loss of connection with the MGB resulted in the loss of load on the free turbine, which led to an immediate overspeed, and as a result the free turbine disc burst and fragments were projected through the surrounding exhaust diffuser. It is considered that the No. 1 engine's supplementary aft mounting was destroyed and the opening in the exhaust diffuser was created at this time.

- ③ Based on the fact that no damage was found to the No. 2 engine, it is considered that this engine was operating normally until the time of the accident.  
(See Figure 6 and Photographs 4, 5)

It is thought that the shock of crash and of the MRB striking the ground caused an excessive misalignment between the No. 1 engine free turbine shaft and the MGB input shaft that the MGB input flexor was unable to absorb, which led to the flexor being severed.

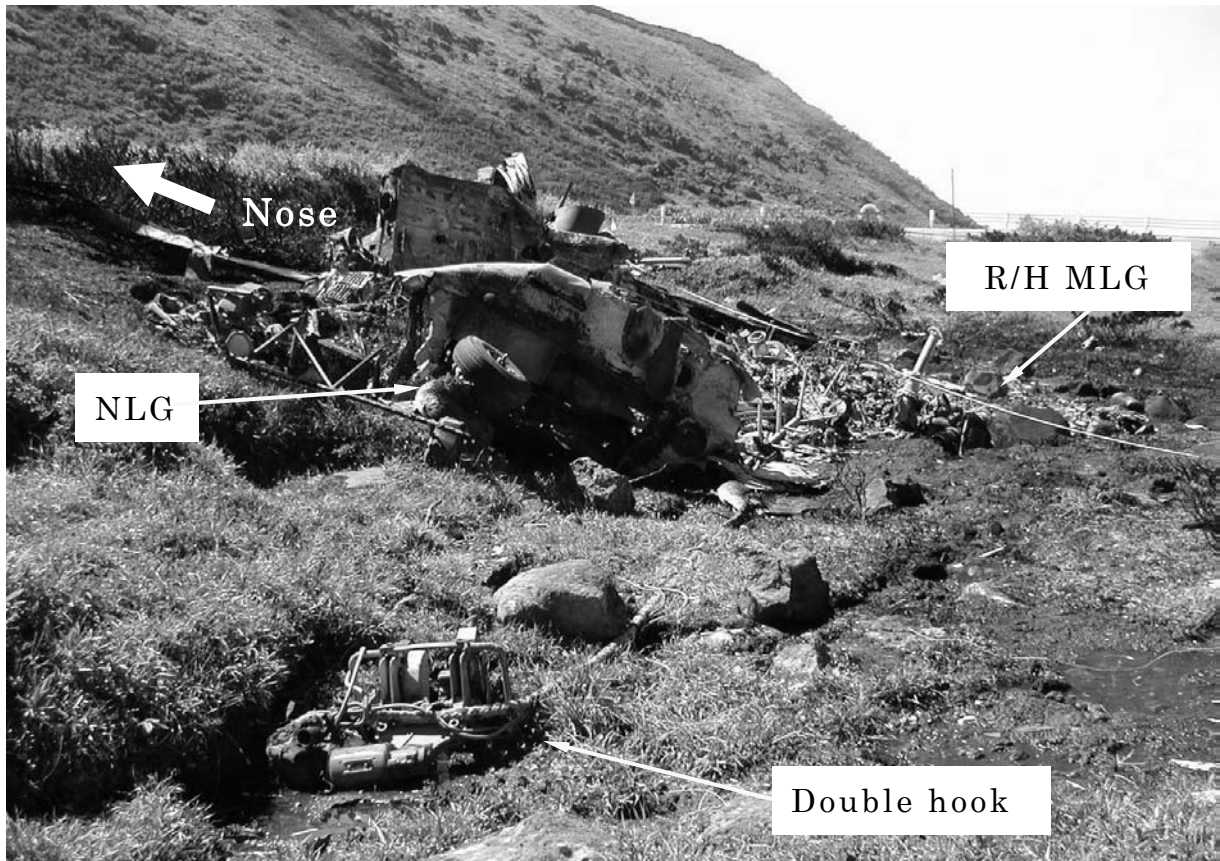
Photograph 3 Wreckage(bottom)

- ① The right main gear was damaged by fire, and the tires were destroyed by fire. Also, a deep depression in the shape of a tire was found in the soft ground surface beneath the wheel axle. This is recognized as having been created, when the helicopter first contacted the ground.
- ② The leg attachment bearing of the left main gear and its lower housing were torn

away from the landing gear leg axle and fell to the ground around 40m short of the crash point. No skid marks were found on the tires.

- ③ The nose gear was damaged, and the area around its fuselage attachment point was damaged by fire.

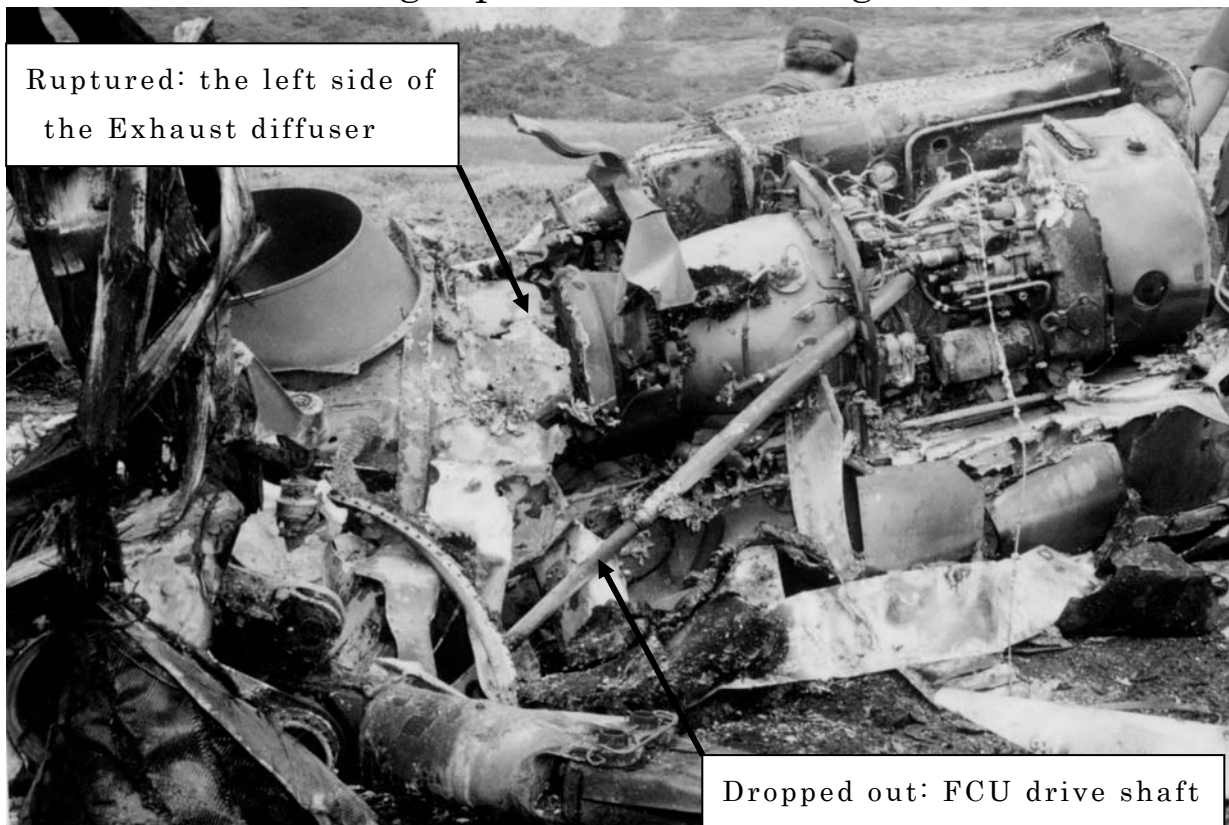
Photograph 4 N o . 1 Engine

- ① Although both engines were damaged by fire, they retained their original shapes. The engine accessories were severely damaged by fire.
- ② An opening was found in the left side of the exhaust diffuser surrounding the free turbine wheel of the No. 1 engine. (See Photograph 4.)

As the result of the investigation of the wreckage, an opening was found in the left side of the exhaust diffuser surrounding the No. 1 engine's free turbine wheel . A detailed examination of the engines was carried out to identify the cause of this damage.

As a result of this investigation, it is estimated that the free turbine disc of the No. 1 engine ruptured and fragments were projected through the left side of the surrounding exhaust diffuser. Further, it is estimated that both engines had been operating normally until the helicopter first impacted the ground.

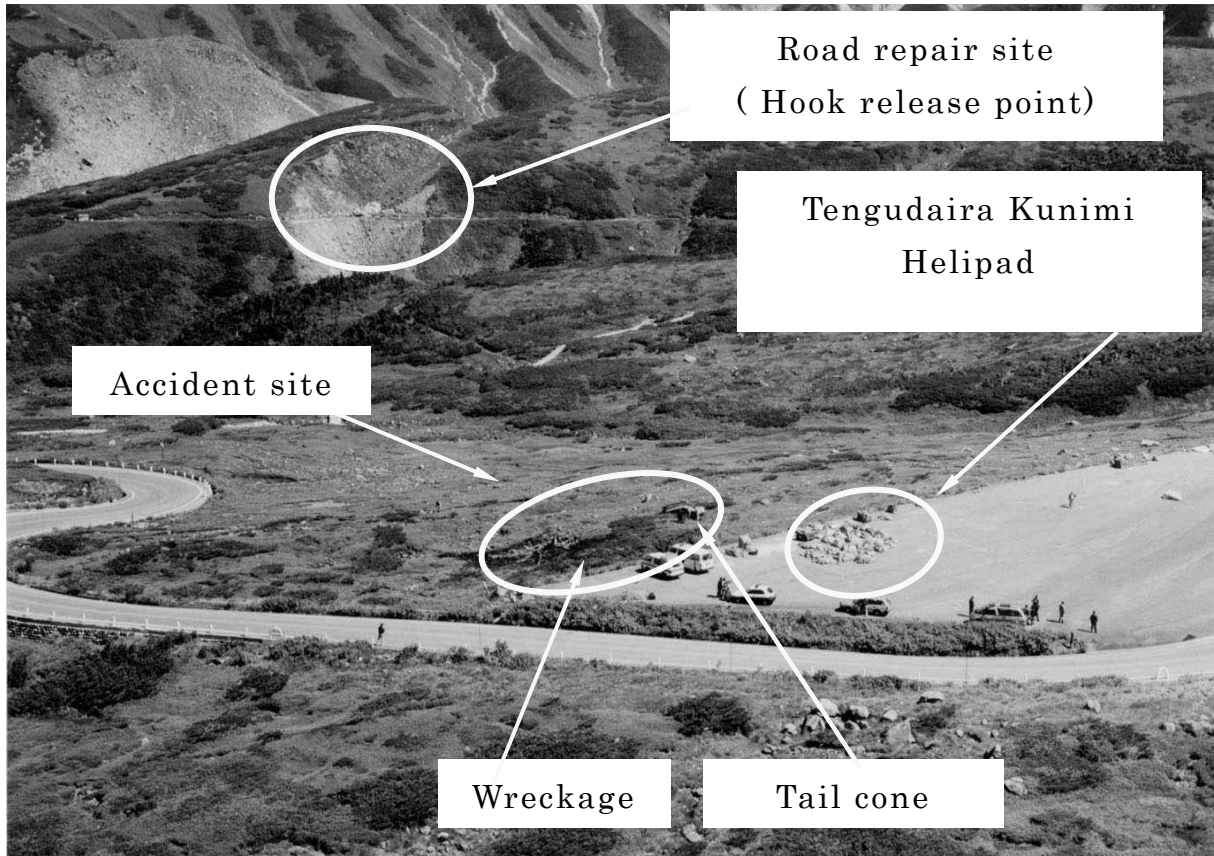
Photograph 1 Accident Site

“Just at the moment, I thought the helicopter had leveled after the flare out, the helicopter dropped in an instant, then seemed to recover and climbed to a height of around 10–15 meters while making at least two rotations to the left. At that time, the tail cone flew off in our direction. After that, the helicopter hit the ground hard and tilted

over as if it would roll over to the right, and fire came out of the lower side No. 2 engine.”  
(See Figures 1, 2 and Photographs 1, 2.)

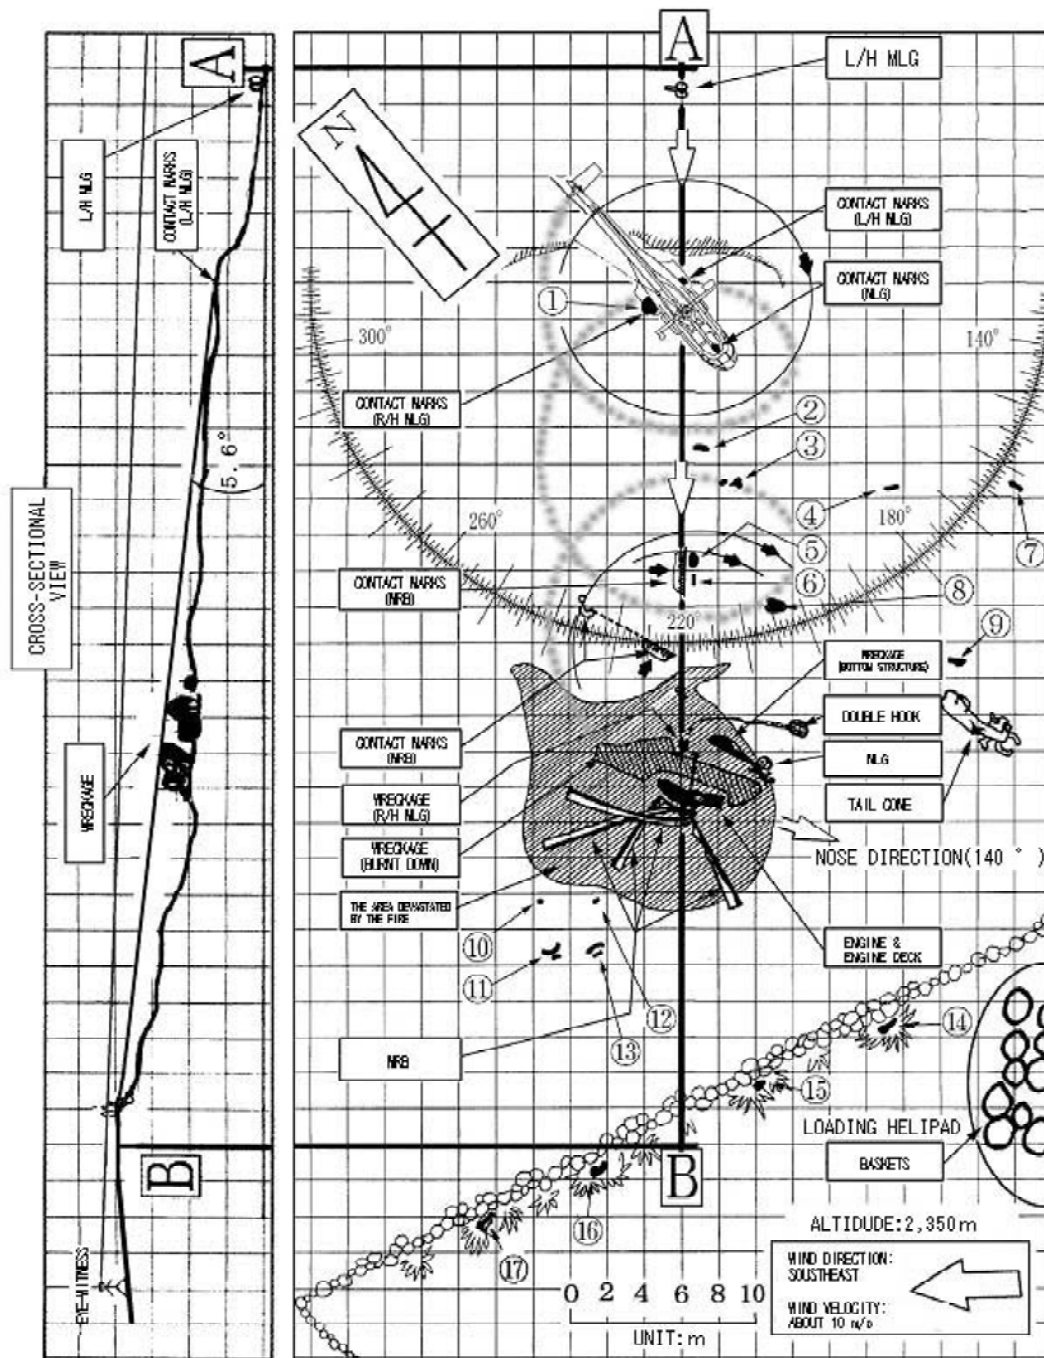
Figure 2 Skttch of Accident Site

- ① Debris of rear window, MRB automatic droop restrainers ② Debris of MRB  
 ③ Debris of main structure ④ Debris of MRB ⑤ Cover: Sound proofing material (Tail cone section)  
 ⑥ On ground retraction safety microswitch ⑦ Debris of MRB leadingedge protective strip  
 ⑧ Debris of T/R drive-shaft, Debris of MRB ⑨ A lump of grass, Debris of MRB  
 ⑩ Debris of T/R drive-shaft ⑪ Debris of MRB leadingedge protective strip ⑫ Debris of MRB  
 ⑬ Debris of R/H Engine cowling ⑭~⑰ Debris of MRB

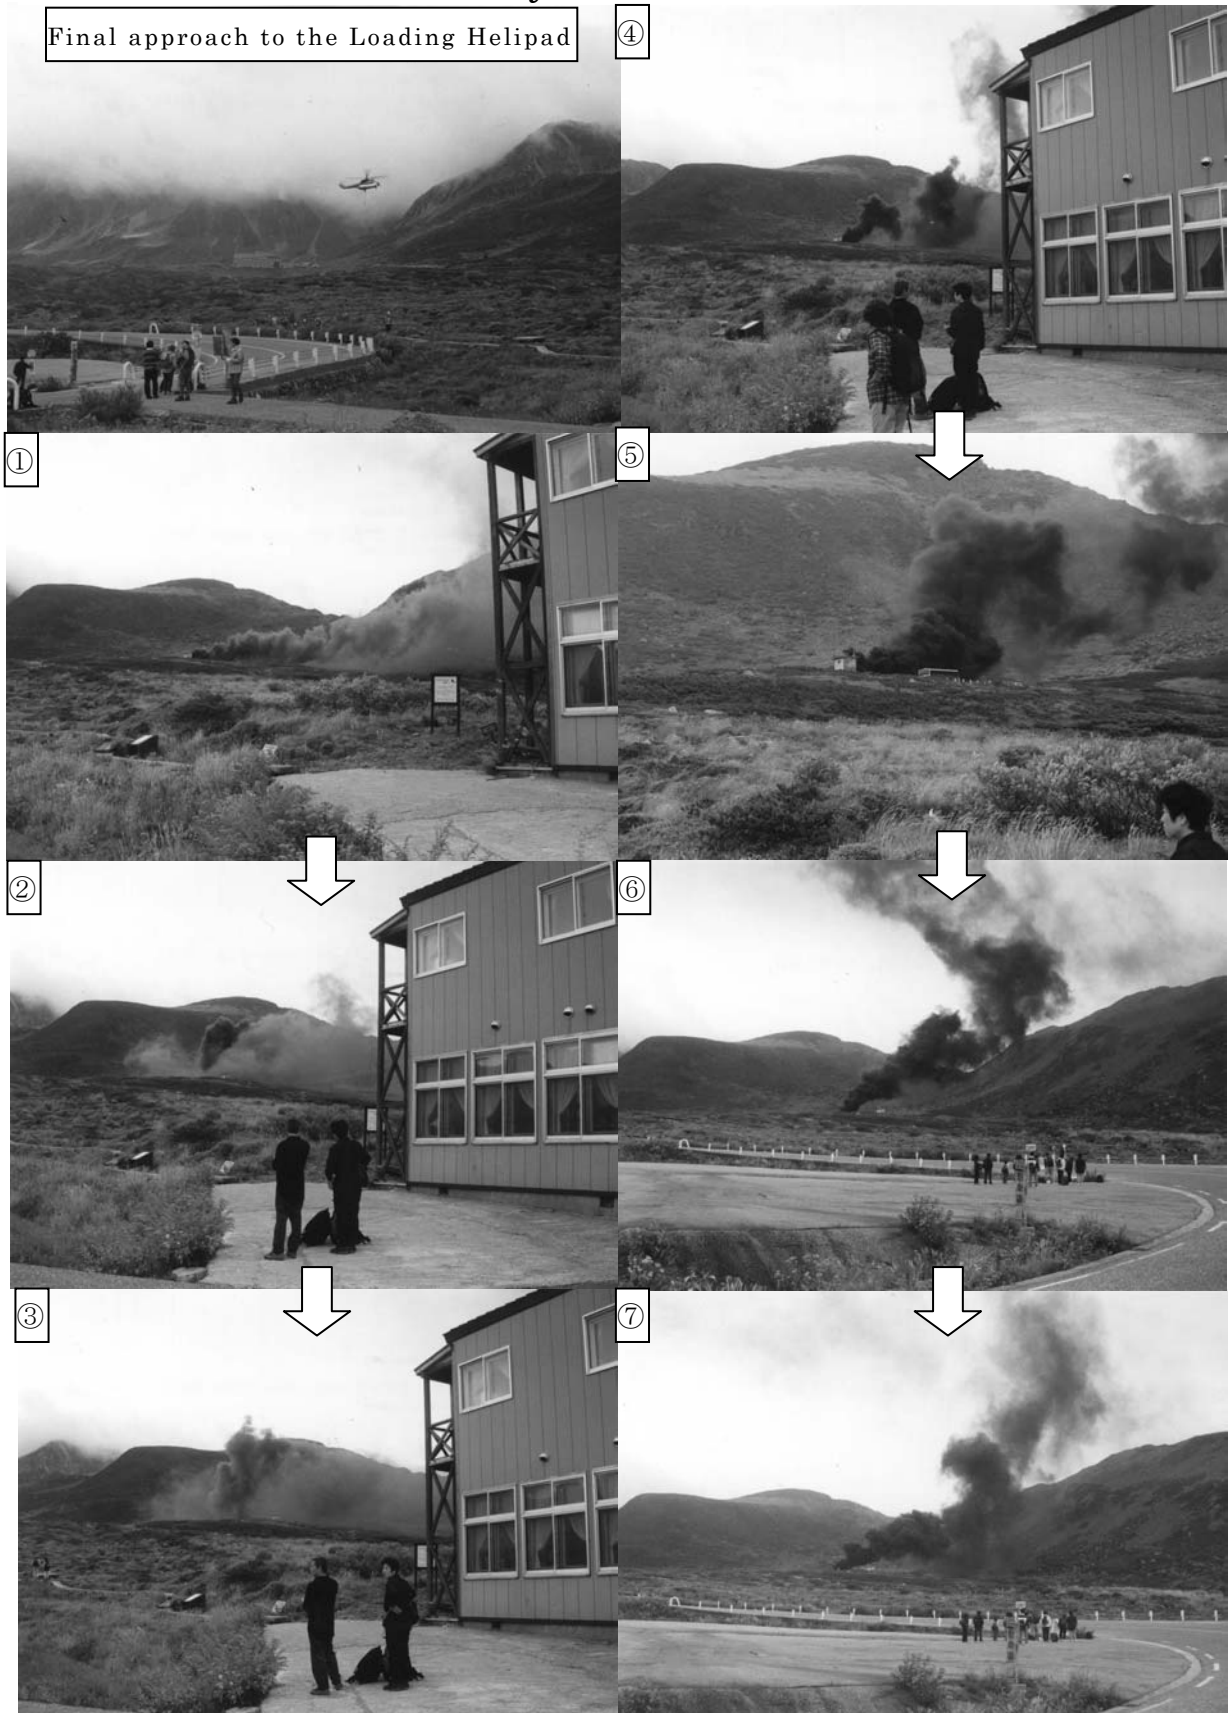
# Photograph 6 The series of Photographs taken immediately after the accident

A witness, sheltering at a lodge around 400m northwest of the accident site, took a series of photographs.
