**AIRCRAFT ACCIDENT
INVESTIGATION REPORT**

Japan Coast Guard

J A 6 7 1 3

**JAPAN COAST GUARD
BELL - 412 (ROTORCRAFT), JA6713
ON THE SEA ABOUT 8km EAST-NORTHEAST OFF IKEMA
ISLAND LIGHTHOUSE, MIYAKOJIMA CITY, OKINAWA
PREFECTURE, JAPAN
AT ABOUT 19:41 JST, DECEMBER 1, 2008**

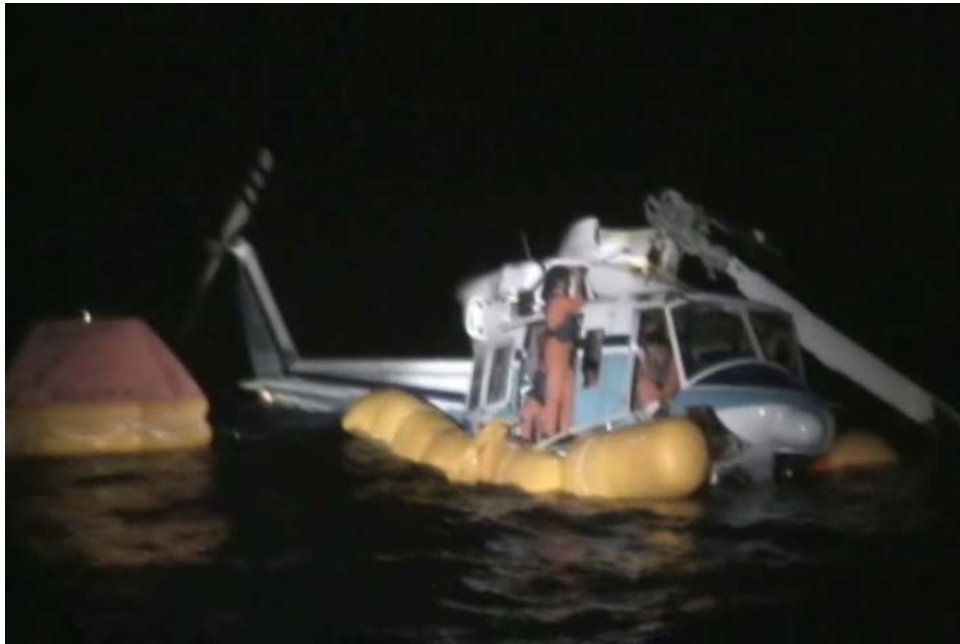
Photo 1 Accident Aircraft (Just After Ditched)

Judging from the statements in 2.1, it is considered highly probable that with the floats inflated when the Aircraft ditched, it was almost stably floating on the sea until the floats ruptured.

As stated in 2.1 and described in 2.7.2, it is considered highly probable that the Aircraft suffered damage at ditching and the pieces of its damaged parts were floating around it. Therefore, it is considered probable that contacts with these fragments punctured holes in the floats.

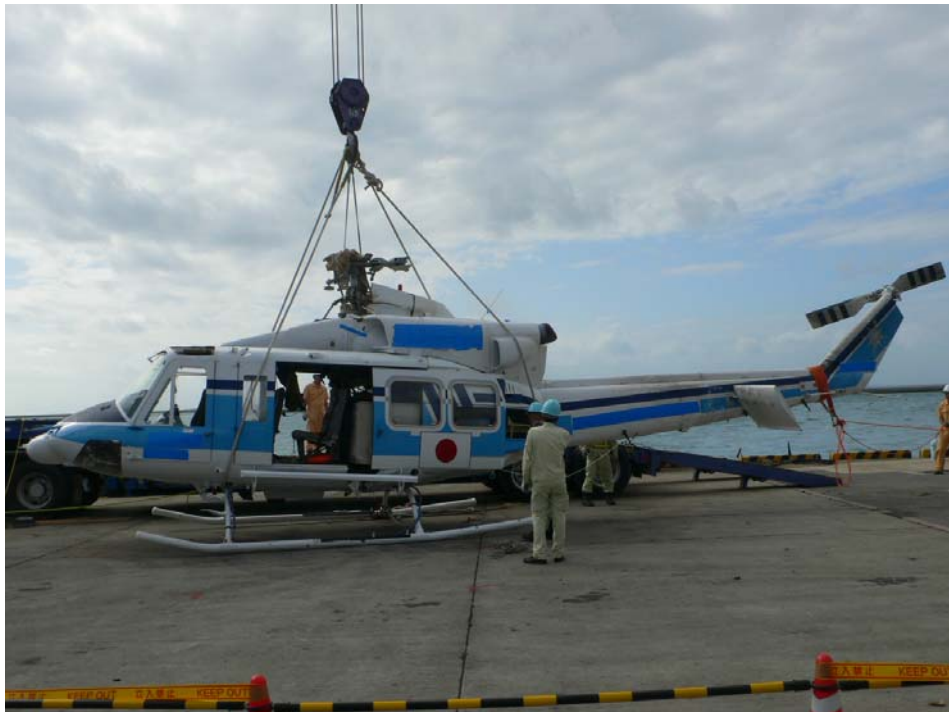
Photo 2 Accident Aircraft
(Transporting on Ishigaki Port)

(1) MR blades

Two MR blades among the four blades were separated from the hub and any pieces which can be identified as those of these two blades were not recovered.

The other two blades were broken and one of them was fractured.

The supporting structure part of the transmission was broken and, together with the MR mast and the flight control system, tilted and displaced forward.

The main drive shaft located behind the transmission was separated from the transmission. The TR drive shaft located also behind the transmission was fractured at a front part where the tail boom is attached to the fuselage.

There was a gap in the lower part of the portion where the tail boom was attached to the fuselage. The left elevator was damaged but the right elevator was not. There was no damage in the TR.

The skylights of both right and left pilot seats were broken. In addition, there was damage like dents made during the crane lifting operation to transport the Aircraft.

On the front and middle floats of the right side were partially torn and holed.

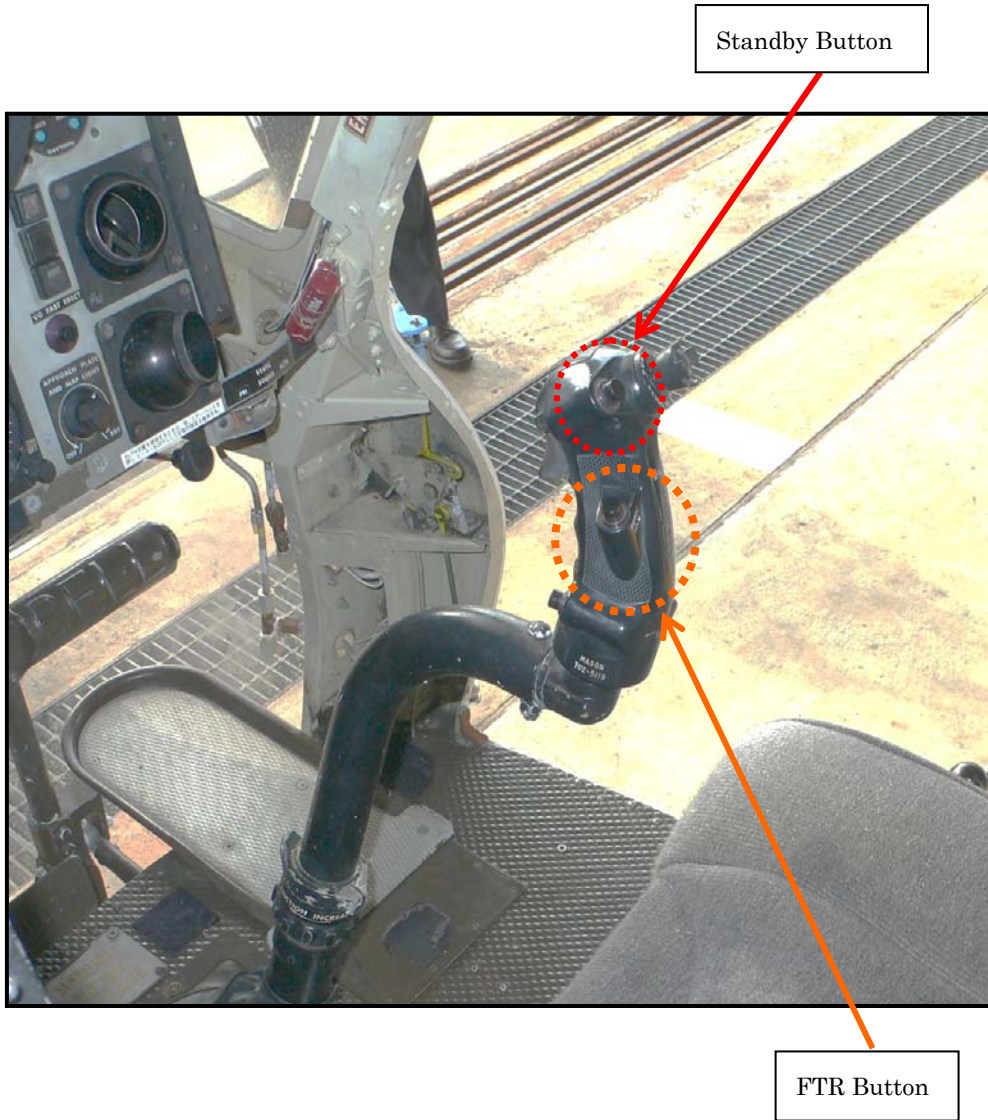
Photo 3 Cyclic Stick

After we were rescued, I heard from the copilot that RADALT was off when he turned VELHLD on. I tried to push the FTR button located in the middle of the cyclic stick to add the manual control, but I might have momentarily pushed a standby button on the top of the cyclic stick before pushing the FTR button. The standby button is used for canceling all modes set by the autopilot, and this means RADALT will be turned off.

The FTR button is used to change the attitude of the aircraft with manual control by temporarily disengaging FLIGHT DIRECTOR (hereinafter referred to as “the FD”) MODE, which is controlled with autopilot, while the button is pushed. The FTR button for the pitch and roll system is located near the center on the left side of the cyclic stick so that it can be pushed with a thumb while holding the stick. The FTR button for the collective and pedals control system is located in the upper part of the collective lever, therefore it can be pushed with a thumb while holding the collective lever. When the FTR button is released, it returns to the autopilot.

A standby button is used to cancel all FD modes of the autopilot which are set at that time. It is located in the upper part of the cyclic stick, therefore it can be pushed with a thumb while holding the stick.

The Aircraft is equipped with no annunciator light or sound device which works when the standby button is pushed and the FD mode of autopilot is canceled.

The Aircraft usually operates using the FD mode of autopilot during the night flight except for takeoff and landing. The FTR button can be pushed while flying on autopilot, but the standby button is not usually pushed except for takeoff and landing with all canceled FD modes of autopilot.
