**AIRCRAFT SERIOUS INCIDENT
INVESTIGATION REPORT**

SKYMARK AIRLINES Co., Ltd.

J A 7 6 7 B

BOEING 767-300

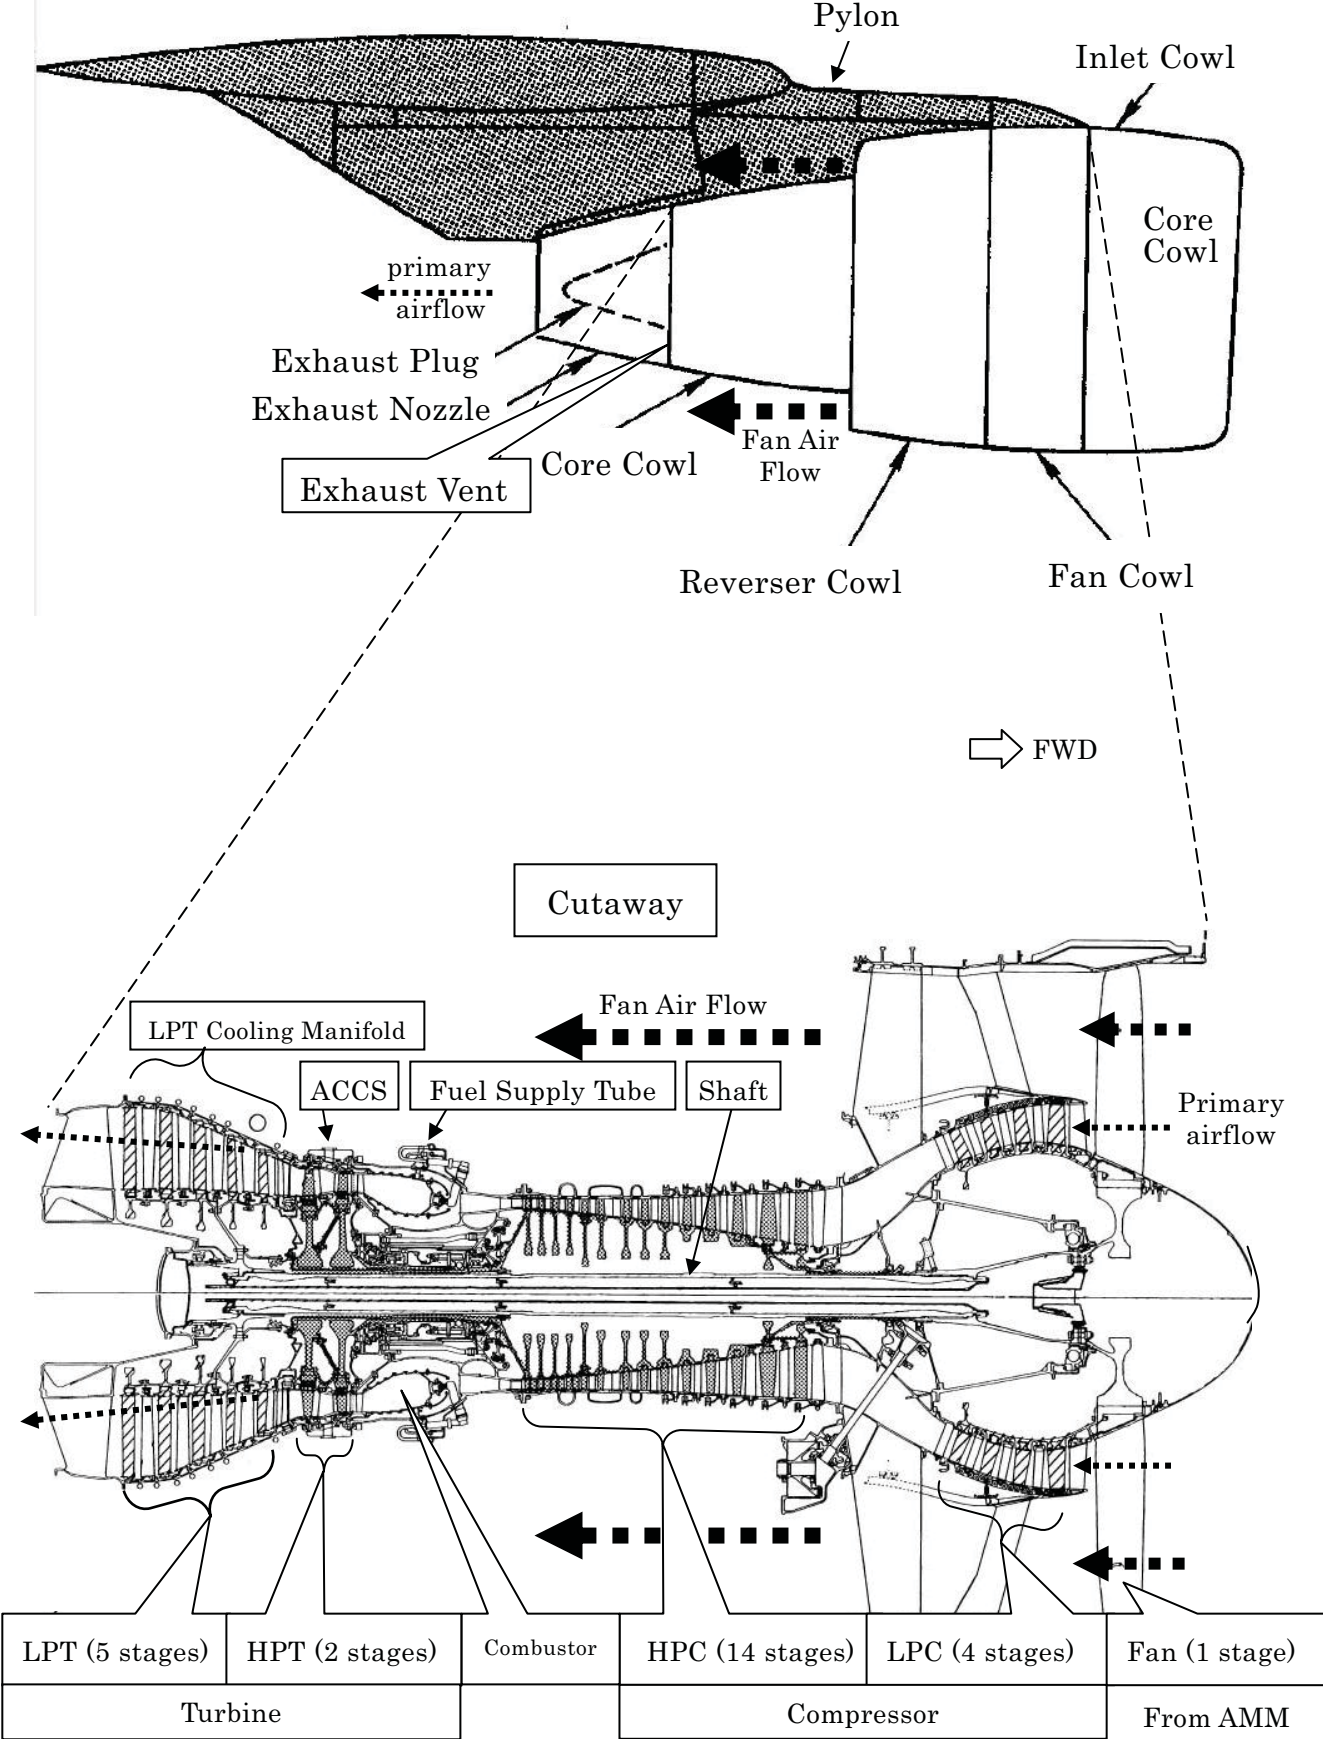
Figure 5 Sooty Condition of Engine Outside

From the thermal damages found on the right hand exterior surface of the engine case and on the core cowl, areas of sprayed and burned fuel leaked from the fractured fuel supply tube are indicated with white strings in Photo 11. And, the condition of the exterior of the engine case is shown in the table below.

Engine case	Position	Surface condition (ex.Soot)	Damage (ex. to Wiring)	Remarks
Right-hand surface	Fuel supply tube fwd. upper portion	Heavily sooted	No damage	
	Fuel supply tube fwd. lower portion	Nearly not sooted	Partly damaged No discontinuity of the wiring	
	Fuel supply tube aft portion	Heavily sooted	At lower aft portion, fire detector burned, fire detector isolator melted, no discontinuity of the wiring	Fire detector isolator melts at about 428 °C
Left-hand surface	General	Sooted		
	Case lower portion	Heavily sooted	Burned, discontinuity of one EGT probe No other wiring discontinuity	
Bottom surface	General	Heavily sooted Traces of flames		Traces looked like remnants of liquid

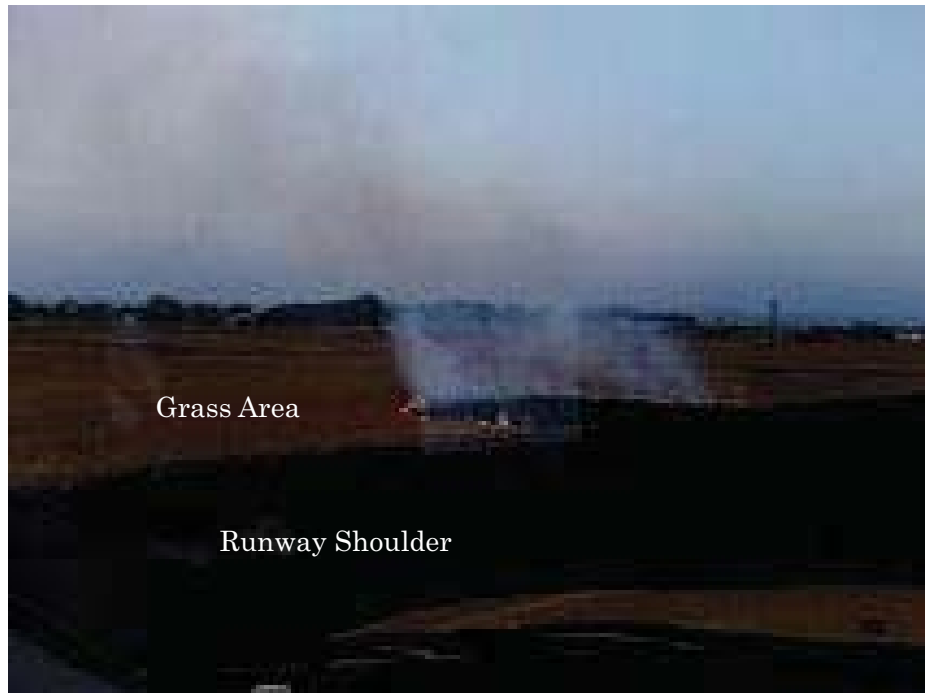
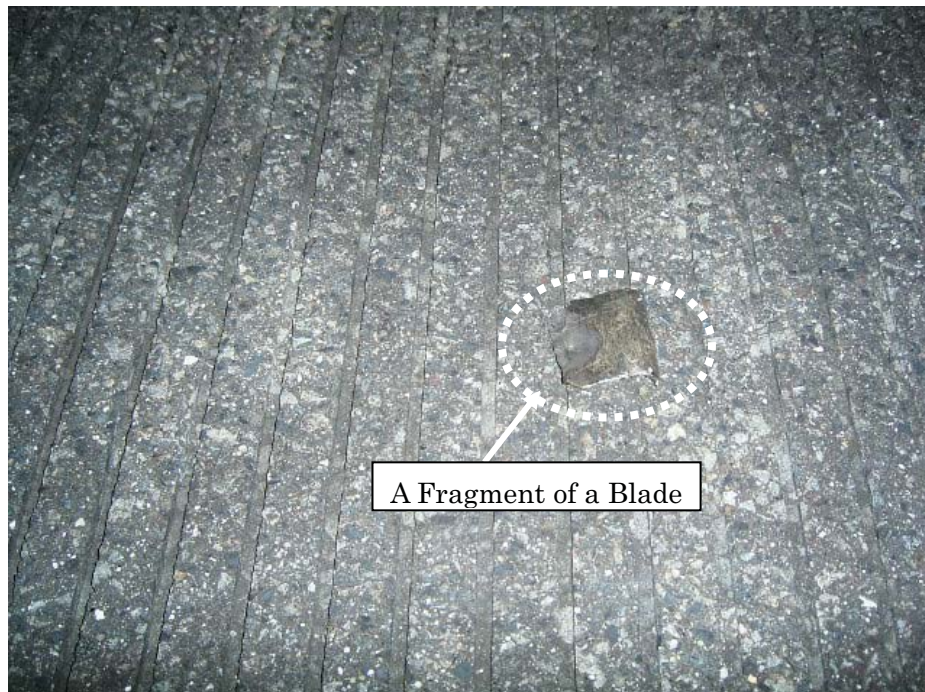
Photo 4 Fire Kindled by Engine Fragments

I found the fire from Operation Room, so I promptly left the Room and headed for the scene, and asked the firefighters nearby to extinguish the fire. It was already twilight and I did not notice fragments such as engine debris on the runway. At that time, we did not make any special inspection of the runway nor investigation on the cause of the fire. (See Photos 4 and 5.)

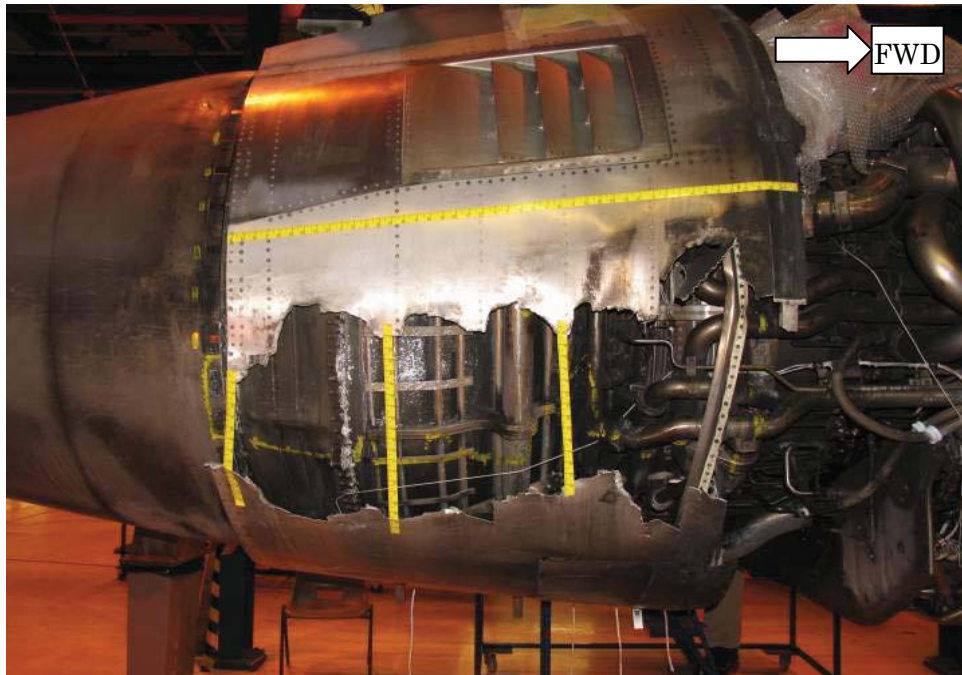
Photo 10 The Burnt Core Cowl

The right hand surface of the core cowl was melted and burned from 3h to 4h position, leaving a hole whose approximate size is 150 cm in length and 25 to 60 cm in width. The forward part of the core cowl at about the position of the stiffener ring was melted in a round shape at its top and bottom. The aluminum alloy outer panel of the core cowl melts at 642 °C. (See photo 10.)

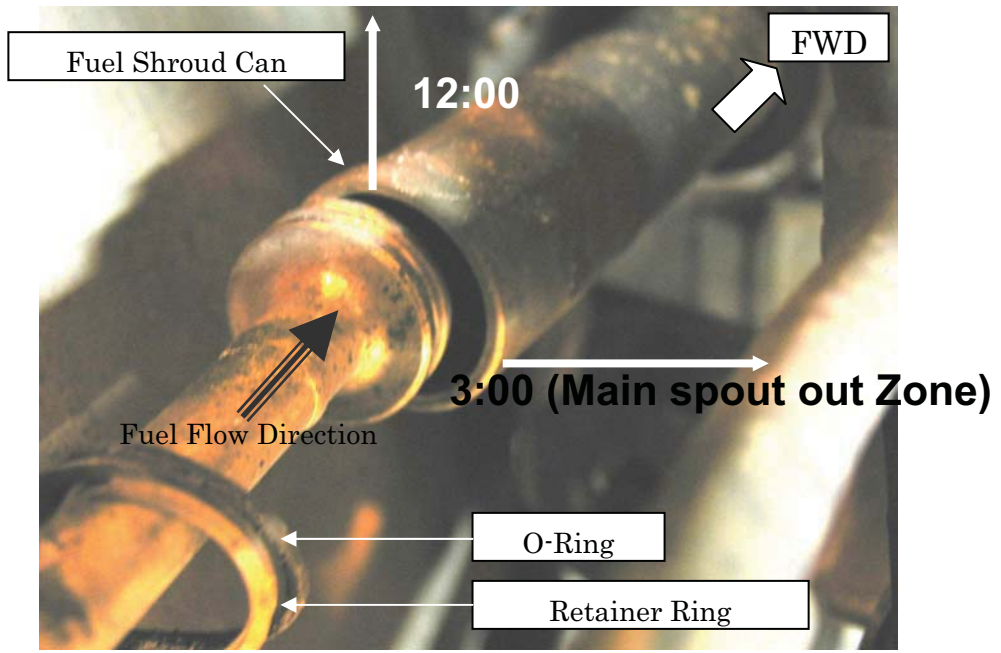
Photo 12 Fuel Manifold Position #6 Tube Separated and Dislodged from Shroud Can

- (3) Fuel supply tube (pigtail) #6
- ① Fuel supply tube #6 at 2h30m position was fractured near the B nut(Built in Nut) coupling with the fuel nozzle.
 - ② The retaining ring^{*24} inside the fuel nozzle shroud can^{*25} (hereinafter referred to as “shroud can”) covering the B nut coupling joint of the fuel supply tube with the fuel nozzle, and the O-ring sealing the gap between the fuel supply tube and the shroud can, were displaced from their normal positions and left on the upstream part of the fuel supply tube.(See photo 12.)

- ③ The mounting base (ferrule) of the O-ring of the fractured fuel supply tube was dislodged from the shroud can, making a crescent-shaped opening centered at 3h position of the engine (core cowl side). The U-shaped portion of the fuel supply tube was bent a little between its bend and the fuel manifold.

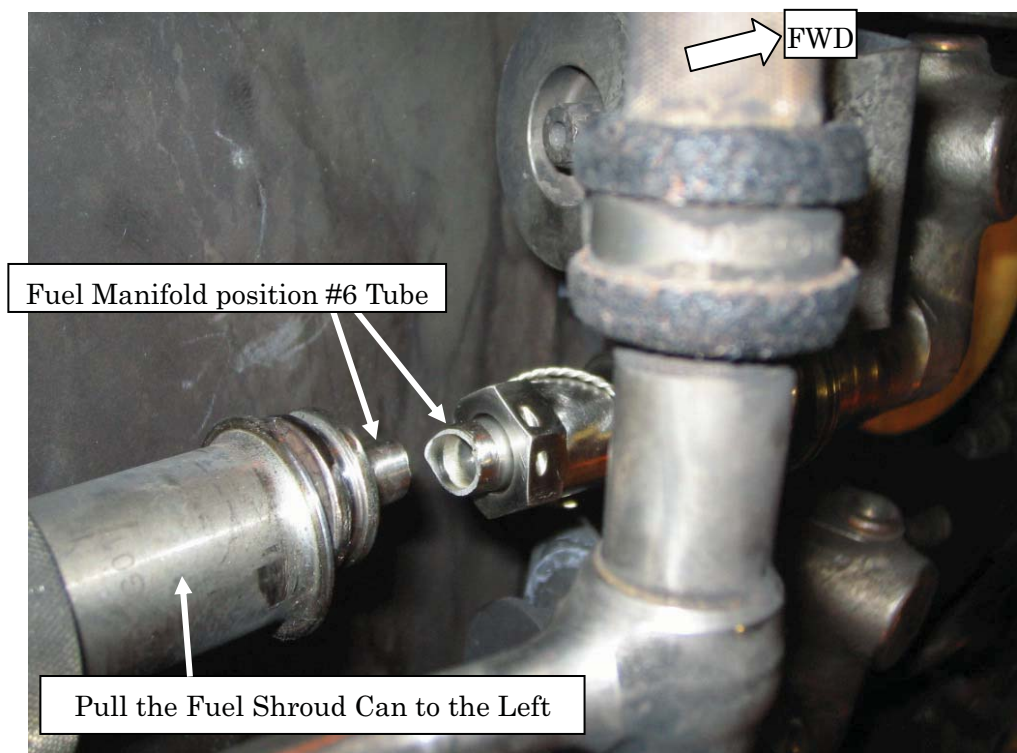
Photo 13 Separated Fuel Manifold Position #6 Tube

There are 30 fuel supply tubes on the entire circle of the manifold and each tube is connected to a fuel nozzle. The fuel supply tube #6 at 2h30m position was fractured inside the shroud can. Furthermore, the retaining ring and the O-ring normally located within the shroud can were found dislocated from their proper positions, and fractured fuel supply tube was out of the the shroud can. The O-ring sustained heat damage.

The thickness of the fractured fuel supply tube was found to be not constant.

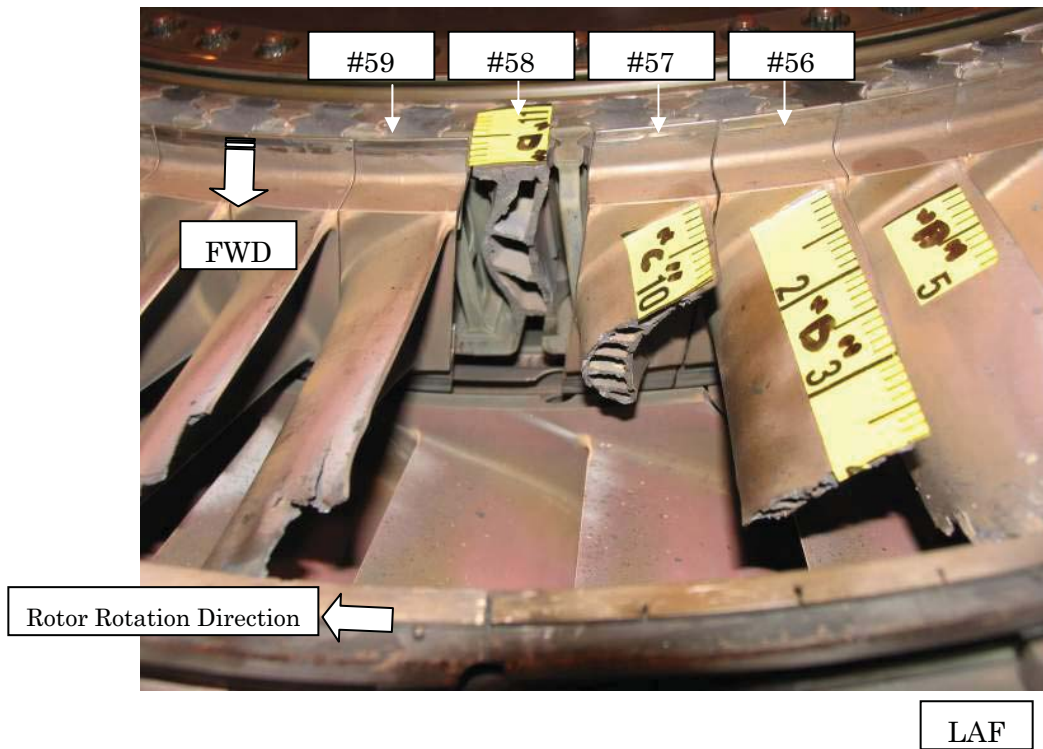
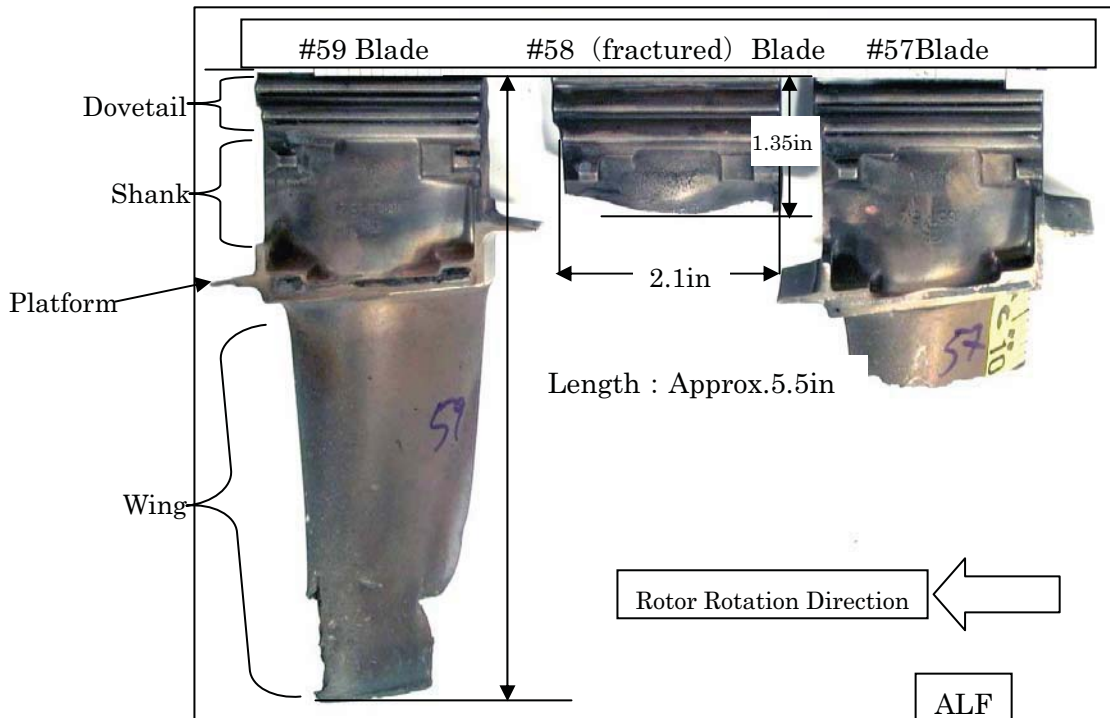
Photo15 Stage 2 HPT Shank Separation and Adjacent Blade Damage

- ④ Of the 74 blades of the HPT 2nd stage, Blade #58 was fractured at the shank^{*21} located between the root (dove tail) and the platform. Blade #57 was fractured in the middle of its airfoil. Blade #56 was fractured near the tip of its airfoil.

- Some of 1st and 2nd Stage nozzle guide vanes^{*40} were covered with grayish white deposits and had damaged trailing edges.
 - 2nd Stage Blade #56 was fractured in its airfoil three inches from the platform.

- 2nd Stage Blade #57 was fractured in its airfoil one inch from the platform (roughly half of blade height).
 - 2nd Stage Blade #58 was fractured in the shank about 1.3 inches(33mm) from its root, and its airfoil was completely missing. (The normal blade height: 5.5 inches(140mm).) Because uniform contact pattern was observed on the CCV and CVX surfaces of the dovetail, the blade is considered to be properly positioned within the disk.

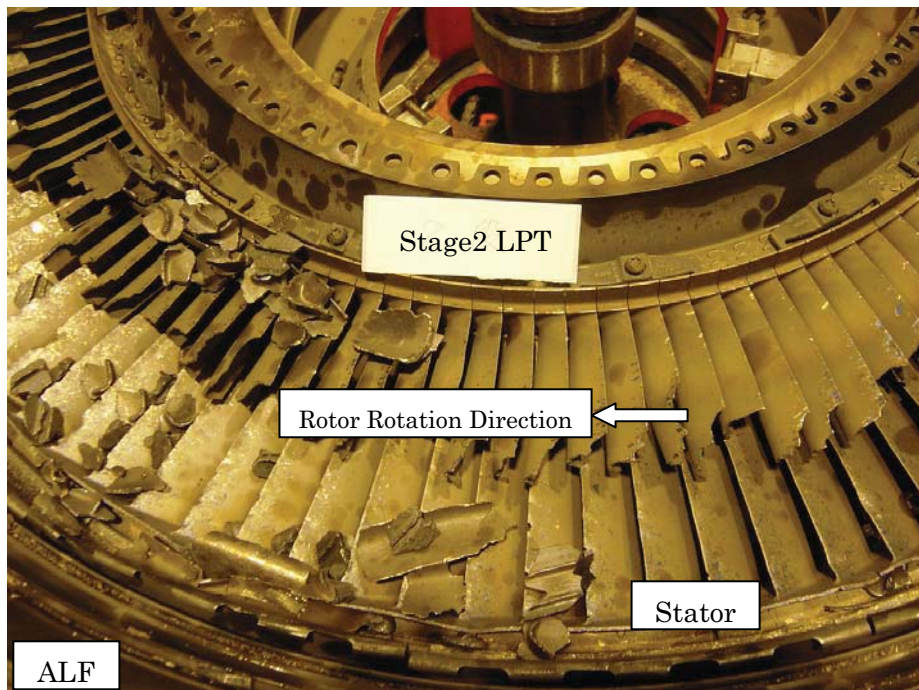
Photo 17 Damage of LPT Blade and Stator

- All stator vanes had damages or missing parts. The case had sustained damage on many parts when the fragments such as fractured blades, hit it. And, low pressure rotor system could not be rotated.
- The airfoils of 1st stage blades exhibited impact marks with contact from internal engine debris.
- The airfoils of 2nd stage blades were fractured at about 50% of their length on average.
- The airfoils of 3rd and 5th stage blades were fractured at various lengths.
- The airfoils of 4th stage blades were fractured at about 75% of their length from their roots on average.

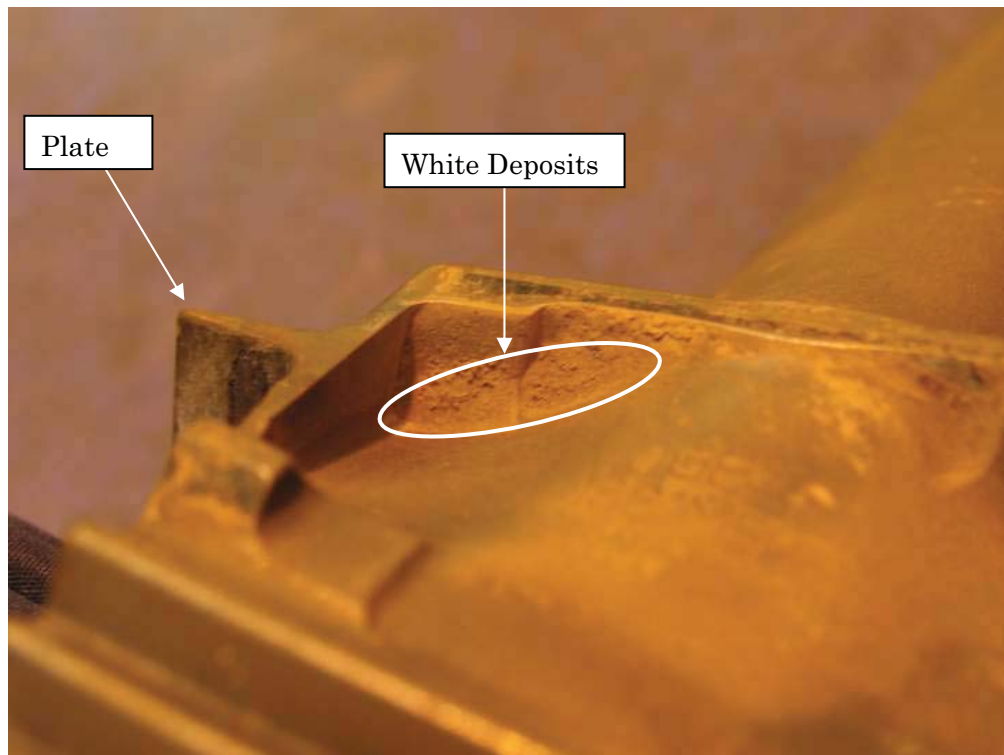
Photo 28 White Deposits on the HPT Blades

- Small cracks were observed in the cooling holes of the inner liner of the combustor.
 - (See Photo 31.)
 - ④ HPT
 - On the CVX^{*39} surface of 1st stage blades, grayish white deposits were observed from the platforms to the airfoils.

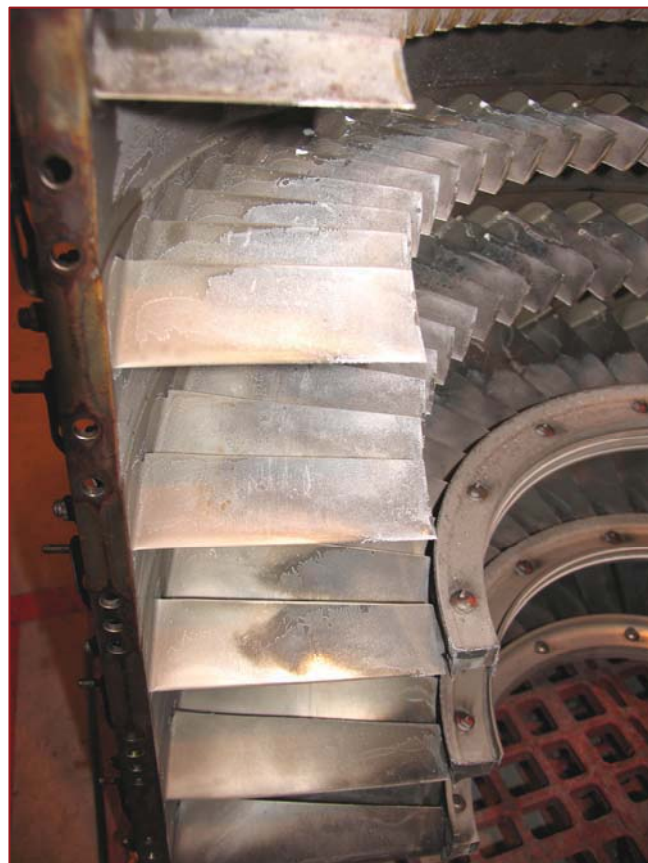
Photo 29 White Deposits on the HPC Vanes

- Grayish white deposits were observed from the blade platform up to about 50 % of the HPC stator vane airfoil as well as the inside of the bleed air port.

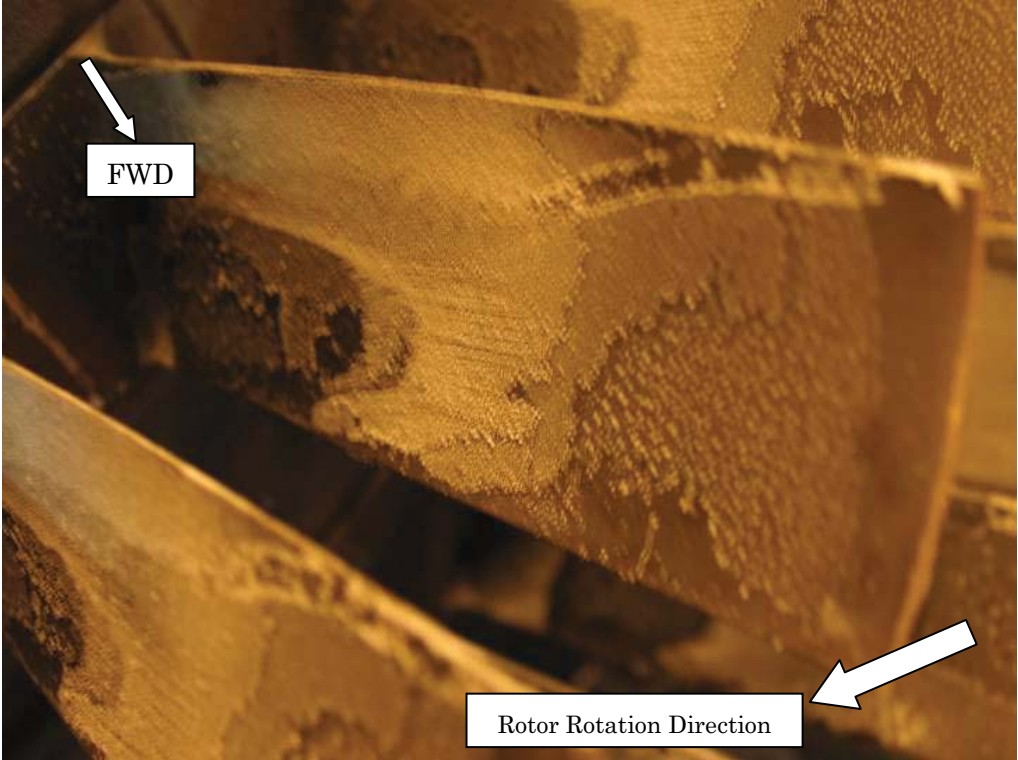
Photo 30 White Deposits on the HPC Blades

- ② Compressor
 - No abnormality was observed with the LPC^{*36} and HPC.
 - Grayish white deposits were observed on the CCV^{*37} surface of almost all blades.
