**AIRCRAFT ACCIDENT
INVESTIGATION REPORT**

**PRIVATELY OWNED
JA77AR**

PRIVATELY OWNED ROBINSON R66 (ROTORCRAFT), JA77AR

AT ABOUT 15:33 JST, DECEMBER 30, 2020

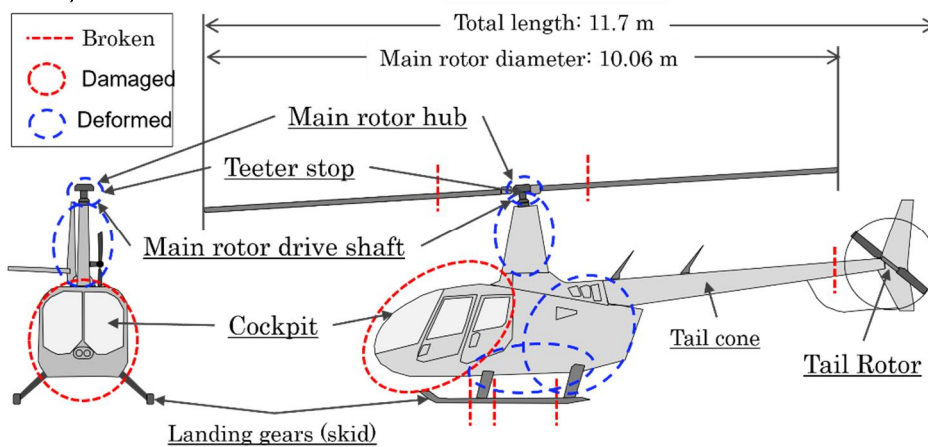
Figure 3: The Helicopter Size and Damaged Locations

| 2.3 Damage to the Aircraft | <p>Extent of Damage: Destroyed</p> <p>Fuselage: Cockpit and cabin destroyed Aft fuselage deformed Upper part of main rotor drive shaft deformed, main rotor hub*³ dented, and teeter stops*⁴ deformed</p> <p>Tail cone: Deformed, and broken at the forward horizontal stabilizer</p> <p>Main rotor blades: Deformed, broken and scattered</p> <p>Tail rotor blades: Damaged</p> <p>Landing gears (skid): Damaged and broken</p> |

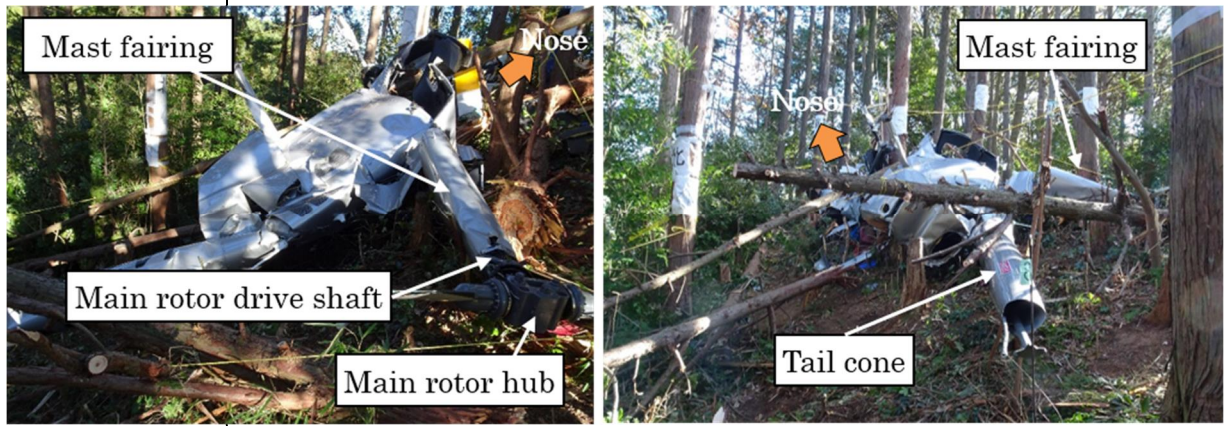
Figure 5: Damaged Helicopter in the Accident Site

The tail rotor was left on the top of the trees. Both the angle the cut surface of the trees and the opening space, which was created because the helicopter had cut the trees, was about 40°. In addition, the Emergency Locator

Transmitter (ELT), which was installed in the frame of the aft fuselage, was operating due to the impact at the time of the crash (Threshold value 6 to 8 G).

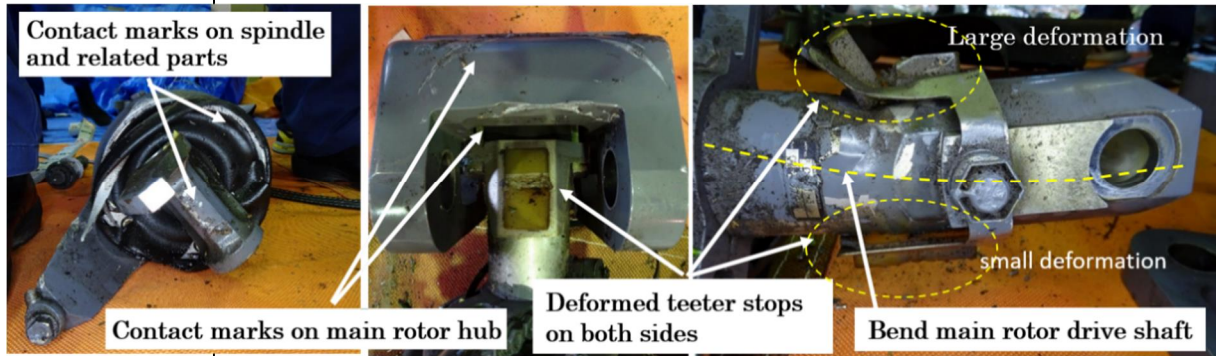
Figure 6: Contact Marks on Spindle, Main Rotor Hub, Teeter Stop and Main Rotor Drive

As shown in Figure 6, the spindle assembly of the helicopter’s two main rotor blades and the main rotor hub had contact marks, in addition, the main rotor drive shaft was significantly bent, the teeter stops on both sides had a difference in the size of deformation due to contact marks, which most likely resulted from a strong contact between the main rotor blade spindle assembly, hub and the main rotor drive shaft during the flight or at the time of the crash.

As shown in Figure 2, the flight route from the point where the radar target of the helicopter disappeared to the crash point was about 900 m, and the helicopter flew for one minute, in addition, according to the recording on the Engine Monitoring Unit, from around 15:32:25, the torque suddenly increased, and the helicopter was more likely flying at a low speed of about 30 kt. According to the statements of eyewitnesses, the helicopter was swinging its tail right and left, and immediately before the crash, therefore, it was flying while largely tilting to the right with a large nose down, the helicopter most likely continued flying in a difficult flight control condition. Besides, if the main rotor drive shaft had been bent during the flight, the imbalance of the main rotor would rapidly result in complete separation of the entire main rotor gearbox, and the airframe will disintegrate in midair. Therefore, it is likely that the main rotor drive shaft was bent after the crash, not during the flight.

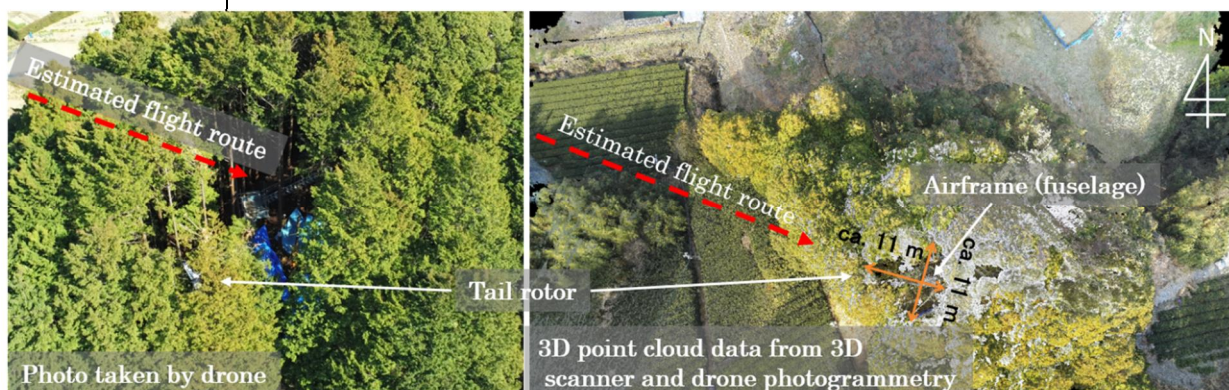
Figure 10: Size of the opening Space in the Mountain Forest at the Accident Site

To the north of the accident site lies the mountain region in northern Shizuoka Prefecture, and there is Mt. Awagatake, with an elevation of 532 m (1,745 ft), 1.2 km west of the accident site. The accident site was a small hill with cedar trees about 30 meters high. As shown in 3D point cloud data of Figure 10, in the mountain forest, there was the opening space which indicated about the same length as the main rotor with a diameter of about 10 m and the fuselage with the overall length of about 12 m. And contact marks were left on the trees at the opening space.

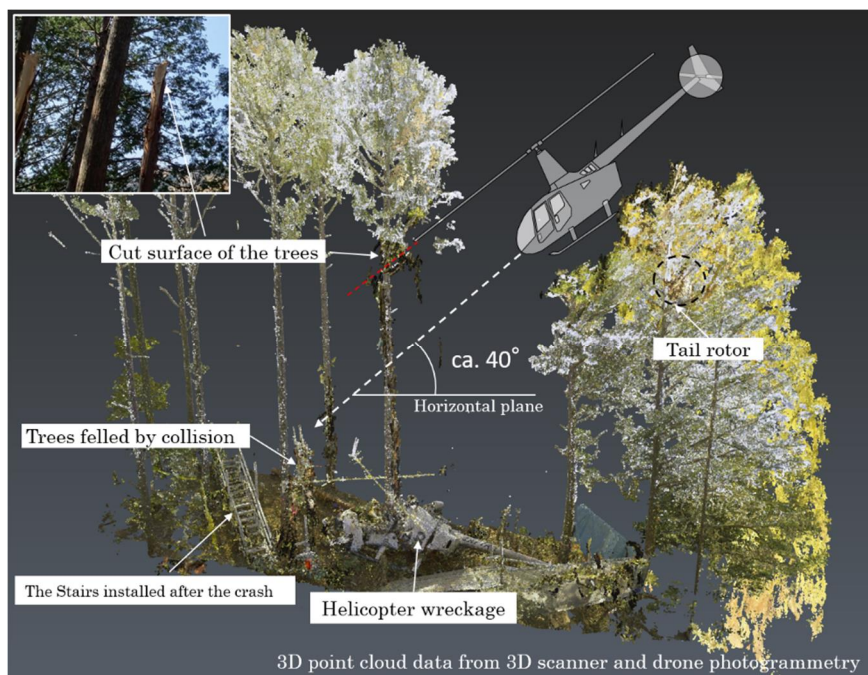
Figure 11: Estimated Approach Angle at the Time of the Crash

Based on the recording on the Engine Monitoring Unit, and the main rotor blade found in the location about 90 m away from the accident site and the cutting condition of the surface of the trees, it is highly probable that the helicopter's engines were working normally, and with its engine output able be transmitted to the main rotors, the helicopter crashed into a mountain forest in an angle of about 40°.

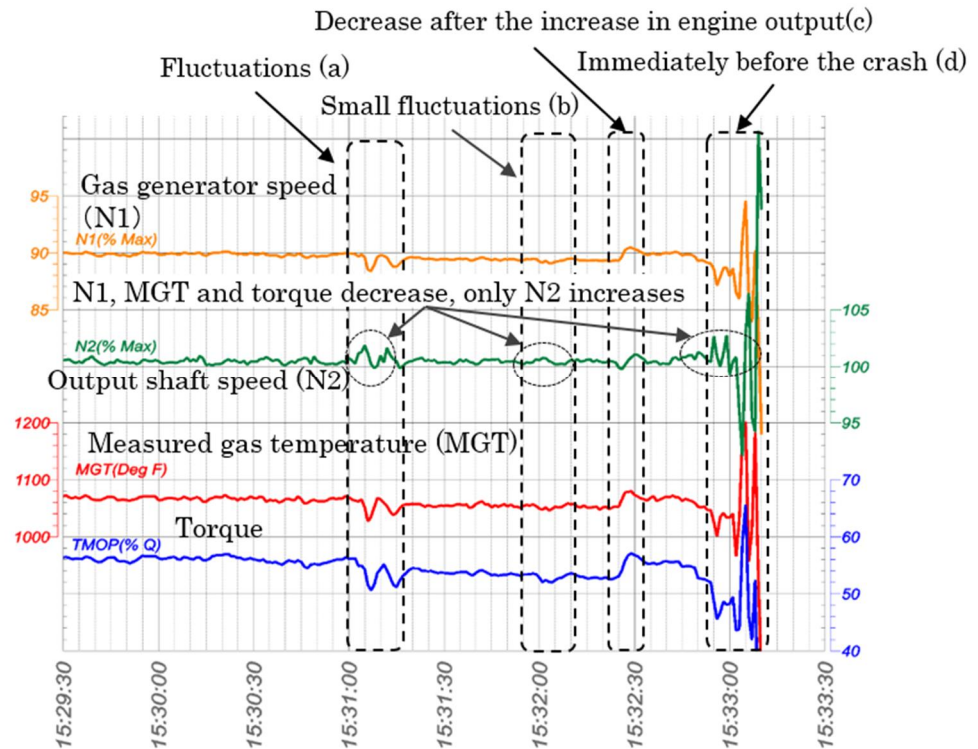
Figure 13: Engine Monitoring Unit (EMU) Recording of Condition just before the Crash

As shown in Figure 1, the helicopter climbed from an altitude of about 1,400 ft up to about 2,000 ft between 15:30:07 and 15:30:46. The Engine Monitoring Unit (EMU), recorded the fluctuations (a) in which the power significantly fluctuated up and down around 15:31:10 after the climb. The record showed that around 15:32:00, there were slight torque fluctuations (b), and the power increase from 15:32:25 to 15:32:30. In addition, the record showed that from 15:32:30 to 15:32:35, the power decreased (c), became almost stable for 20 seconds, and then significantly changed (d) between 15:32:50 and the crash. Especially, in the fluctuations (a), (b) and (d), N1, MGT and the torque decreased, only N2 increased.

According to the collated results including the estimated flight path from the point at 15:30:46 to the point at which the radar target disappeared at 15:32:08, the engine monitoring unit (EMU) records in Figure 13 and the numerical analysis in Figure 16, against the large output fluctuation region (a) from 15:31:00 to 15:31:20, the flight altitude decreased and the deviation of the vertical flow during that period exceeded 5 m/s. If the output shaft speed (N2) is in the normal 1G state, the engine output is transmitted, so the main rotor RPM is maintained at around 100%. In particular, in the output fluctuation region (a), around 15:31:05, N2 increased by about 2 to 3% while N1, MGT, and torque suddenly decreased. This is more likely that encountered turbulence with strong vertical flow, and reduced the load on the main rotor and temporarily increased the main rotor RPM.

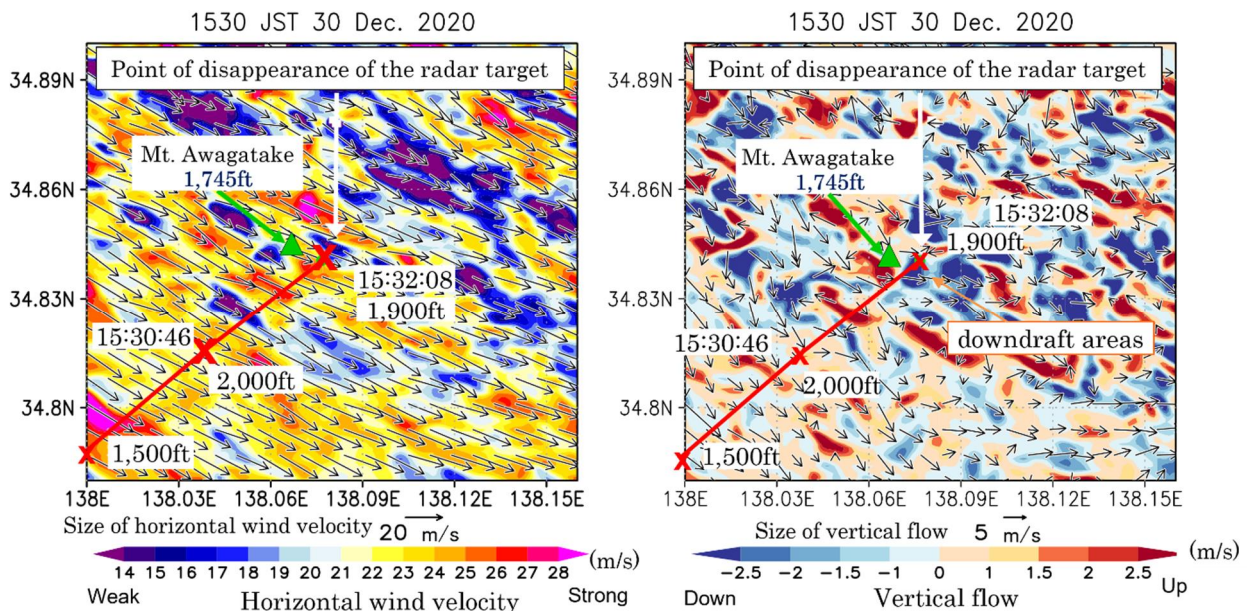
**Figure 16: Horizontal wind velocity at altitude 600 m (colored areas) from analysis B (Left)
Vertical flow at altitude 600 m (colored areas) and horizontal wind deviation
from the area-averaged (indicated by arrows) (Right)**

The left in Figure 16 shows horizontal wind velocity and the horizontal wind vector diagram from the numerical analysis B and the right in Figure 16 indicates the vertical flow, and the horizontal wind deviation from the area averaged.

As shown in Figure 15 (Right), topographic features in the vicinity of the estimated flight route of the helicopter were mountainous in the north and plain in the south. Around an altitude of about 600 m (about 2,000 ft) where the helicopter was flying, as shown in Figure 16 (Left), on the southwest side, the horizontal wind was blowing from an angle of 300° at about 25 m/s (50 kt), which is indicated mainly in yellow color, and the northeast side, the horizontal wind was blowing at about 15 m/s (30 kt), which is indicated in dark blue. In addition, as shown in Figure 8: Meteorological Satellite Imagery (Visible), in the Tokai region, there are three streaky cloud lines running through the northwest to the southeast, and one of these lines is located near the accident site, and as shown in Figure 9, at Shizuoka Airport, the strong wind had continued blowing until 17:00. The horizontal wind velocity and the vertical flow in Figure 16 (Right) show

a wind pattern running through northwest to southwest, and it is indicated that the wind tends to be strong in downdrafts area and weak in updrafts. It is probable that on the flight route of the helicopter, in the section between the point where the helicopter was flying at 15:30:46 and the point at 15:32:08 when the radar target, which was captured by Hamamatsu Radar and seemed be the helicopter, disappeared, there were increases and decreases in horizontal wind velocity with about 10 m/s (20 kt), and there were alternating updrafts and downdrafts with a velocity of about 2.5 m/s, therefore, a roll-shaped thermal convection with an axis running through northwest to southeast was generated, which resulted in the strong wind blowing in downdraft area and the weak wind in updraft area. Besides, as shown in Appended Figure, comparing the analysis results from 600 m to 1,000 m altitude of numerical analysis B revealed that according to the increase in altitude, in the wind velocity distribution (left column), the wind velocity increased as indicated in red, while in the vertical flow distribution (right column), the downdraft areas indicated in blue decreased. According to the increase in altitude, the likelihood of encountering downdrafts may decrease, however, since the horizontal wind velocity increases, it is probable that only increasing altitude would not be sufficient to response to the turbulence generated by a roll-shaped thermal convection.

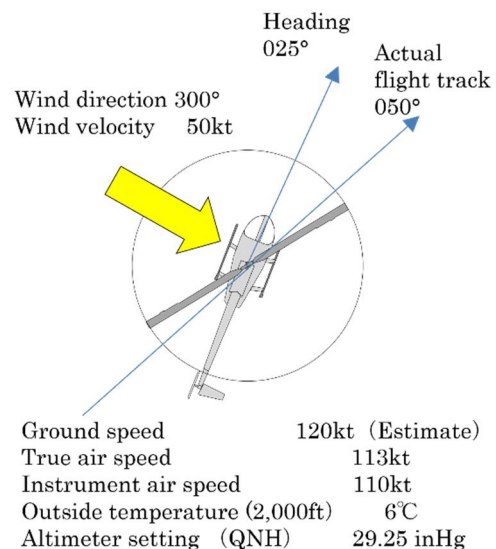
Figure 17: Estimated Airspeed

From the helicopter’s flight route and ground speed, it is probable that in order to avoid the influence of mountain waves, the captain chose the route at an altitude higher than Mt. Awagatake located on the west side of the flight route, in addition, the route at around 2,000 ft in order to avoid the cumulus clouds, which were observed to be present around 2,500 ft, as described in 2.6 (2), and climbed from 1,500 ft. Based on the helicopter’s actual flight track, ground speed, outside air temperature, atmospheric pressure, and wind direction and velocity from numerical analysis, the helicopter probably was flying at 110 KIAS and at a heading of about 025° in winds of 300° and 50 kt.

The helicopter maintained the maximum cruise speed of 110 KIAS, therefore, it is probable that the helicopter caused a low-G at the time of encountering turbulence with vertical flow, resulting in flying at the velocity that mast bumping more likely occurred.

During high-speed flight, an aircraft tends to respond to the external force faster and greater, therefore, before severe turbulence is encountered, as in the caution in the Pilot's Operating Handbook for Robinson R66, the airspeed should have been probably reduced to 60 to 70 KIAS.
