**AIRCRAFT ACCIDENT  
INVESTIGATION REPORT**

**PRIVATELY OWNED  
SCHWEIZER 269C-1 (ROTORCRAFT), JA7926  
FUSELAGE DAMAGE BY CONTACT WITH GROUND  
HOSOKAWA-CHO, MIKI CITY, HYOGO PREFECTURE, JAPAN  
AT ABOUT 13:35 JST, JUNE 7, 2015**

August 26, 2016

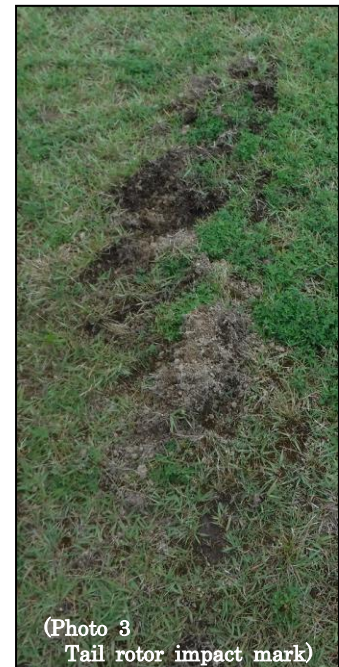
(Photo 2  
Skid impact mark)

2.8 Additional Information	<p>Situation of the accident site</p> <p>The ballpark of the accident site was on the ground about five meter lower than the road, on with there was the witness' tent. The aircraft was overturned with the nose directed to the north and the left side of the fuselage down side. There was an impact mark of the tail rotor at the point located about 11 m southeast from the aircraft and two impact marks of skid were left in-between.</p>

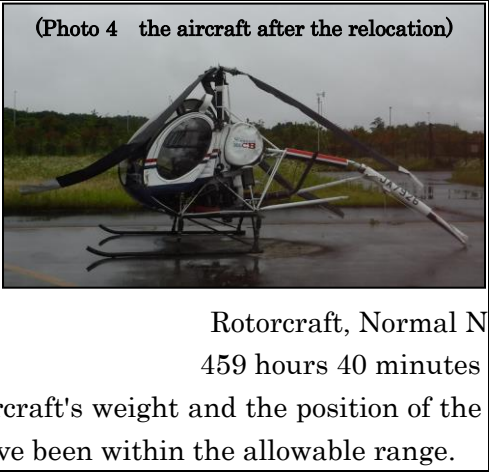
2.2 Injuries to Persons	Passenger C: Seriously injured
2.3 Damage to the Aircraft	<p>Extent of damage to the aircraft: Substantially damaged</p> <p>Fire outbreak: None</p> <ul style="list-style-type: none"> <li>• Three main rotor blades were damaged.</li> <li>• One main rotor control rod in the rear of the fuselage was bent.</li> <li>• The left side of the fuselage was damaged.</li> <li>• Cross tube in the rear was deformed.</li> <li>• Tail boom and tail rotor drive shaft were ruptured.</li> <li>• Tail rotor gear box fell off.</li> </ul>
