**AIRCRAFT SERIOUS INCIDENT
INVESTIGATION REPORT**

ALL NIPPON AIRWAYS CO., LTD.

J A 8 0 4 A

**EMERGENCY EVACUATION USING SLIDES
ALL NIPPON AIRWAYS CO., LTD.
BOEING 787-8, JA804A
TAKAMATSU AIRPORT
AT 08:49 JST, JANUARY 16, 2013**

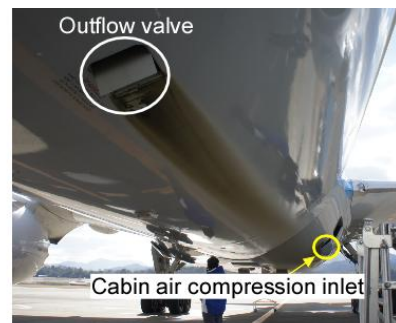
Fig. 2.8.3-1: Conditions Downstream of Outflow Valve

Dark green/black deposits coated inside wall of air ducts downstream of forward EE bay and fuselage skin downstream of the Override Valve and Outflow Valve. There was no trace of fire

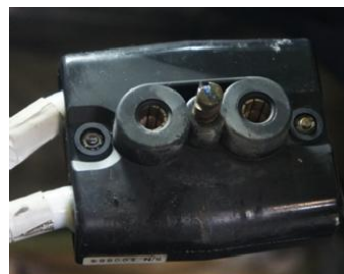
Fig. 2.8.3-2: J3 Cable Connector

The power cable (J3 cable) which connects the battery and the BDM, and the cable that connects the battery and the BCU (J1 cable) were intact. The battery case had no discoloration or puncture caused by arcing; however, the battery case ground wire was fused open.

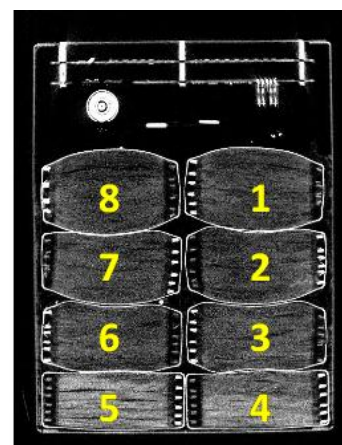
Fig. 2.8.3-3: Battery CT Scan Image

Each cell was deformed as Fig. 2.8.3-3: CT Scan Image shows.

S1 was concave while S3 was convex. Two cathode current collector fingers on W3 were fused open. Each winding was heat-damaged. Separators and both electrodes exhibited high temperature heat damage. Metal foils clipped by current collectors were also damaged. The cell was vented.

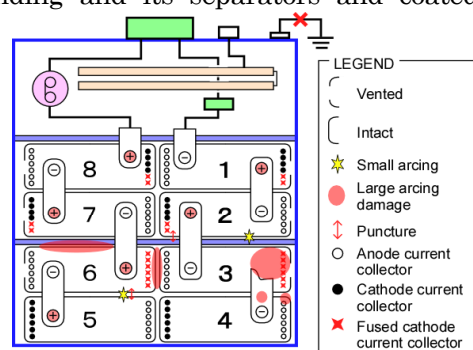
Fig. 2.8.3-4: Battery Damage

Fig. 2.8.3-4 illustrates the summary of battery damage. Cathode current collectors were fused except cells 4 and 5. All cell windings were heat-damaged and this denied to identify the

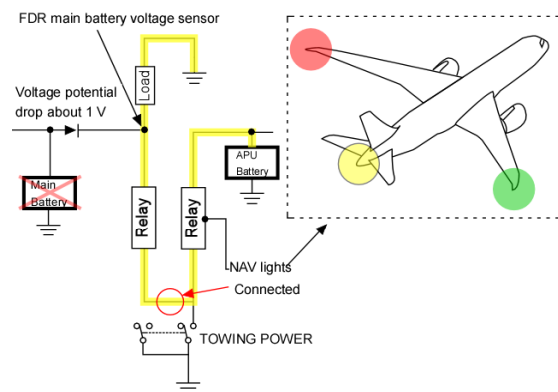
Fig. 2.11.1-1: Wiring Which Caused Navigation Light Illumination

After the airplane was delivered to ANA, Boeing identified a potential discrepancy in the Window Heat/Towing Power control panel. Consequently, Boeing sent a request to the airline on September 10, 2012 to check the presence of a discrepant circuit card assembly in the Window Heat/Towing Power Control Panel and requested a response by January 11, 2013. The airplane had the circuit card and its presence became apparent after the serious incident.

With this circuit card installed, under voltage equilibrium between the APU battery and main battery, electric currents do not flow. However, with the absence of the main battery or lower voltage than that of the APU battery, the card circuitry allows the currents to flow from the APU battery to the main battery circuit even if the TOWING POWER switch is in OFF position and wingtip lights and fuselage-end light are illuminated.

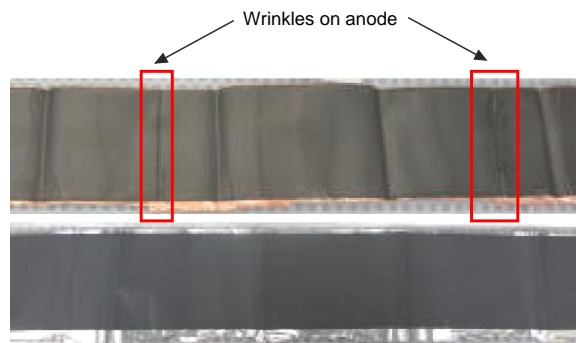
Fig. 2.11.2: Anode (top) and Cathode (bottom) from a Dismantled Cell

It is noted that wrinkles were found in the anode of dismantled cells, but not on the cathode.

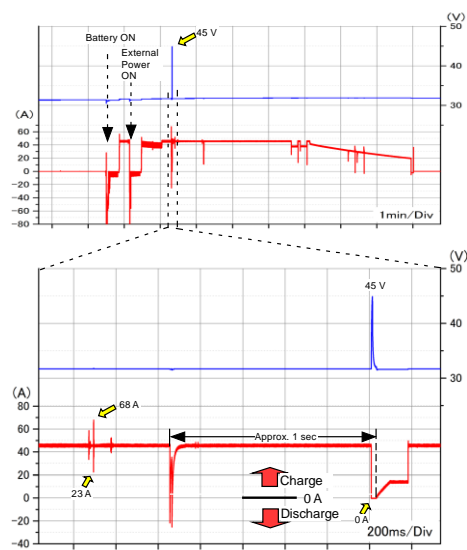
Fig. 2.11.4-2: Voltage Spike

- b. During battery charging, charging current fluctuated between 23 A and 68 A. Voltage spike as high as approximately 45 V was observed in the main battery voltage. The spike was observed approximately 1 sec after the charging currents went less than approximately 8A, accompanied by a current interruption of approximately 25 msec as shown in Fig. 2.11.4-2.

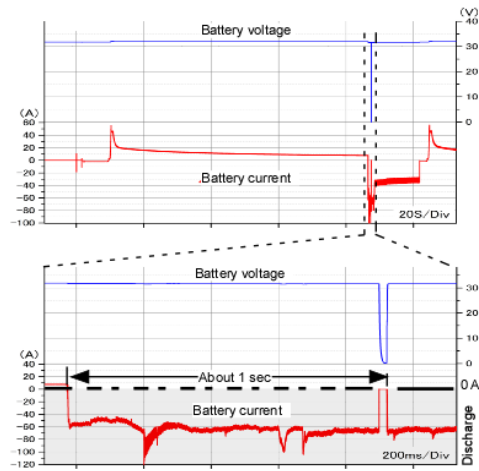
Fig. 2.11.4-3: Instantaneous Voltage Drop

c. During a discharge (approximately -60 A) a momentary voltage drop to 0 V was observed. This phenomenon was observed approximately 1 sec after the charging current went less than approximately 8 A, accompanied by a current interruption of approximately 23 msec as shown in Fig.2.11.4-3.

It is noted that the instantaneous voltage drop/spike and charging current oscillation did not accompany heat generation or other anomalies.

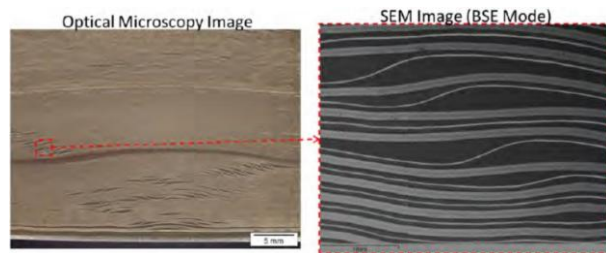
Fig. 2.11.6.9-3: Gaps in Electrodes

One swollen cell which had been on-board an airplane was analyzed by Computed Tomography (CT) and optical microscopy. The analysis found some gaps in some parts of the winding.

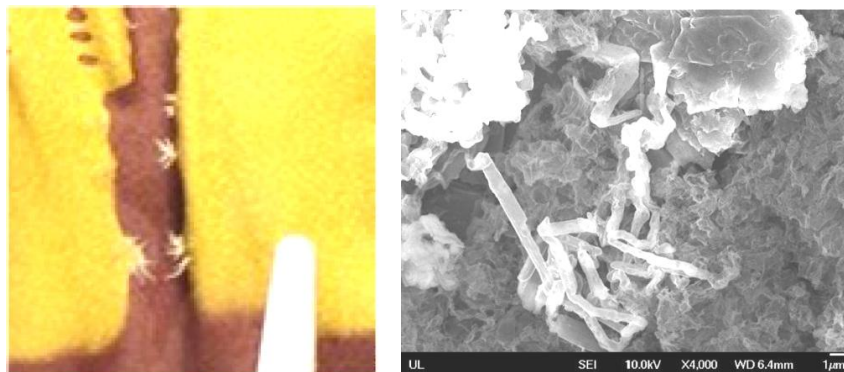
Fig. 2.11.7.2: Branching Crystals and Dendrites
(white conical object is pointer)

A cell DPA under 100 % SOC condition found wrinkles and discolorations on anode. Presence of crystallized branching compounds was observed near the wrinkles. The composition of the compounds was not definitively verified by analysis. The laboratory says that compared with the morphology of the lithium dendrites published in literatures, these observed protrusions are suspected to be metallic lithium dendrites electro-deposited on the carbon anode during cycling.

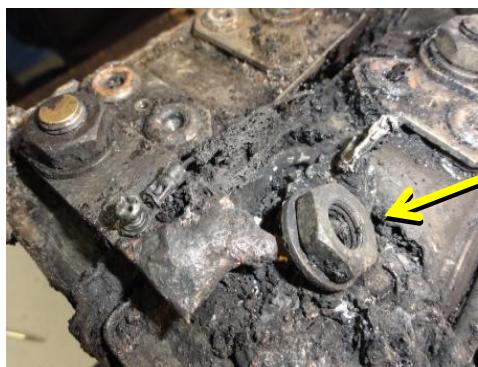
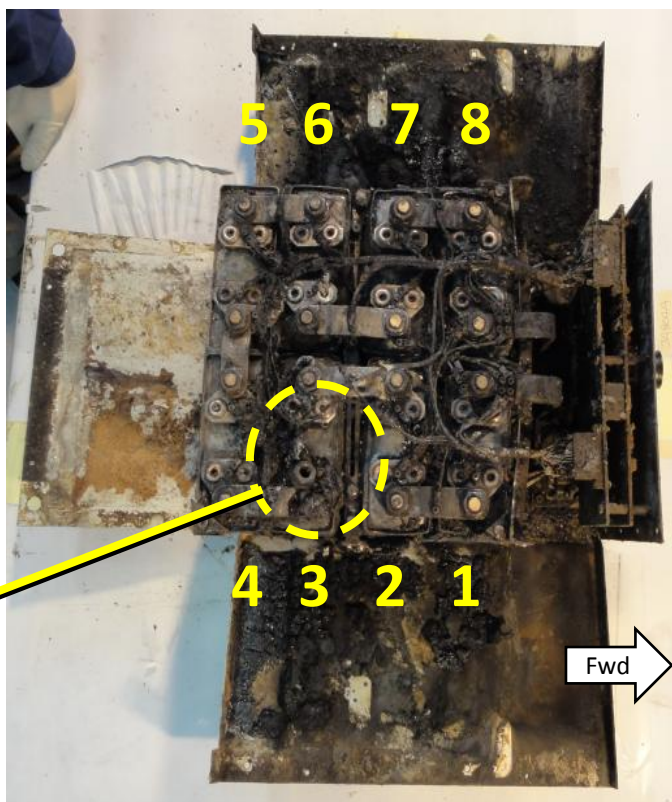
- Positive terminal of cell 3 was missing.
- The nut and washer remained.
- The busbar which connects cells 3 and 4 was melted.

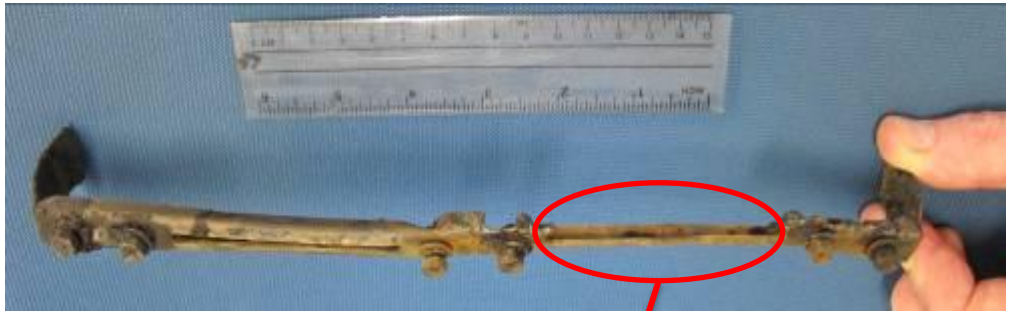
Part of this portion was welded to the cell case.

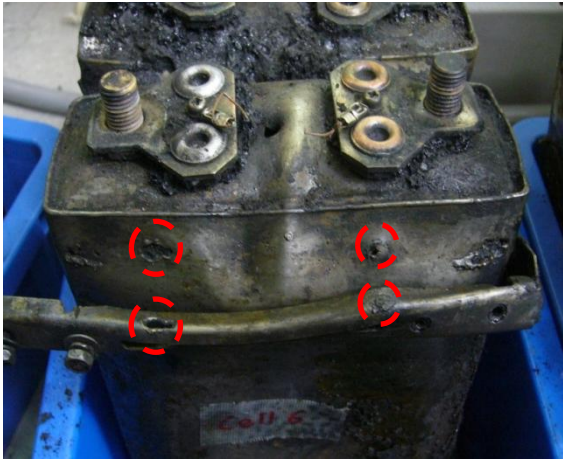
Config. 1 (Two arcing pits)

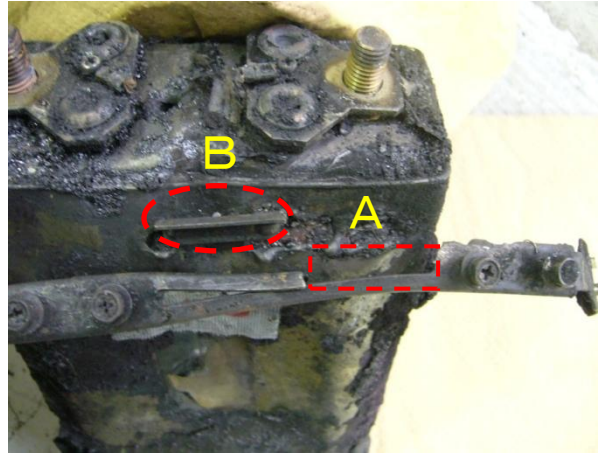
Config. 2 (Part of the brace bar is fused to the cell case (from A to B))
