**AIRCRAFT SERIOUS INCIDENT  
INVESTIGATION REPORT**

**ANA WINGS CO., LTD.  
J A 8 0 5 K**

**ENGINE INTERIOR DAMAGE  
ANA WINGS CO., LTD.  
BOMBARDIER DHC-8-314, JA805K  
6, 700 FT, SOUTHWEST OF OSAKA INTERNATIONAL  
AIRPORT, JAPAN  
AT 16:50 LOCAL TIME, JUNE 27, 2011**

January 25, 2013

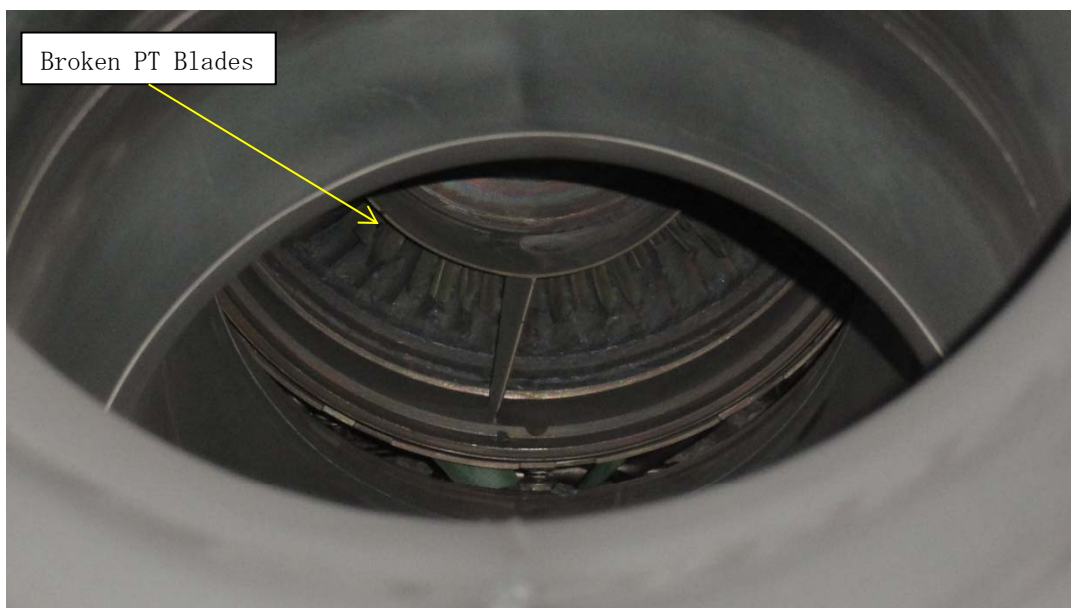
Photo 2 Around the Exhaust Duct of the Engine

When the airplane was climbing through 6,700 feet at 16:50, a loud noise was heard from the No.1 engine. The inter-turbine temperature (ITT) exceeded the limit of 950 °C and the engine power decreased. The flight crew shut it down and decided to turn back to the airport. After declaring a state of emergency, the airplane stayed over SHINODA VOR/DME to prepare for approach and made an uneventful landing at the airport at 17:18.

Post-flight engine inspection found the damage of turbine blades on the whole circumference in several stages.

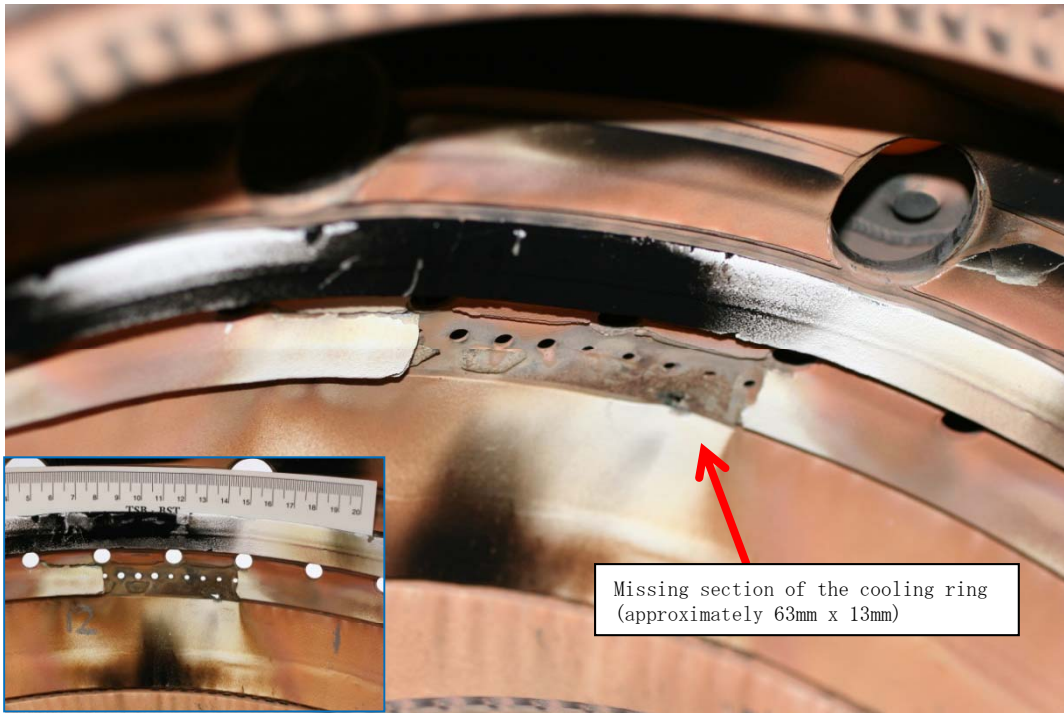
Photo 3 Combustion Chamber Outer Liner

Fatigue cracks in the circumferential and axial directions were found on several locations of cooling ring attached to the combustion chamber outer liner. A missing section (approximately 63 x13 millimeters) as a result of crack development was confirmed.

In light of the damage descriptions in 2.7 (discovered in the teardown inspection), it is very likely that fatigue cracks in circumferential and axial directions on the cooling ring had formed before the occurrence of this serious incident due to repeated stress in the combustion chamber, and the cracks had grown bigger as time passed, causing the section involved to be broken. As the fracture surface of the bases of the HPT blades indicated the cause of fracture by impact, it is very likely that the missing section of the cooling ring was carried into the HPT area by the combustion gas to strike against the fast-rotating HPT blades or to be caught between the HPT blades and vanes. This generated fractured HPT blades and broken pieces and they further damage the other components leading to the whole circumference. The downstream LPT and PT stages were very likely damaged by broken fragments of the HPT blades and others coming from the upstream.

It could not be determined what had caused the fatigue cracks which led to the missing section of the cooling ring in the combustion chamber.

The Company voluntarily carried out engine borescope inspections for seven same models responding to the advice of the engine manufacturer. The inspection found cracks in one of them, in the circumferential direction in the cooling ring of the combustion chamber outer liner and the Company grounded the engine. It was sent to the manufacturer for teardown inspection and the inspection found a similar damage observed in this serious incident.

Because the combustion chamber outer liners of the two engines had been repaired in the same period of time, the engine manufacturer started to review the repair process.

The engine manufacturer released a temporary revision of its engine manual, No. 72-106 (effective on April 17, 2012) to insert the permissible crack criteria for cooling rings in the section of engine borescope inspection.

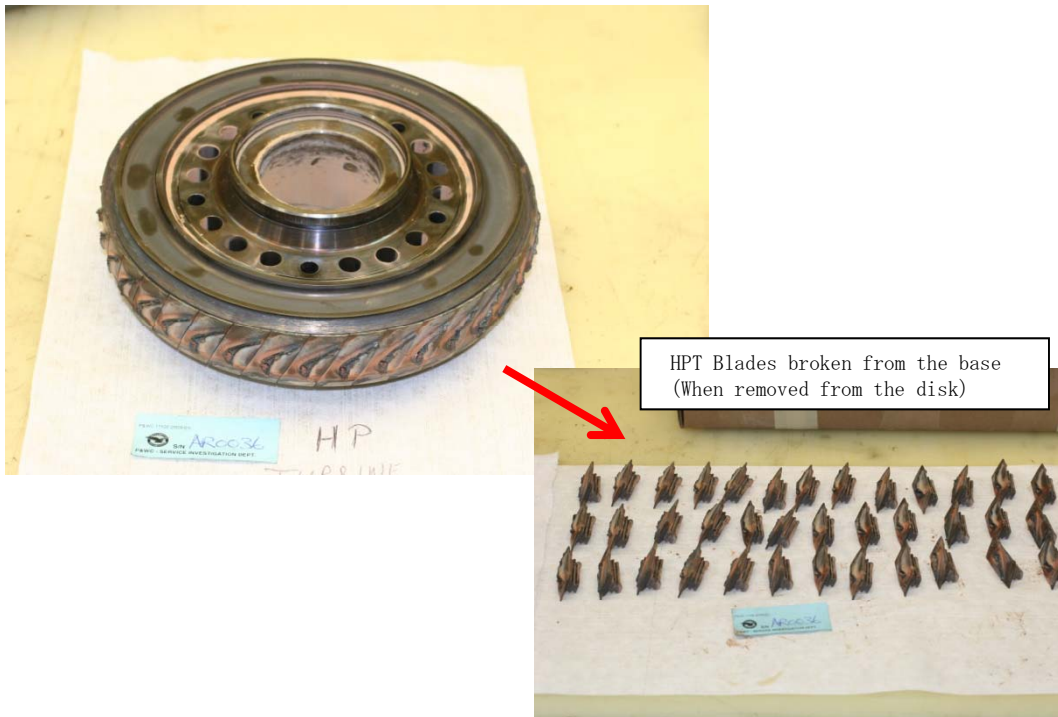
Photo 4 HPT Disk

The HPT vane ring at the combustion chamber outlet showed impact damages at the trailing edge (chip-offs and impact marks).

All 38 HPT blades were fractured just above the platform. Fracture surface indicated blade fracture due to impact damage. One blade exhibited a small fatigue crack on the fracture surface: a crack with a length of approximately 2.5 millimeters near the mid section of the pressure side of the aerofoil. Judging from the fracture surfaces of other blades indicative of impact fracture, it was confirmed that this blade had been fractured due to impact, too.
