AIRCRAFT SERIOUS INCIDENT INVESTIGATION REPORT

JAPAN AIRLINES INTERNATIONAL CO., LTD.

BOEING 747-400, JA8072

MAY 8, 2005

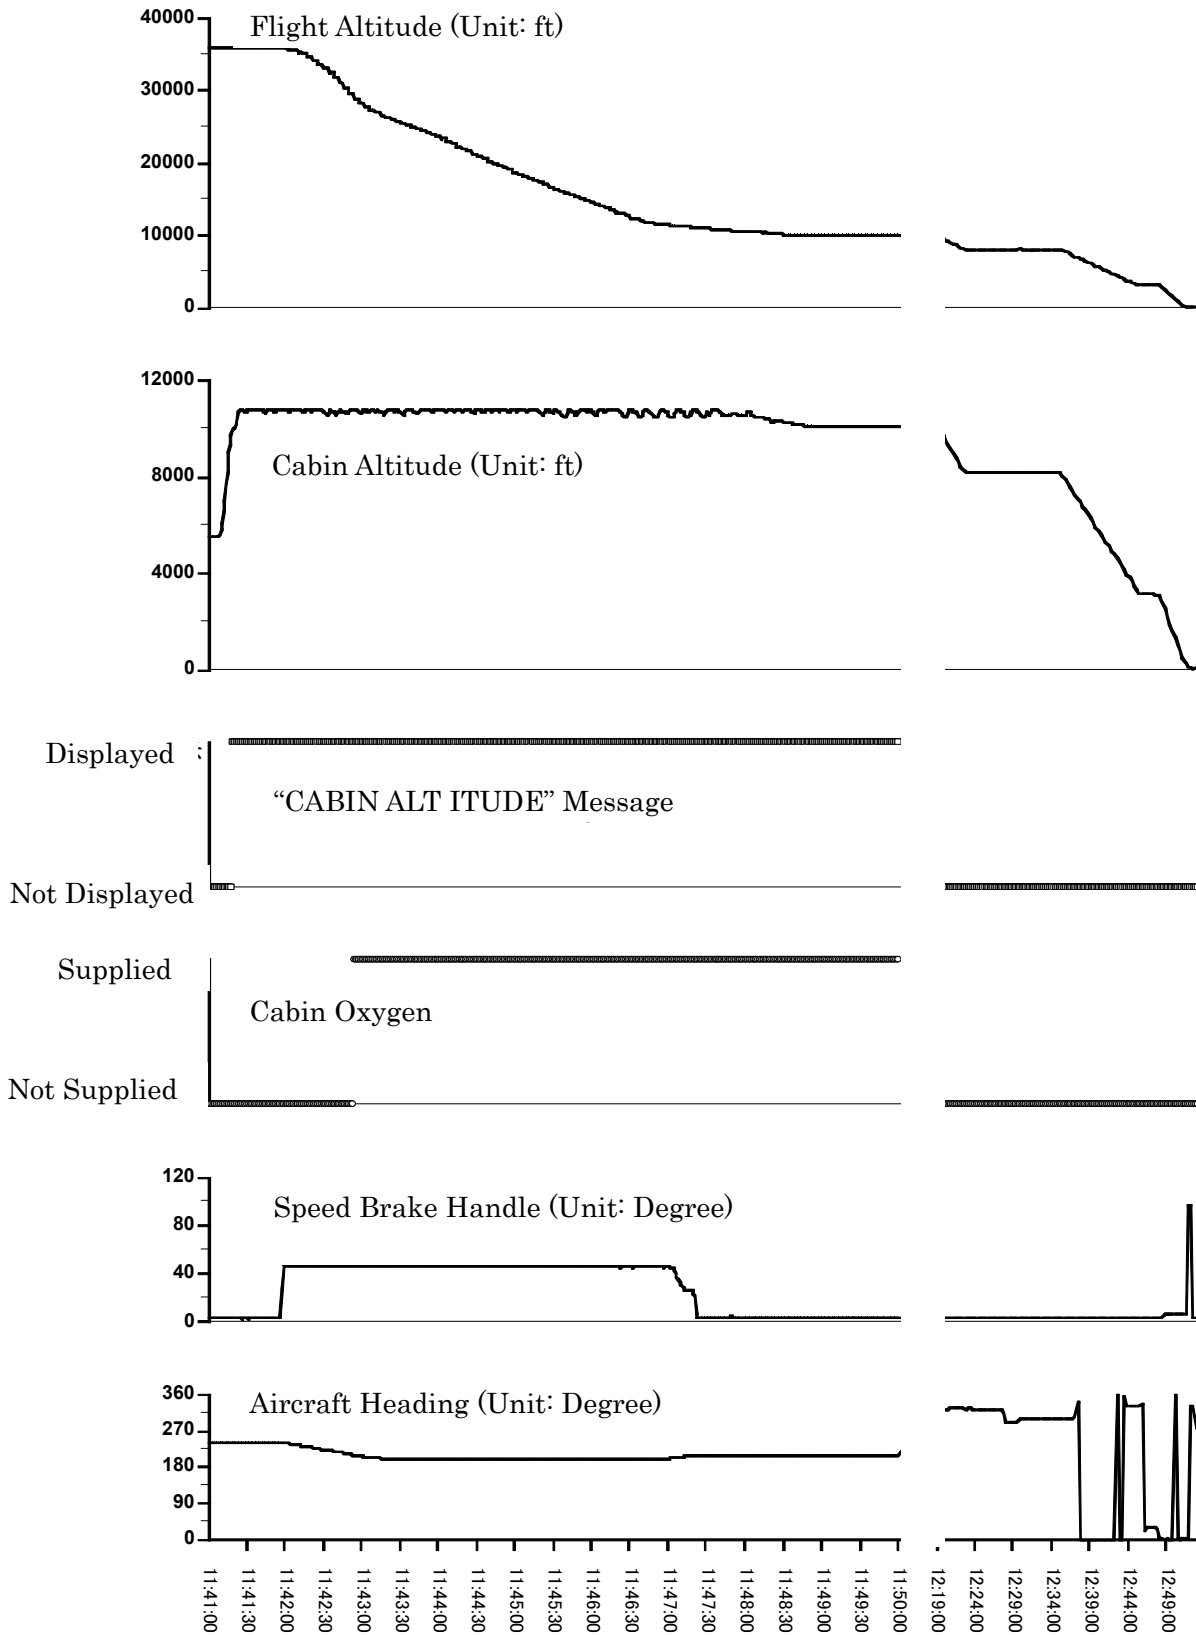
Figure 3 DFDR Data

11:41:08	Cabin altitude began increasing from 5,548 ft.
11:41:19	Cabin altitude reached 10,046 ft. “CABIN ALTITUDE” message was displayed.
11:41:31	Cabin altitude reached the maximum of 10,795 ft.
11:41:56	Speed brakes were deployed.
11:42:01	The aircraft began descent from a flight altitude of 36,000 ft.
11:42:54	Passenger oxygen masks were deployed.
11:48:32	The aircraft leveled off at a flight altitude of 10,143 ft (cabin altitude of 10,222 ft). Subsequently, the flight altitude and the cabin altitude stayed nearly the same until landing.
12:18:34	The aircraft began descent for landing at New Chitose Airport.
Approximately 12:51	The aircraft landed at New Chitose Airport.

Based on the DFDR records at the time of transition from cruise to descent, cabin altitude was 10,744 ft (9.81 psi) at a flight altitude of 35,745 ft (3.33 psi), with the pressure difference of 6.48 psi. Of the pressure differences retained in the memory devices of CPCs that were mentioned in 2.10.4, the value stored in CPC Unit A was reasonable and considered to have been recorded during the descent while the value stored in CPC Unit B are estimated to be erroneous.

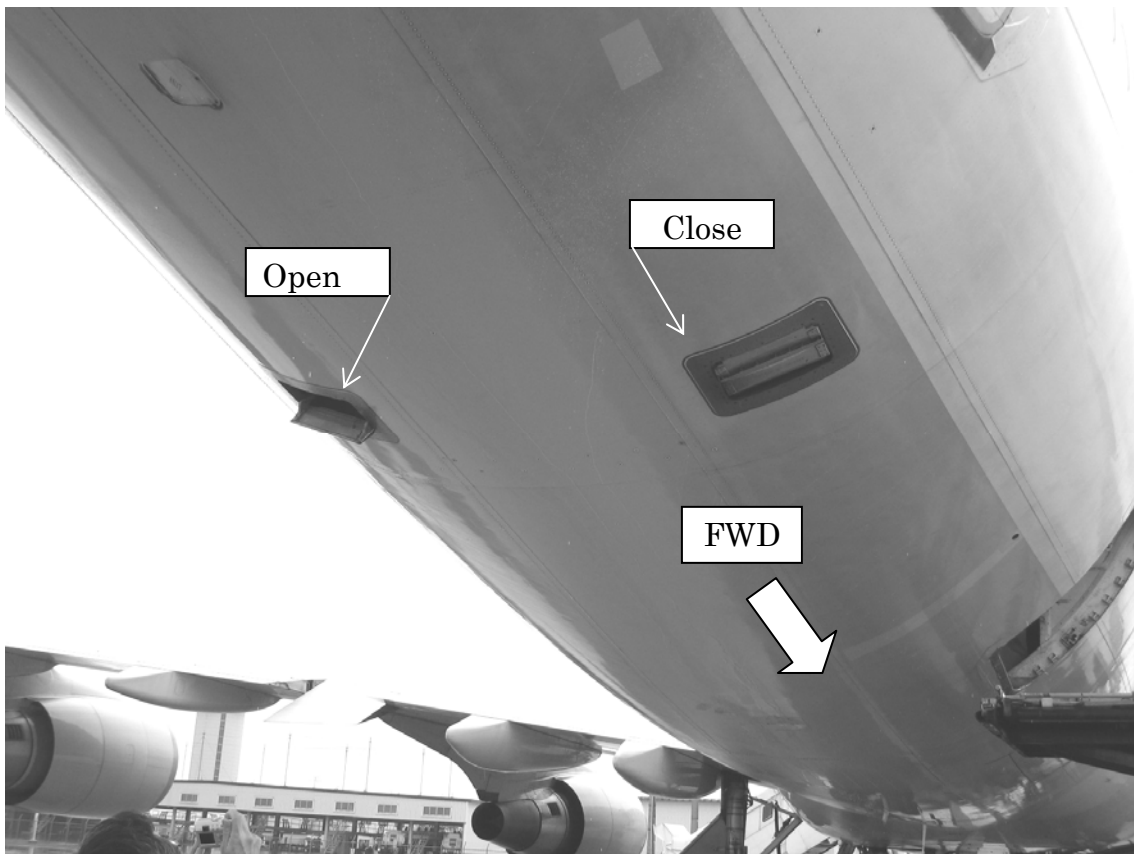
Photograph 2 Out Flow Valve Condition

Immediately after the landing, positions of the OFVs located on the lower part of the aft fuselage were as follows: LH OFV was fully open and RH OFV was fully closed.

Pillows were found on the wire meshed cover for the LH OFV under the floor in the aft fuselage. A passenger’s small bag was found between the RH outer skin of the fuselage and the inner lining.

As mentioned in 2.10.2, in condition of a flight altitude of 36,000 ft and a cabin altitude of 5,524 ft, both LH and RH OFVs normally are opened to approximately 10%. As mentioned in 2.10.1, the serious incident is estimated to have occurred due to the fact recorded by the CMC that LH and RH OFVs were opened to 93% and 63% respectively.

As mentioned in 2.10.1, after the occurrence of the serious incident, it is considered that LH and RH ICUs started to control LH and RH OFVs respectively, LH OFV closed to approximately 30% and RH OFV was closed fully.

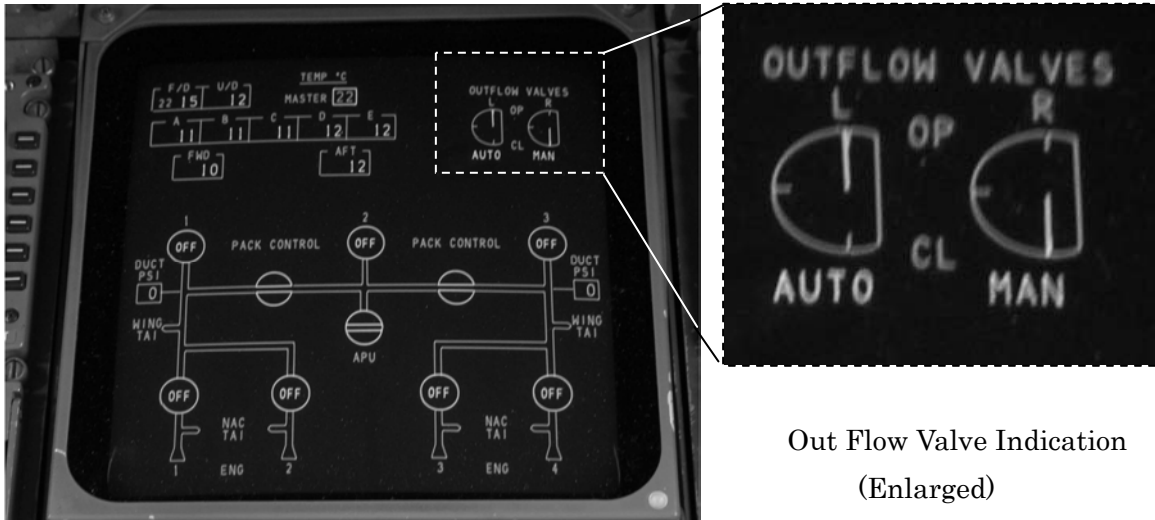
Photograph 3 E I C A S (E C S Page)

After landing at New Chitose Airport, a disagreement was confirmed as follows between the positions of PSL switches and ECS page indications. While AUTO / MAN selector switches on the PSL were both in AUTO position, ECS page showed that the LH OFV was in

AUTO (white) and the RH OFV was in MAN (yellow).

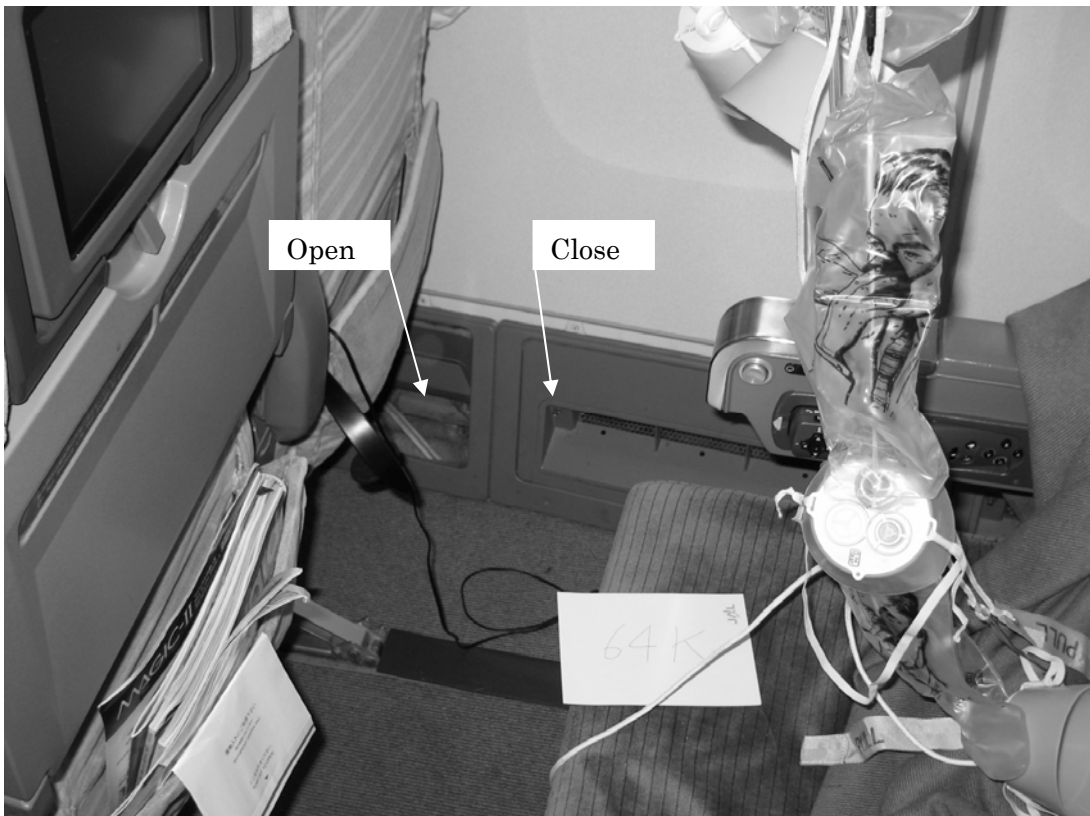
Photograph 4 Dado Panel

Dado panels are movable panels installed at the lower part of the cabin side walls, near the floor level. If depressurization occurs in the cargo compartment and the pressure difference between the cargo compartment and the cabin becomes 0.09 psi or larger, the panels open to release the pressure difference and protect the cabin floor from collapsing.

In the cabin, the oxygen masks were deployed, and of the dado panels installed at the lower part of LH and RH side linings near the floor level, 10 aft LH and 4 aft RH panels were open.
