AA2023-7

**AIRCRAFT ACCIDENT
INVESTIGATION REPORT**

**Solaseed Air Inc.
J A 8 0 7 X**

CABIN CREW MEMBER INJURY BY SHAKING OF THE AIRCRAFT SOLASEED AIR INC. BOEING 737-800, JA807X AT AROUND FL260 OVER ABOUT 120 KM SOUTHWEST OF NAHA AIRPORT AT ABOUT 08:37 JST, JULY 16, 2022

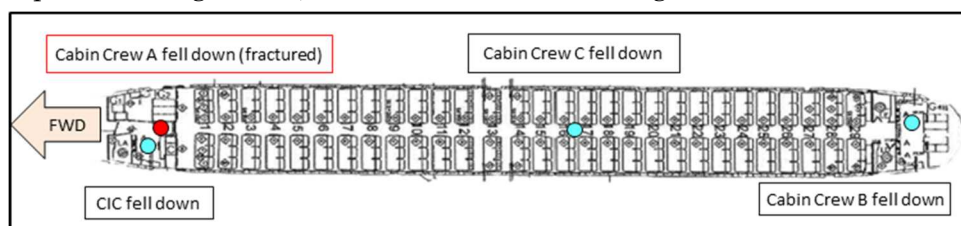
Figure 2: Locations of Cabin Crew Members at the Time of Aircraft Shaking

This sudden shaking took a toll on the CIC and Cabin Crew A, who were exchanging the tray after delivering the drinks and the tray for the resupplied drinks in the forward galley, and they fell down on the floor and landed on the butts as holding the trays with their both hands. At this time, Cabin Crew A was made in a position like sitting sideways with left leg down and felt pain in the left foot. Cabin Crew B, who was standing by after placing the tray for the prepared drinks in the aft galley, squatted down with her knees bent. Cabin Crew C, who had just finished delivering drinks to the passengers in the 17th row, fell on the back while scattering the paper cups containing drinks, and landed on the butt (Figure 2).

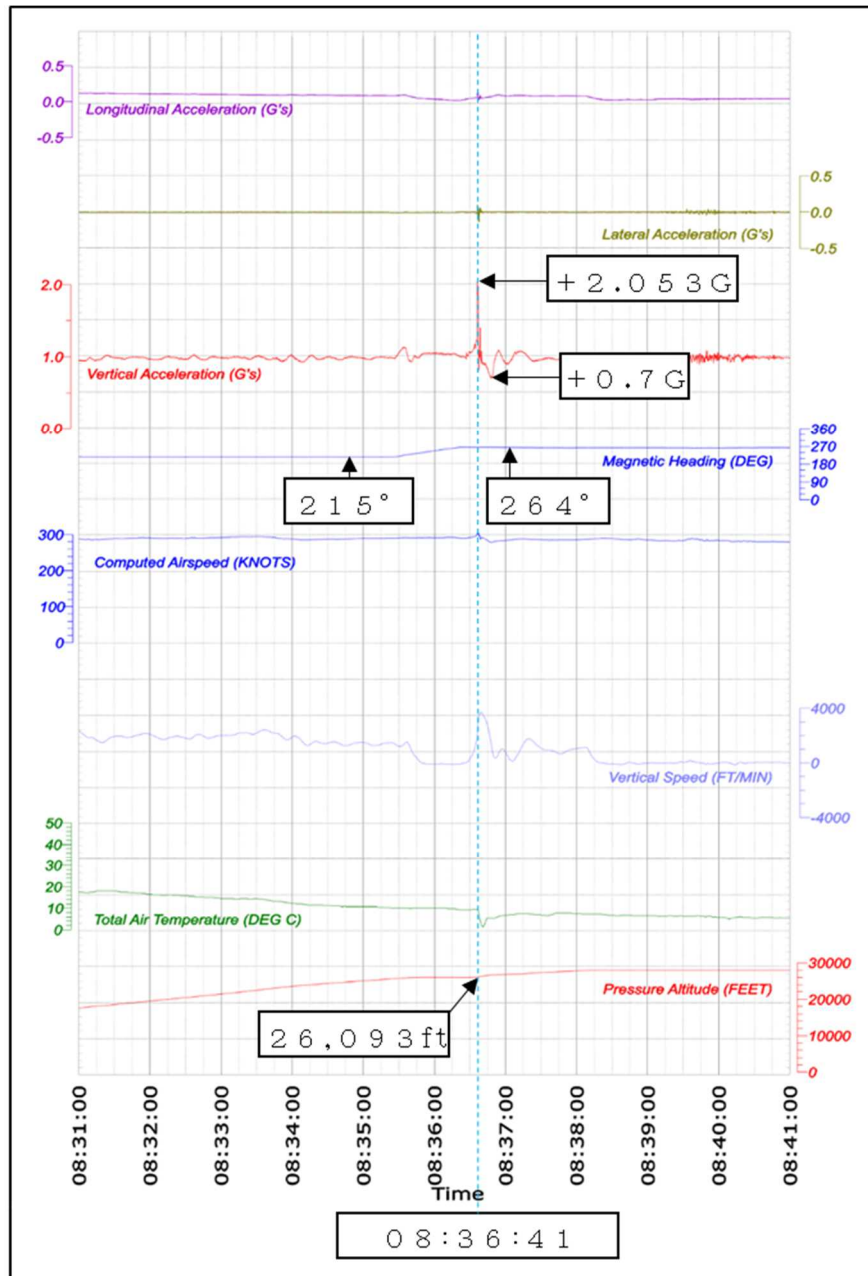
Figure 3: FDR Records

The JTSB concludes that the FDR records show that at 08:36:41 when the aircraft passed over the developing convective clouds at close range, the vertical acceleration was +2.053G, and it is highly probable that the shaking as if to hold the body down that occurred at that time, due to which Cabin Crew A, who was standing with the trays in her both hands, fell down in a moment while being neither support the body, and was made in a position like sitting sideways with left leg down, resulting in the injury in the left foot.

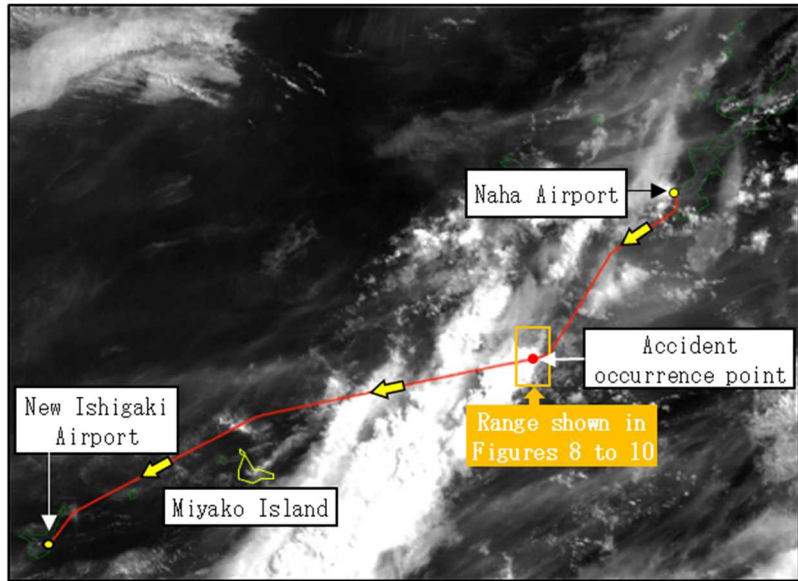
Figure 7 Composite Chart of Meteorological Satellite Image (visible) and Estimated Flight Route (at 08:35)

<p>(1) Meteorological Information</p> <p>The JTSB concludes that according to Figure 7 and Figure 8: Echo Top Height at 5 Minute Intervals, as for the convection clouds near the accident site, the echo top height changed from an</p>
--

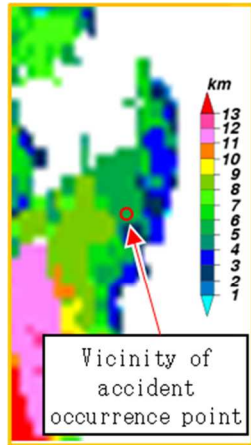
Figure 8
Echo Top Height
(08:30)

altitude of 5 km at 08:30 to 9 km at 08:35, thus the maximum change was 4 km in 5 minutes, and that converting this maximum change into the vertical speed will be about 2,600 ft/min.

After 08:35:28 when the aircraft changed the heading until 08:36:41 when this accident occurred, it is likely that the top height of the clouds, which the PIC had tried to avoid and seen about 2,000 ft below, raise approximately by 3,200 ft at a maximum and reached close to about 27,000 ft.

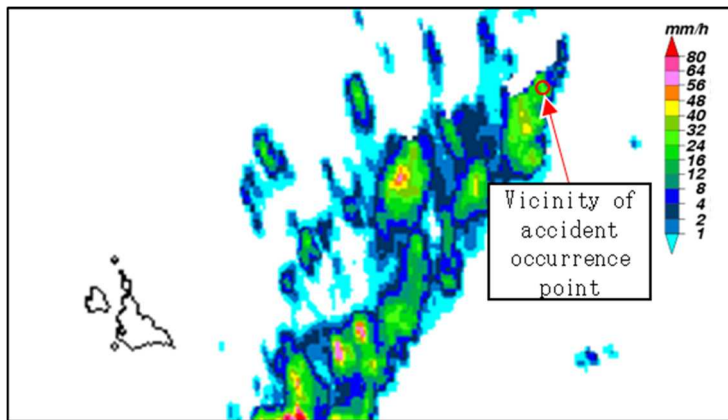
Figure 11: Echo Intensity (08:35)

composite chart, the echo intensity near the accident occurrence point at 08:35 was shown in a yellow green indicating 24 to 32 mm/h (Figure 11).
