**AIRCRAFT SERIOUS INCIDENT  
INVESTIGATION REPORT**

**Asahi Airlines Co., Ltd.  
J A 8 0 A P**

**September 28, 2023**

**AIRCRAFT SERIOUS INCIDENT INVESTIGATION REPORT**  
**CASE WHERE ANY OTHER PART OF THE LANDING GEARS OF THE**  
**AIRCRAFT WERE DRAGGED DURING LANDING**  
**ASAHI AIRLINES CO., LTD.**  
**CESSNA 172S, JA80AP**  
**YAO AIRPORT, YAO CITY, OSAKA PREFECTURE**  
**AT ABOUT 11:58 JST, OCTOBER 18, 2022**

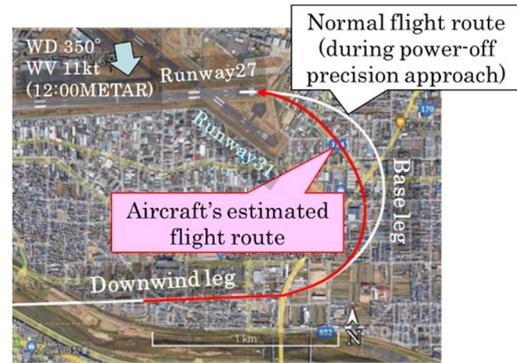
Figure 1: Estimated Flight Route

The trainee made corrections in the fifth power-off accuracy approach in the last half so as to prevent the Path Angle from becoming higher, contrary to this, the Path Angle became too low, therefore, the trainee made corrections on the Path Angle by flying on some undershooting path (flying inside of the base leg) (see Figure 1).

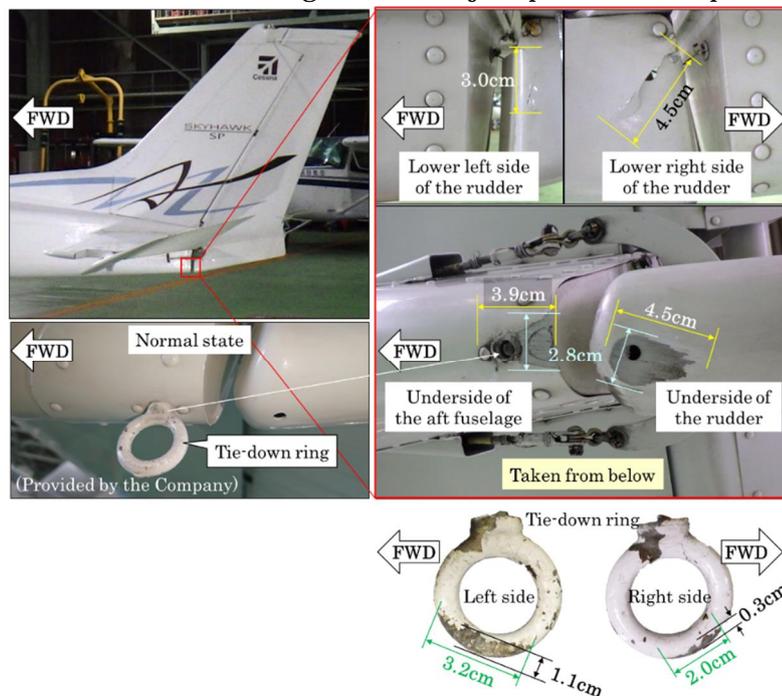
Figure 2: Damage to the Aircraft

<b>2.2 Injuries to Persons</b>	None
<b>2.3 Damage to the Aircraft</b>	<p>(1) Extent of damage of the aircraft: Minor damage</p> <p>(2) Damage to the aircraft (see Figure 2)</p> <p style="padding-left: 40px;">Lower sides of the rudder: Cracks in the outer skin (Length: Left 3.0 cm, Right 4.5 cm)</p> <p style="padding-left: 40px;">Underside of the aft fuselage: Abrasion mark of 3.9 cm in length and 2.8 cm in width</p>

**Underside of the rudder:**

Abrasion mark of 4.5 cm in length and 2.8 cm in width

**Tie-down ring: Fractured at its root**

**Left side:** Abrasion mark of 3.2 cm in length, 1.1 cm in height

**Right side:** Abrasion mark of 2.0 cm in length, 0.3 cm in height

The abrasion mark on the left side was roughly scraped off, while that on the right side was just peeled off the paint.

Regarding how the aircraft made contact with the runway surface, based on the characteristics of the abrasion marks on the runway surface and the aircraft fuselage, it is most likely that the underside of the tie-down ring touched and broke first, followed by the underside of the rudder and the aft fuselage.

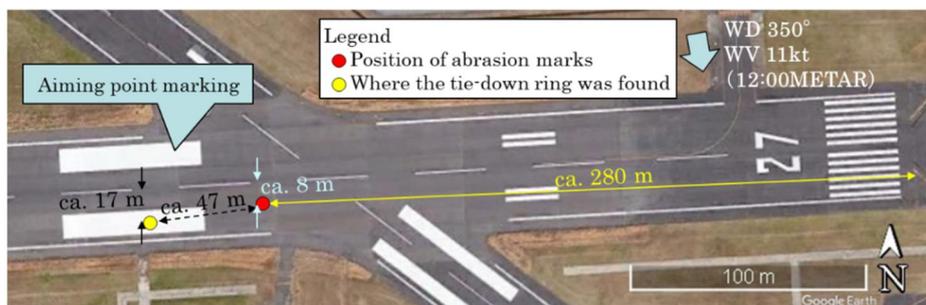
Figure 3: Runway Surface Condition

The abrasion marks on the runway surface were found at about 280 m west of the threshold of Runway 27 and about 8 m to the left (the south side) of the runway centerline. And the tie-down ring of the aircraft was found about 47 m forward (west side) of the aiming point marking about 17 m to the left of the runway centerline (see Figure 3 and Figure 4).

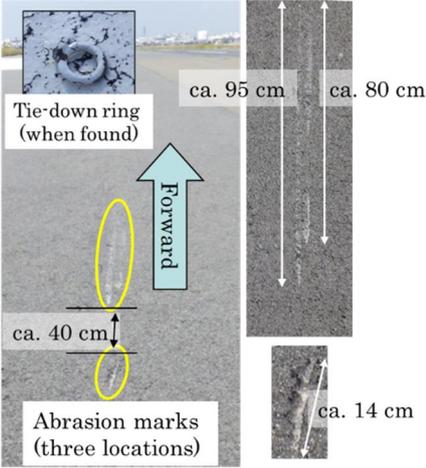
<p>A total of three abrasion marks were found on the runway surface. The closest (east side) one was about 14 cm long and 0.5 cm deep. The other two were left almost in parallel from about 40 cm west of the nearest mark in the same direction as the runway direction, the length was about 95 cm for the left (south side) mark, about 80 cm for the right side mark, and there was no depth in both (see Figure 4).</p>

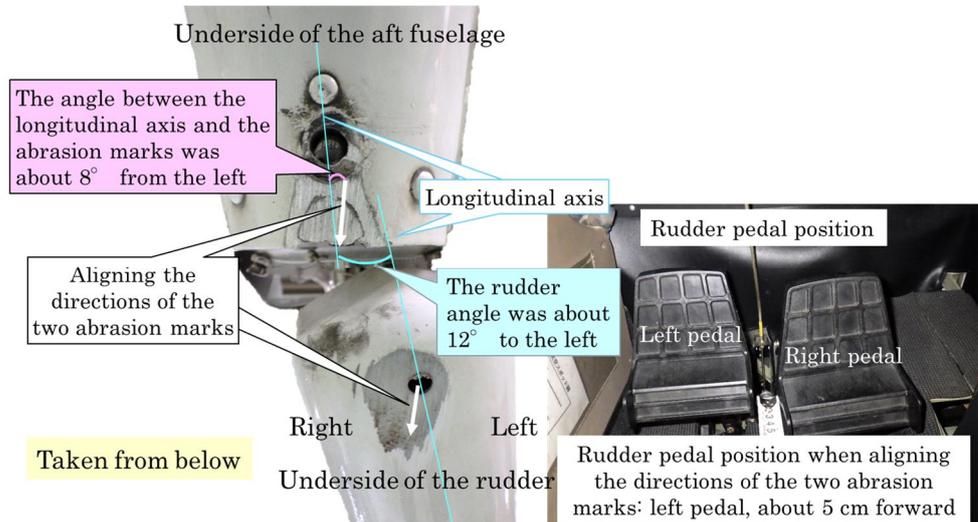
Figure 5: Abrasion Marks and Rudder Position

The difference in the direction of the abrasion marks between those on the underside of the aft fuselage of the aircraft and those on the underside of the rudder was confirmed. When the rudder was moved by aligning the directions of the two abrasion marks, the left rudder pedal position was about 5 cm forward, and the rudder angle at that time was about 12° to the left. And the angle between the longitudinal axis (nose direction) of the aircraft and the abrasion marks on the underside of the fuselage was about 8° to the left (see Figure 5).

The reason why the left rudder pedal on the leeward side was about 5 cm forward when the underside of the rudder contacted the runway surface is most likely because the aircraft was making a wing-low approach with a right crosswind.

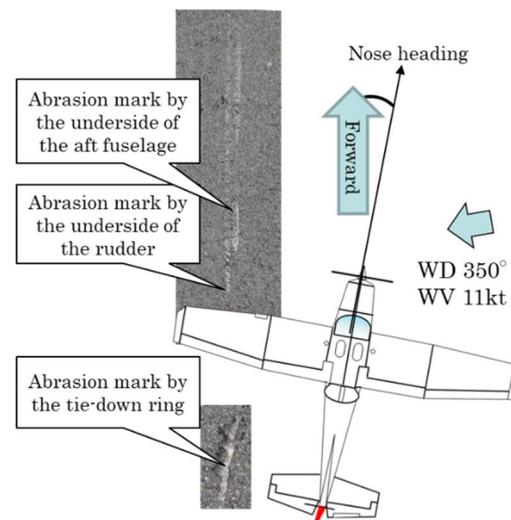
Figure 6: Situation at the Time of Contact with the Runway Surface

As for the abrasion marks caused by contact with the rudder and the aft fuselage underside that were left on the runway surface, their directions were generally consistent with that of the runway, but the abrasion marks on the fuselage were at an angle of about 8° from the left side with respect to the nose heading.

The abrasion marks on the tie-down ring itself are more extensive on the left side than the right, and the surface has also been roughly scraped.

This indicates that the aircraft most likely made contact with the runway surface while side sliding to the left with a residual right crab angle (see Figure 6).
