**AIRCRAFT SERIOUS INCIDENT
INVESTIGATION REPORT**

JAPAN AIR COMMUTER CO., LTD.

ALL NIPPON AIRWAYS CO., LTD.

ABOUT 3 KM NORTHWEST OF FUKUOKA AIRPORT
AROUND 11:59 JST, MAY 10, 2011

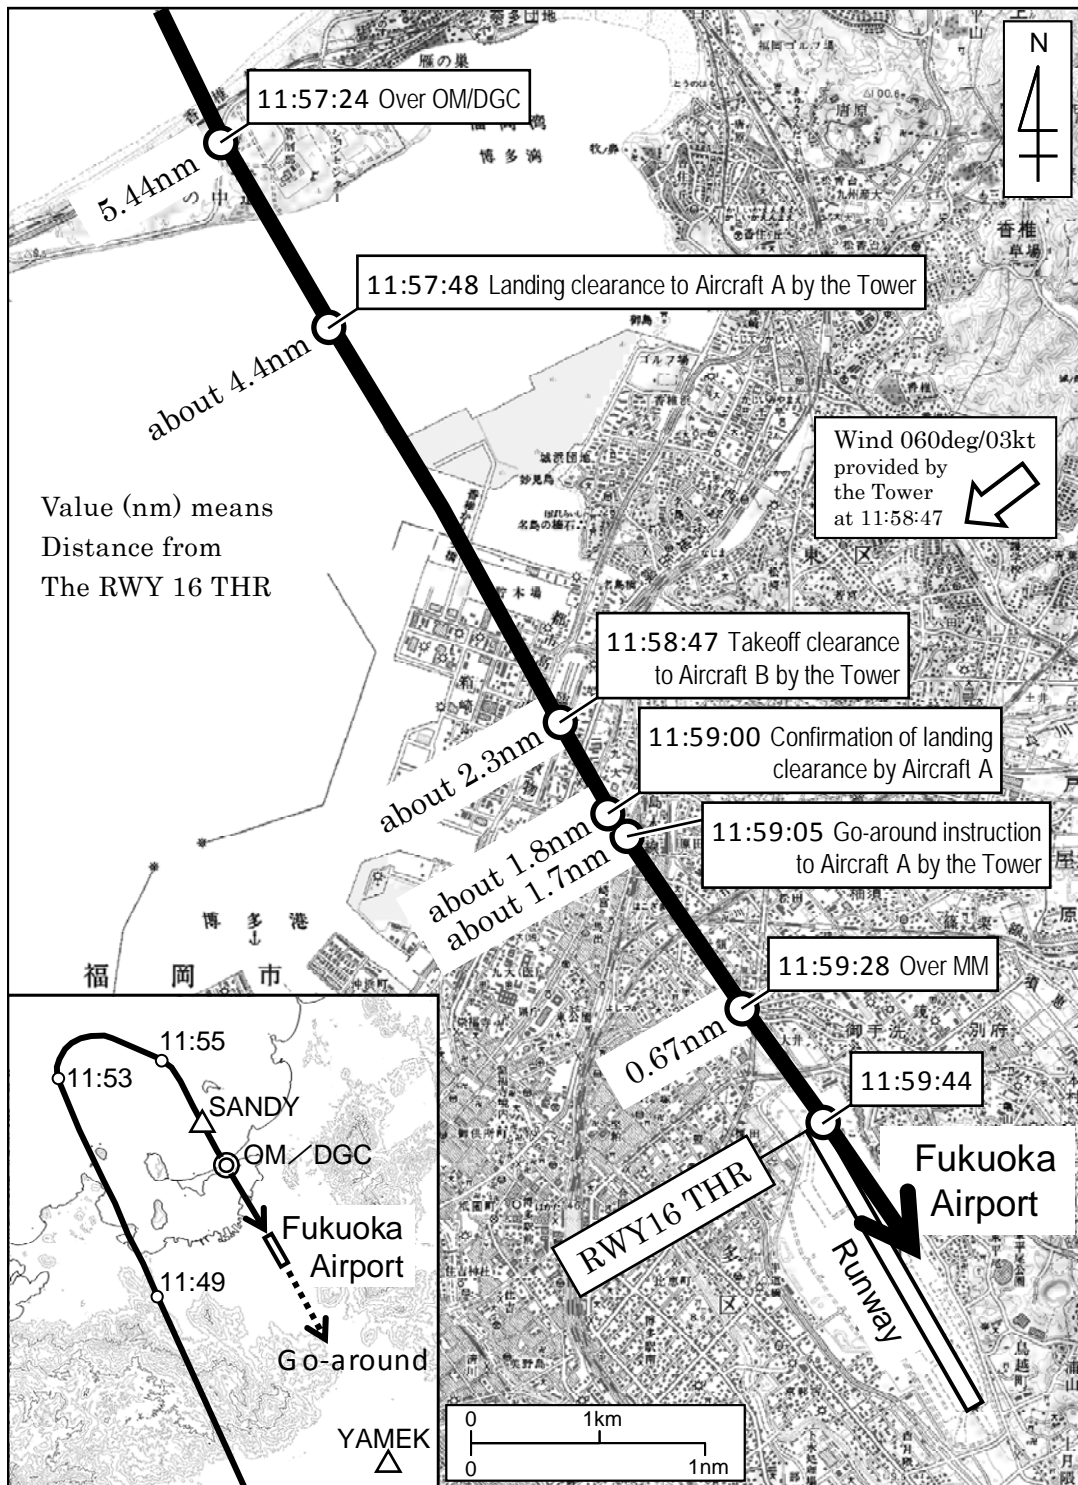
Figure 1 Estimated Flight Route of Aircraft A

This serious incident occurred at about 11:59 on May 10, 2011 and the location was about 1.7 nm (about 3 km) from the threshold on the final approach course to runway 16 of Fukuoka Airport. (See Figure 1 Estimated Flight Route of the Aircraft A, Figure 2 Estimated Taxiing Route of the Aircraft B, Figure 3 Estimated Traffic Condition in Area Concerned at the Aerodrome at the Time of the Occurrence of the Serious Incident, Figure 4 Three Angle View of Bombardier DHC-8-402, Figure 5 Three Angle View of Boeing 767-300, Photo 1 Scene of the Control Tower and The Runway, Attachment 1 ATC Communication)
