**AIRCRAFT ACCIDENT
INVESTIGATION REPORT**

**ORIENTAL AIR BRIDGE CO., LTD.
J A 8 4 5 A**

August 25, 2022

**DAMAGE TO AIRFRAME FROM TAIL STRIKE
ORIENTAL AIR BRIDGE CO., LTD.
BOMBARDIER DHC-8-402, JA845A
FUKUE AIRPORT, NAGASAKI PREFECTURE, JAPAN
AT 09:24:32, OCTOBER 23, 2020**

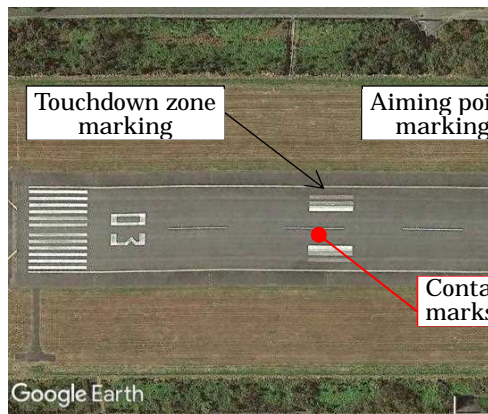
Fukue Airport was at 251 ft elevation and has a runway 03/21 (magnetic bearing 033°/ 213° with a length of 2,000 m and a width of 45 m). The on-site investigation found contact marks in an area about 7.7 meters long and a maximum of about 0.6 meter wide from a point about 152 meters from the threshold of Runway 03. In addition, judging from the position relation between the tire marks of the Aircraft and the contact marks, it was found that the Aircraft touched the ground in the following order with slight time difference, although those parts touched down almost simultaneously.

1. left main wheel
2. right main wheel and
3. lower surface of the fuselage

Figure 6 Location of contact marks on runway

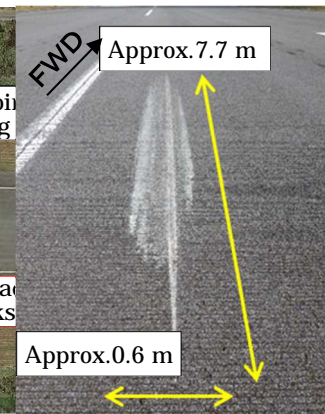
Figure 7 Contact marks

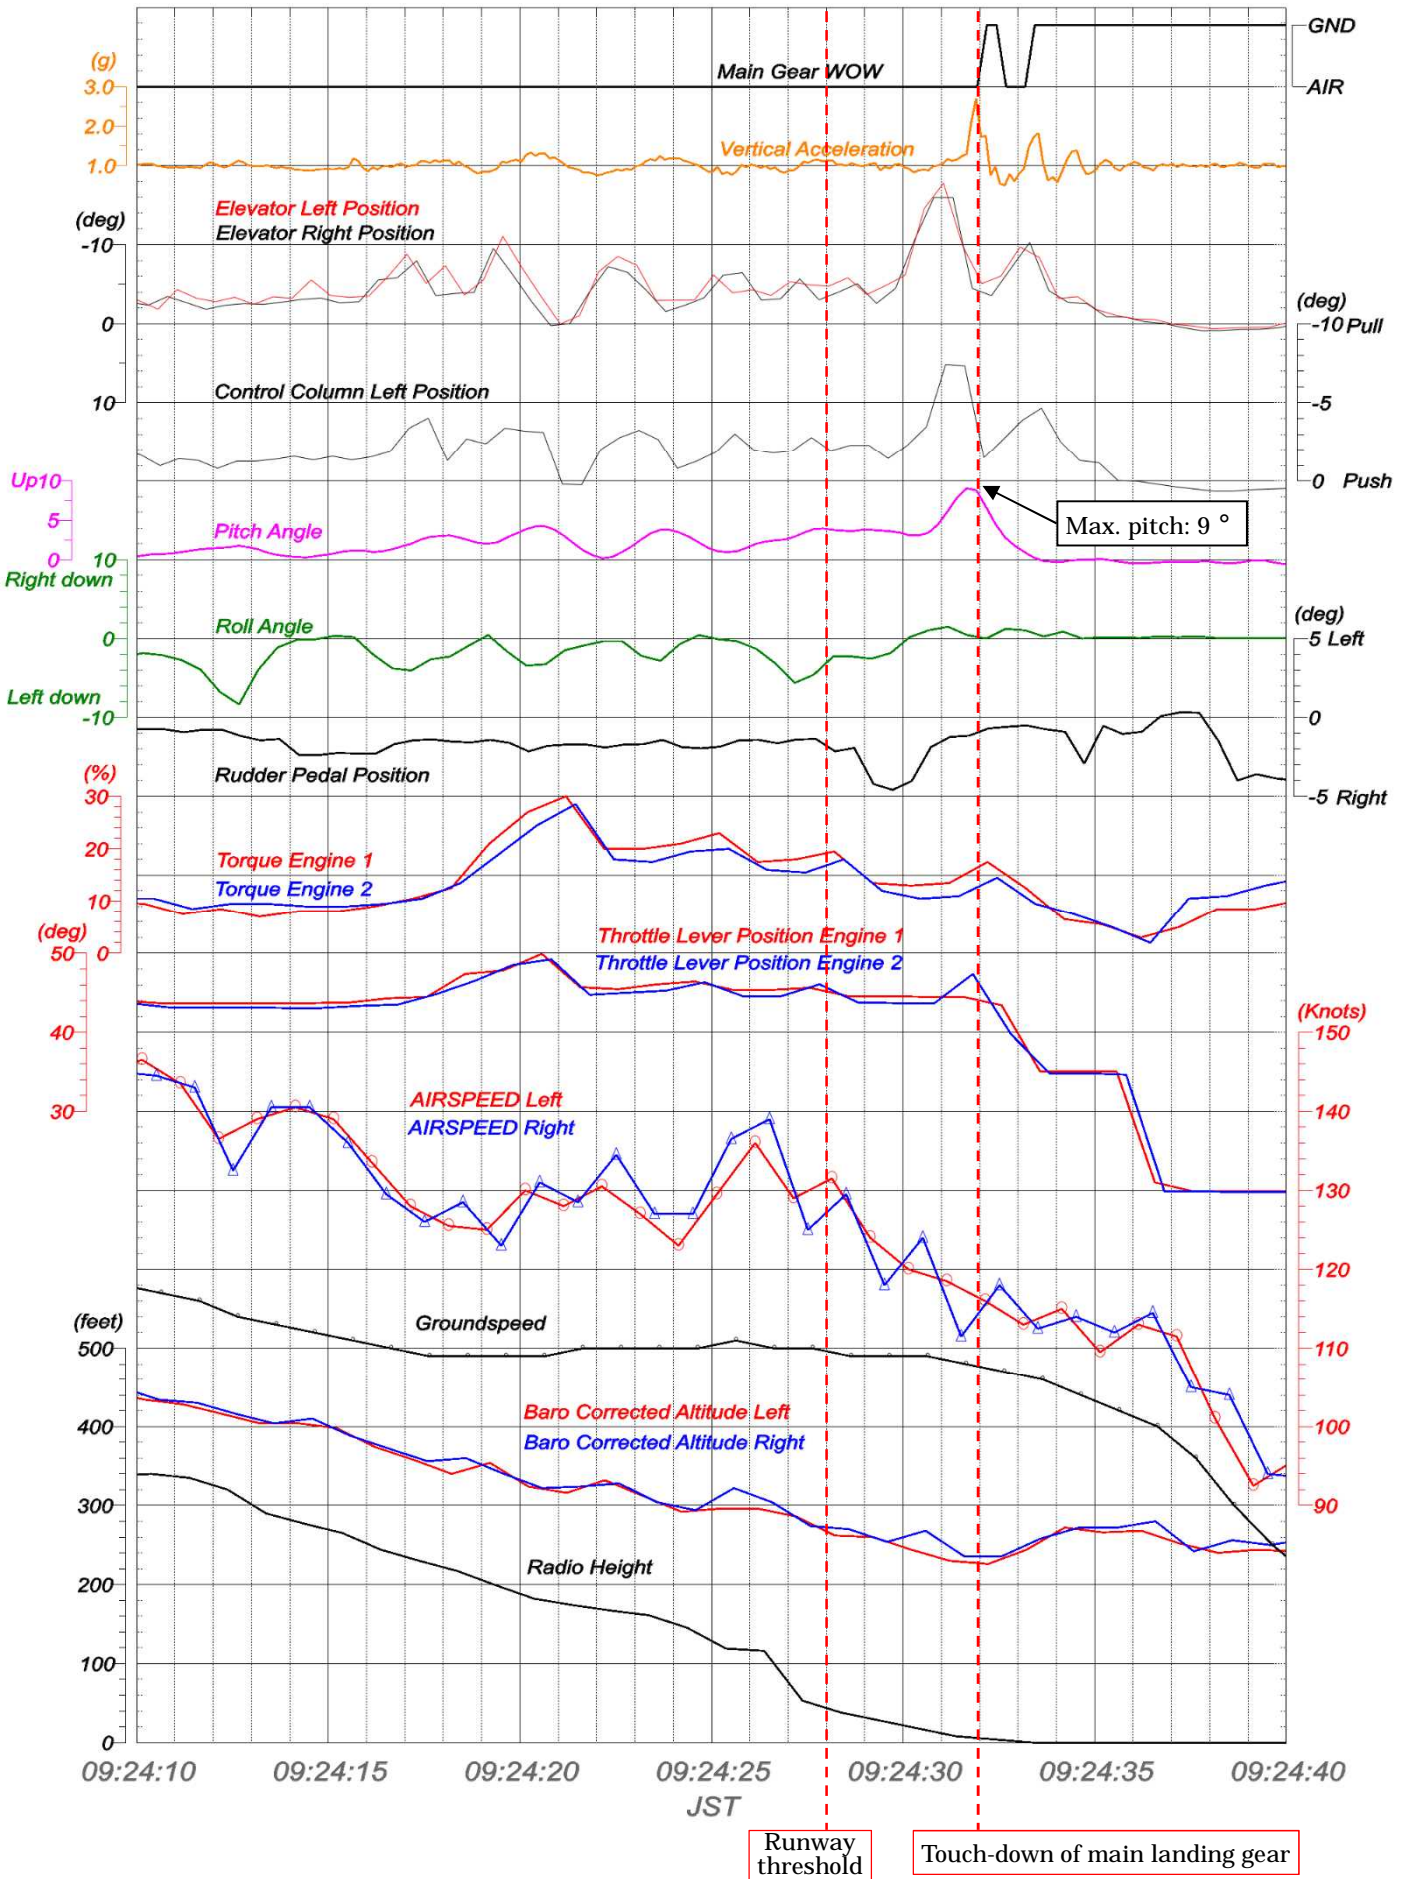
Appended Figure 1: FDR Records (09:24:10 to 09:24:40)

According to the FDR records (Figure 1), the engine torque dropped from about 19 to 12 % after the Aircraft passed the runway threshold. And the airspeed in the left seat (captain's side) was 131 kt ($V_{REF} + 12$ kt) when it passed the runway threshold but decreased to 116 kt ($V_{REF} - 3$ kt) at the time of touchdown. As the airspeed of the Aircraft dropped 15 kt in speed in the left seat and 11 kt in the right seat for four seconds from when the Aircraft reached the runway threshold to when it touched down, the airspeed decreased most likely at the deceleration rate of about 3 kt/sec from when the Aircraft passed the runway threshold to when it touched down. This airspeed reduction was most likely caused by the decrease in headwind component because the change in ground speed was small. However, the deceleration rate of about 3 kt/sec was too large for the speed change after passing the runway threshold, therefore, it is highly probable that the Aircraft was flaring while greatly decreasing the airspeed.

Most likely the lift of the Aircraft decreased as the airspeed decreased, and therefore, probably the control column input during flare operations was not enough to stop descent. For this reason, it is probable that as the captain continued to pull the control column to stop the descent, the Aircraft was in an excessive nose-up attitude with the pitch angle reaching a maximum value of 9° immediately before touchdown, the Aircraft touched down before stopping descent, and the lower side of its tail contacted the runway.
