**AIRCRAFT ACCIDENT
INVESTIGATION REPORT**

**ANA Wings Co., Ltd.
J A 8 5 4 A**

CABIN CREW MEMBER INJURY BY SHAKING OF THE AIRCRAFT ANA WINGS CO., LTD. BOMBARDIER DHC-8-402, JA854A AT FL 170 OVER YOSHINOAWA CITY, TOKUSHIMA PREFECTURE, JAPAN AT ABOUT 13:29 JST, JUNE 25, 2022

October 6, 2023

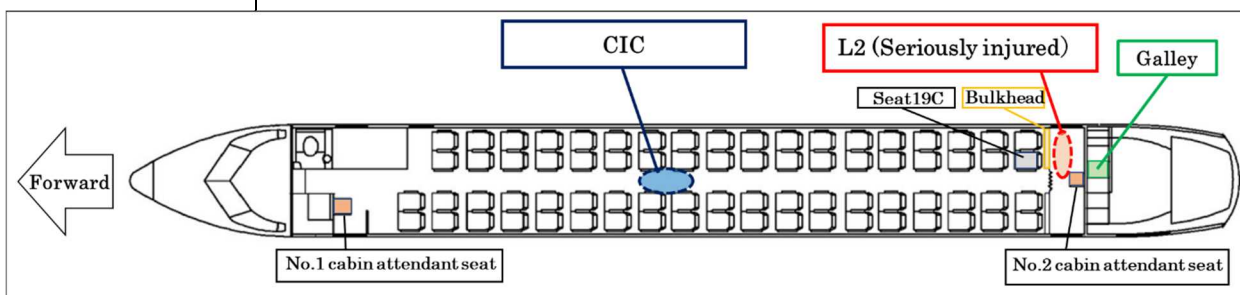
Figure 2: Locations of All the Cabin Crew Members at the Time of Aircraft Shaking

On the other hand, in the cabin, when the strong vertical tremor was encountered, the L2 had just placed them on the top shelf with the same squat posture after opening the door of the aft galley, squatting down, and taking out the plastic bottles of water from the bottom shelf. Due to that tremor, the L2's

feet were completely away from the floor, and straightly the L2 fell down sideways on the floor from the low back. The CIC, who was moving backward around the center of the cabin, squatted down soon after the strong turbulence was encountered, and reflexively held the armrests of the passenger seats on both sides of the CIC with CIC's sides.

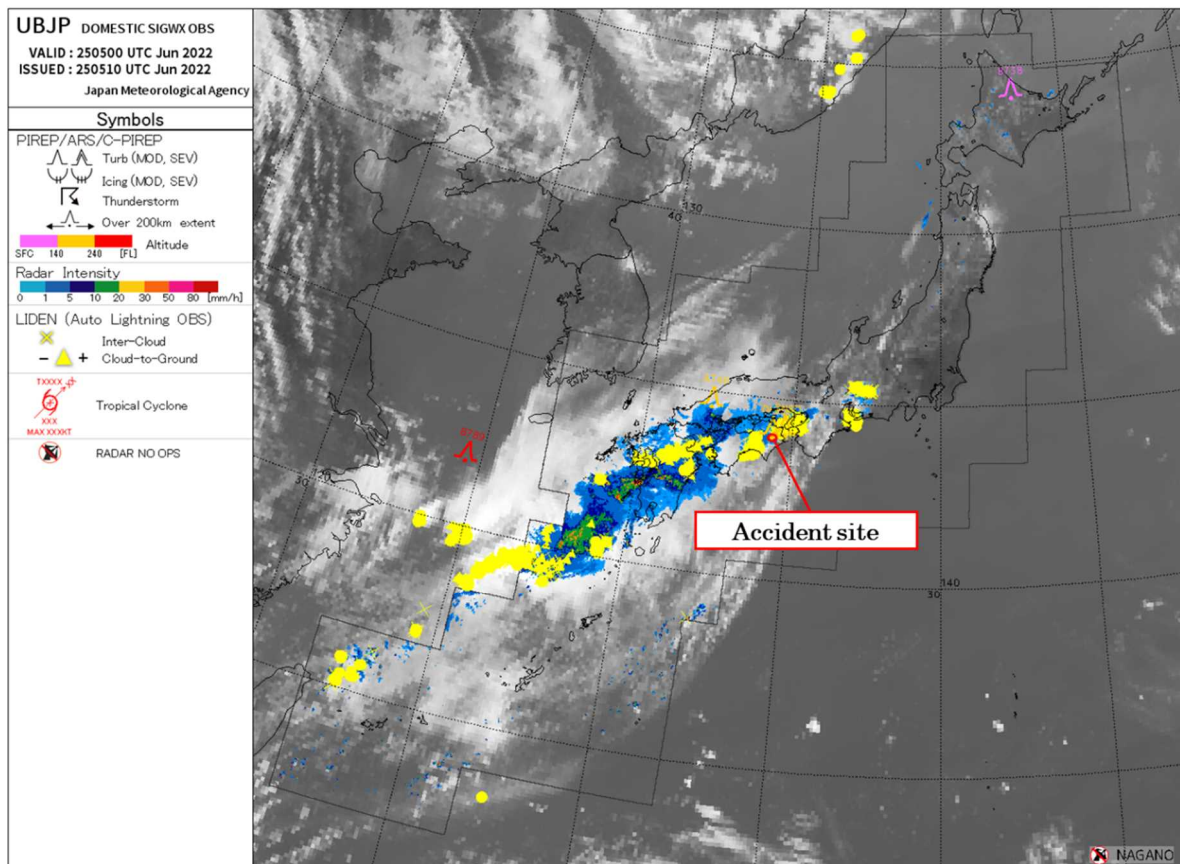
Figure 6: Domestic Significant Observation Chart at 14:00 on June 25, 2022

According to the Domestic Significant Observation Chart (Figure 6) at 14:00, announced by the Japan Meteorological Agency at 14:10 on June 25, 2022, rainfall echoes with a precipitation of 20 mm or more and less than 30 mm per hour and lightning were observed near the place where the accident occurred.

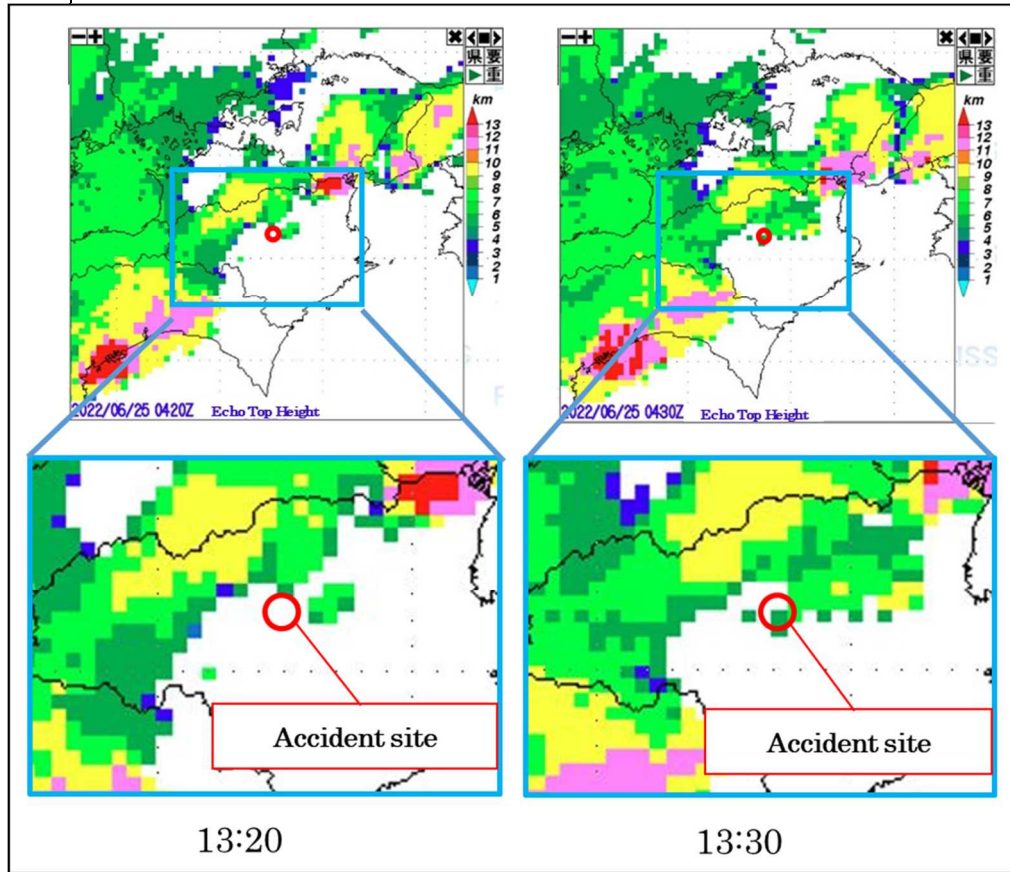
Figure 8: Radar Composite Map (Echo Top Height)

According to the radar composite map observed by the ground weather radar around the accident occurrence site (echo top height) (Figure 8), at 13:30, close to the time of the accident, a radar echo, whose cloud top height had developed from 5 km (16,404 ft) to 6 km (19,685 ft), was observed near the place where the accident occurred.

In the Aircraft's travel direction on the northeast side of the accident site, a radar echo, whose cloud top height had rapidly developed from a maximum 9 to 10 km, was observed.

The JTSB concludes that from the Radar Composite Map (Echo Top Height)(Figure 8), convective clouds*⁶ had most likely developed up to the cloud top height of 5 km (16,404 ft) to 6 km (19,685 ft) near the place where the accident occurred.

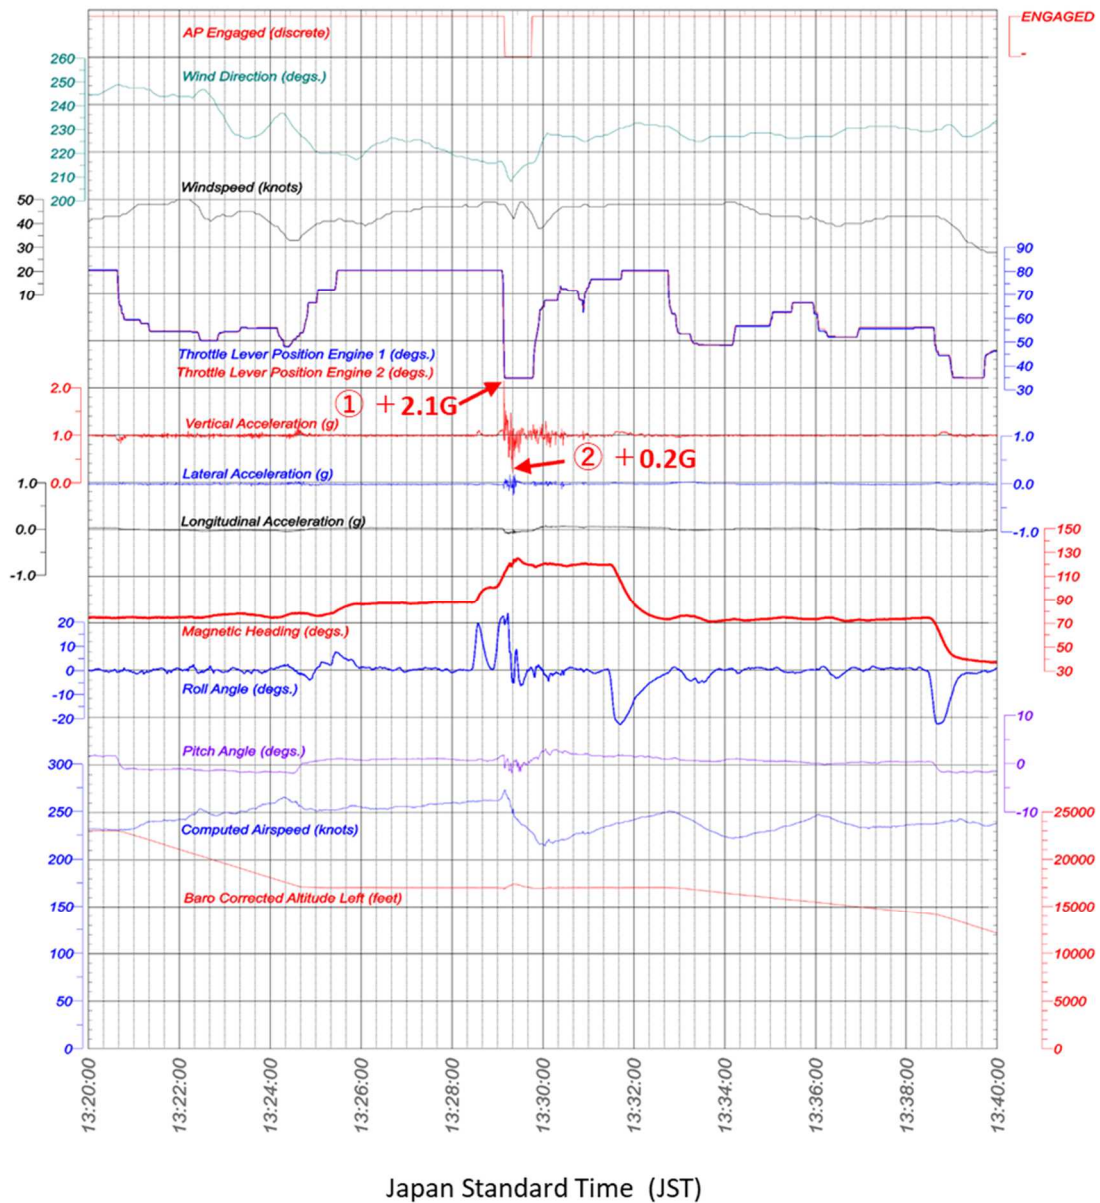
Figure 9: FDR Records

According to the FDR records of the Aircraft (Figure 9), from 13:29:08 to 13:29:20, the recorded vertical acceleration changed between +0.2 G (see ① in Figure 9) and +2.1 G (see ② in Figure 9).

The JTSB concludes that as the FDR records (Figure 9) show that the vertical acceleration changed between +0.2 and +2.1 G for 12 seconds from 13:29:08, at this time, the Aircraft was more likely flying just close to developed convective clouds, encountering an airflow disturbance due to convective clouds and being shaken violently.
