AIRCRAFT ACCIDENT
INVESTIGATION REPORT

JAPAN AIRLINES FLIGHT 706
McDONNELL DOUGLAS MD-11, JA8580
OVER SHIMA PENINSULA, JAPAN
JUNE 8, 1997

December 17, 1999

AIRCRAFT ACCIDENT INVESTIGATION COMMISSION

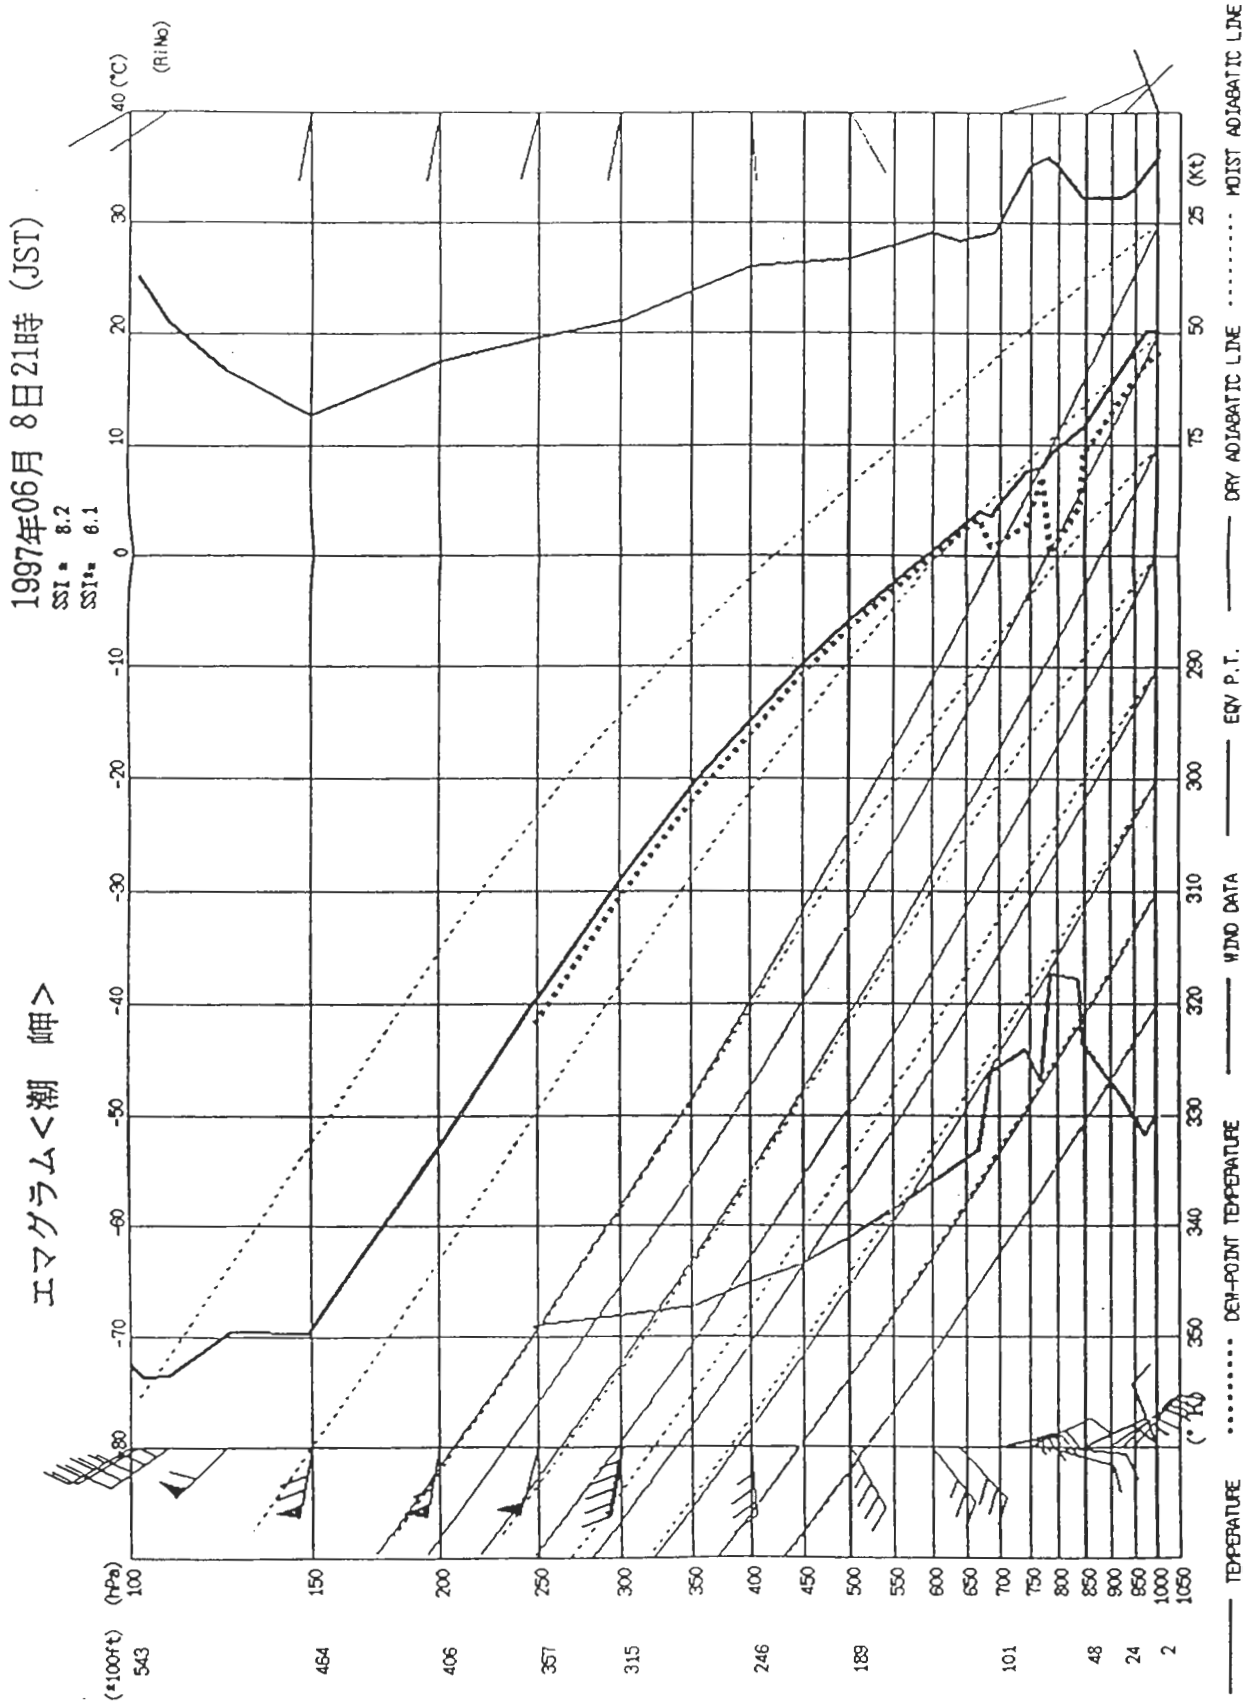
Figure 9 Emagram(Shionomisaki)
2100JST on June 8, 1997

According to an energy-per-unit mass diagram (hereinafter referred to as "Emagram") observed at Shionomisaki and Hamamatsu at 2100JST after the accident, there existed a stratification (atmospheric temperature inversions) at an altitude of about 11,000 ft over Shionomisaki, about 20,000 ft over Hamamatsu and other several altitudes. (Refer to attached Figure 9 and 10)

Based on the SAT (Static Atmosphere Temperature) data on the ADAS and the Emagram Chart observed at Shionomisaki and Hamamatsu after the accident, it is estimated that a stratification (atmospheric temperature inversions) existed near the flight route over Shima peninsula where the aircraft was passing at the time of the accident.

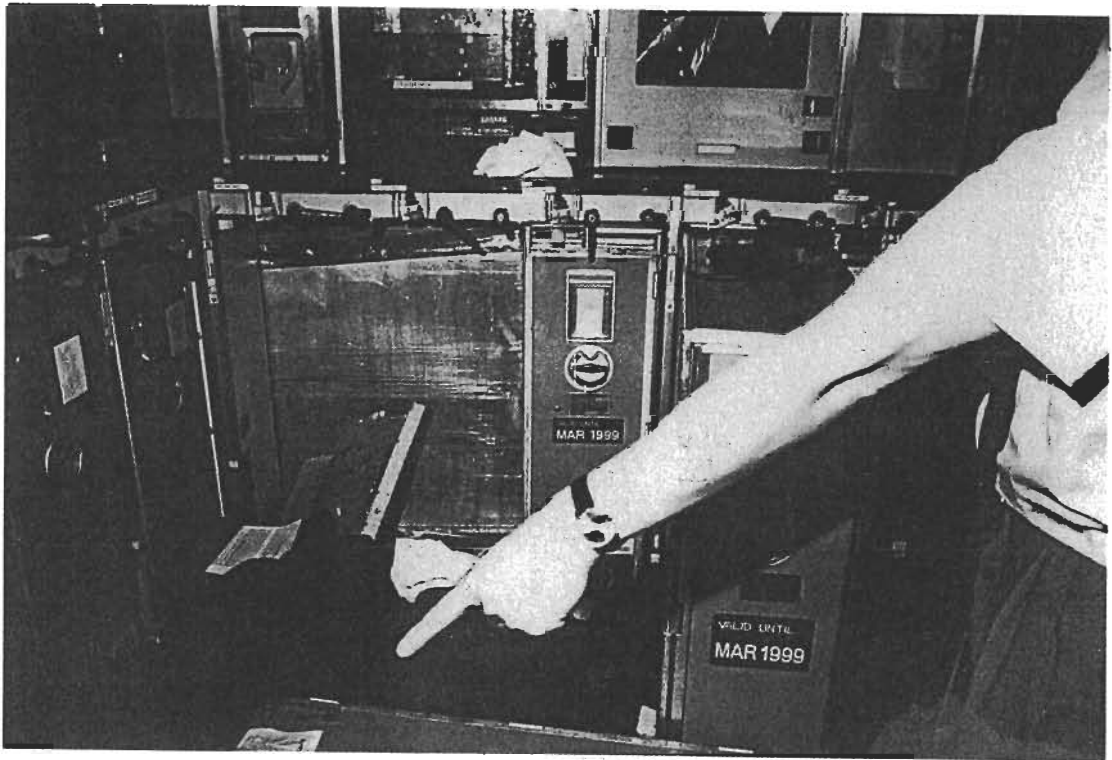
- (1) The cover of an exit indicator lamp for the L4 door was fractured.
- (2) The cover of an emergency exit indicator lamp near the L4 door was fractured
- (3) The ceiling support rods and brackets, which supported the ceiling panels in the aft cabin, were found damaged.
- (4) The damage to several portions of the ceiling panels in the aft galley were found.

Photograph 1 Scatters in the Aft Galley

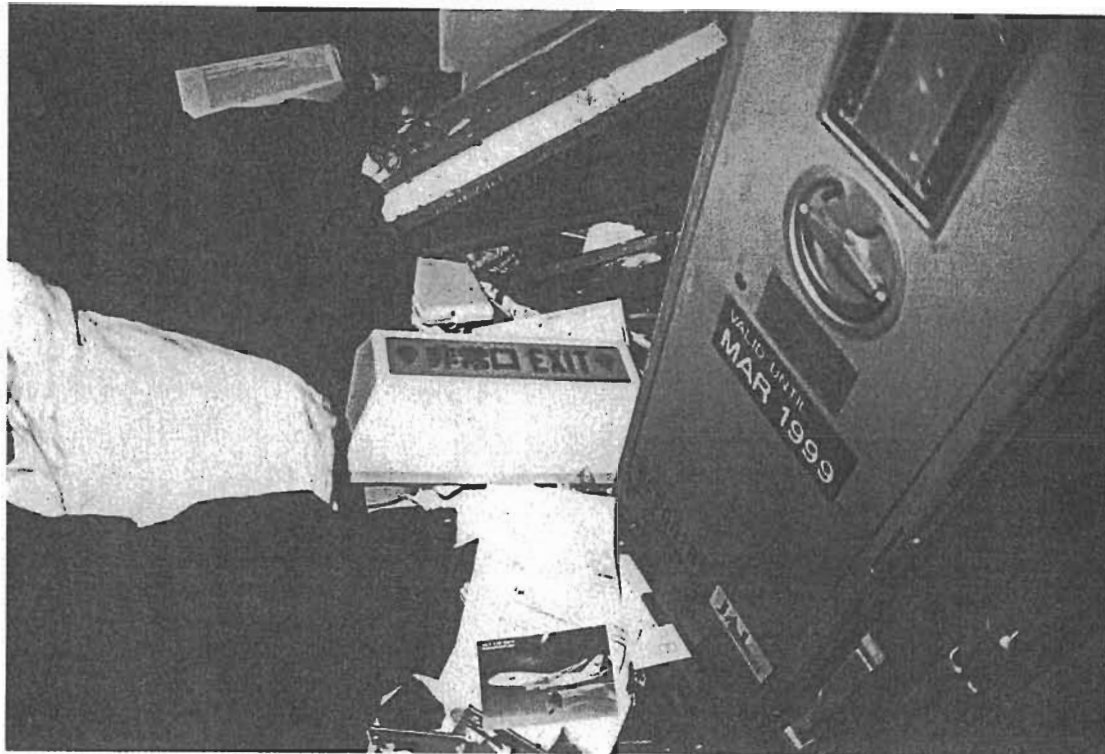
Photograph 3 Separated Emergency Exit Light Cover
(L4 Door)

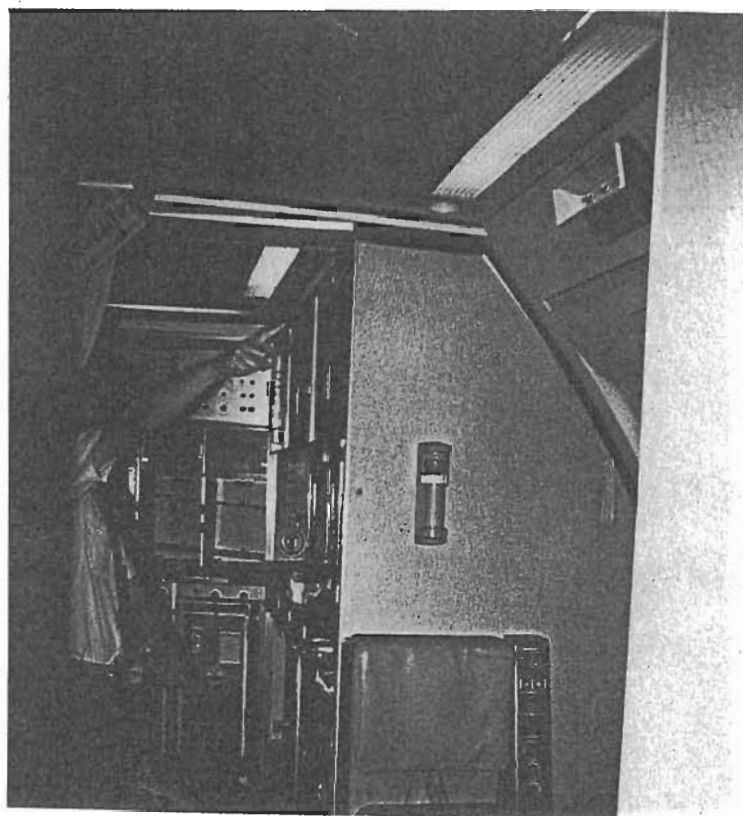
Photograph 4 Emergency Exit Light without Cover
(L4 Door)

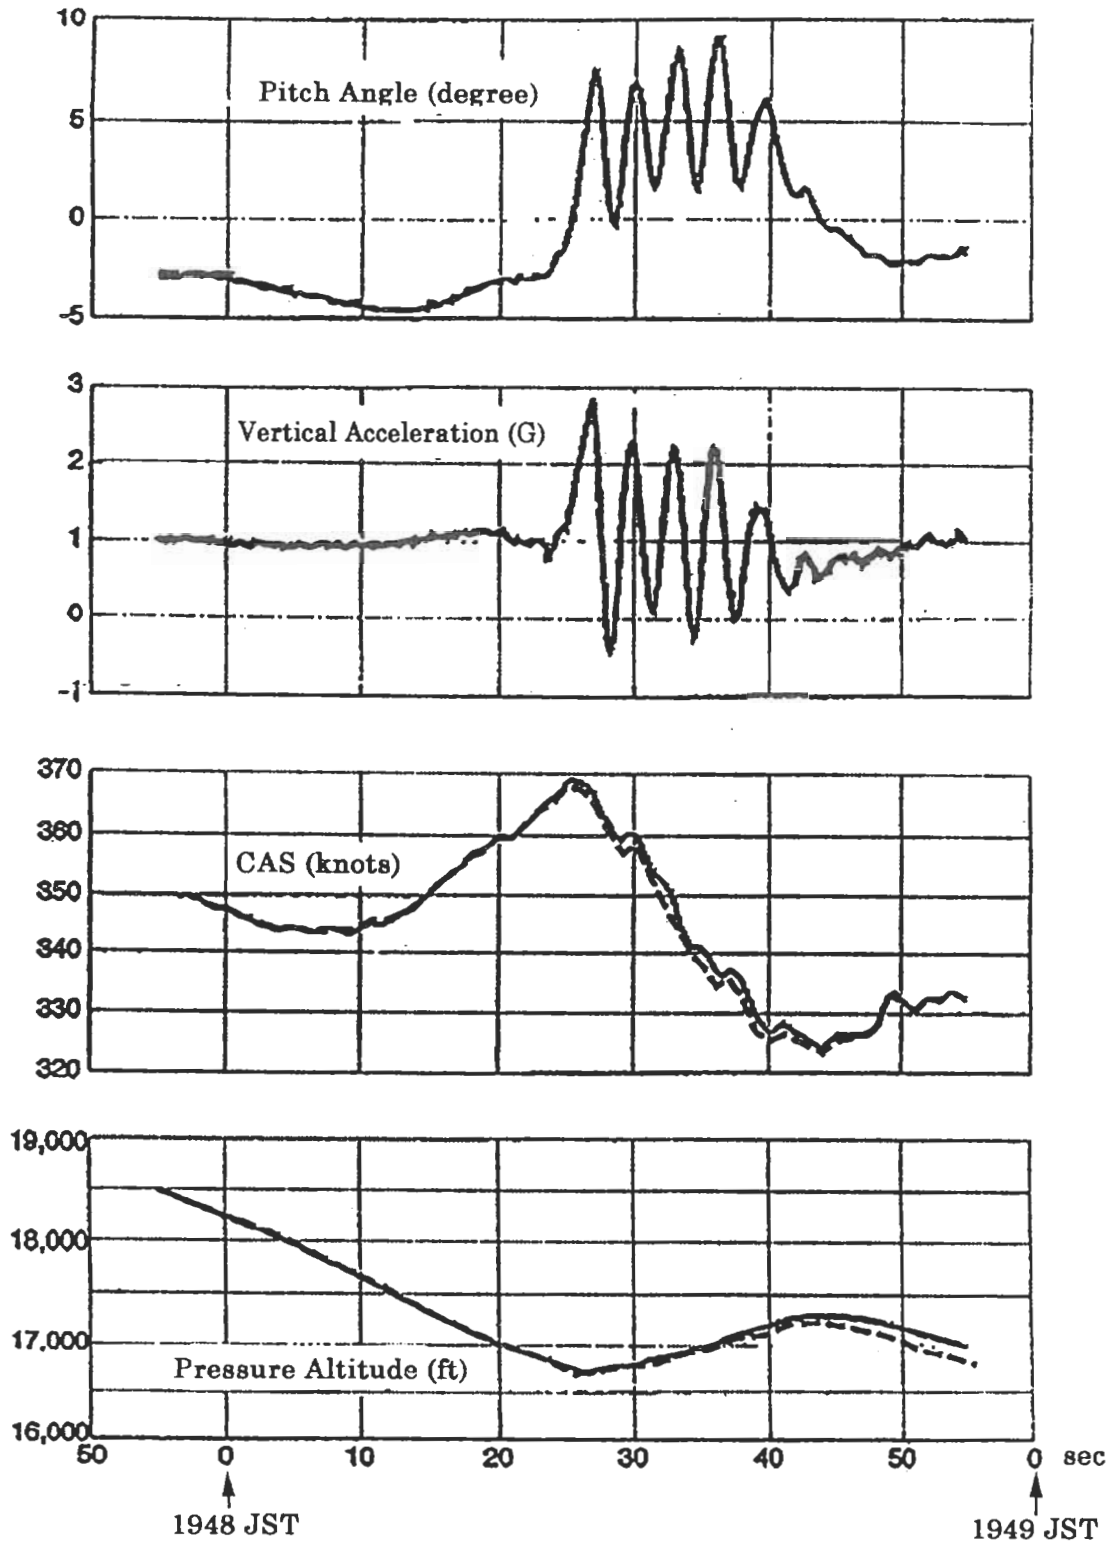
Based upon the above assumptions, the motion of the aircraft was numerically analyzed by carrying out a numerical computation with the equation of the aircraft motion during one minute time interval starting from 1947:55. As the result of the numerical analysis, pitch angle used as the initial value, estimated vertical acceleration, estimated CAS and estimated pressure altitude compared respectively with those recorded on the DFDR (drawn by the broken line) are shown in Figure A2-1 of this appendix.

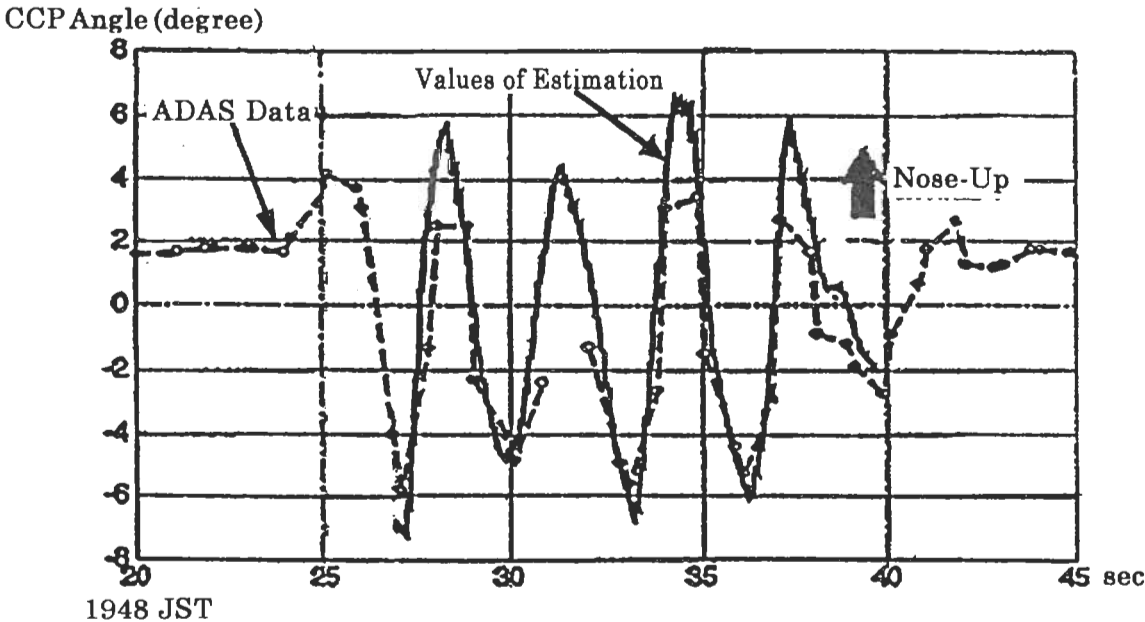
Figure A2-2 Comparison between Estimation and ADAS Data of Control Column Position (CCP)

Further, comparison between the estimated values of the control column angle and those recorded on the ADAS (drawn by the broken line) is shown in Figure A2-2 of this Appendix. Since the estimated values nearly correspond to the ADAS data, it is estimated by tracing the result of the numerical analysis in opposite direction that the pitch oscillations at the time of the accident occurred corresponding to the control column deflections.

Based upon the following reasons, it is estimated that the movements of the control column were caused by the pilot controls.

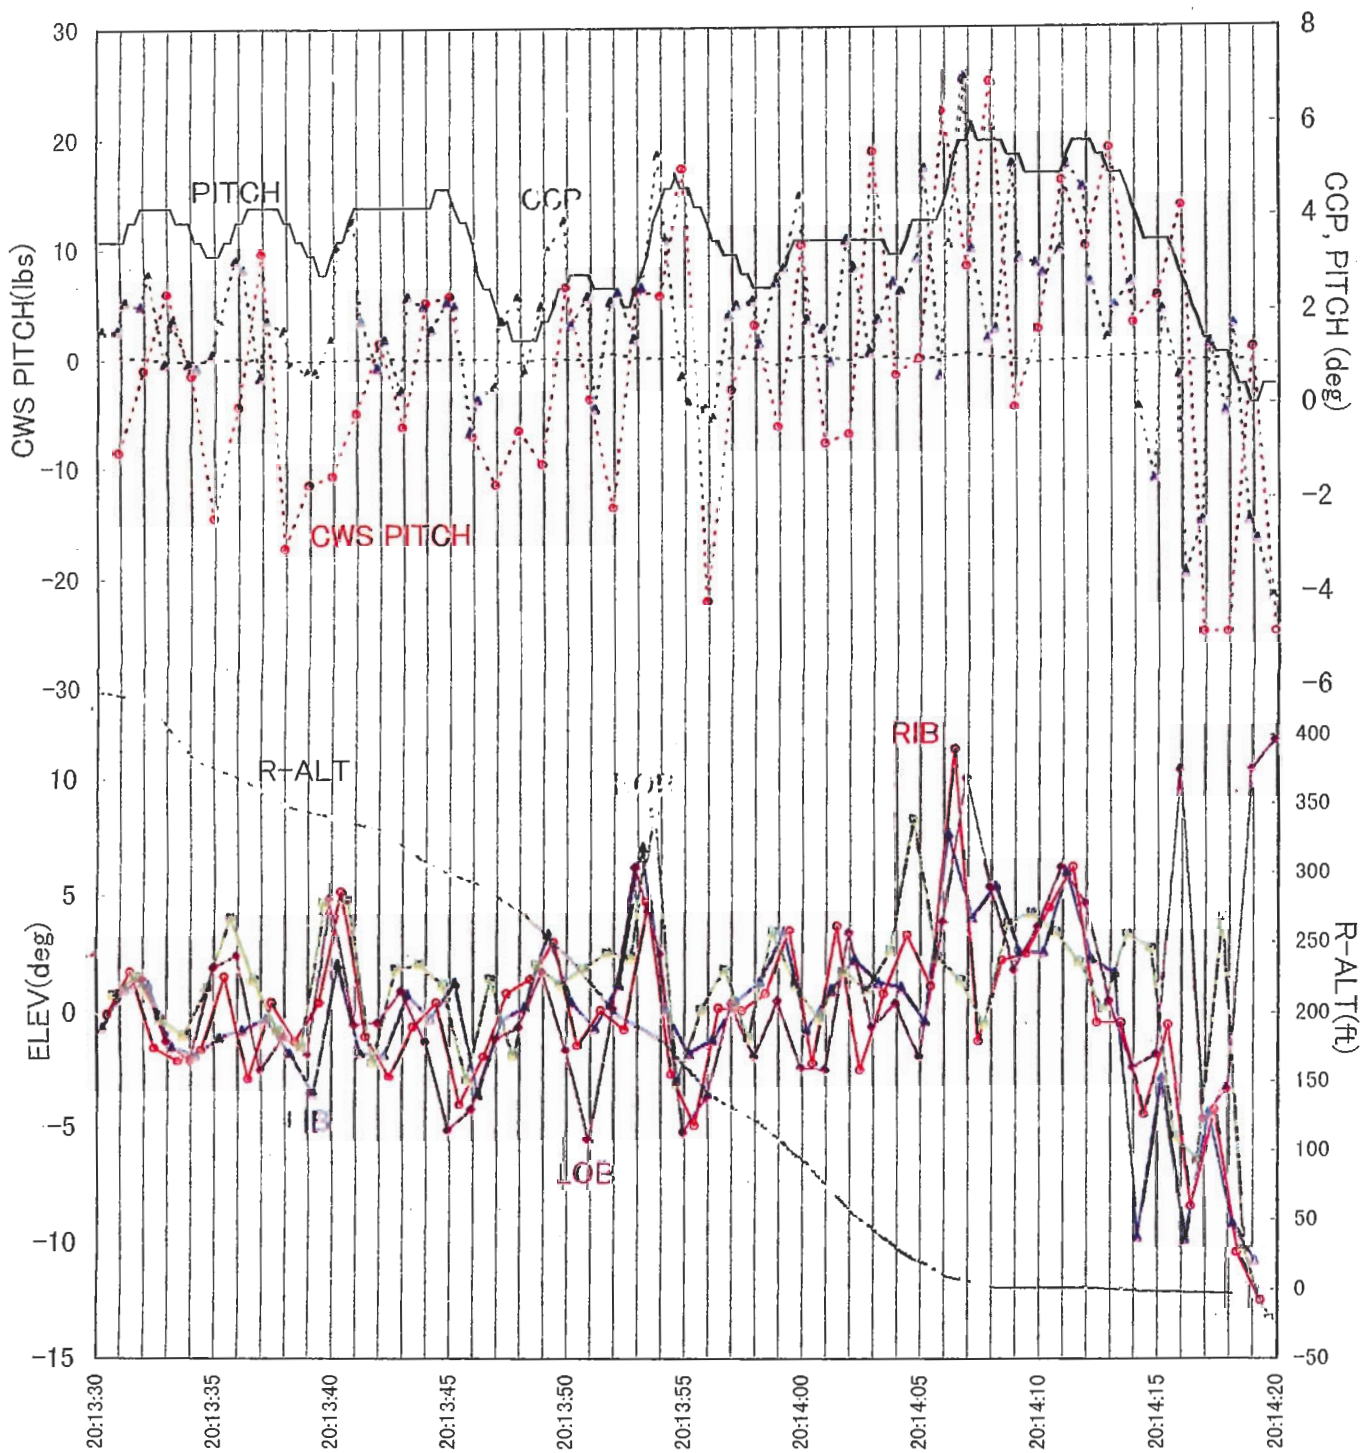
Figure A14 The Timing Relationship between CWS-PITCH and CCP while the Aircraft was in Final Approach to Nagoya Airport

It is apparent from Figure A14, showing that the timing relationship among the parameters is equivalent to that shown in Appendix 1-2, that the time difference between the CWS-PITCHs and the CCP is associated with the recording characteristics of the ADAS including the time delay on the data bus. Thus, it is estimated from a standpoint of mechanism of the control column that the movement of Control Column Force (CWS-PITCH) and Control Column Position (CCP) simultaneously occurred.
