**AIRCRAFT ACCIDENT
INVESTIGATION REPORT**

SHOWA AVIATION Co., Ltd.

J A 8 8 2 8

SHOWA AVIATION CO., LTD.
FAIRCHILD SWEARINGEN SA226-AT, JA8828
ON THE RUNWAY OF YAO AIRPORT, JAPAN
AROUND 14:39 JST, FEBRUARY 18, 2011

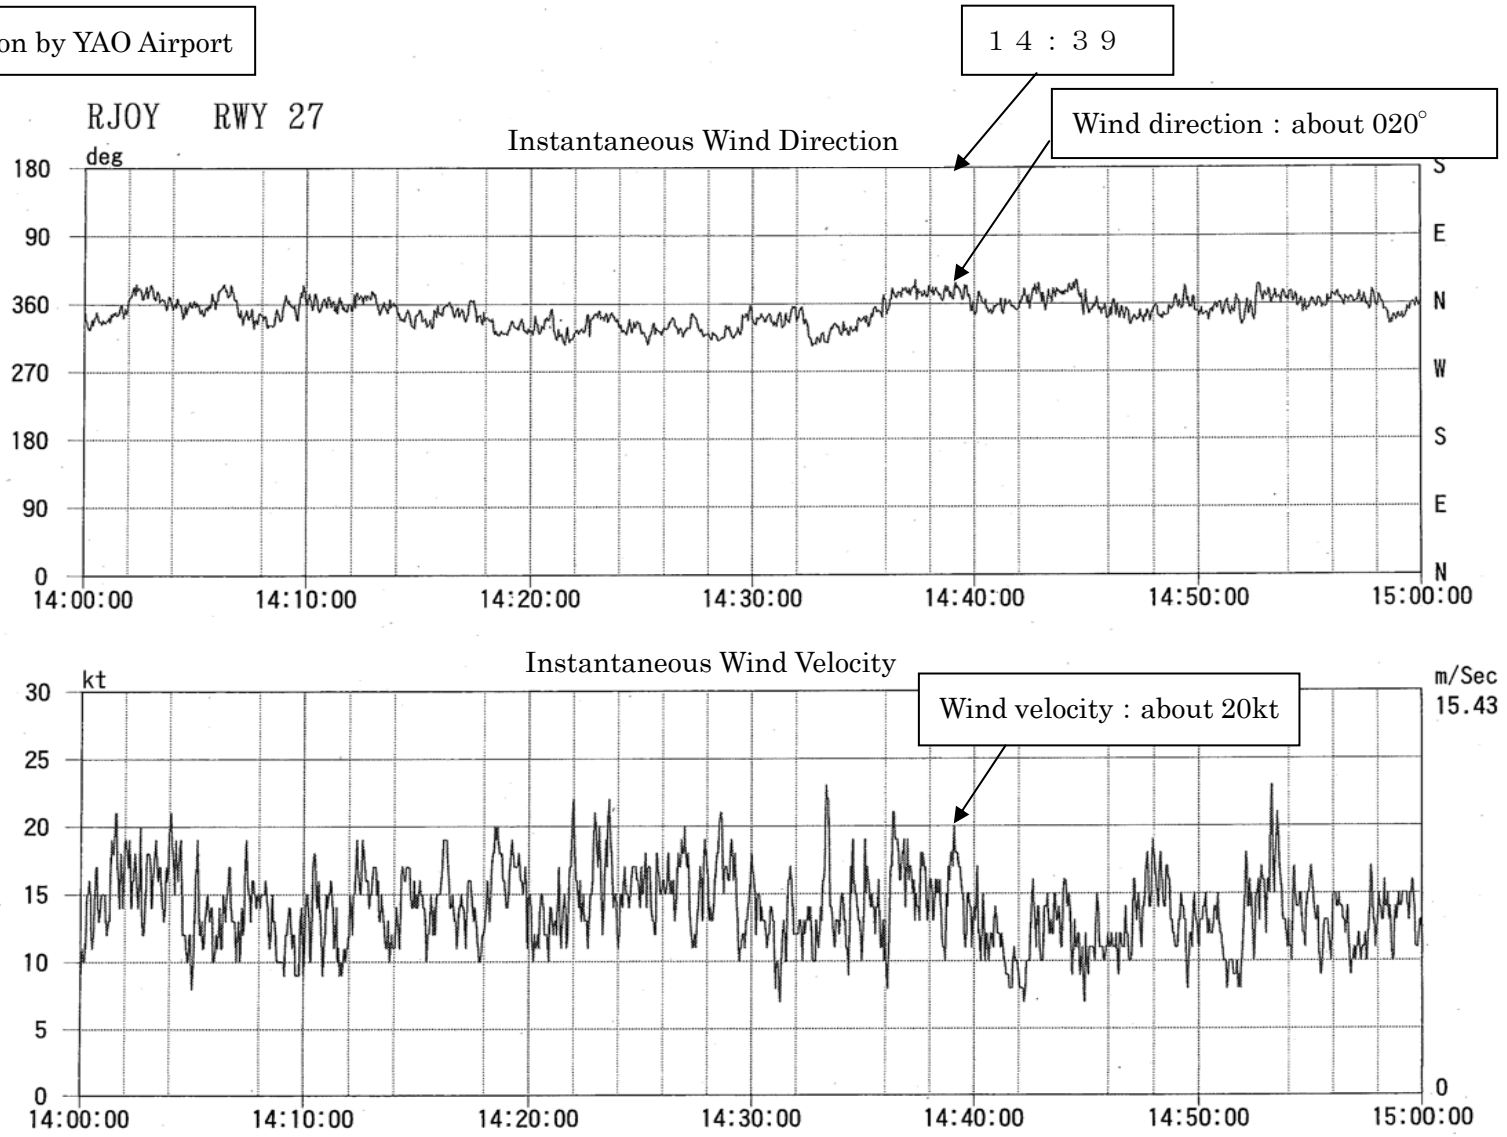
Figure 3 The Instantaneous Wind Direction and Wind Velocity

Regarding the instantaneous wind direction and wind velocity at Yao Airport, observed data around the time of the Aircraft landing indicates that up until around 14:36 the wind directions were fluctuating between about 310° and about 335° while the wind velocity was fluctuating between 9 kt and 19 kt with the average velocity of about 14 kt.

After around 14:36, the wind direction shifted eastward. The wind direction changed rapidly to an average of about 020°. The wind velocity was changing in a range of about 10 kt to about 20 kt.

Around 14:39, the time when the Aircraft is believed to have touched down, the wind direction was about 020°, while the wind velocity ranged from a maximum of about 20 kt to a minimum of about 10 kt.

As described in 2.1.1, Yao Tower provided the Aircraft with the wind information about five minutes before landing – 330° 14 kt with maximum velocity of 24 kt. About two minutes before landing, the wind direction had changed to 010° 16 kt. It is highly probable that the wind direction was changing fast from the head wind to the tail wind under the strong cross wind condition where winds were blowing from around 360°– right angle cross wind to runway 27.

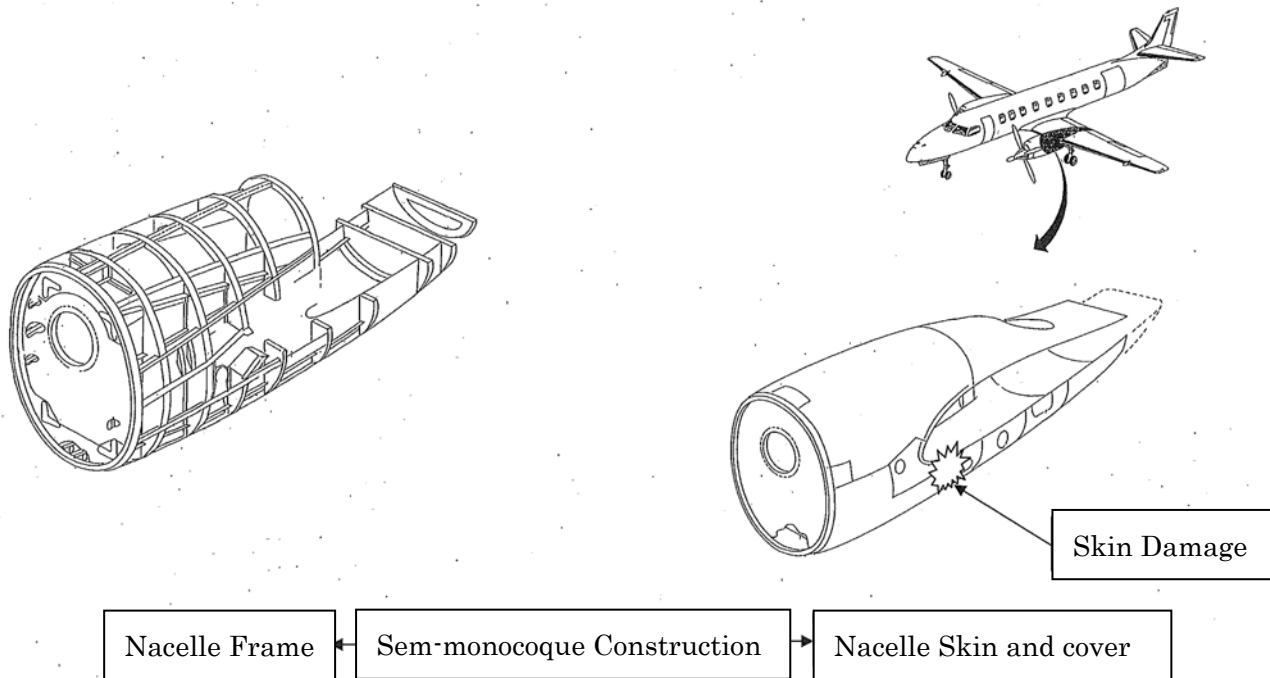
Figure 5 Engine Nacelle Structure

The Aircraft's engine nacelle has a semi-monocoque construction consisting of stringers, frames and cowling. It supports the engine and propellers load while storing the MLGs. The engine weighs 358 lb and the propeller weighs 129 lb. The distance from the attaching point of the left MLG to the CG of the engine is 97 in, while that of the propellers is 124 in from the same point. (See Figure 5 Engine Nacelle Structure)

According to 2.1.2 (2), the co-pilot stated that the Aircraft had a large dip when it passed the runway threshold. Therefore, it is considered probable that its airspeed was reduced with the reduction of a head wind component following quick changes in both the wind direction and velocity at a low altitude just before touchdown, generating a quick aircraft lift deprivation. Because the Aircraft was banked to the left under the fluctuation of the wind velocity near the runway threshold as well as the inappropriate flight operation to correct the effects of its shift from crab to wing low method, it is considered probable that the Aircraft touched down violently from the left MLG, causing the deformation on the left hand engine nacelle.

Skin Damage

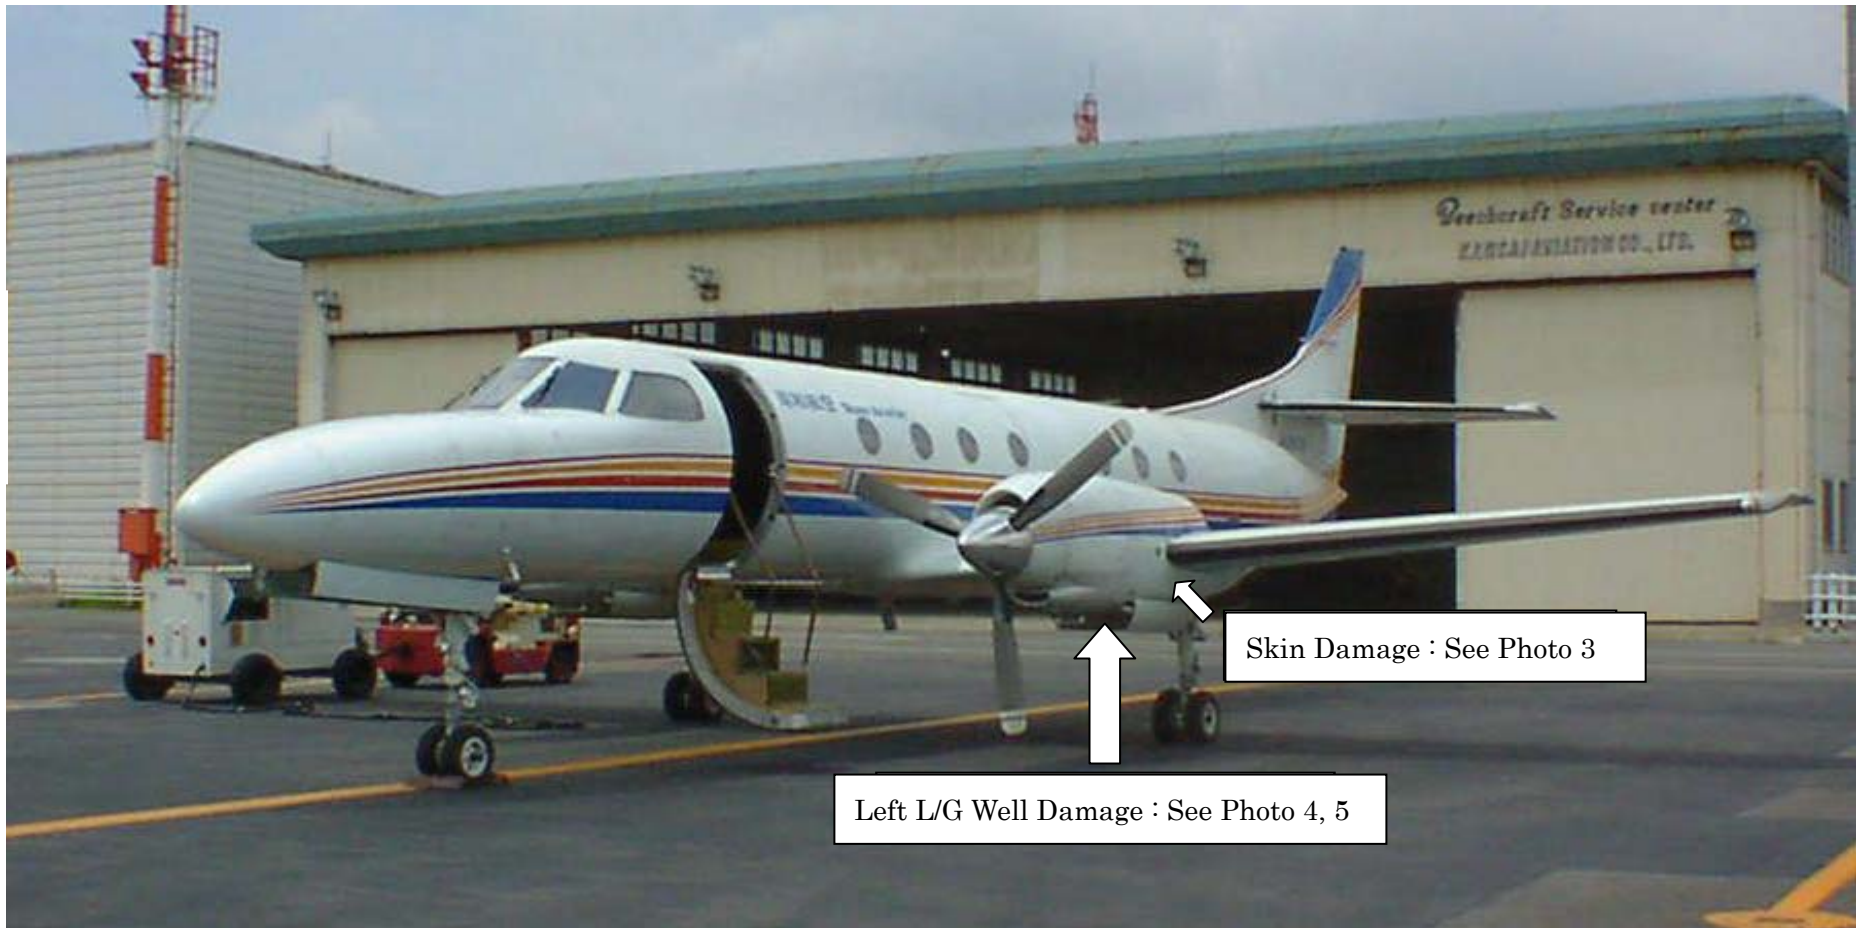
Photo 1 Accident Aircraft

(1) L/H Engine Nacelle Box Structure	Deformed
(2) L/H Engine Nacelle Cowling on Both Sides	Dented
(3) L/H Engine Nacelle Main Landing Gear (MLG) Well Stringer	Deformed
(4) L/H MLG Strut	Cracked
(5) Right Side Fuselage Outer Skin	Cracked

Fine cracks were confirmed on the left hand MLG strut and outer skin on the right side of the fuselage near the right wing front spar.

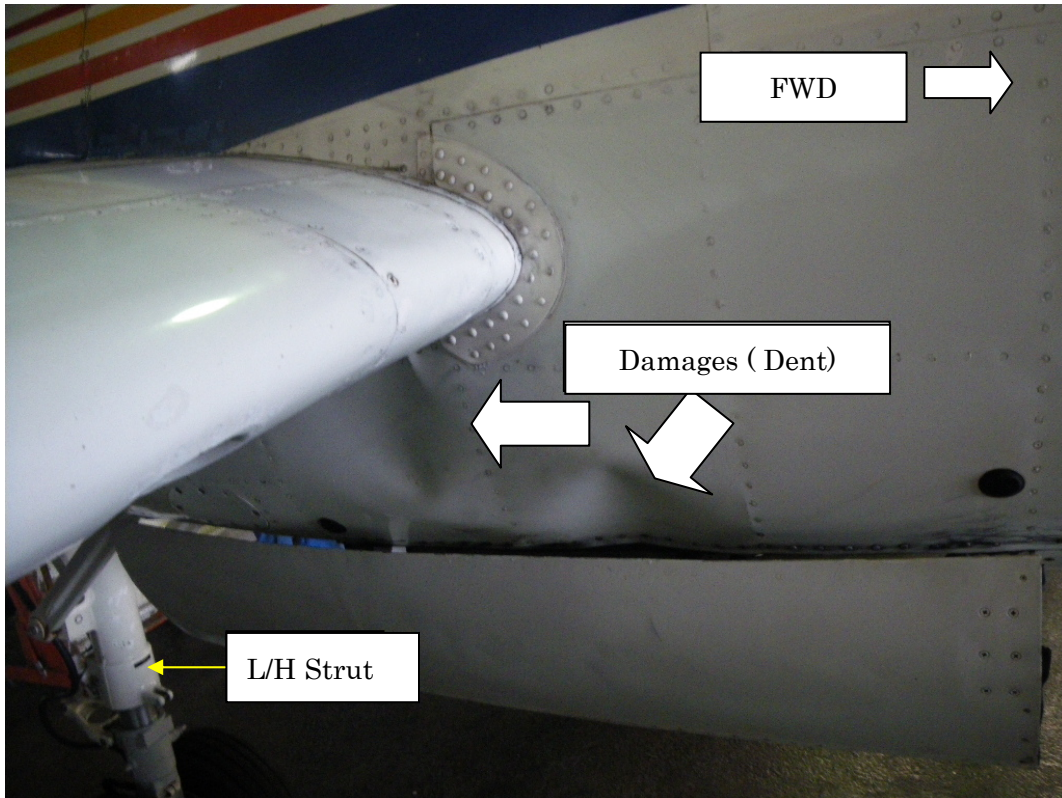
Photo 2 Right Side Damage of L/H Engine

The whole left hand engine nacelle was deformed. The stringer inside the left hand engine nacelle MLG well was deformed. Cowlings of the left hand engine nacelle (from F.S*⁸ 254 to F.S. 269) was bent on both sides.
