**AIRCRAFT SERIOUS INCIDENT
INVESTIGATION REPORT**

AN ATTEMPT OF LANDING ON A RUNWAY BEING USED BY OTHER AIRCRAFT

KUMAMOTO AIRPORT

AROUND 09:50 JST, MARCH 7, 2022

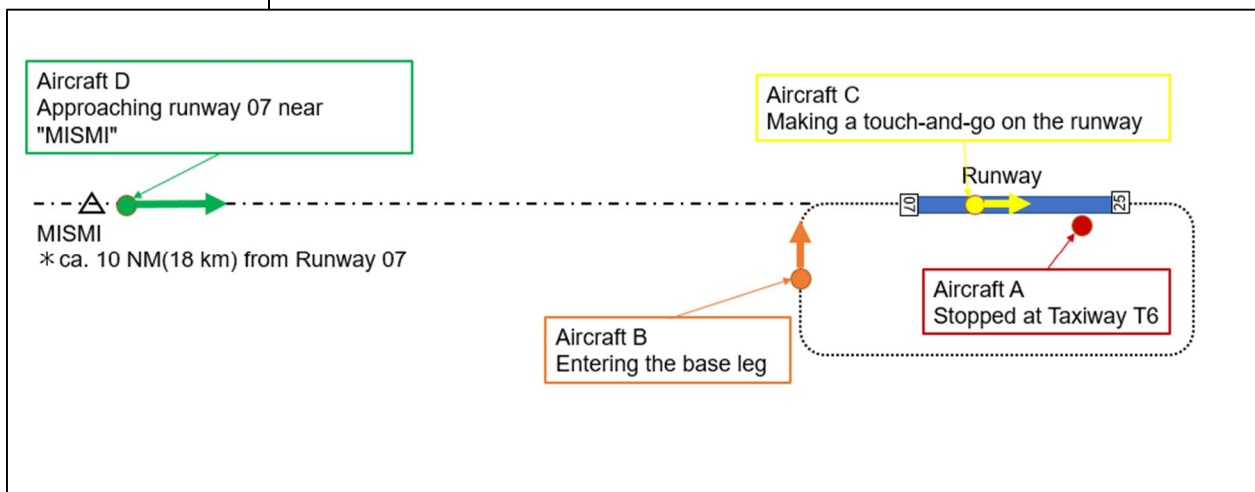
Figure 3: Positions of Aircraft B, C and D when Aircraft A stopped at Taxiway T6

At this moment in the Kumamoto Airport, there were a Cessna 172S (hereinafter referred to as "Aircraft C"), which had been conducting touch-and-go prior to Aircraft B, and a Boeing 737-800 (hereinafter referred to as "Aircraft D"), which was on the final approach course. (See Figure 3)

Subsequently, at the time when Aircraft C continued to take off after the touchdown, the Tower visually recognized that Aircraft B was flying the base leg, so the Tower changed the original plan and thought of letting Aircraft A take off after Aircraft B made the touch-and-go.

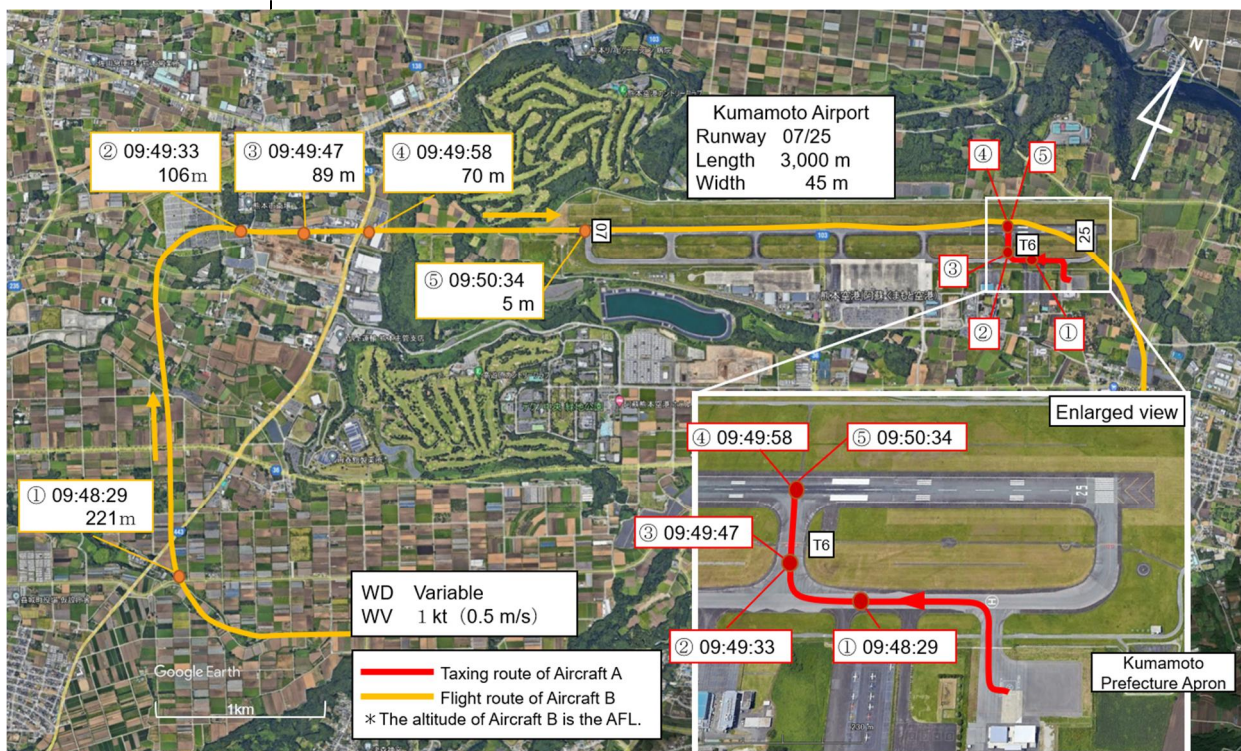
Figure 4: Taxing route of Aircraft A and flight route of Aircraft B

Aircraft A's PIC thought that as it was their turn to take off, they had to hurry in order to take off before the aircraft (Aircraft B) on the final approach, and at 09:49:33, the Aircraft A's PIC requested the Tower to send them again the instructions which they were unable to hear due to the transmission from Aircraft D. The Tower instructed Aircraft A again to hold short of runway, saying "HOLD SHORT OF RUNWAY AT T6, BOEING 737 9 MILES ON FINAL," in order to inform that the Aircraft A's take-off sequence would be after the landing of Aircraft D, and provided with the traffic information on Aircraft D. Aircraft A's PIC read back the instruction saying "ROGER, HOLDING AT T6, RUNWAY 07," and the Tower confirmed the read-back. (See Figure 4 ②)

At 09:49:47, the Tower visually confirmed Aircraft A was on Taxiway T6 and gave touch-and-go clearance to Aircraft B which had entered the final approach from the base leg. (Figure 4 ③)

Aircraft A's PIC read back to the Tower, "ROGER, HOLDING AT T6" but thought that it was instructed by the Tower to hold on the runway. So, the Aircraft A's PIC instructed the FO to release the parking brake, started to enter the runway, and requested the air corps member in the aft seat to reconfirm the fasten seat belt before the take-off. The FO thought that the Tower had instructed to "Hold short of runway", and the PIC had read back, saying, "Holding at T6", but the FO visually confirmed Aircraft B, which was on the final approach, thinking that they were able to take off before Aircraft B, and followed the PIC instruction. The PIC and the FO of Aircraft A did not hear the touch-and-go clearance the Tower had issued to Aircraft B, however, promptly entered the runway as they visually confirmed Aircraft B, which was on the final approach, was approaching the runway. And at 09:49:58, Aircraft A stopped eastward on the runway (take-off direction) and waited for the take-off clearance from the Tower. (Figure 4 ④)

visually recognized Aircraft A was entering the runway. At 09:50:34, the Tower instructed Aircraft B to make a go-around, Aircraft B, which was entering near the runway threshold, made a go-around immediately. (Figure 4 ⑤)

- ① 09:48:29 Aircraft A established communication with the Tower. The Tower instructed Aircraft A to hold short of the runway on Taxiway T6 and provided with the traffic information on Aircraft C which was on the runway. Aircraft A read back to the Tower the intention of holding short of the runway on Taxiway T6.
- ② 09:49:33 The Tower instructed Aircraft A to hold short of runway again and provided with the traffic information on Aircraft D on its final approach. Aircraft A read back to the Tower the intention of holding at T6.
- ③ 09:49:47 The Tower issued touch-and-go clearance to Aircraft B.
- ④ 09:49:58 Aircraft A entered the runway and stopped.
- ⑤ 09:50:34 The Tower visually confirmed Aircraft A was entering the runway and instructed Aircraft B to make a go-around.
