**AIRCRAFT ACCIDENT
INVESTIGATION REPORT**

J A 9 6 3 5

**CRASH DURING CARGO TRANSPORT
WITH UNDERSLUNG EXTERNAL CARGO
INTO THE MOUNTAIN SLOPE
AERO ASAHI CORPORATION
AEROSPATIALE AS332L (ROTORCRAFT), JA9635
NEAR KIGENSUGI CEDAR TREE
YAKUSHIMA-TOWN, KUMAGE-GUN
KAGOSHIMA PREFECTURE
AT ABOUT 07:50 LOCAL TIME, SEPTEMBER 26, 2010**

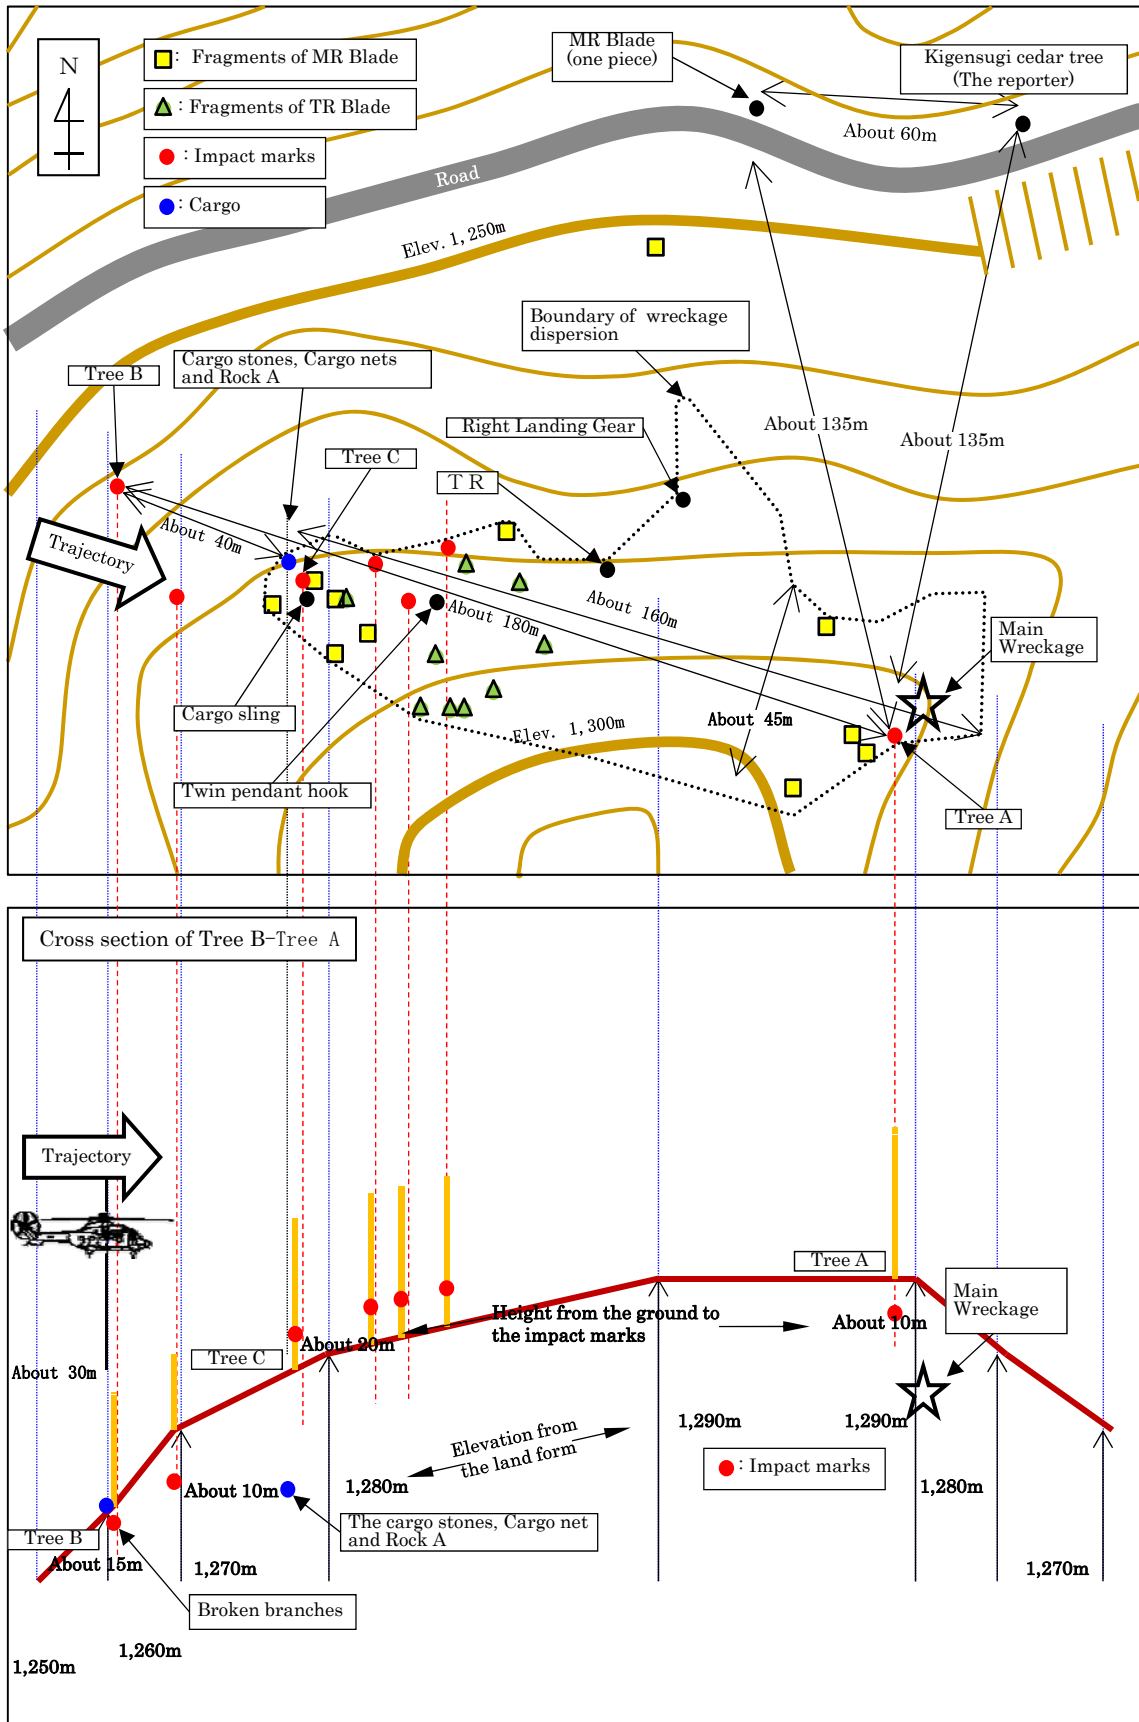
Figure 2: Accident Site Layout

A tall tree of about 15-meter high (at an elevation of 1,260 meters) located 180 meters west-northwest of the Main Wreckage (hereinafter referred to as “Tree B”), was found to have had its top branches broken. From this tree toward the east-southeast on uphill slope scattered the fragments of main rotor (MR) blades, tail rotor (TR) blades, cargo nets, cargo pebble stones, cargo sling, twin pendent hook, tail gear box (TGB), TR assembly and the right main landing gear.

Trees with broken branches or impact marks were found along the line from Tree B to the Main Wreckage. A tree about 20-meter high, (at an elevation of 1,280 meters) standing east-southeast of the underslung cargo (hereinafter referred to as “Tree C”) was found to have had its top branches broken.

One of the four MR blades was found at a place 135 meters north-northwest of the Main Wreckage (elevation 1,240 meters).

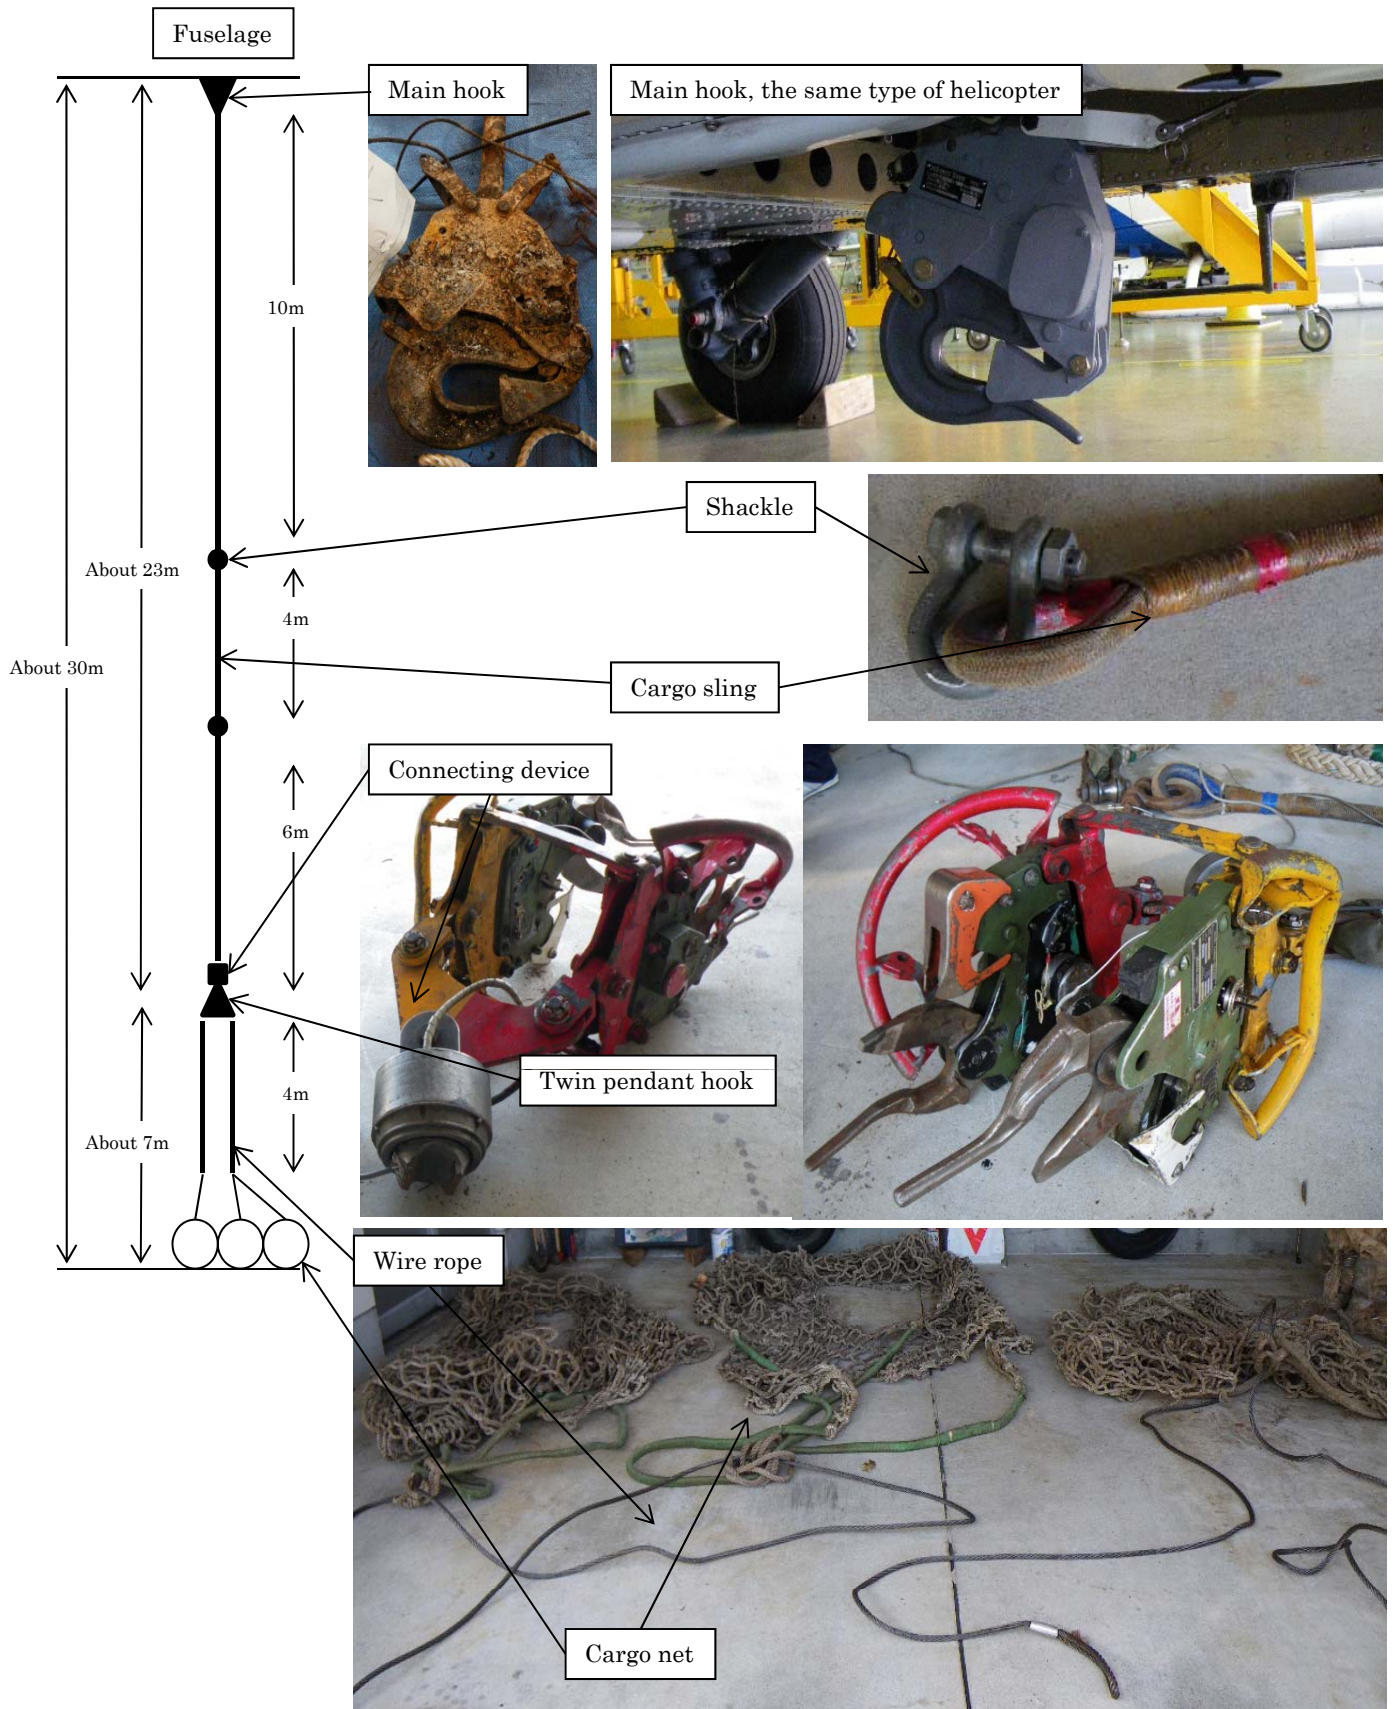
Figure 5: External Cargo Sling Device

The twin pendant hook was broken, and was found alone away from the Main Wreckage, the underslung cargo and the sling. The shackle was

ruptured. Both hooks were open. Due to the deformation of the housing and hooks, hooks did not lock.

The cargo slings hung from branches of the nearby trees. Neither the cargo slings nor the shackles were broken.

- c. The cargo slings were found at a location away from the Main Wreckage, while neither the cargo slings nor the shackles were broken. The main hook was locked at its regular position with no major deformation, crack or rupture.

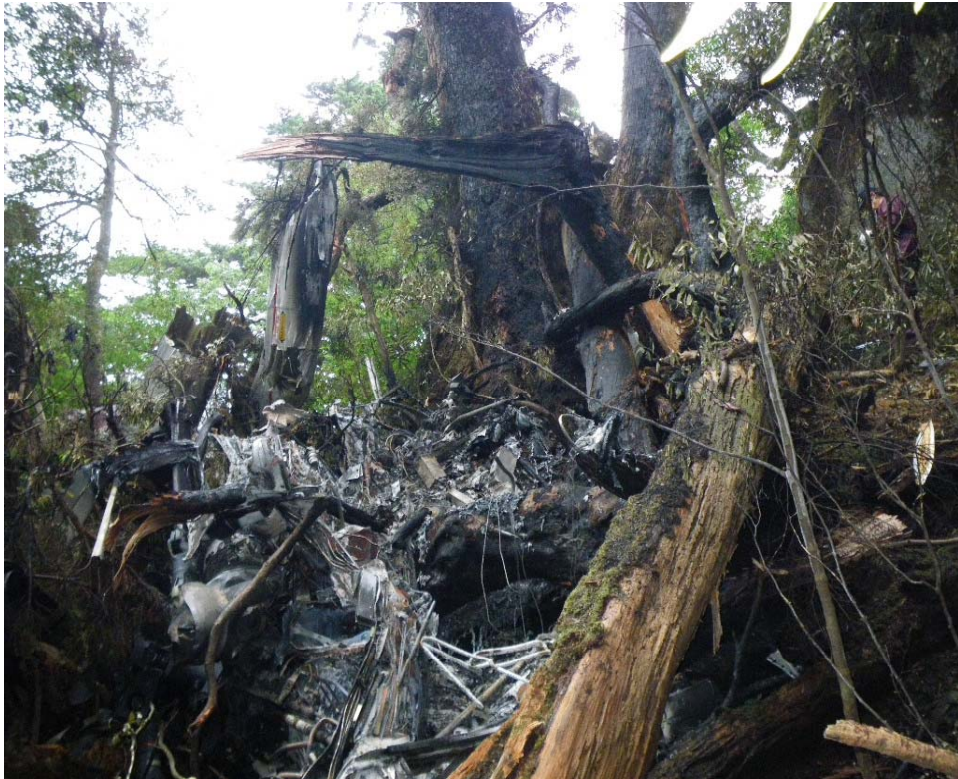
Photo 2: Accident Helicopter (Main Wreckage)

Fuselage:	Broken and burnt
Main Rotor (MR) System:	Broken and burnt
Tail Rotor (TR) System:	Broken

The Main Wreckage rested close to the base of a big tree (hereinafter referred to as “Tree A”) standing on the slope with an average degree of incline of approximately 30°, and its trunk and branches were charred black by fire while big branches at about 10 meter high were broken and lay on the ground.

The entire tail boom was damaged with crush marks on its right side.

- b. All the four MR blades were broken. One of them was separated from the MR hub, and was found away from the Main Wreckage.
- c. The TGB and the TR assembly were damaged and separated from the tailboom. The TR drive shaft was ruptured, separated, and found away from the tail boom. All of five TR blades were damaged: one was separated from the hub and the others were fractured near the hubs.
- d. The main hook was properly locked and its exterior was damaged by fire. Interior inspection revealed no deformation, crack or rupture.
