**AIRCRAFT ACCIDENT  
INVESTIGATION REPORT**

**AERO ASAHI CORPORATION**

**J A 9 6 9 0**

**AERO ASAHI CORPORATION  
AEROSPATIALE AS332L (ROTARCRAFT), JA9690  
AT ABOUT 500 M ELEVATION, IN THE MOUNTAIN,  
IMAZU-CHO, TAKASHIMA CITY, SHIGA PREFECTURE, JAPAN  
AT ABOUT 8:28 JST, AUGUST 3, 2009**

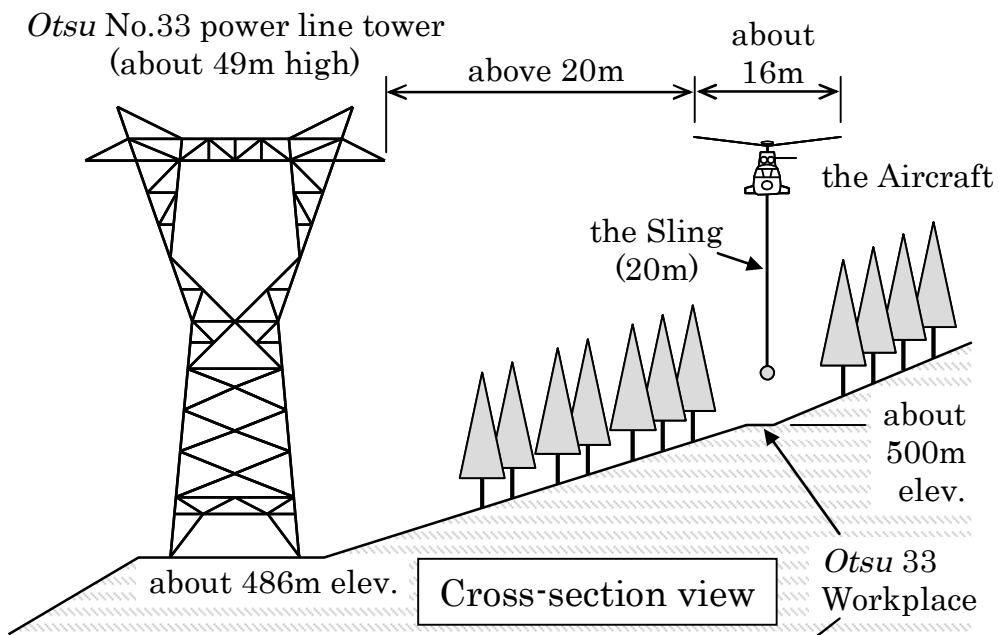
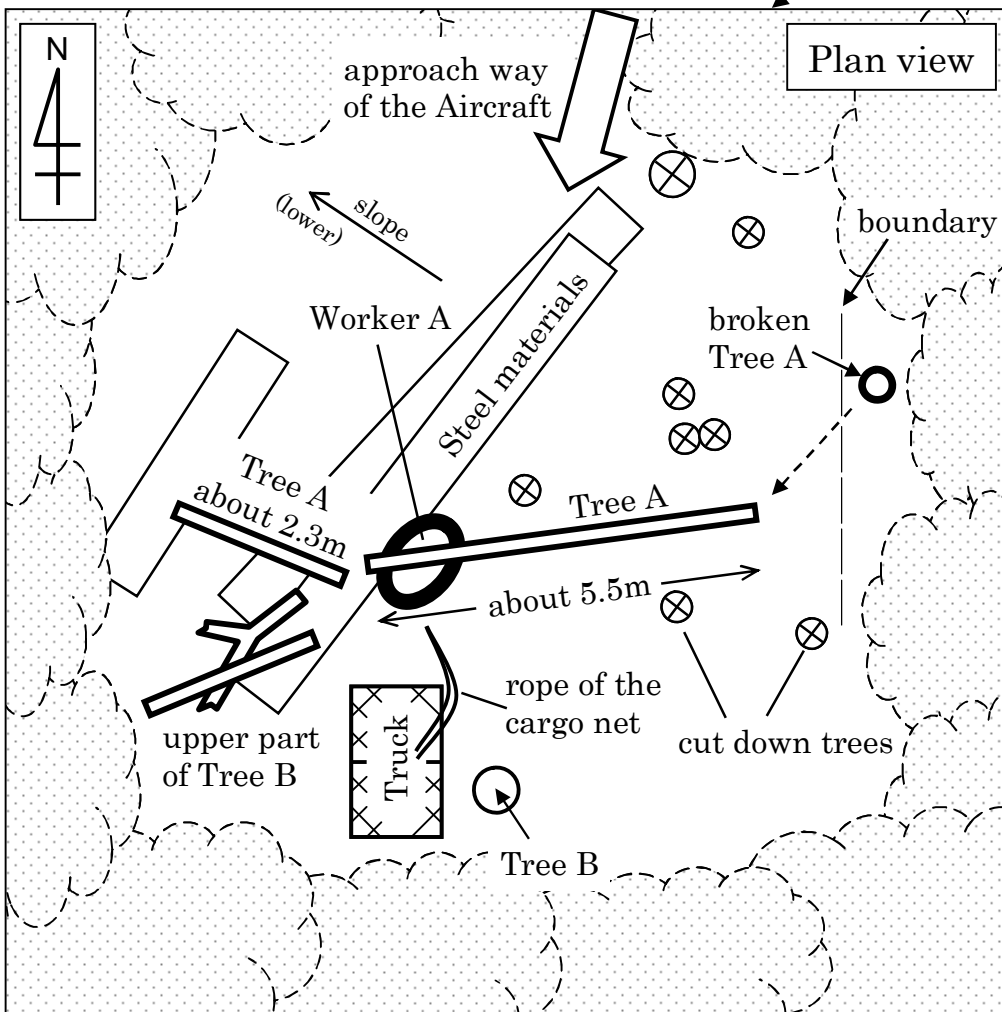
Figure 2 Accident Site Layout

The accident site was a workplace for material transport by helicopters set up in the mountain at about 500m elevation of Imazu-Cho, Takashima City, Shiga Prefecture, and was a slope of high in the east and low in the west with the maximum slope angle about 20 degrees and with a flat part. Trees within about 11m square had been cut down and *Otsu* No.33 power line tower of 49m high was on the ground about 40m in the west from the accident site (about 486m elevation).

Tree A was about 9m high on the ground and was outside of cut down area in the mountainside. It broke down at about 1m high from the ground (about 20cm in diameter) and the broken tree fell down to the valley side. It broke at about 5.5m from the broken point again and the broken parts fell on the steel materials. Tree A had no leaves, and though there remained bark at around the broken part, the inside rotted and became a cave.

Not only Tree A but a broken part of the tree near the truck (hereinafter refer to as "Tree B") fell on the steel materials and the inside rotted.

To select a workplace, it is necessary to decide the cutting area properly not only by considering various factors above but also by paying sufficient attention to the condition of trees around which might be broken with the downwash of a helicopter.

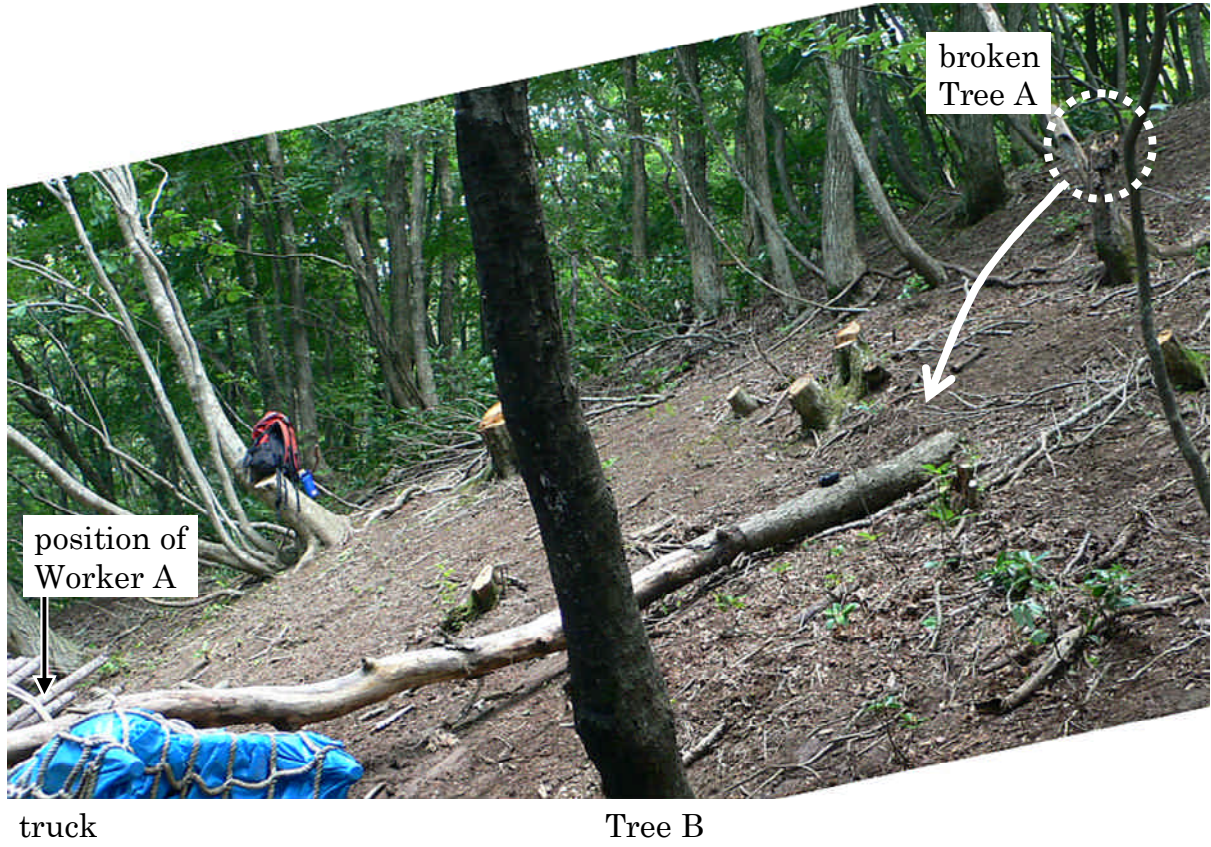
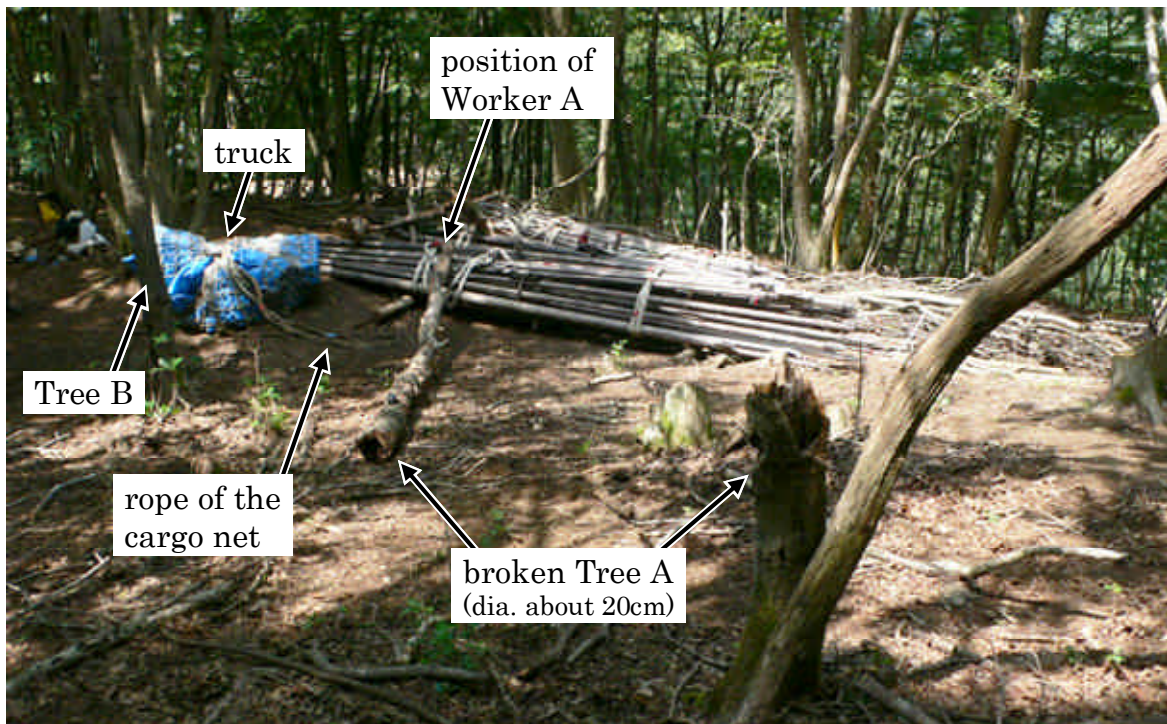
Photo 3 Accident Site

Judging from the description in 2.1 and 2.6, it is considered highly probable that Tree A, the inside of which rotted and became a cave, about 9m high on the ground and had been outside of cut down area on the mountainside of *Otsu 33 Workplace*, broke down at about 1m high from the ground because it had been swayed by the downwash of the Aircraft. It is considered highly probable that the broken Tree A fell down involving Tree B which also had been rotten inside and hit Worker A from his back. It is considered highly probable that Worker A could not notice the falling tree and could not avoid it because it occurred in the noise of the Aircraft and its downwash and also Tree A fell down from out of his view.
