# AIRCRAFT ACCIDENT INVESTIGATION REPORT

UNITED AIRLINES FLIGHT 801  
BOEING 747-400, N179UA  
NEW TOKYO INTERNATIONAL AIRPORT  
NARITA, JAPAN  
MAY 12, 1998

DECEMBER 1, 2000

AIRCRAFT ACCIDENT INVESTIGATION COMMISSION

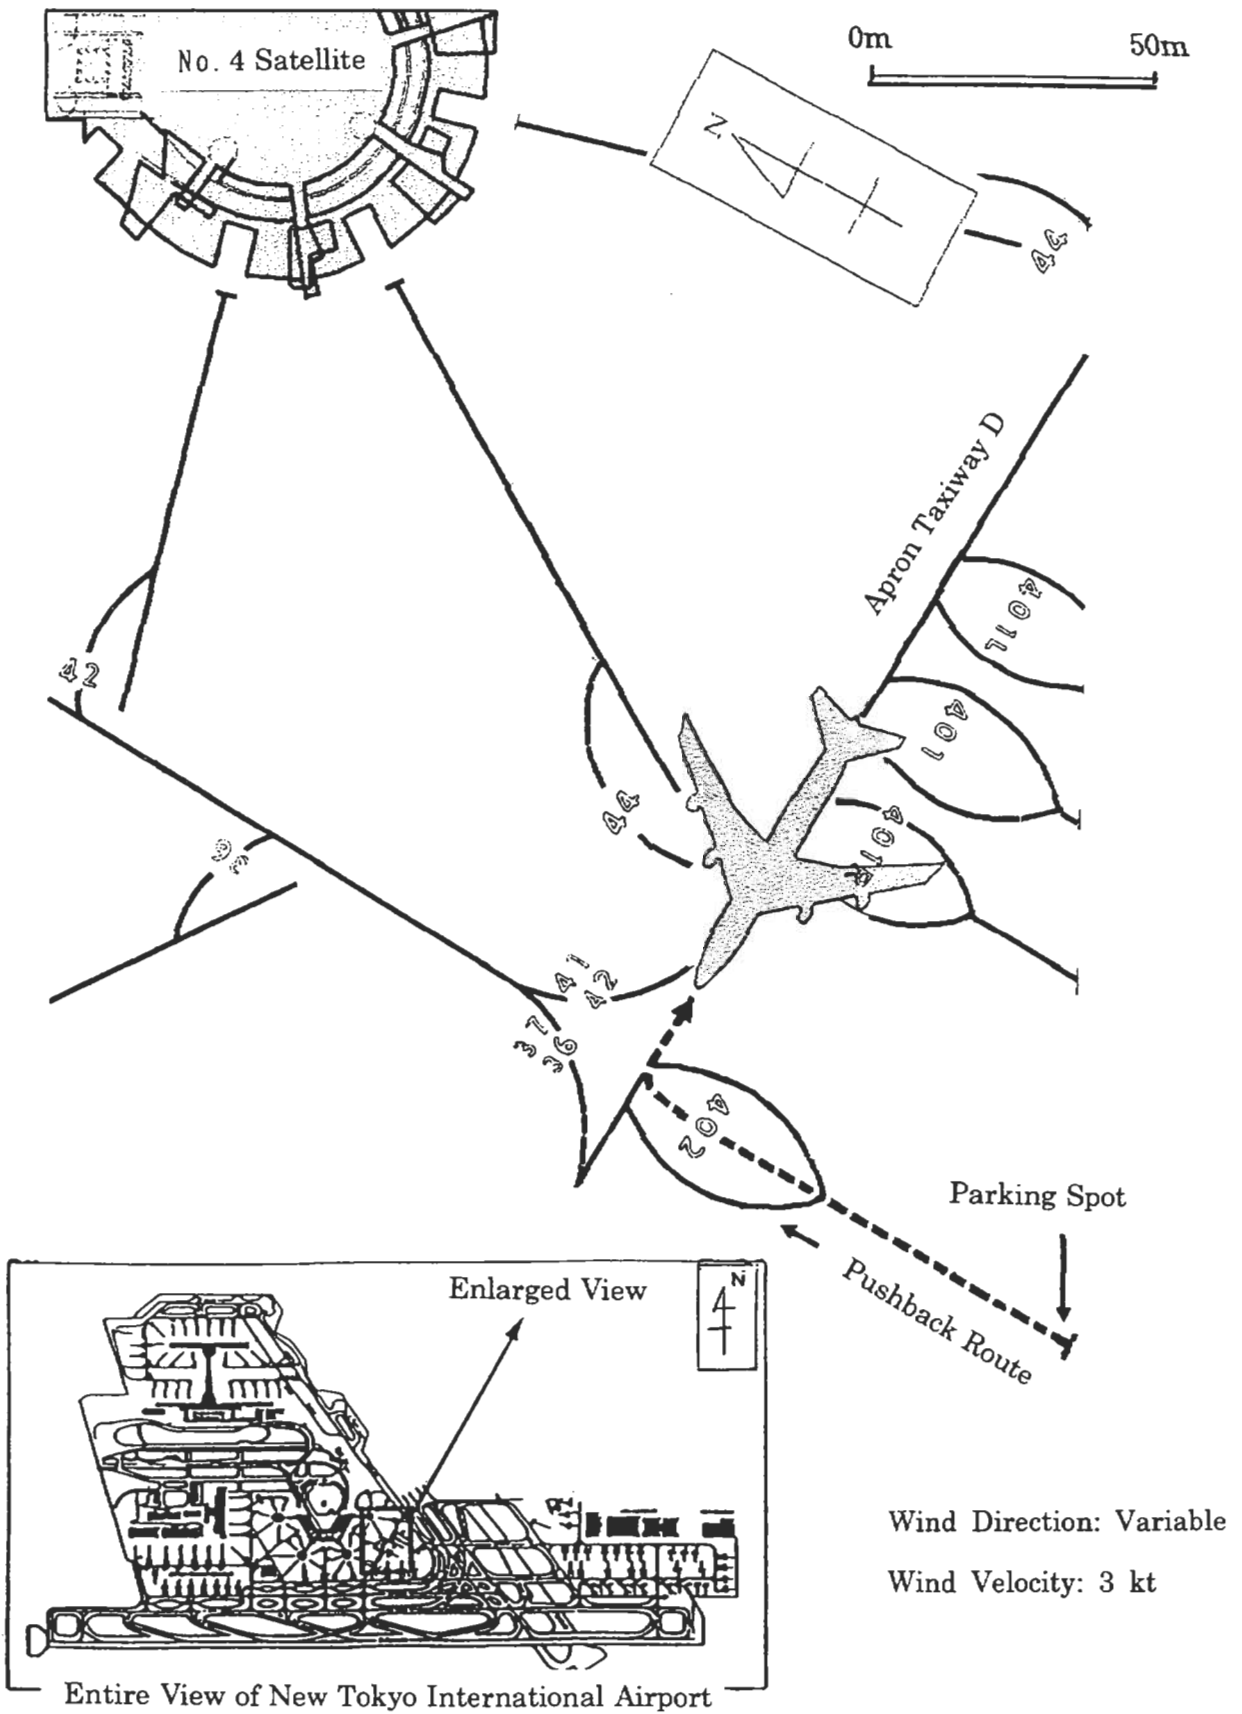
Figure 1 Location of Emergency Evacuation of the Aircraft Involved at New Tokyo International Airport

The accident occurred at a rearward area of the No.402 spot on an apron-taxiway D at approximately 1812.

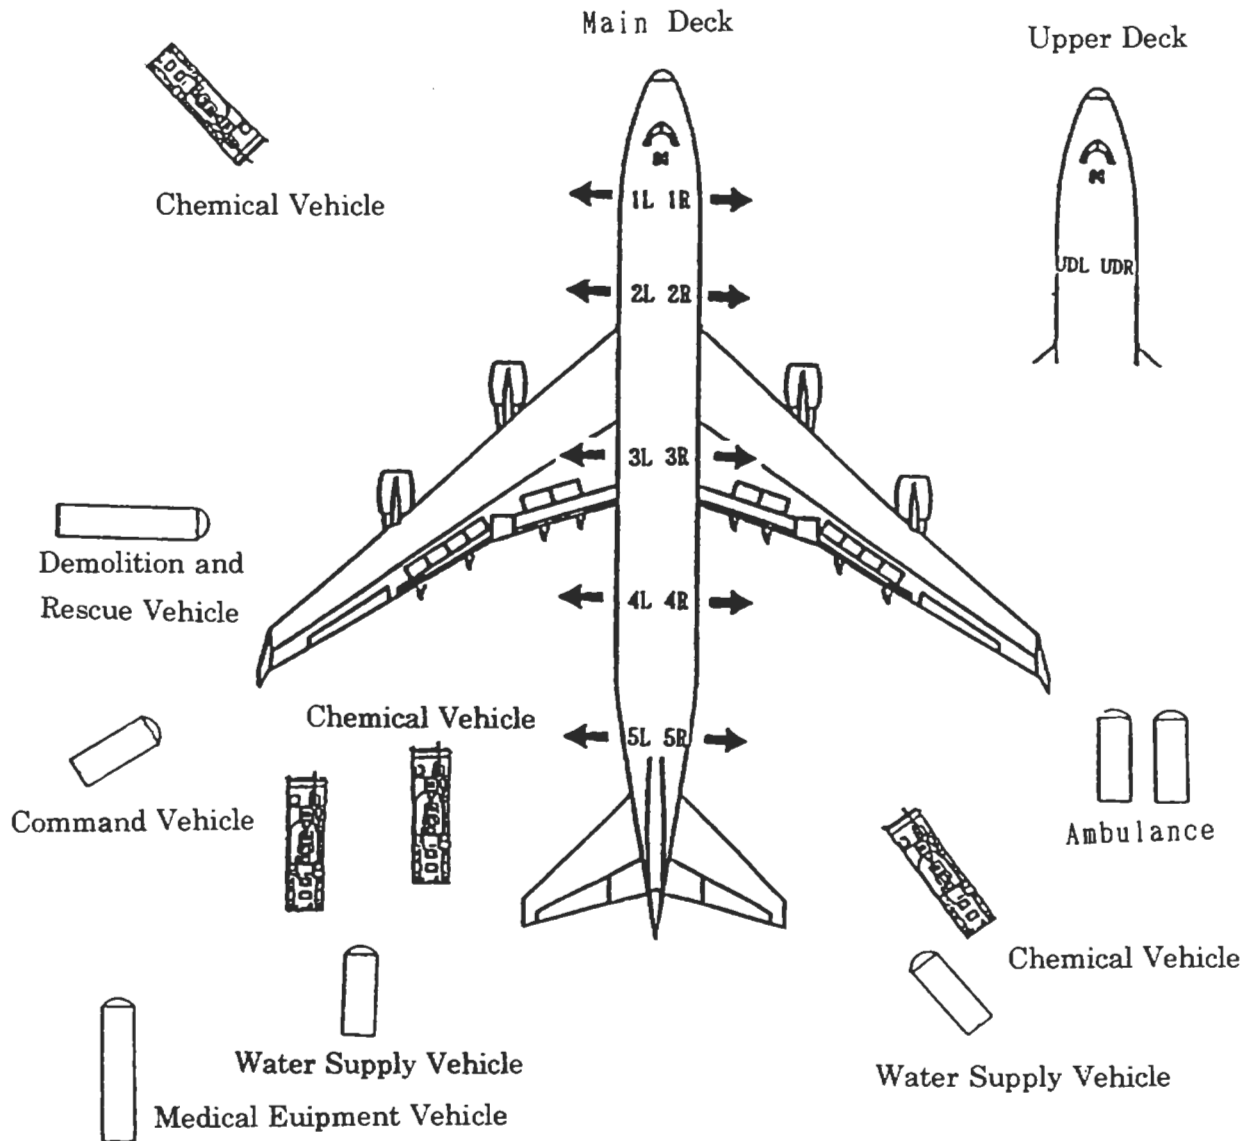
Figure 3 Drawing showing deployed Evacuation Slides  
and Standby positions of Fire Fighting and Rescue Vehicles

Note: 1 Arrows ( ← · → ) in the drawing show the deployed evacuation exits.

Note: 2 UDL and UDR were not used.

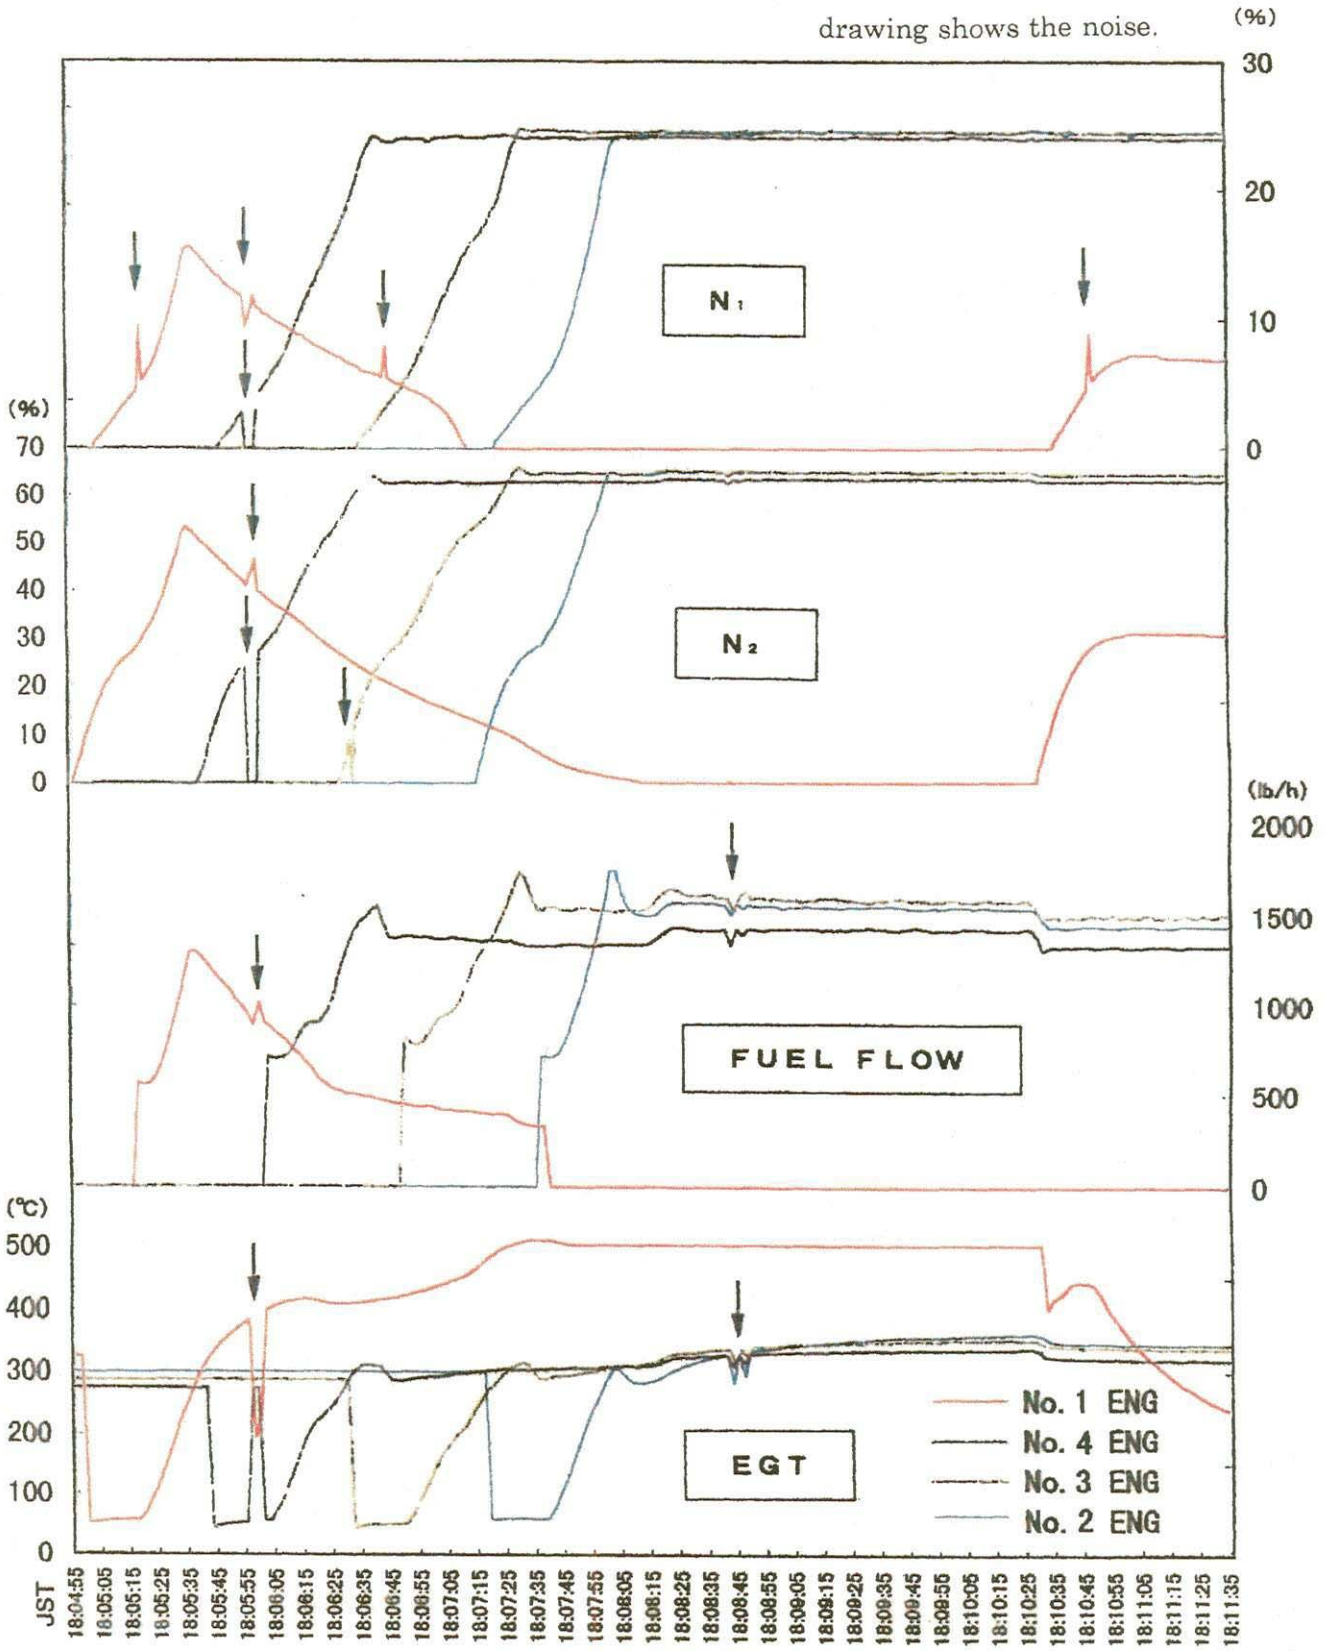
Figure 4 Engine Parameters

At 1804:56,  $N_2$  (Rotating Speed % of High Pressure Compressor) of the No.1 engine began to increase and 40 seconds later once reached to approximately 53% RPM, then gradually began to decrease.

At 1807:41, a fuel flow to the No.1 engine dropped to 0 lb/h.

At 1808:13,  $N_2$  of the No.1 engine spooled down to 0% RPM.

At 1810:31, N<sub>2</sub> of the No.1 engine began to increase and about 23 seconds later reached approximately 30% RPM. Correspondingly, from 1810:33, EGT of the No.1 engine increased from approximately 400 °C to 450 °C and thereafter gradually decreased.

(1) Based on the investigation of the DFDR readouts during No. 1 engine starting shown in 2.12.1, it is estimated that during the acceleration period of the engine start, the abrupt drop of N2 and the abnormal rise of the exhaust gas temperature the starting stall conditions outlined in 2.13.1.

- (3) It is estimated that since the flight crew had not monitored well the engine instruments during the engine starting, they were late for noticing the occurrence of the starting stall, failing to turn the fuel control switch to "CUT OFF" position promptly.
- (4) It is estimated that since fuel had been pumped into the combustion chamber for about 2 minutes between the time since the fuel flow reached the maximum value of approximately 1,300 lb/h at 1805:36 and the time till it dropped to 0 lb/h at 1807:41 as described in 2.12.1(2), fuel in excess did not burn completely as shown in 2.13.1 and collected in the low pressure turbine section, resulting in the torching.

- (1) Flight crew's instrument monitoring during engine starting,
- (2) Cabin crew's knowledge on torching phenomenon,
- (3) Communication between the flight attendant and the flight crew during emergency situation, and
- (4) Orderly execution of emergency evacuation.
