**AIRCRAFT ACCIDENT
INVESTIGATION REPORT**

**UNITED AIRLINES
N 2 2 4 U A**

FLIGHT ATTENDANT INJURY BY THE SHAKING OF THE AIRCRAFT UNITED AIRLINES BOEING 777-200, N224UA (UNITED STATES OF AMERICA) AT AN ALTITUDE OF APPROX. 23,000 FT, ABOUT 150KM NORTH OF NARITA INTERNATIONAL AIRPORT AT 14:18 LOCAL TIME, JULY 5, 2012

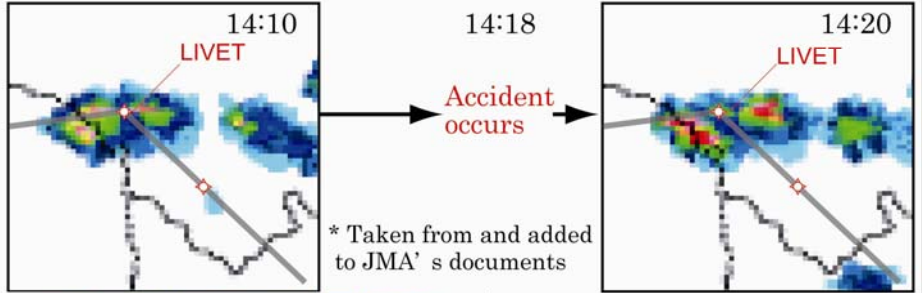
2.6 Meteorological Information	<p>(1) General Weather Conditions The atmosphere was in an unstable condition in eastern and northern Japan from the afternoon through the night due to the passage of a trough accompanied by a cold of minus nine degrees C or less in the vicinity of an altitude 5,500 m, and convective clouds such as cumulonimbus and cumulus developed in several places.</p> <p>(2) Weather Radar Imagery around occurrence point (Strength and Top Height) According to the Weather Radar Imagery at 14:10: before the accident occurred, and 14:20: shortly after the accident occurred, the echo strength increased during this period as its top height reached 26,000 ft and over.</p> <div data-bbox="464 1697 1433 2094"> <p>Weather Radar Imagery (Strength: indicates precipitation intensity)</p>

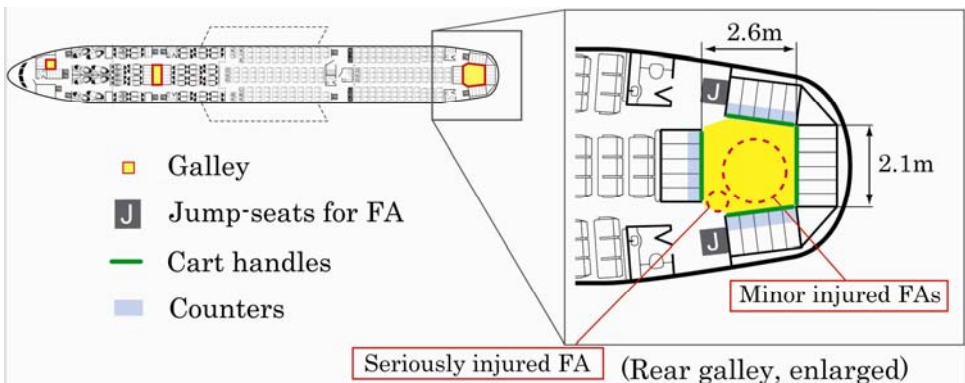
<p>(3) Prognostic Chart of Significant Weather (for domestic use)</p> <p>No significant weather including turbulence was forecasted to affect the flight on their route.</p>
<p>2.7 Rear Galley</p>	<p>Handholds designed specifically for the shaking of the aircraft were not equipped in the rear galley where the four injured FAs were working. Fixed objects such as the counters and the cart handles stored in the lower part of the galley on four sides were available to hang on as substitute for handholds. All of the carts had been stored when the accident occurred. The rear galley had more space than the other galleys did in the aircraft, thus making the FAs and the fixed objects, which were substitute for handholds, slightly far apart.</p>
