AI2012-4

**AIRCRAFT SERIOUS INCIDENT
INVESTIGATION REPORT**

**EVERGREEN INTERNATIONAL AIRLINES, INC.
N 4 8 2 E V**

**EVERGREEN INTERNATIONAL AIRLINES, INC.
BOEING 747-200 (CONVERTED FREIGHTER MODEL), N482EV
ABOUT 4 NM SOUTHWEST OF
CHUBU CENTRAIR INTERNATIONAL AIRPORT, JAPAN
AROUND 06:03 JST, NOVEMBER 28, 2010**

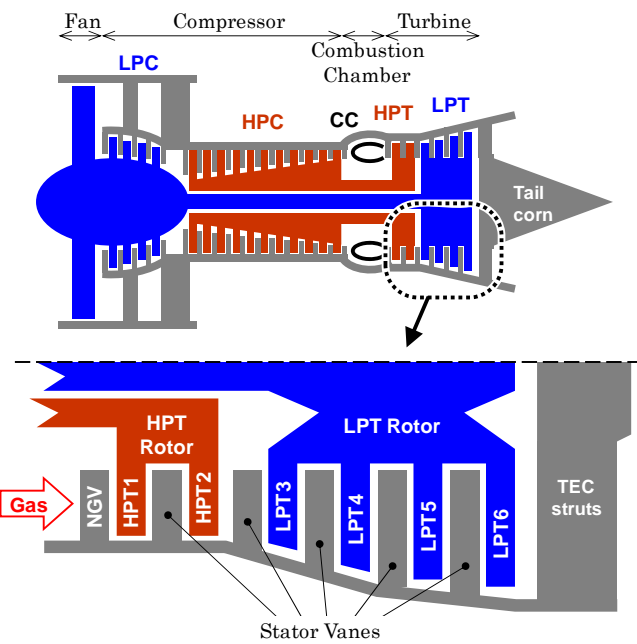
Conceptual Diagram of the No.2 Engine

As described in 2.3.2, it is possible that the LPT3 blades involved were fractured and their fragments damaged the downstream components in each LPT stage.

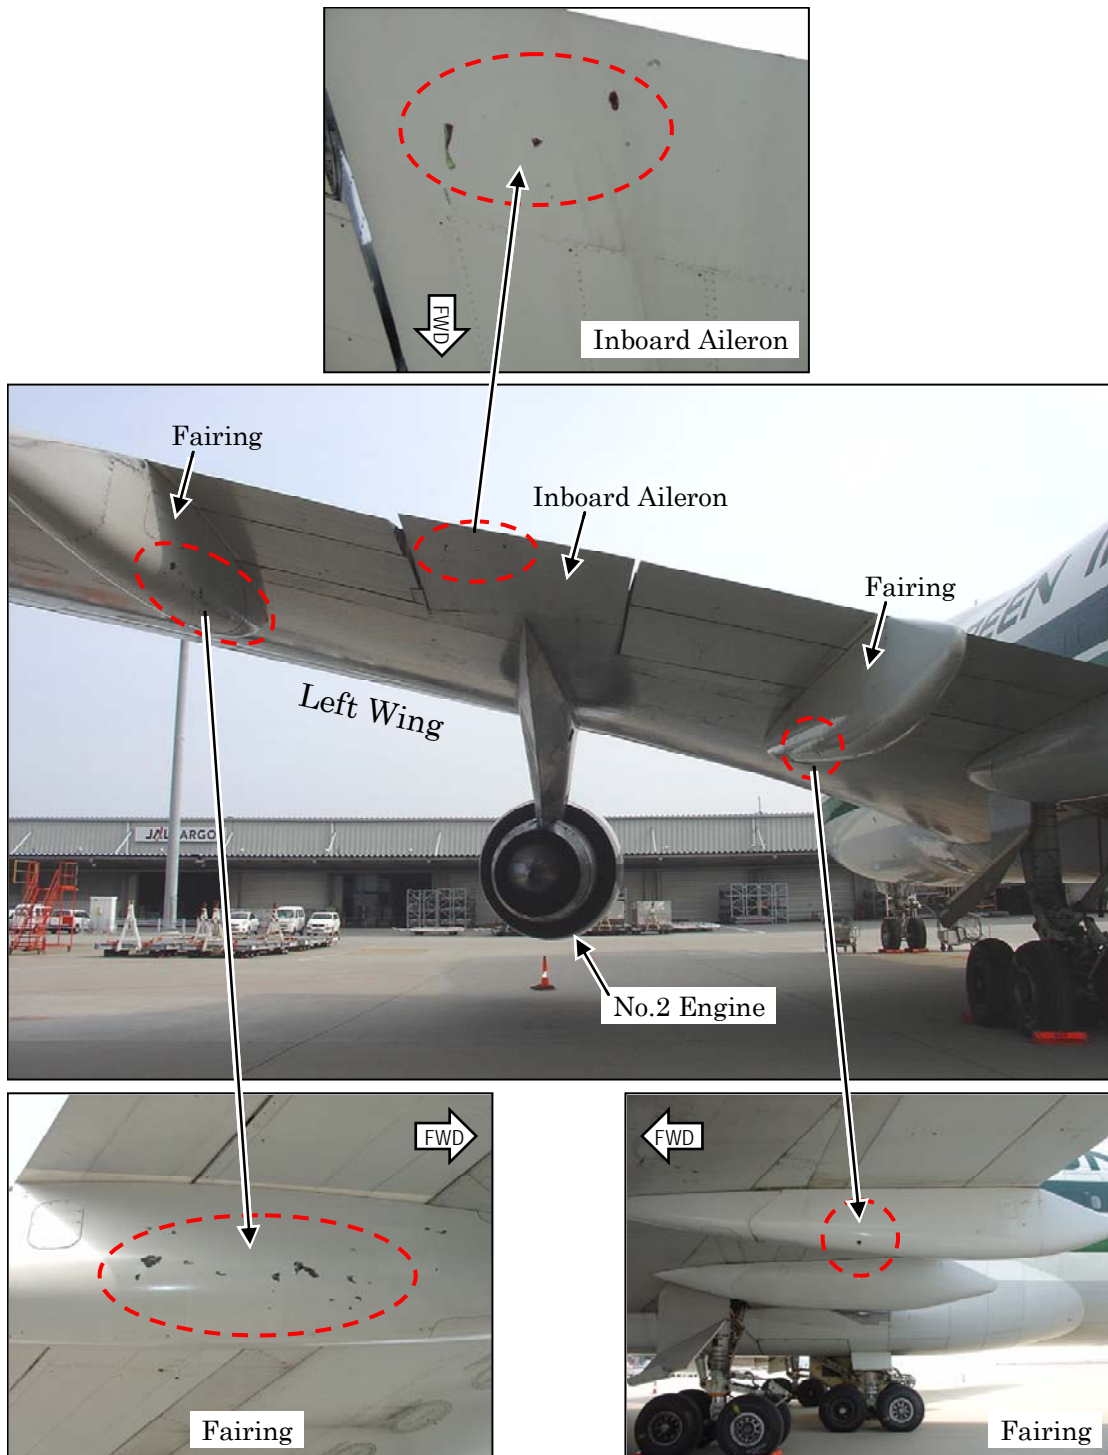
Photo 3 Damage to the Aircraft

The inside of the No.2 engine had extensive damage. The fairings of the flap driving system (hereinafter referred to as “the Fairings”) and the inboard aileron had small traces of collision.

It is highly probable that the small traces of collision found on the fairings and the inboard aileron, as described in 2.3.1, were created when the expelled fragments of LPT section hit them.

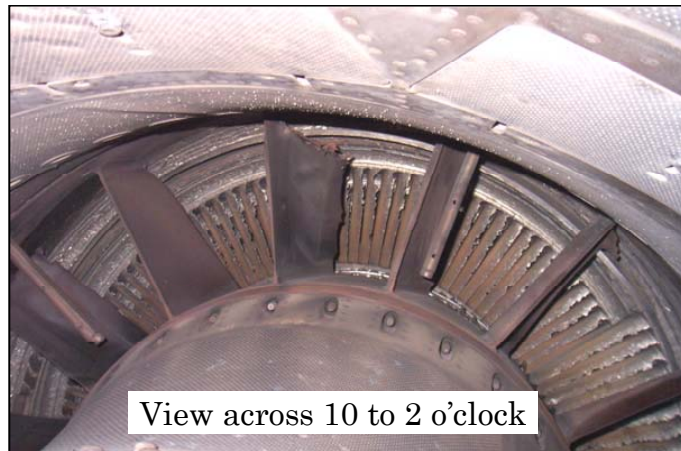
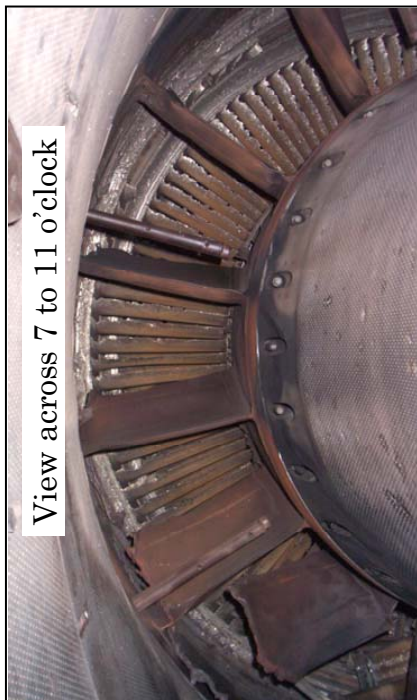
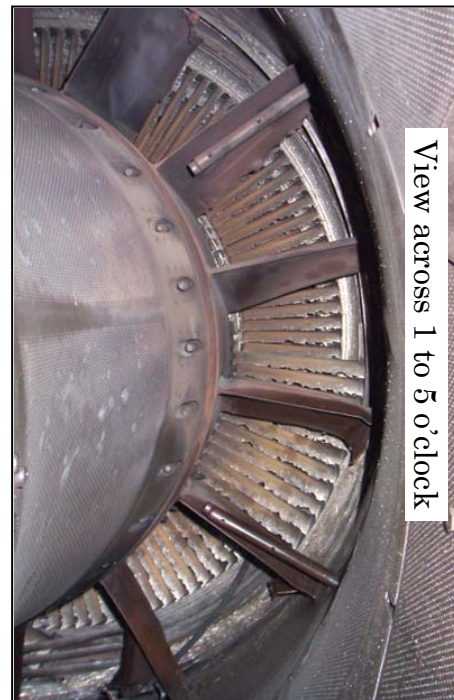
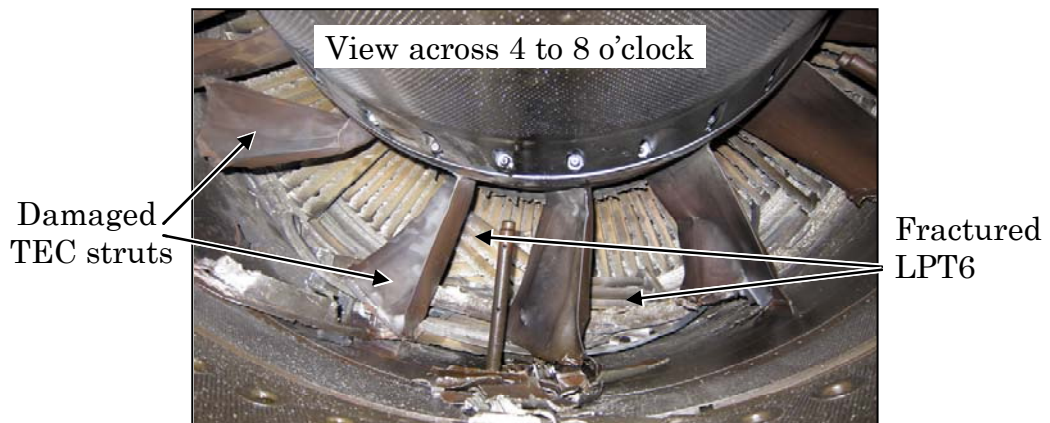
Photo 4 Damage viewed from Engine Exhaust

(4) In the four-stage low pressure turbine (LPT) section, the stator vanes and the rotor blades had severe damage as their stages go rearward.

The 1st stage LPT rotor blades (hereinafter referred to as “the LPT3 Blades”) and the trailing edges of the stator vanes in front of the LPT3 blades as well as the tip of the exhaust gas temperature (EGT) probe at 12 o’clock*1 exhibited severe damage.

All the leading edges of stator vanes in front of LPT4 blades were damaged. LPT5 blades were fractured and stator vanes had trailing edge damage.

All the LPT6 blades were fractured and the stator vanes were broken.

The turbine exhaust case (hereinafter referred to as “the TEC”) struts were partially fractured and damaged.

It is possible that the trailing edges of the stator vanes just in front of and behind LPT3 blades and the tip of the EGT probe were damaged when the fragments of the fractured LPT3 blades hit them. It is probable that LPT4 to LPT6 blades and the TEC struts as well as the tail cone were damaged as a secondary effect when the fragments of the fractured LPT3 blades or those of the LPTs downstream spread to other areas.

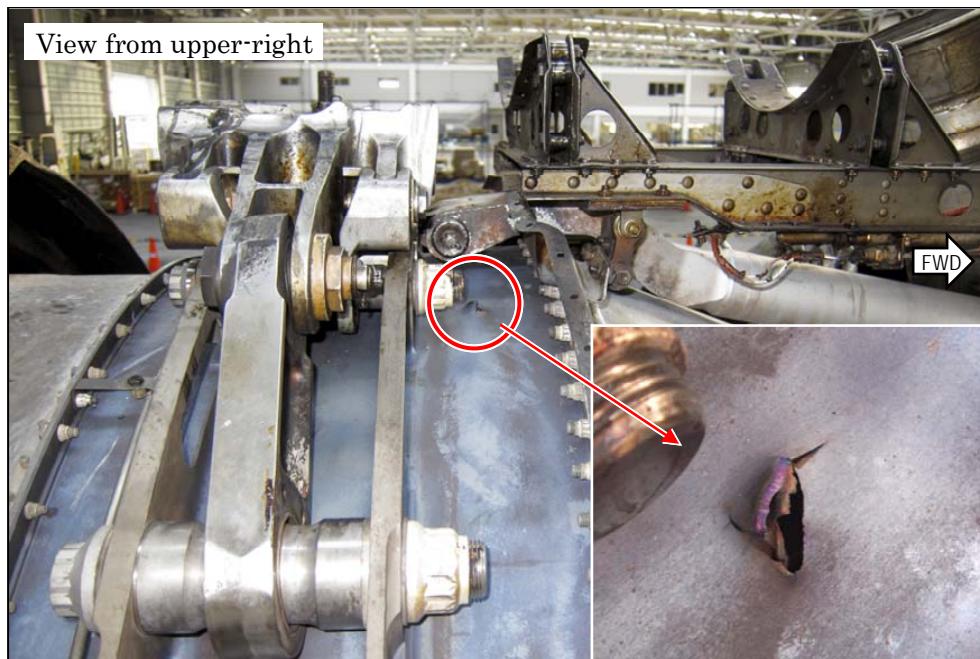
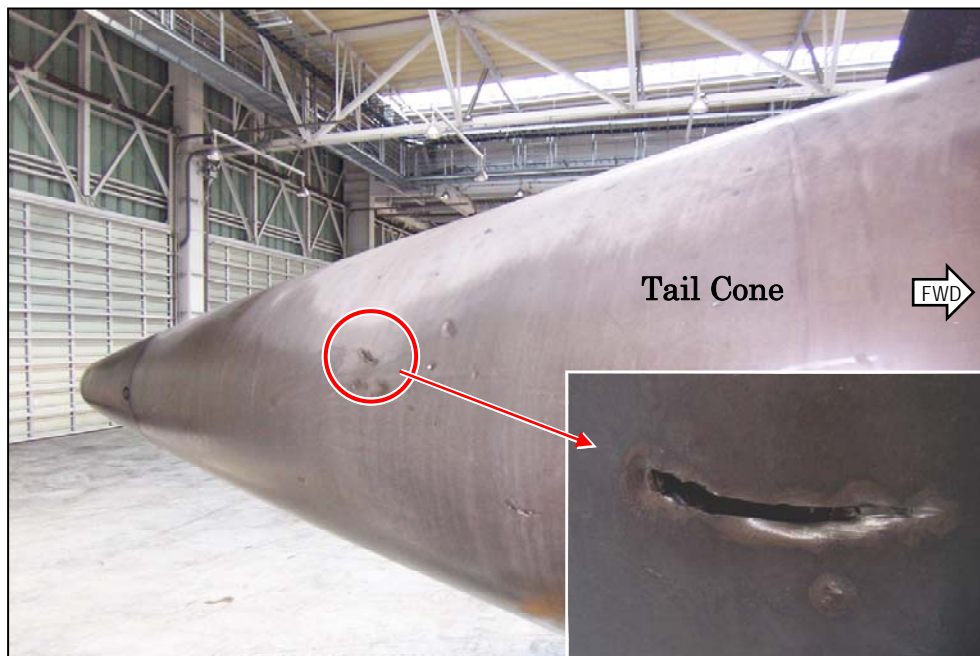
Photo 5 Damage to Engine Case and Tail Cone

(6) About 1 cm-long rapture was found in engine case at one o’clock. The tail cone had traces of collision.
