**AIRCRAFT ACCIDENT  
INVESTIGATION REPORT**

**PRIVATELY OWNED  
N 7 0 2 A V**

## CRASH DUE TO LOSS OF CONTROL DURING FLIGHT PRIVATELY OWNED SOCATA TBM700, N702AV IN YAMAZOE VILLAGE, YAMABE-GUN, NARA PREFECTURE AT AROUND 12:15 JST, AUGUST 14, 2017

June 14, 2019

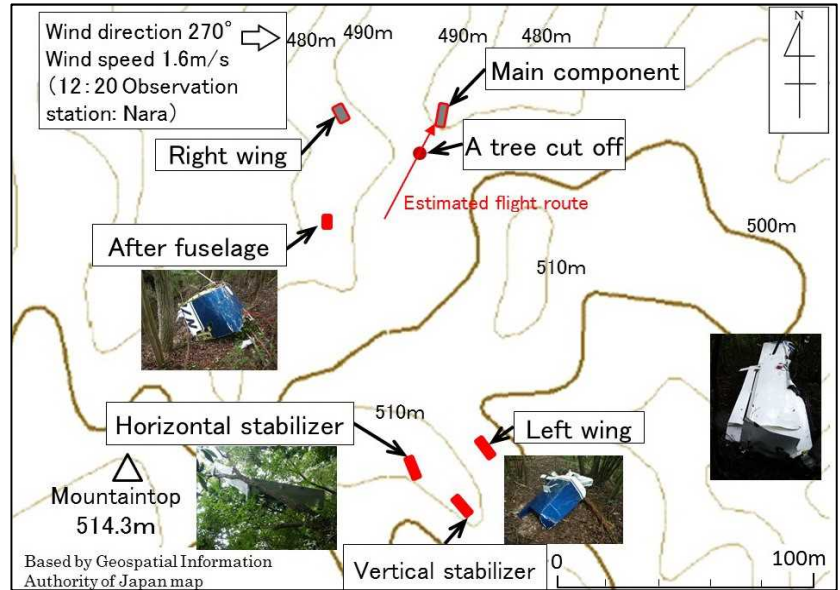
Figure 7: condition of the Aircraft scattering

components of the Aircraft (front part of cabin, engine part and propeller) were found being crashed into the bottom of the valley with its nose facing north-northeast in upside down, and were severely burned. The trees on the south-southwest side of the main components were cut down halfway, and the elevation angle of the cut part measured from the position of the propeller was at about 60°.

The broken fuselage aft was found on a slope over the ridge about 60 m away in a straight distance on the southwest side of the main components. With its front part was grounded, there was no trace of fire and the electrical wirings were extended toward the main components. The antenna of the emergency locator transmitter (ELT) installed in the fuselage aft had fallen off.

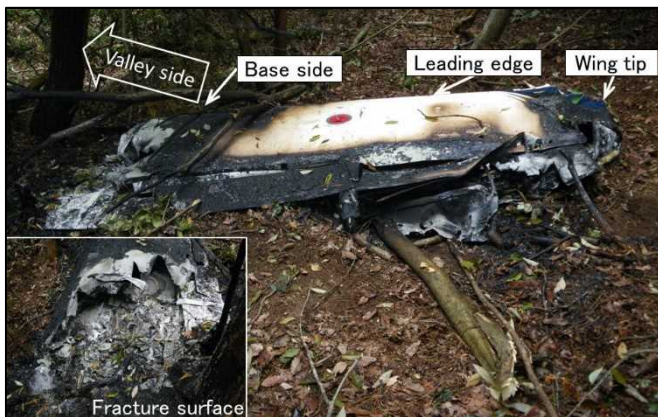
Figure 10: right wing

The right wing was broken halfway and found lying with its top surface facing up, on the ground of a slope over the ridge about 40 m away in a straight distance on the west side of the main components. The right wing was entirely burned, particularly the fracture surface was burned at high temperature, and therefore, the metal was melted and its color changed to white.

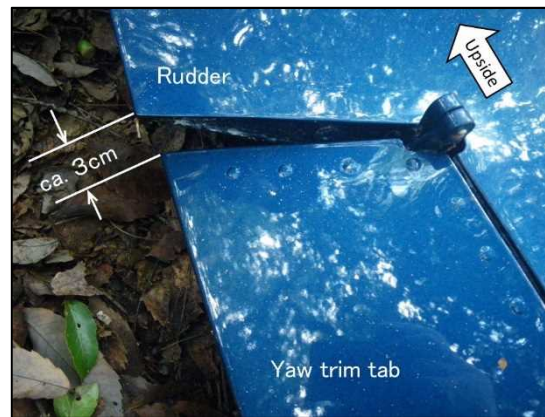
Figure 11: opening in yaw trim tab

The yaw trim tab on the trailing edge of the rudder was open 3 cm to the left side (the direction in which the right rudder is applied) from the neutral position.

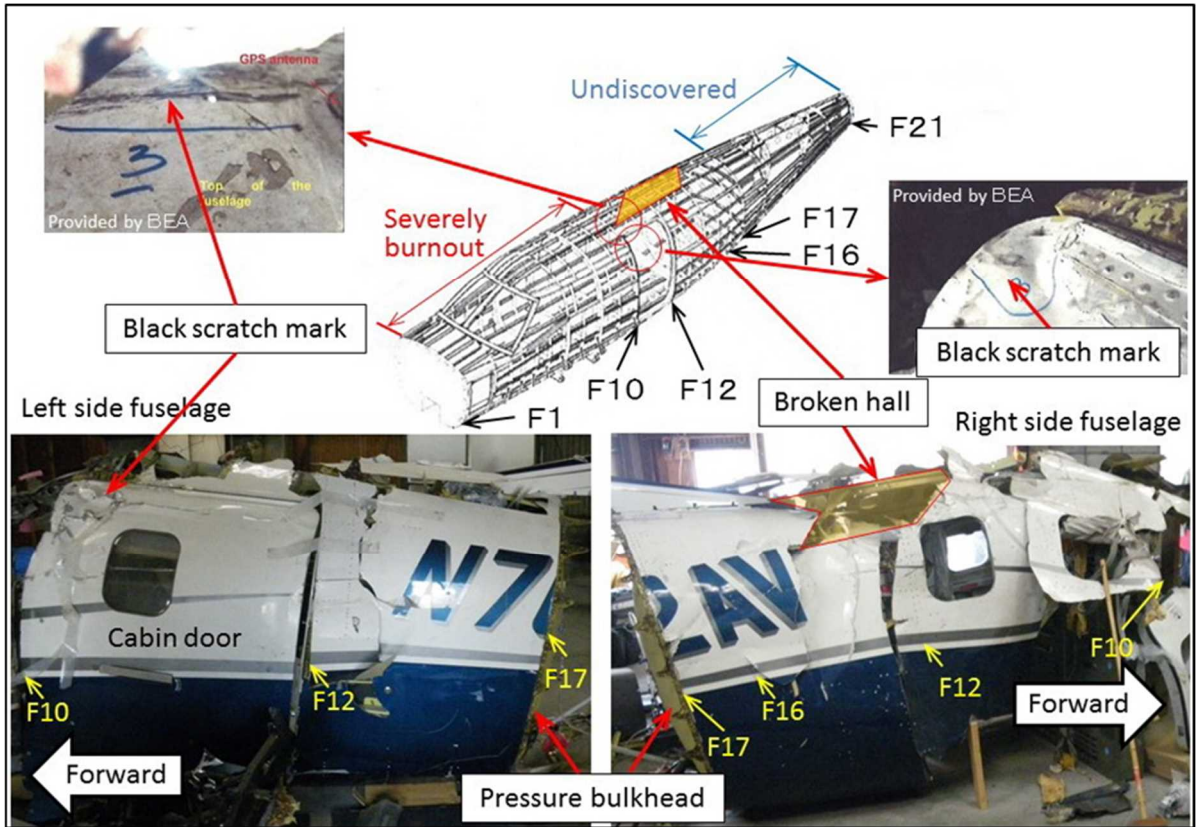
Figure 12: damage to the fuselage

The fuselage was broken at the positions of frame (F) 10, from F12 to F16, and F17.

The fuselage was severely burned from F1 to F10. The fuselage part from F1 to F10 was not found (stabilizer was recovered).

There were black scratch marks on the upper part of the fuselage and the upper front of the cabin door. The right part of the ceiling from F10 to F15 was broken due to an impact from above.

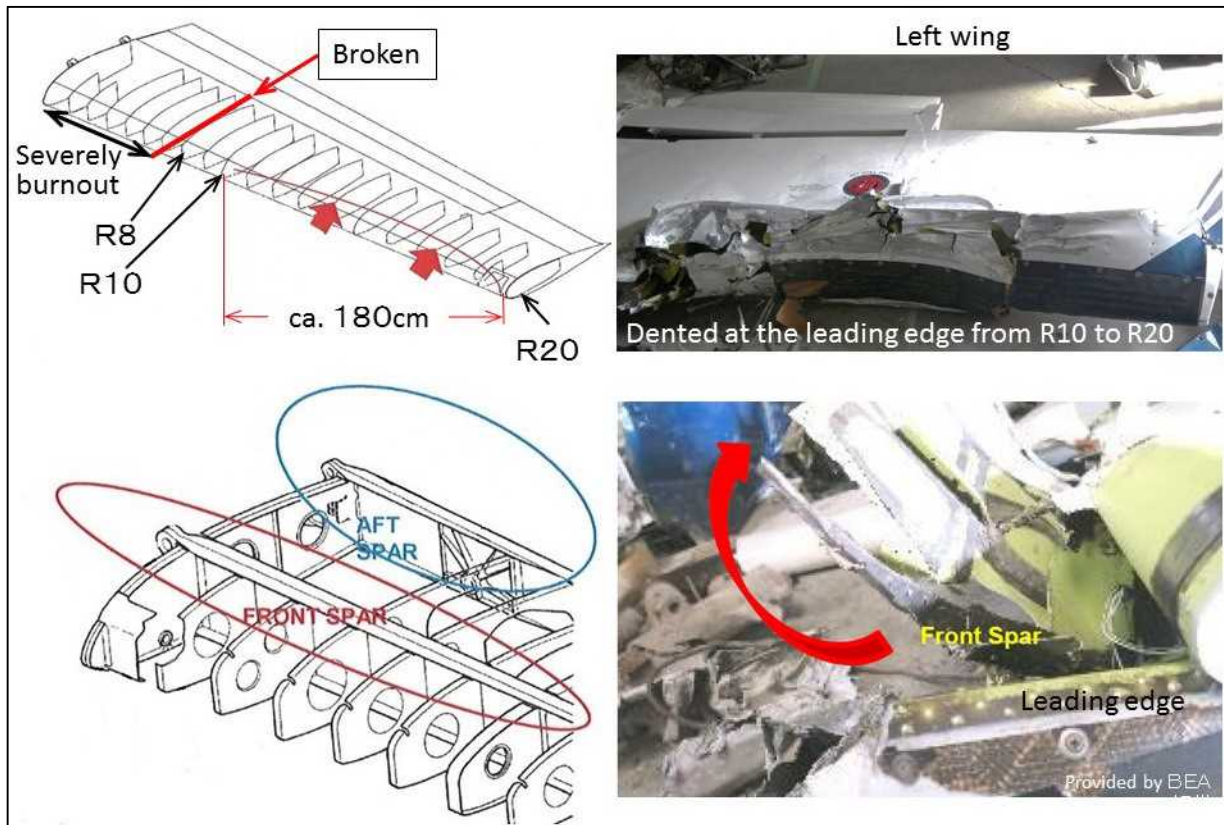
Figure 13: damage to the left wing

The left wing was broken near the rib (R) 8, and the spar was bent upward at an angle of 45° or more and broken. The wing root side from R8 was severely burned along with the fuselage, but there was no trace of fire on the wing tip side from R8. About 180 cm from R10 to R20 of the leading edge equipped with black rubber deicing boots was damaged and dented by the impact from the front. As the aileron had not been found, it was impossible to identify the position of the aileron trim tubs mounted only on the left wing. The spoilers in unison with aileron did not sustain any damage and were retracted. The flaps were detached from the main wing and cut into three parts, but there was no trace of fire. The jackscrew used for moving the flaps was in the “up” position.

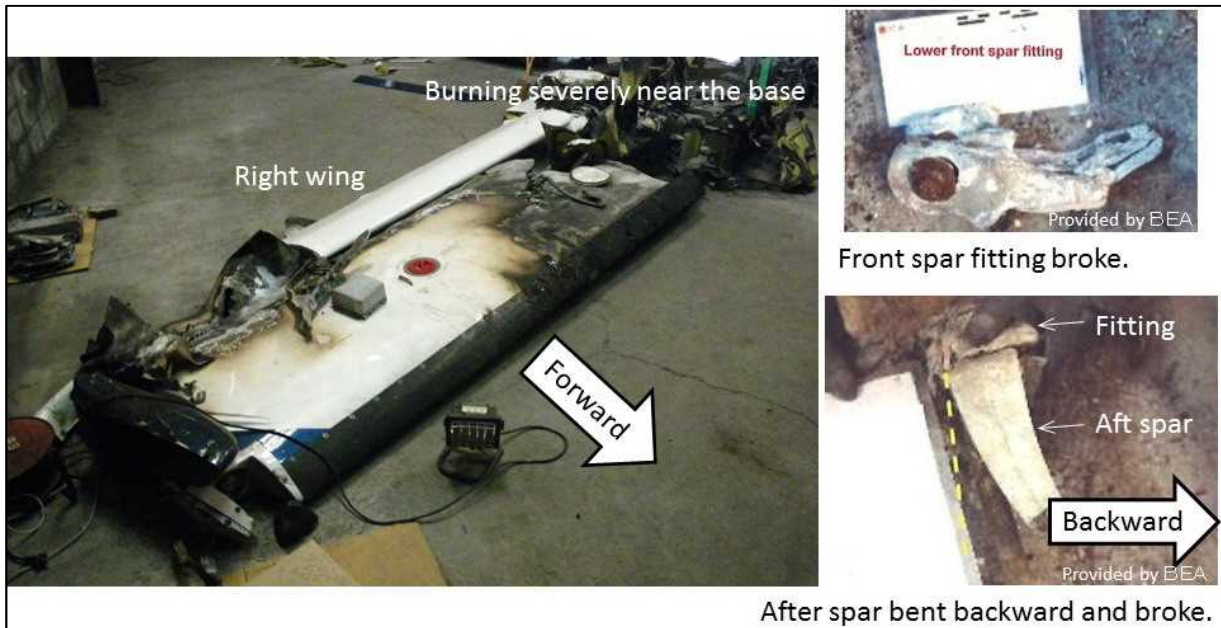
Figure 14: damage to the right wing.

The right wing was broken around R8 and the wing tip side was entirely burned, especially around the fractured surface was severely burned. The wing root side from R8 was not found. As for the fitting part between the front spar and the fuselage, the part for the front spar was broken, the aft spar was bent backward and broken around the root part. The ailerons and spoilers were burned down. The flaps were detached from the main wing and cut into three parts, and there was no trace of fire except the wing root side found around the fuselage. The jackscrew used for moving the flaps was in the “up” position.

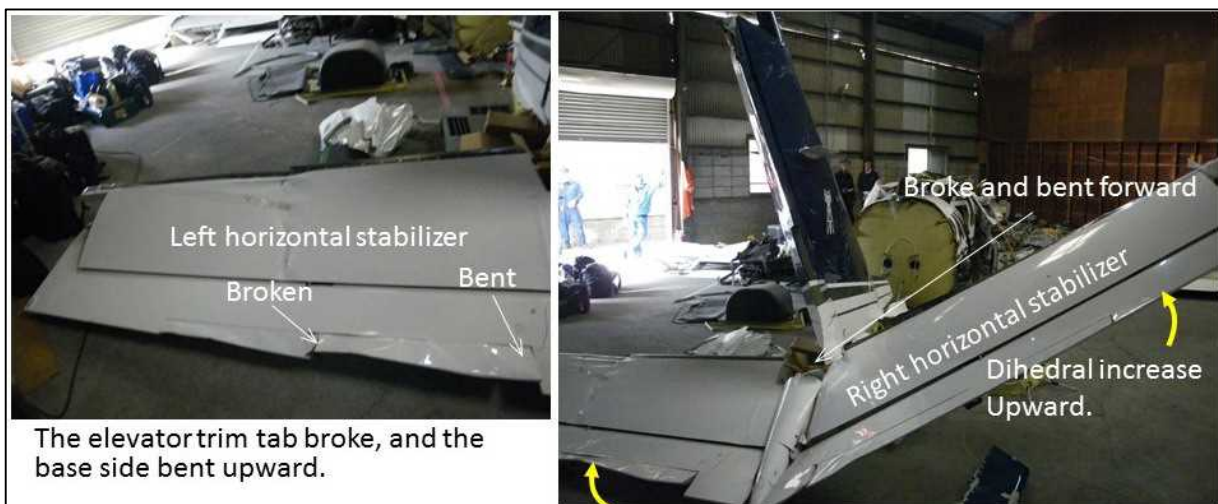
Figure 15: damage to the horizontal stabilizer

The fitting part between the fuselage of frame 21 and the horizontal stabilizer was broken and bent forward. The front spar of the right horizontal stabilizer was bent upward and the dihedral angle increased upward. The left elevator trim tab was broken around at the center, and its fuselage side was bent upward, but the positions of both elevator trim tabs were close to the neutral. The control systems for the elevators were remained in the horizontal stabilizer.

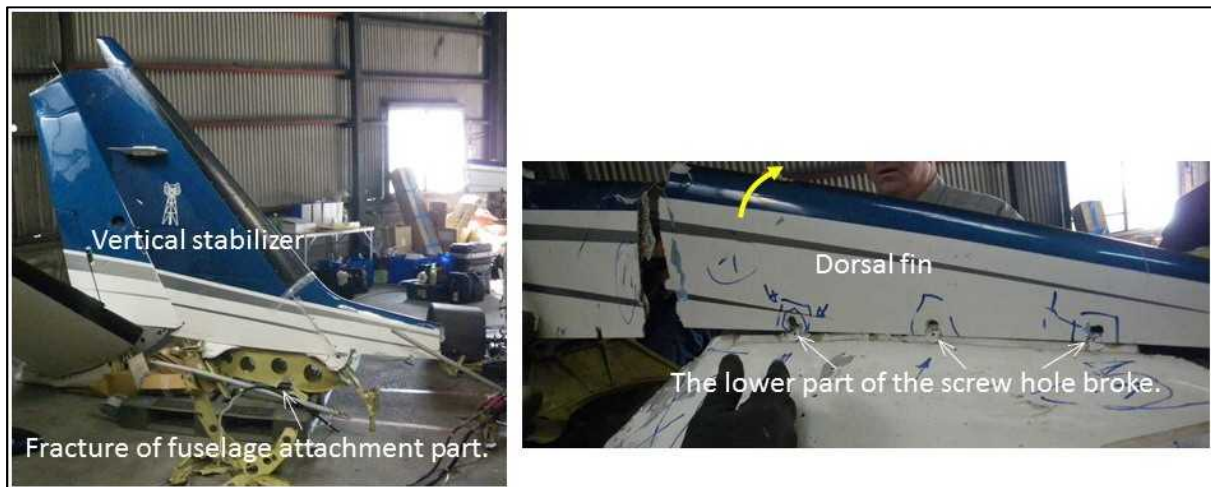
Figure 16: damage to the vertical stabilizer

As the dorsal fin and all screw holes for connecting the fuselage in the lower part of the vertical stabilizer were broken, and indicating that the vertical stabilizer was

falling-off upwards. The vertical stabilizer was fractured from the fuselage attachment part of the fuselage structure.

For the yaw trim actuator, the manufacturer performed the operation test, but found no abnormality. The yaw trim actuator was set at the left position (the difference between the trailing edges of the yaw trim tub and the one of the rudder was 30 mm). According to the design of the manufacturer, the value was close to the maximum movable width (37.5 mm). The control systems for the rudder were remained in the vertical stabilizer.

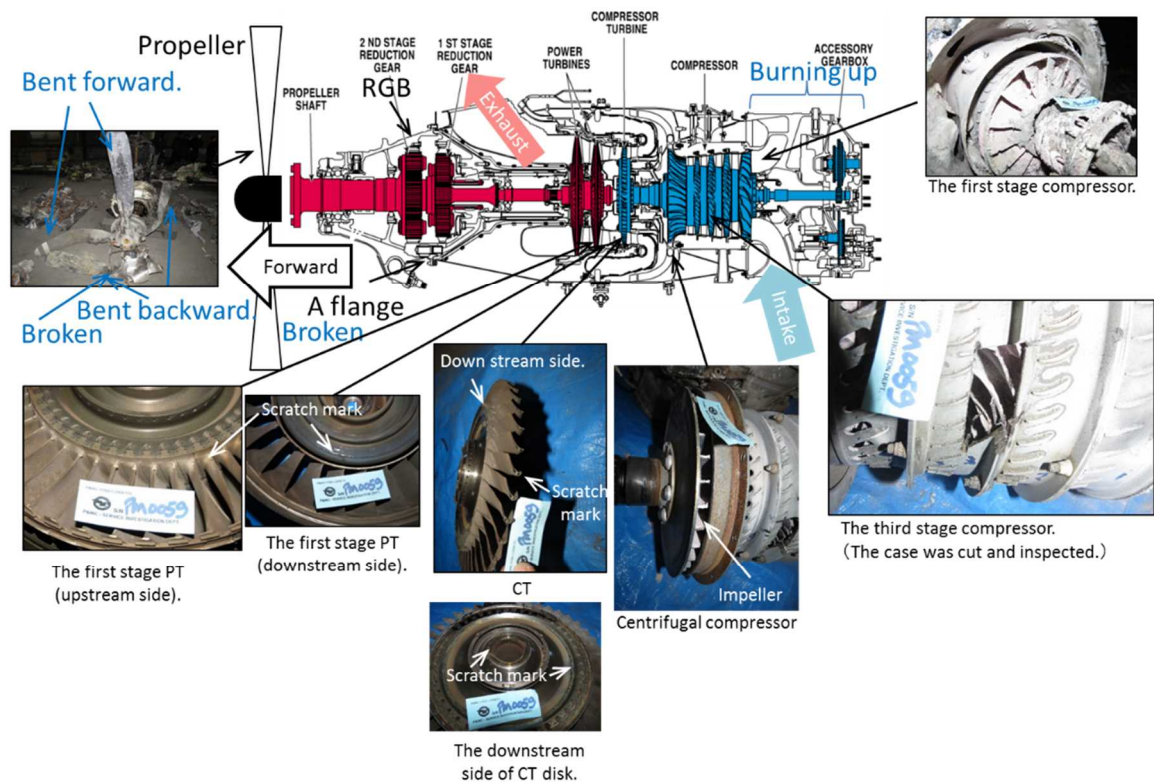
Figure 17: damage to propellers and engine

The reduction gear box (RGB) and propellers were broken at A flange and detached from the engine body. One of the four propeller blades was broken near the hub and two of them were bent forward, and other two blades (including the broken one) were bent backward. Each propeller blade did not show any traces that would clash while rotating. And each propeller blade was shown to have an adequate pitch.

The impellers (of the centrifugal compressor) had slight scratch marks at the gas outlet. There was slight scratch marks on the tip of the CT blade. The downstream side of the CT disc showed slight circular scratch marks in the blade fixed region as those on the central hub. All of the blades of the first stage PT were found in a certain position, and there were scratch marks caused by contact with the first stage PT vane in the leading edge of the blades. These scratch marks indicate that rotors at both of the CT (the blue part in Figure 17) side and PT side (the red part in Figure 17) were rotating at low speed when the impact was applied to the engine.

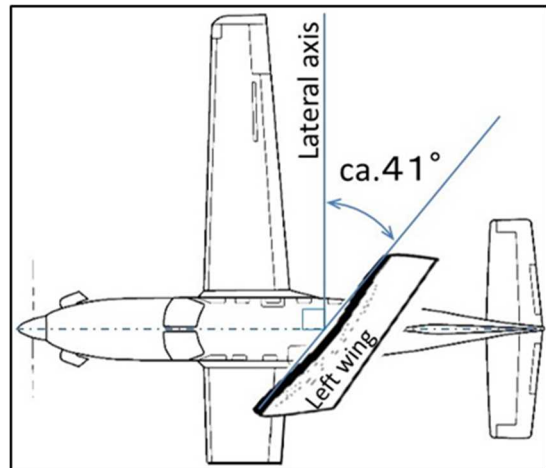
Figure 24: situation of the collision between the fuselage and left wing

scratch marks on the upper part of the fuselage and the upper front of the cabin door, that the left wing leading edge equipped with black rubber deicing boots was damaged and dented by the impact from the front, and that the spar was bent upward at an angle of 45° or more and broken, it is highly probable that the left wing was bent upward and broken near the R8, then the leading edge impacted the upper part of the fuselage. Judging from the facts that the fuselage was 136 cm in width, and the damaged and dented part of the left wing leading edge was about 180 cm in length, it is highly probable that the left wing leading edge impacted the upper part of fuselage at an angle of 41° backward to the lateral axis ( $\cos^{-1}(136/180) \doteq 41^\circ$ ).

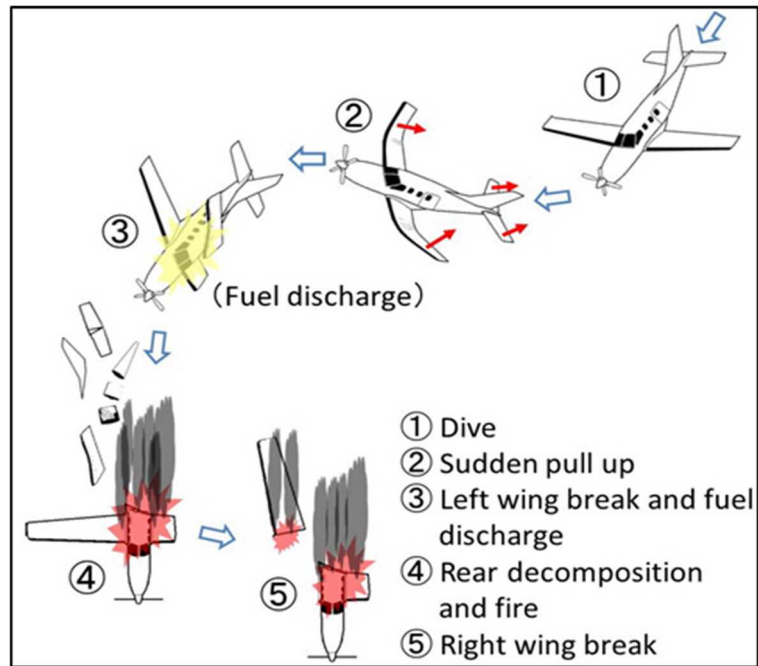
Figure 25: conditions of crash and fire

As described in 3.6, it is probable that a fire broke out after the left wing of the Aircraft was broken upward and impacted the upper part of the fuselage; therefore, it is somewhat likely that when the left wing was broken and impacted the upper part of the fuselage, the fuel in the fuel tank loaded inside of the left wing was discharged into the main components, and ignited. Regarding the reason for the ignition of the fuel, it is somewhat

likely that sparks and engine emission, which were generated when the electric wiring was cut, might trigger the ignition, however, it was impossible to identify the causes due to heavy damage to the airframe.
