**AIRCRAFT SERIOUS INCIDENT  
INVESTIGATION REPORT**

**POLAR AIR CARGO WORLDWIDE, INC.  
N 8 5 2 G T**

CASE EQUIVALENT TO RUNWAY OVERRUN  
(LIFT-OFF IN THE VICINITY OF  
THE END OF DEPARTURE RUNWAY)  
ON RUNWAY 16L AT NARITA INTERNATIONAL AIRPORT  
AT 22:41 JST, JULY 15, 2017

POLAR AIR CARGO WORLDWIDE, INC.  
BOEING 747-8F, N852GT

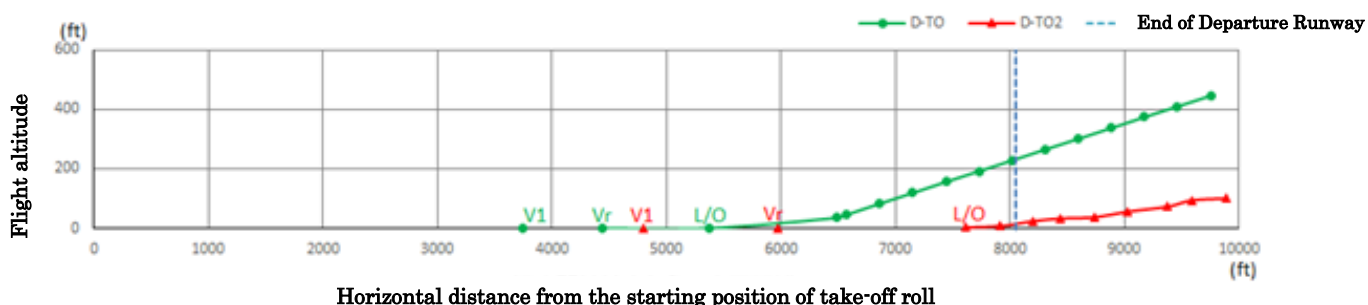
Figure 2 Take-off Path

Figure 2 shows the take-off path of the Aircraft according to the QAR records (red line) and the calculations by using D-TO (38) (97.2 % N1) (green line). L/O indicates the lift-off position of the Aircraft.

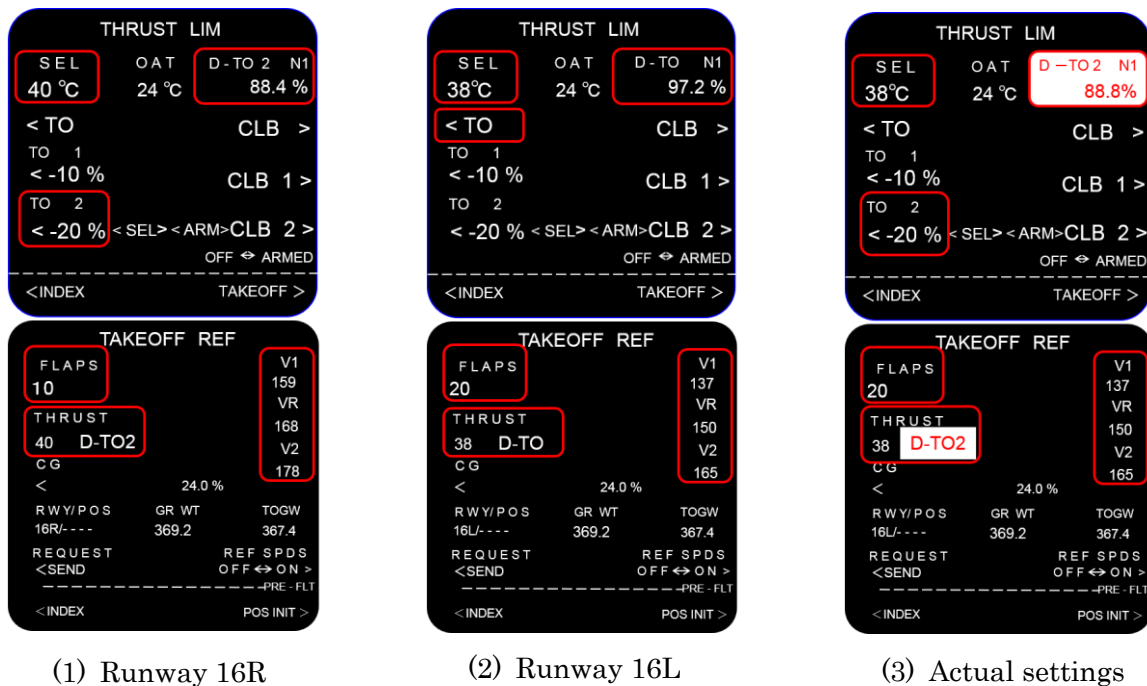
Figure 6 FMC settings screen (Image)

It is highly probable that the FMC of the Aircraft was set before departure by assuming a take-off from runway 16R. (See Figure 6 (1).)

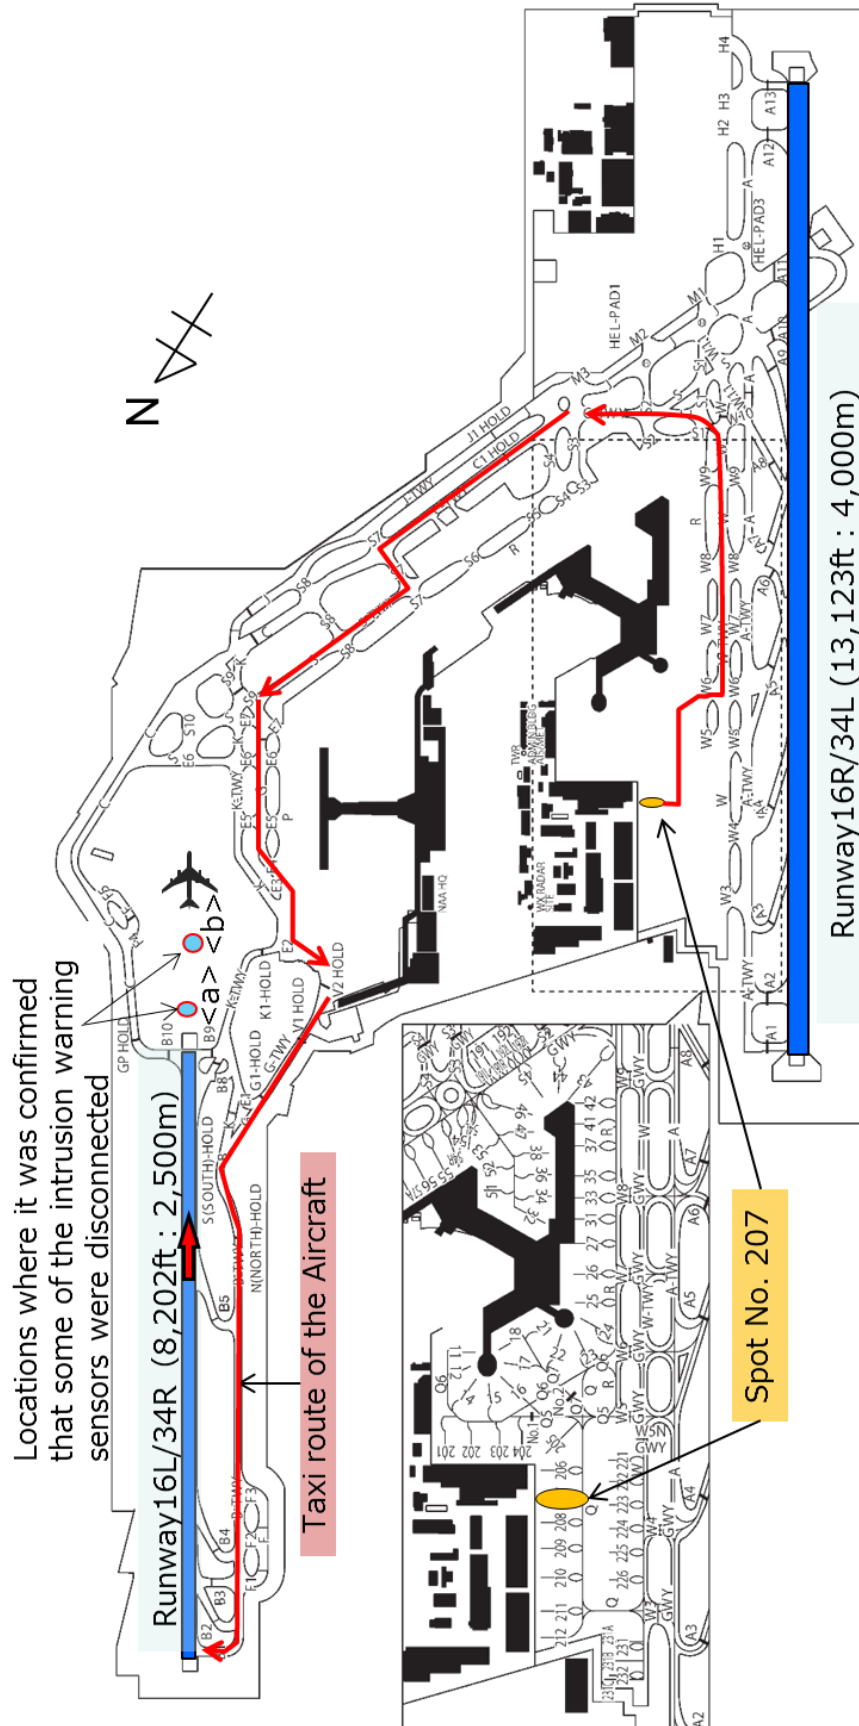
Appended Figure 1 Narita International Airport and Estimated Taxi Route of the Aircraft

At around 22:41:08 on the day when this serious incident occurred, the security camera the NAA installed around the Airport recorded the images of the Aircraft flying over the area in the vicinity of Appended Figure 1 <a>. After that, it was confirmed that some of the intrusion warning sensors were disconnected in the vicinity of both <a> (about 150 m south of the end of departure runway) and <b> (about 450 m south of the end of departure runway) in Appended Figure 1.
