AI2018-7

**AIRCRAFT SERIOUS INCIDENT
INVESTIGATION REPORT**

PARTS DROPPED FROM AIRCRAFT COLLIDED WITH A VEHICLE ON THE GROUND AT OSAKA CITY, OSAKA, JAPAN AT AROUND 10:57 JST, SEPTEMBER 23, 2017

KLM ROYAL DUTCH AIRLINES BOEING 777-200, PH-BQC

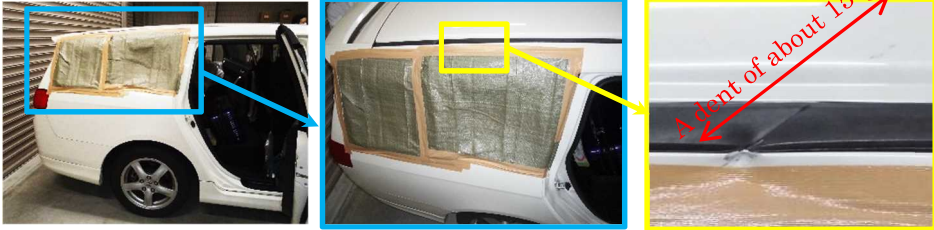
2.2 Injuries to Persons	None
2.3 Damage to Aircraft and Vehicle	<p>(1) Extent of Damage: Slightly damaged (Appendix Figure 1-2)</p> <ol style="list-style-type: none"> 1) Panel 198AR detached and missing from aircraft. 2) The bracket that fixes Panel 198AR in place was cracked. 3) The bolt and screw holes of Panel 198AR were damaged. 4) The mounting screws were broken. <p>(2) Damage of the vehicle</p> <ol style="list-style-type: none"> 1) The roof was dented. 2) The right-side rear window was broken. <div style="text-align: center;">

<p>Photo 1 Damage of the vehicle</p> </div>

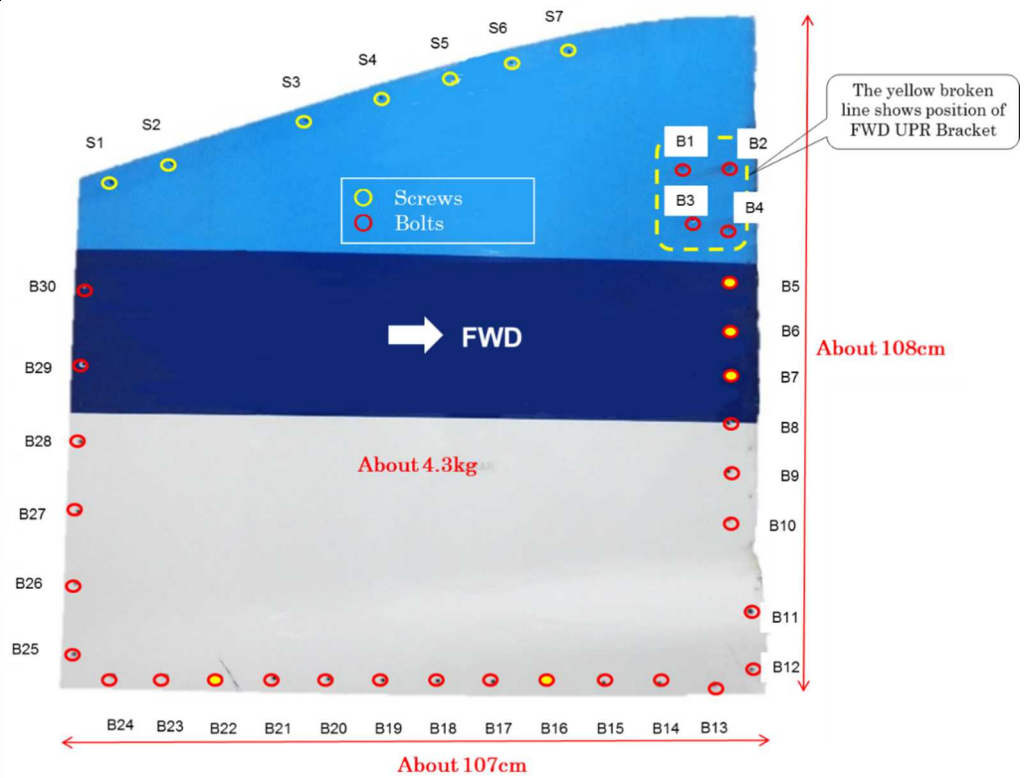
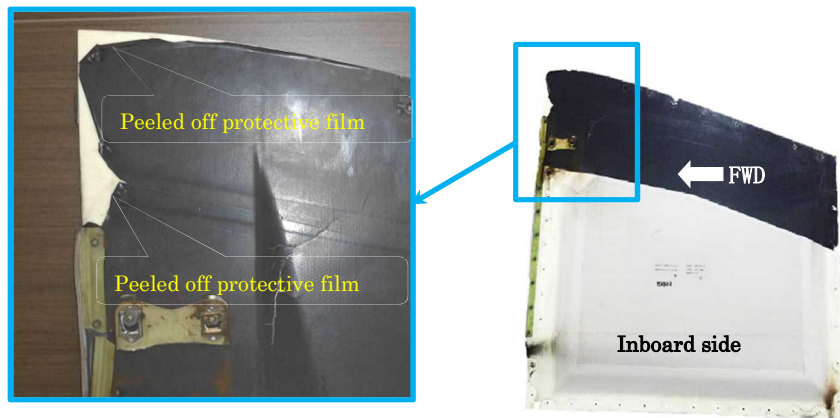
Photo 2 Dropped Panel

The Panel is secured to the Aircraft with seven screws (S1 to S7 in Photo 2) and thirty bolts (B1 to B30 in Photo 2).

Limited space between the fuselage and the panel's forward upper corner (between S7 and B5 in Photo 2) precludes attachment of the panel by the use of fasteners in this area. Instead the panel is attached to a forward upper bracket (hereinafter referred to as "the Bracket"). This bracket provides support for the forward upper corner and allows the panel to be mounted under certain preload, so that the panel smoothly lines up with the surrounding panels.

The aircraft examination revealed that all of the seven screws remained on the aircraft side. Of them, the heads of two (S6 and S7 in Photo 2) were broken.

Regarding the bolts, 26 bolts remained on the aircraft side and three bolts (B1, B2, and B4 in Photo 2) on the Panel side remained. One bolt (B3 of Photo 2) was not there.

Almost all of the holes for securing the Panel were enlarged greatly and bore marks where the bolt and screw heads passed through. (Appendix Figures 1 and 2)

A protective film made of Teflon was affixed to the inboard side of the Panel; the film located in the forward upper corner had peeled off. (Photo 2)

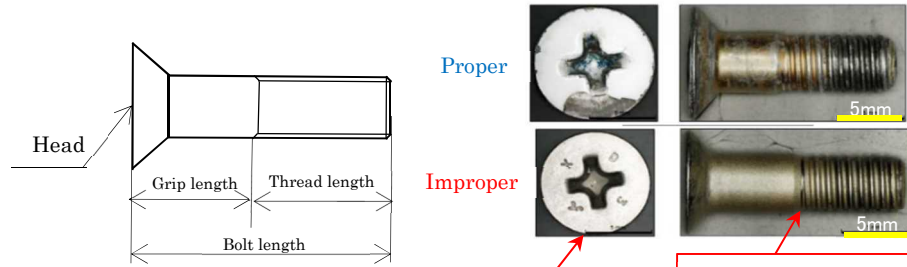
Photo 3 Proper Bolt (Top) and Improper Bolt (Bottom)

Actual measurements of the bolts that attached to the Aircraft were taken. As result, it was found that the Improper Bolt (BACB30XD3K5) has a longer grip length, shorter thread length, and smaller outside diameter of head than the Proper Bolt (BACB30LH3-4). (Figure 3)

It was found that if the Panel is attached using the Improper Bolts, the bolts torqued at the end of thread because the grip length is longer and creates a situation in which the Panel is not fully secured, and that a maximum 0.7 mm gap can be formed between the Panel and the Bracket. The Improper Bolts were not used in the positions of the damaged forward upper Bracket; however, three were used in the positions just below the upper forward Bracket location. (Figure 4) Marks remained where the bolt was torqued at the end of thread of the Improper Bolts. (Photo 3)

Depending on the Improper Bolts' specifications and installation place, the attachment of similar panels using the Improper Bolts can be a direct factor in the similar panel's departure. From the standpoint of preventing the occurrence of similar incidents, it is desirable that the Operator reviews its maintenance procedures (Compliance with the Maintenance Manual) and parts management and takes preventive measures concerning use of Improper Bolts so that the installation of Improper Bolts in aircraft does not occur.

- (2) The Operator completed replacing the Brackets in aircraft of the same type of aircraft with the enhanced Brackets by December 2017.
- (3) The Operator checked the installation conditions of similar panels and confirmed that the Improper Bolts are not used in any of its aircraft.
- (4) The Operator improved fastener cabinets so that Improper Bolts are not mixed in or erroneously taken.

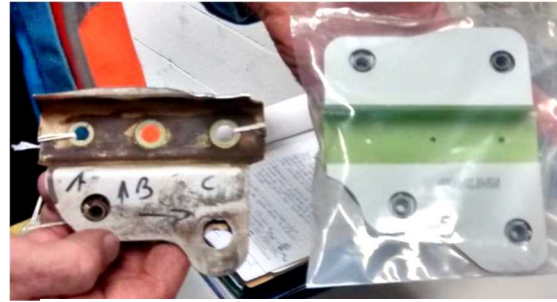
Photo4 Comparison of Brackets

Broken bracket Enhanced design bracket

numbers between 1 and 699. The enhanced Bracket has a part number of 149W5913-15/-16 or part number 149W5913-23/-24 and is installed in aircraft with line numbers of 700 or higher. The pre-enhancement Bracket is manufactured using a bending process from plate material with thickness of 1.6 mm and has dimension accuracy of ± 1.52 mm. On the other hand, the enhanced Bracket is manufactured using machine processing and is reinforced with increased thickness of 2.54 mm. It has dimension accuracy of ± 0.25 mm. (Photo 4)

The Aircraft's line number is 461, and its Brackets were the pre-enhancement Brackets that were installed when it was manufactured.

The Aircraft's Bracket was broken and its upper flanges remained in the Panel, and evidence of fatigue fracture was observed in the Bracket's fractured surface. (Appendix Figure 1)

Given that the enhanced Brackets have greater strength and higher dimension accuracy, it is probable that replacement with the enhanced Brackets is an effective means of preventing the departure of similar panels. Moreover, thus far, there have been no reports of damage to the Brackets or departure by similar panels on aircraft on which the enhanced Brackets were installed.

- (1) The Aircraft's manufacturer provided information to operators by issuing a service bulletin that instructed them to make replacements to the enhanced Brackets as a measure to prevent recurrence of panels departing from airplanes. (SB 777-53-0088 Issued March 8, 2018)

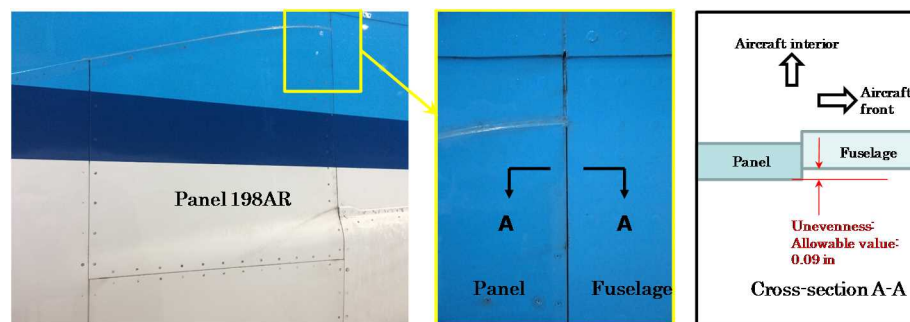
Figure 5 Location where Unevenness between the Panel and Fuselage was Confirmed

-200 Aircraft operator reported that the right aft wing-to-body fuselage panel departed the airplane during flight. Subsequent manufacturer review of other airplanes revealed that the panel on some -300 and -300ER airplanes had misfair, eliminating required panel preload. If the unevenness grows larger, air can flow to the panel's inboard side and result in damage to the fairing panel or Brackets caused by vibration and may also result in departure of the panel. Accordingly, check misfair between the aft wing-to-body fairing and the fuselage and confirm that it is within the specified value. If misfair less than or equal to 0.09 inches and no gap, apply sealant. If misfair is greater than 0.09 inches and/or with gap, replace the panel with a new one. This applies to -300 Aircraft and -300ER Aircraft with line numbers from 508 to 543. Aircraft after line number 543 were determined in production to have properly contoured fairing panel. (See Figure 5)

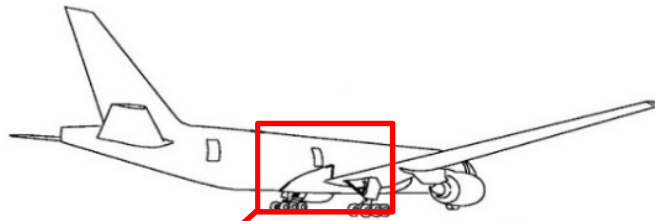
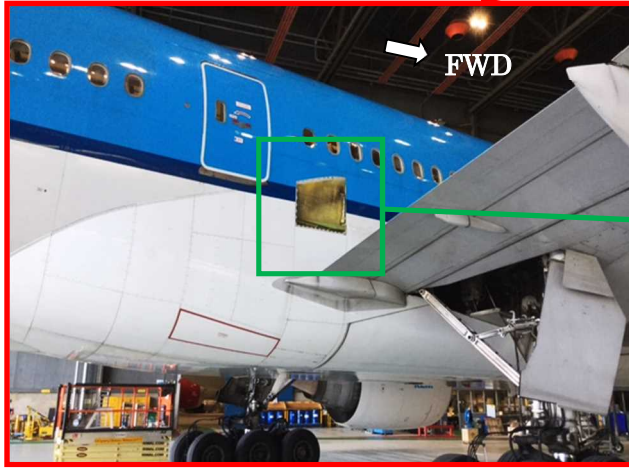
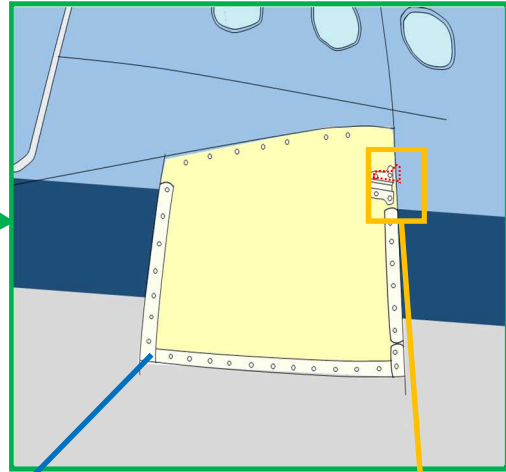
Appendix Figure 1 The Conditions of the Panel and Brackets

The part shown by the red line broke and remained on the panel side.

Enlarged bolt hole

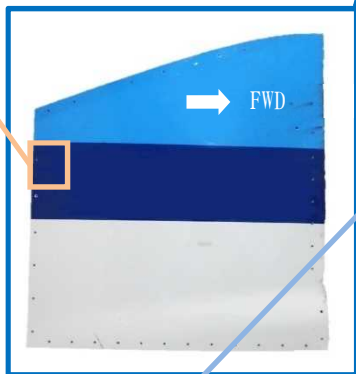
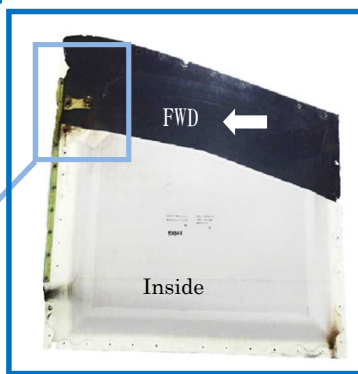
A bracket that broke and remained on the fuselage side

The part shown by the red line broke and remained on the panel side.

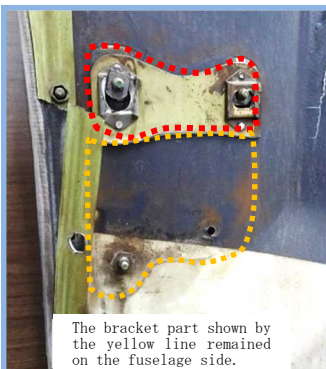
The bracket part shown by the yellow line remained on the fuselage side.

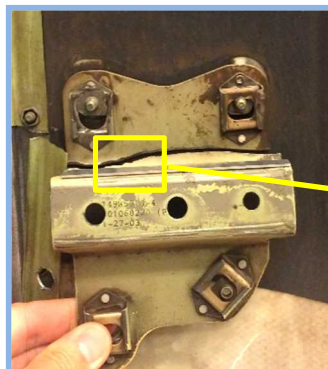
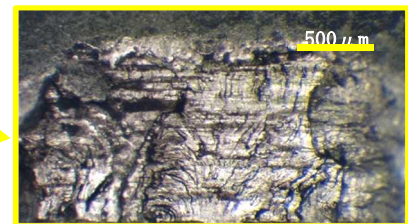
Given that marks caused by fatigue fracture were left on the broken Bracket's fractured surfaces, it is probable that load was placed on the Bracket and bolts by the air flowing inside the Panel that was in addition to the load caused by ordinary aerodynamic force from the Panel's exterior, and that repetition of this force to create repeated bending stress on the Bracket's flanges and led to fatigue fracture.

Evidence of fatigue fracture was observed when the broken brackets' fractured surfaces were enlarged.

The broken bracket was removed from the Aircraft and its fractured surface was matched with the bracket remaining on the panel.

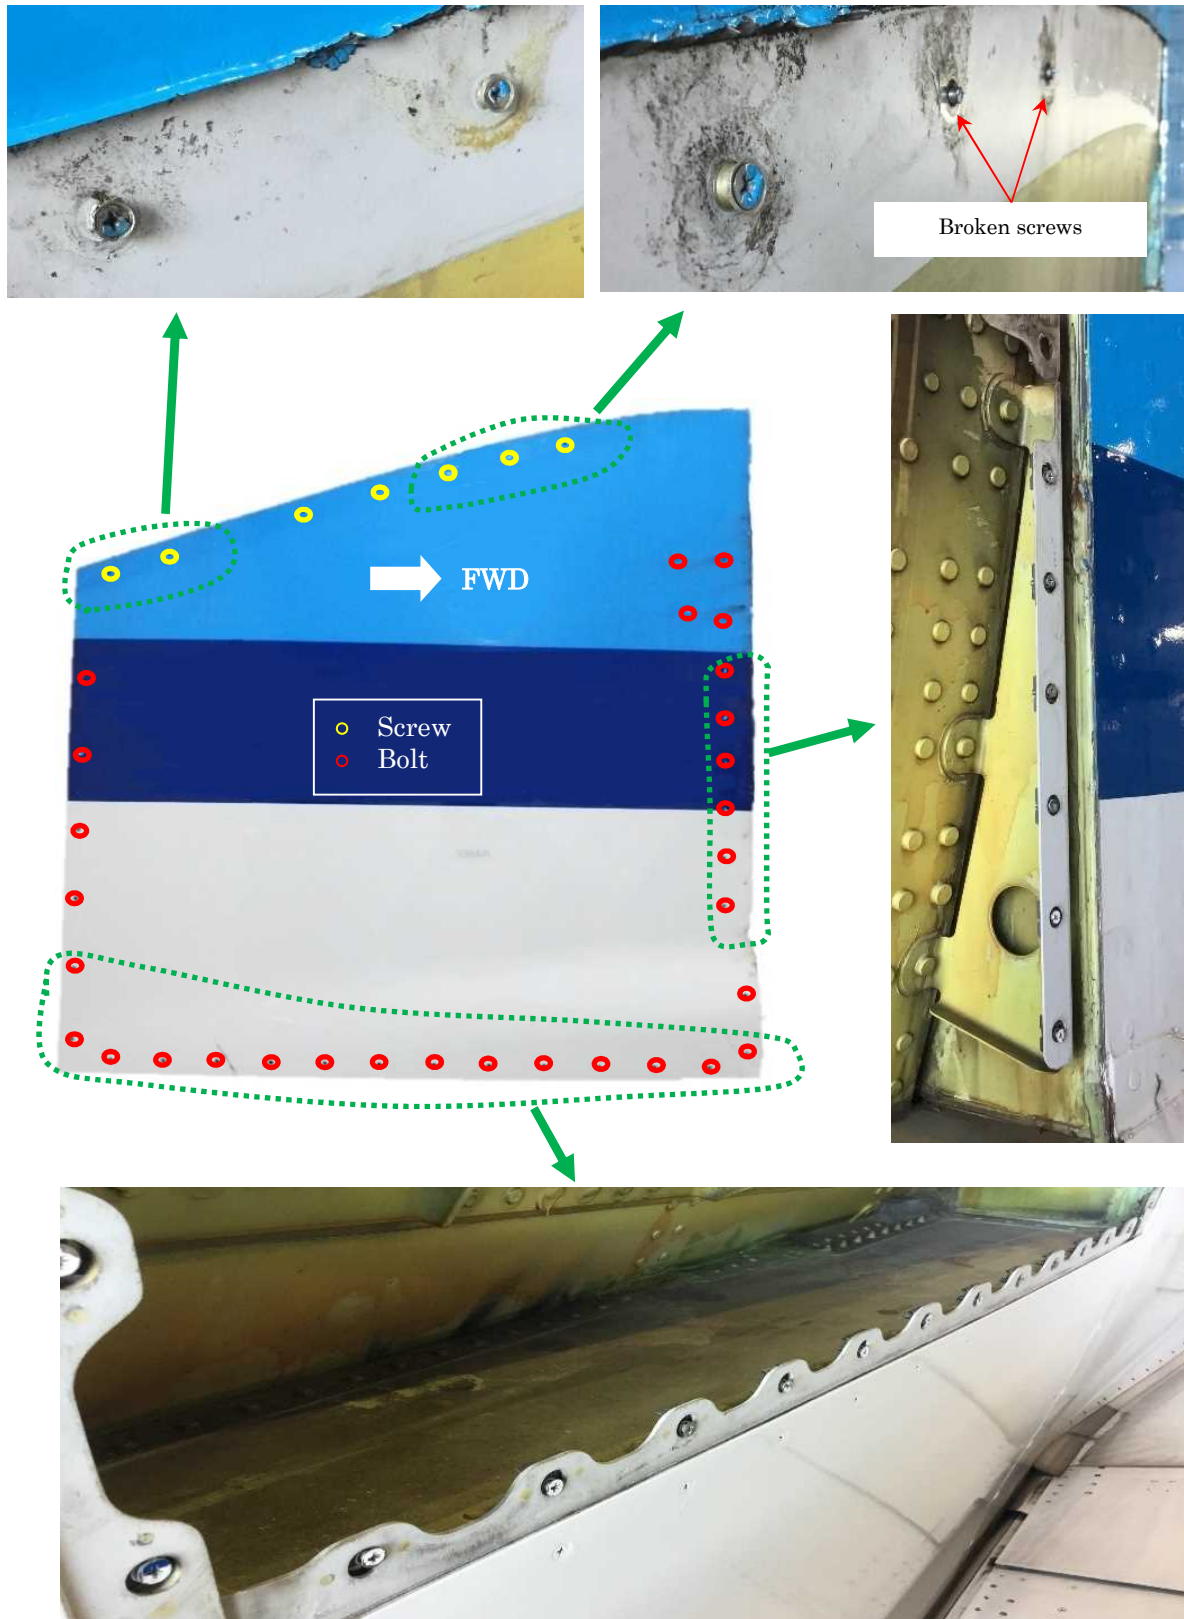
Appendix Figure 2 Conditions of the Screws and Bolts Remaining on the Aircraft

Regarding the part numbers of the aforementioned seven screws and 29 bolts, it was found in a cross-check with the parts table of the AIPC that the proper parts were used for all of the screws. However, regarding the bolts, five bolts with parts number BACB30XD3K5 (hereinafter referred to as "the Improper Bolt") were used where parts number BACB30LH3-4 (hereinafter referred to as "the Proper Bolt") should have been used. Paint was not applied to the heads of the five Improper Bolts.
