**AIRCRAFT SERIOUS INCIDENT
INVESTIGATION REPORT**

**AIR INDIA
V T - E P W**

Japan Transport Safety Board

AIR INDIA
BOEING 747-337 (COMBI), VT-EPW (INDIA)
IN THE AIR, APPROXIMATELY 10 KILOMETERS SOUTH OF NARITA
INTERNATIONAL AIRPORT
AT ABOUT 12:38 JST, SEPTEMBER 21, 2008

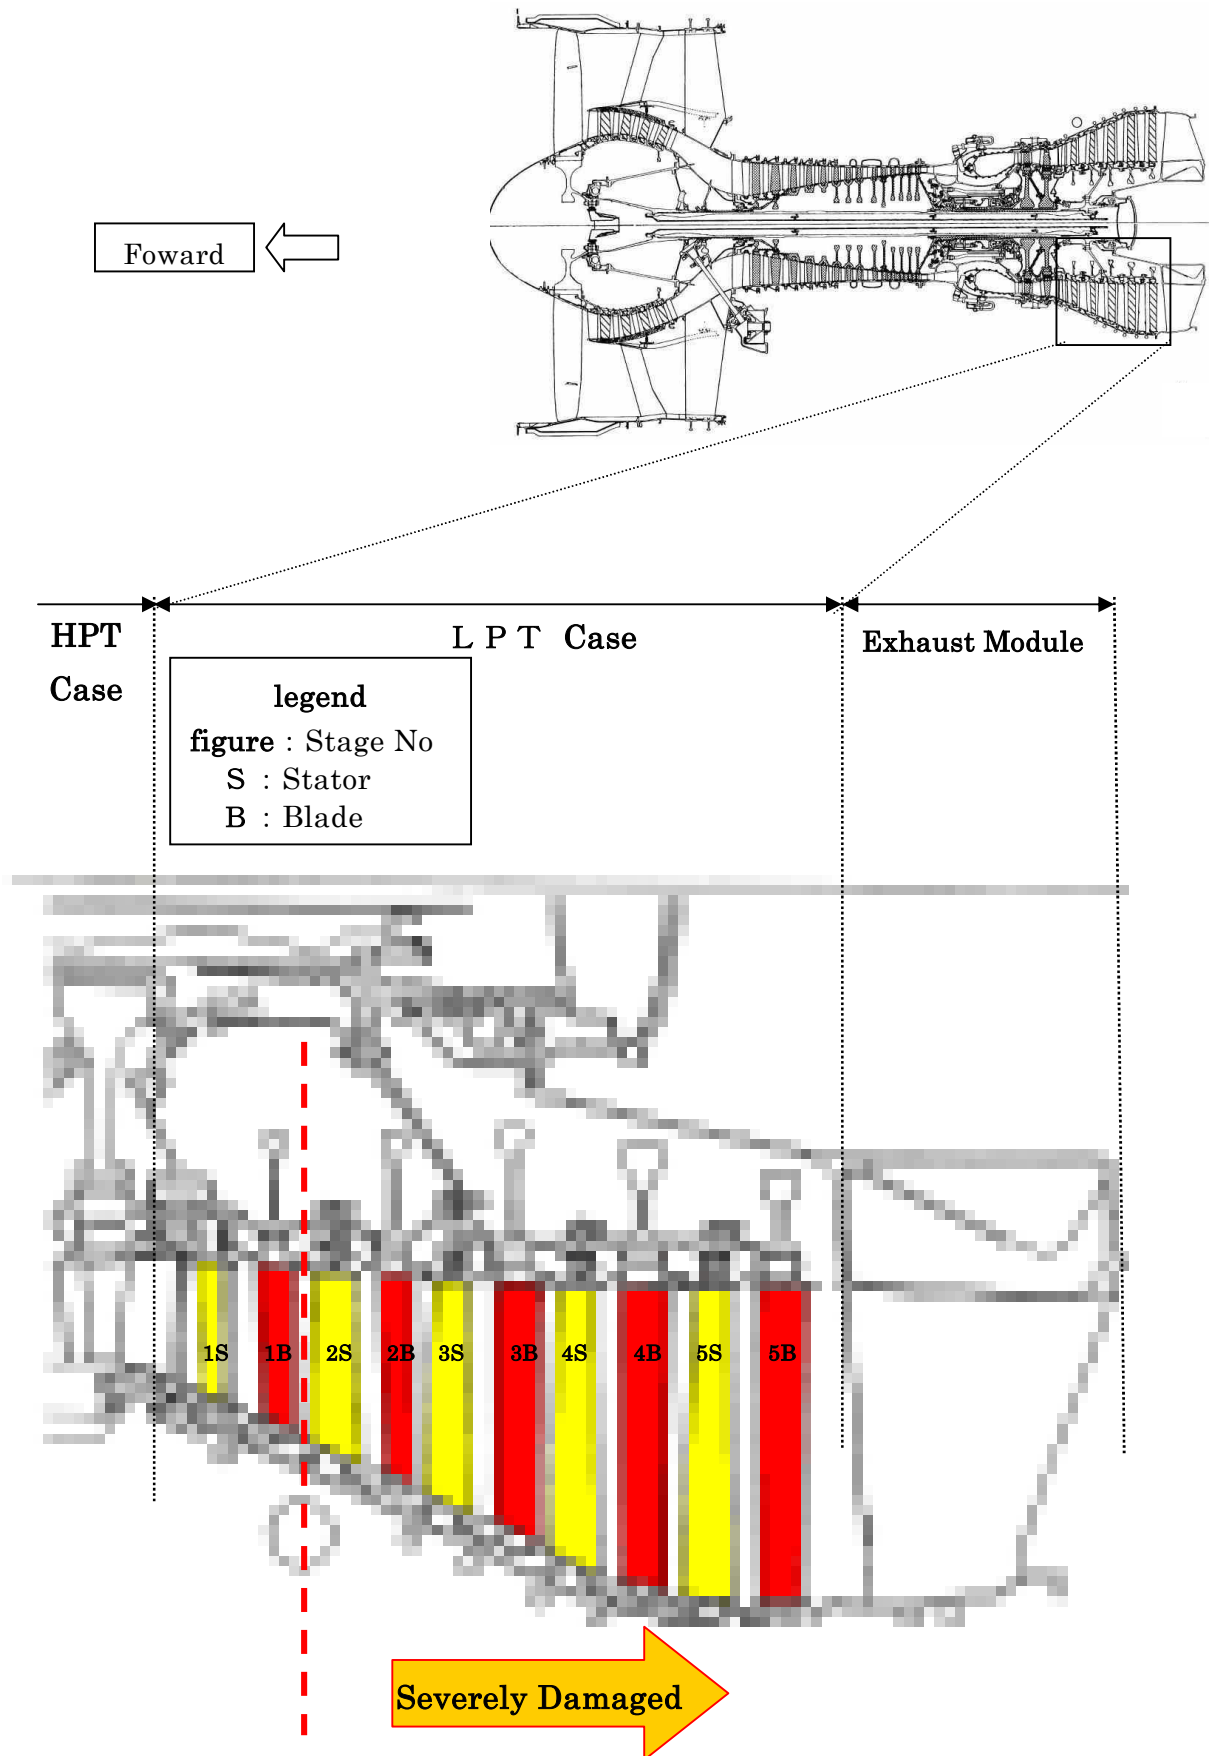
Figure 2 No.3 Engine LPT

The LPT is a five-stage, axial-flow turbine consisting of five stator and rotor combinations with the stator on the upstream side in each stage. The condition of the damage to the main parts of the No. 3 engine LPT was as follows:

- ① All six NGVs of the No. 3 Vane Segment were found to have fractured at sections near their outer ends and had become lost. The inner platform of the Vane Segment was missing.
 - ② One NGV of the No. 1 Vane Segment had cracks. Other NGVs were also severely damaged.
 - ③ The 124 turbine blades on the entire circumference were damaged. One of these blades was found to have fractured at its root attached to the LPT disc.
- (3) The turbine blades and the NGVs of the third LPT stage (hereinafter referred to as “STG-3”) to the fifth LPT stage (hereinafter referred to as “STG-5”) were severely damaged.
 - (4) The LPT casing had numerous holes and cracks that were apparently caused by turbine blades and other objects having struck against it, but did not pass through the LPT case. The liberated blades discharged axially from the engine exhaust.

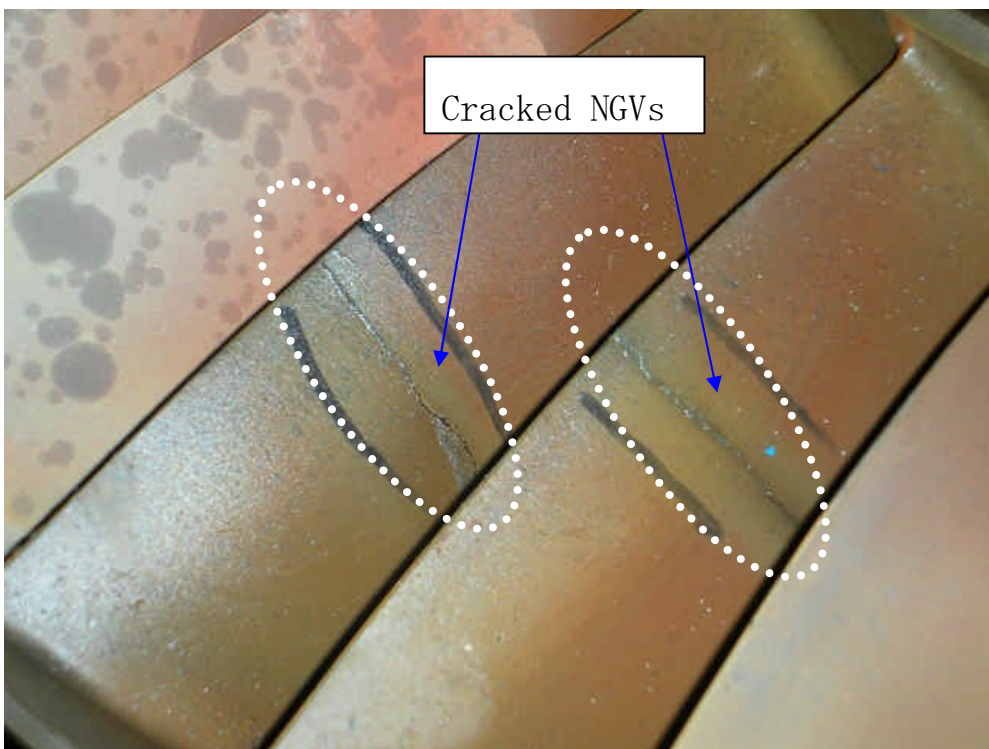
Of these Vane Segments, the No. 2 Vane Segment had cracks in two of its NGVs.

Photo 2 Cracked No.2 Vane Segment NGVs of LPT
STG-1

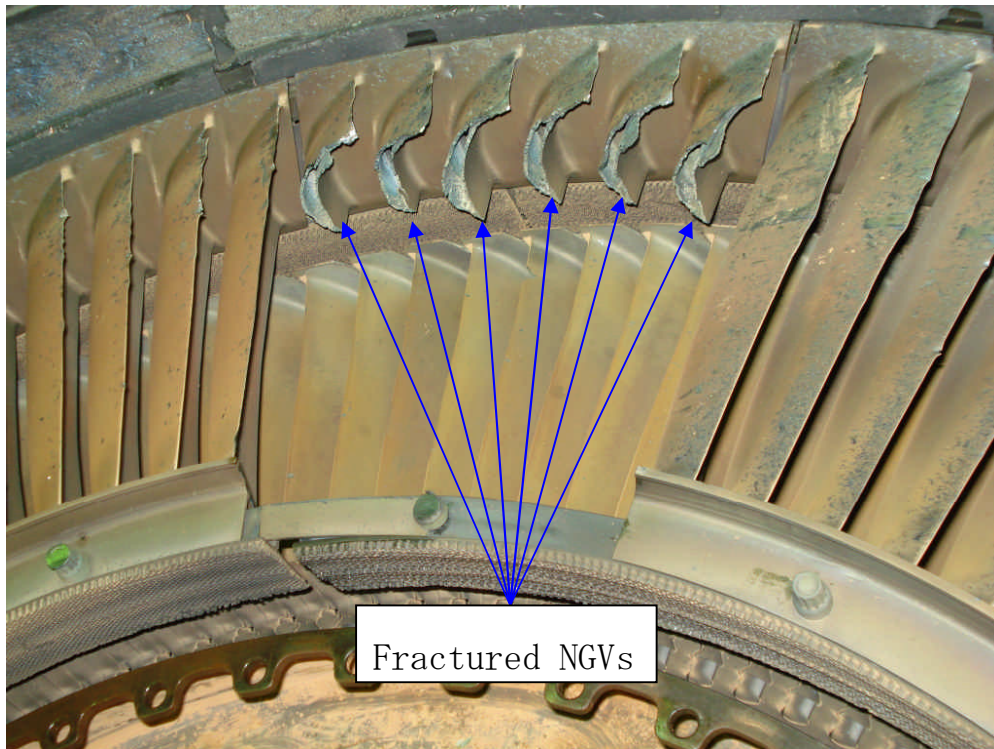
resistant material, and become more susceptible to oxidation corrosion. For this reason, it is considered highly probable that developing intergranular corrosion accelerated the degradation and strength reduction of the material, and caused cracking from the inner surface of the blade, eventually resulting in a fracture.

Photo 3 Fractured No.3 Vane Segment NGVs of LPT STG-2

As described in 2.11.1, the Service Bulletin dated June 16, 2006, issued by the engine manufacturer, noted that the internal airfoil cavities of the LPT STG-1 and STG-2 NGVs did not have an environmental protection coating and were susceptible to degradation from intergranular oxidation and intergranular corrosion, that had led to through wall cracks and fragmentation of airfoils, and advised that replacing the NGVs with ones having an oxidation resistant coating on the inner wall surfaces would improve the reliability and durability of the nozzles. However, after receiving the Service Bulletin, the Company did not have scheduled maintenance of NGVs of the engine nor did they replace any NGVs.

Judging from the above, it is considered probable that the engine manufacturer should have made clear the appropriate timing to replace NGVs for the operator to ensure overall engine reliability and durability.

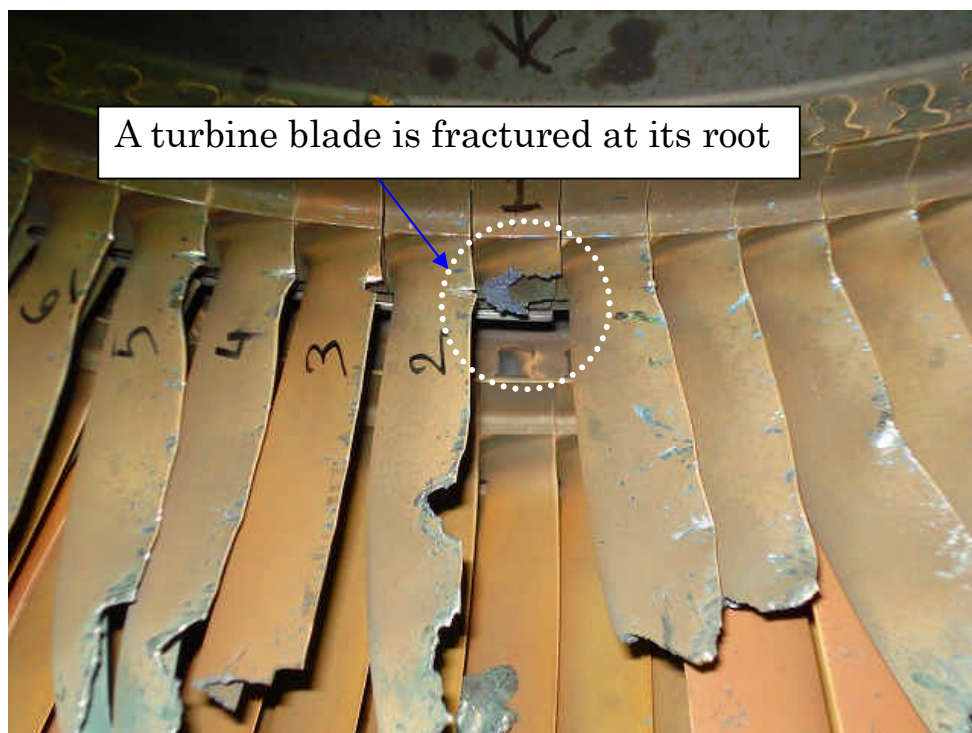
The root portion of the STG-2 turbine blade in question had a deep dent which appeared to be impact damage on the leading edge. The shape of the dent matched the shape of the inner platform of the STG-2 No. 3 Vane Segment NGVs.

Photo 4 Fractured Turbine Blades of LPT STG-2

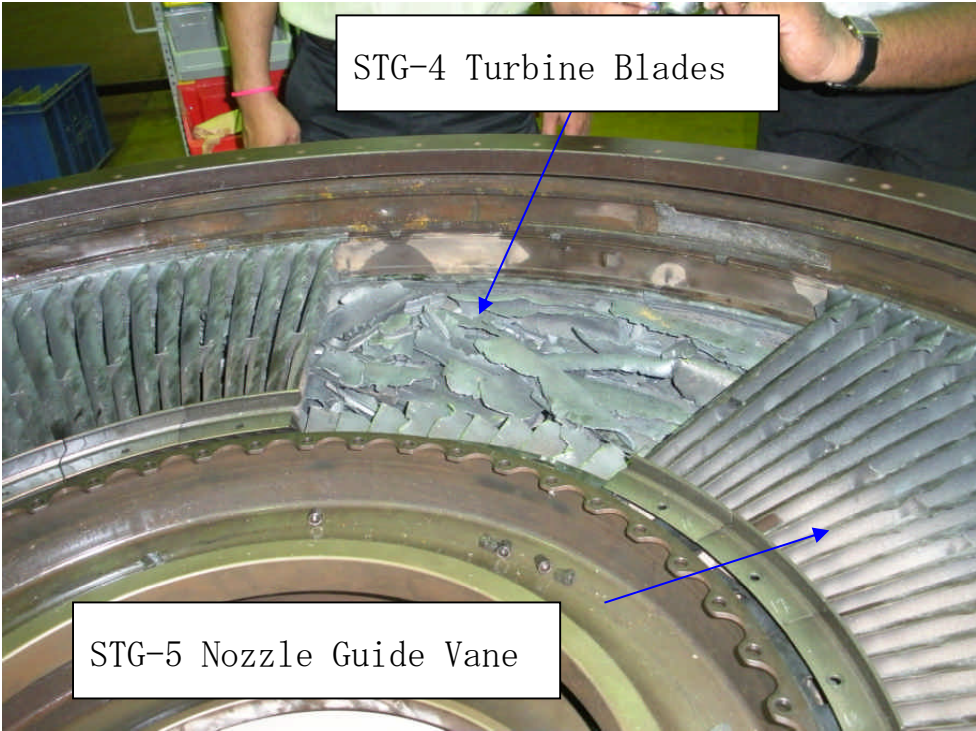
As a result of the STG-2 NGVs having fractured and liberated, the turbine blades of the STG-3 to STG-5 had fractured at their roots attached to the LPT discs.

The NGVs of the STG-3 to STG-5 were also severely damaged, with some portions missing. (See Photo 5 – Fractured Turbine Blades of LPT STG-4.)

With regard to the fracture of the turbine blades on STG-3 to STG-5, which took place in all of the blades near their roots attached to the LPT discs, and the damage to the NGVs of these stages, it is considered highly probable that, as described in 2.10.4, the STG-2 NGVs having fractured and liberated, struck against the STG-2 turbine blades causing secondary breakage, and the secondary breakage expanded further as the broken pieces continued striking against the turbine blades and NGVs of the downstream stages.

Photo 5 Fractured Turbine Blades of LPT STG-4

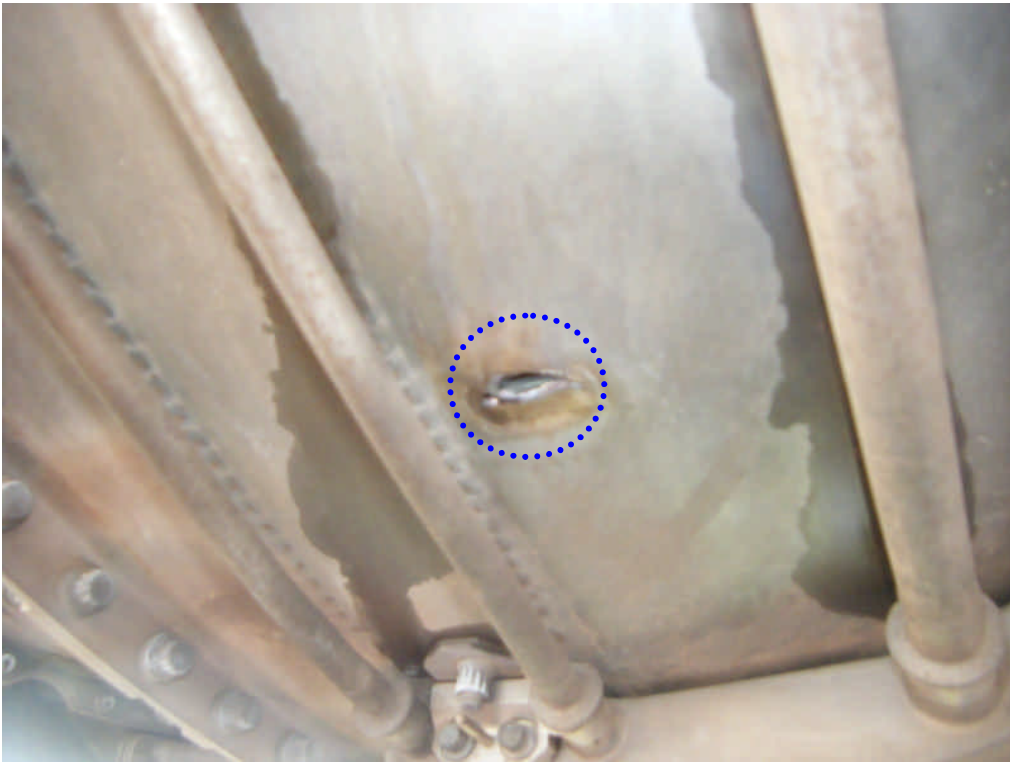
Photo 6 Damaged LPT Casing of No.3 Engine

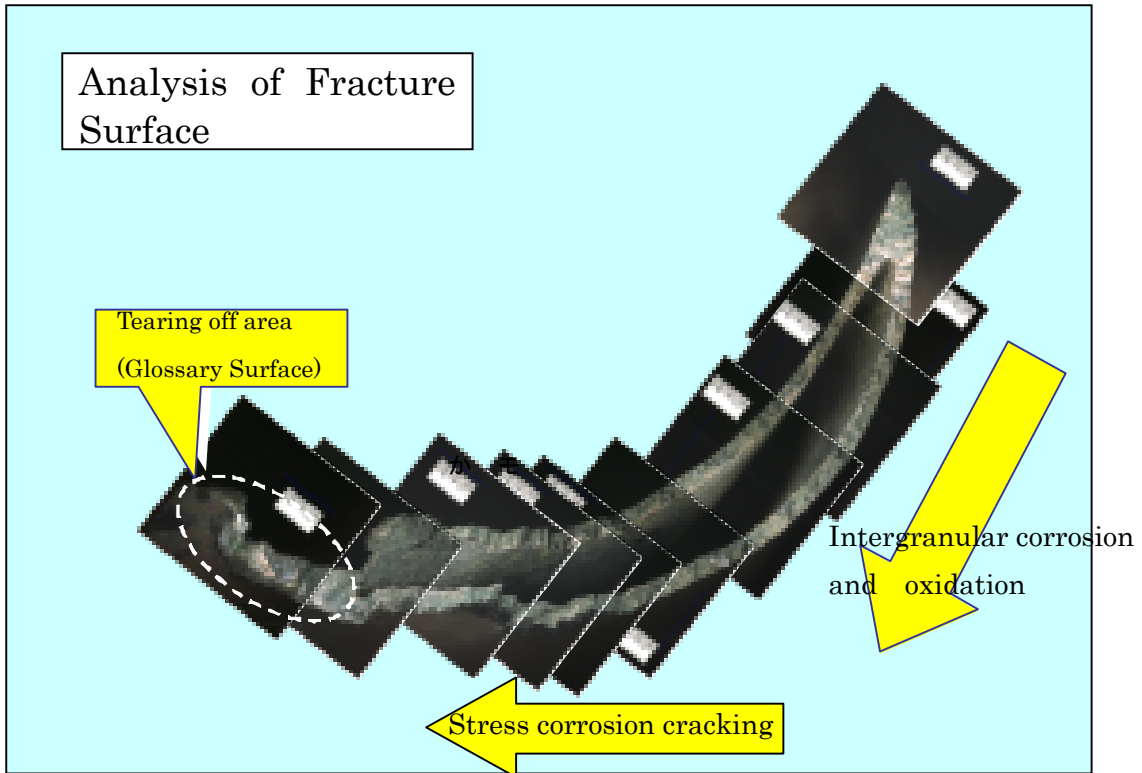
The fracture surfaces had become corroded due to oxidization and some of them showed signs of stress corrosion cracking*⁷ that had developed in the grain boundaries*⁸.

Multiple cracks that started at different points joined one another to present the appearance of branching fracture, which resulted in the through-wall cracking.

Photo 7 Fractured Surface of LPT STG-2 NGV

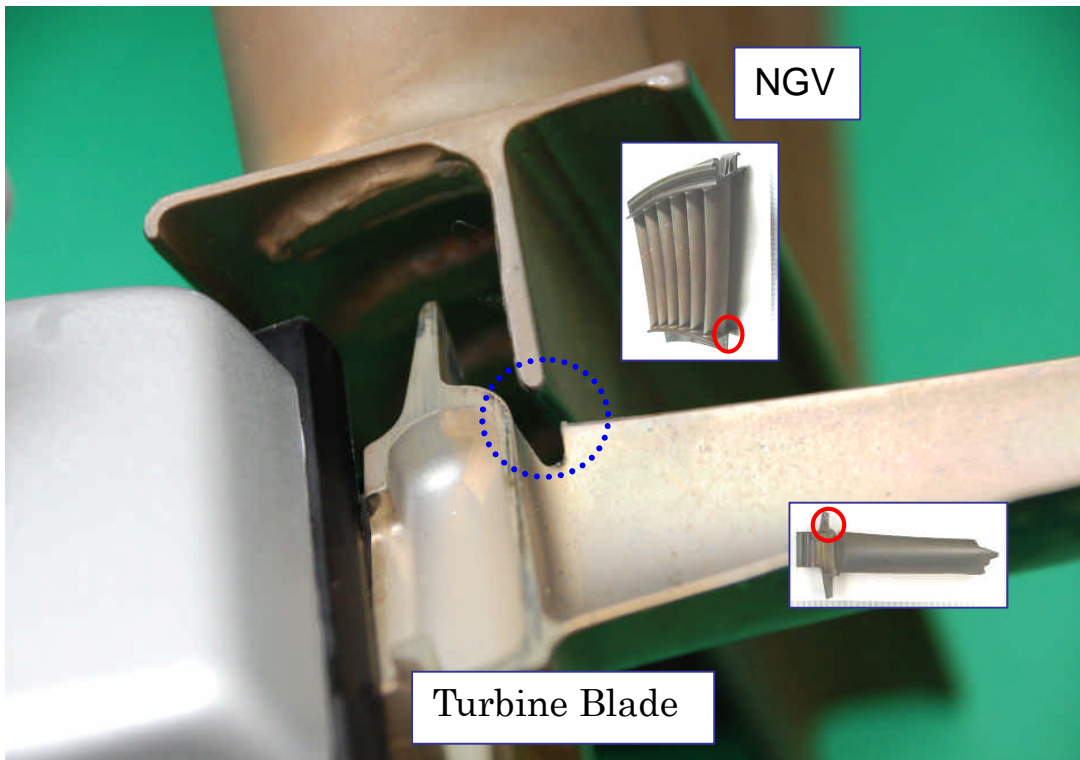
The STG-2 turbine blade that had fractured at its root attached to the LPT disc had a deep dent which appeared to be an impact damage at the leading edge.

As described in 2.10.3, the shape of the dent matched the shape of the inner platform of the No. 3 Vane Segment NGVs that had fractured become liberated and were not recovered. It is therefore considered highly probable that the inner platform became detached at the same time as the fracture of the No. 3 Vane Segment NGVs, striking high-speed rotating turbine blades and breaking the turbine blade in question.

Photo 8 Impact Damage on LPT STG-2 Turbine Blade

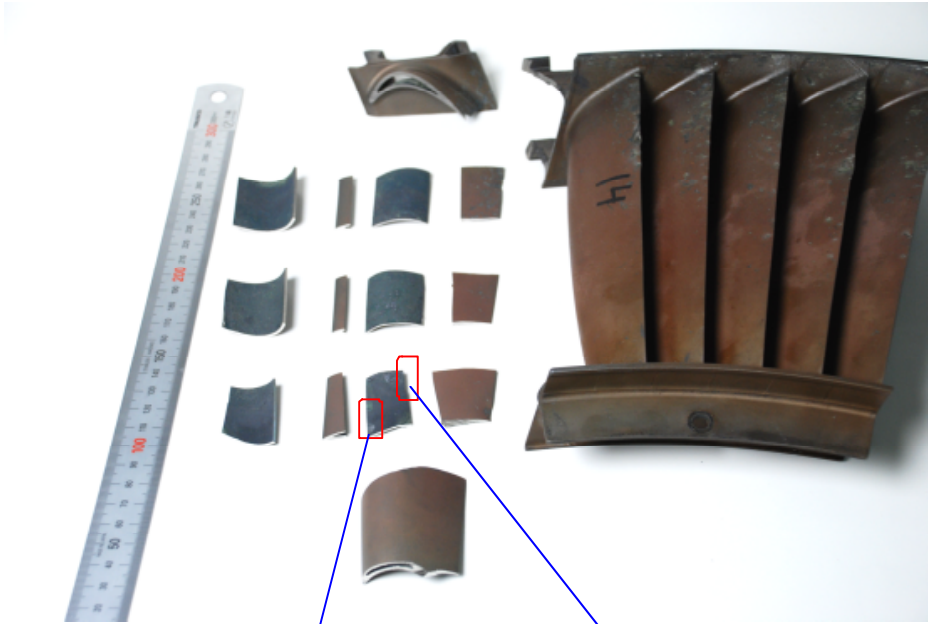
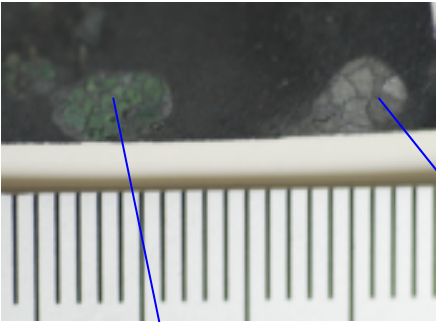
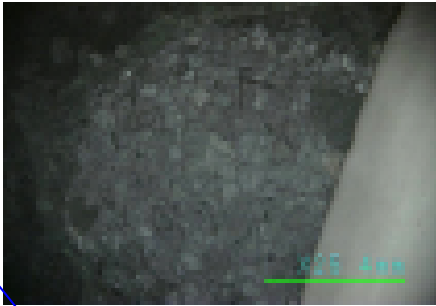
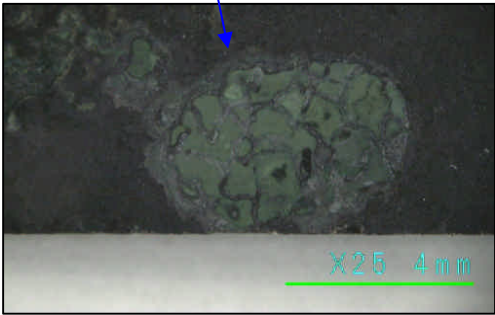
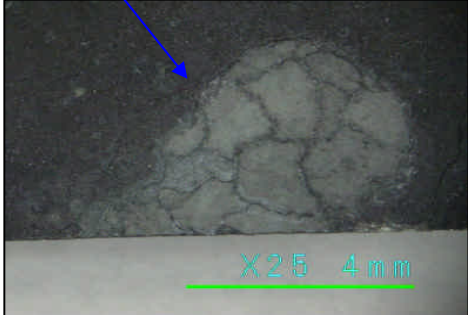
Each of the NGVs had an oxidation resistant coating on the outer surface, whereas the inner wall surfaces were covered with black, oxidized film that was in an easily separated condition.

Under the inner wall surfaces with no oxidation resistant coating, the parent metal showed severe intergranular corrosion*¹⁰ and intergranular oxidation*¹¹ and easily broke into fragments.

As suggested by this fact, an examination was conducted by cutting the broken pieces and cracked areas of the NGVs, which revealed that the inner wall surfaces of the NGVs were covered with black oxide film that appeared easy to separate and that severe intergranular corrosion had developed in the parent metal.

Photo 9 Intergranular Corrosion and Intergranular Oxidation of LPT STG-2 NGV Inner Wall Surfaces

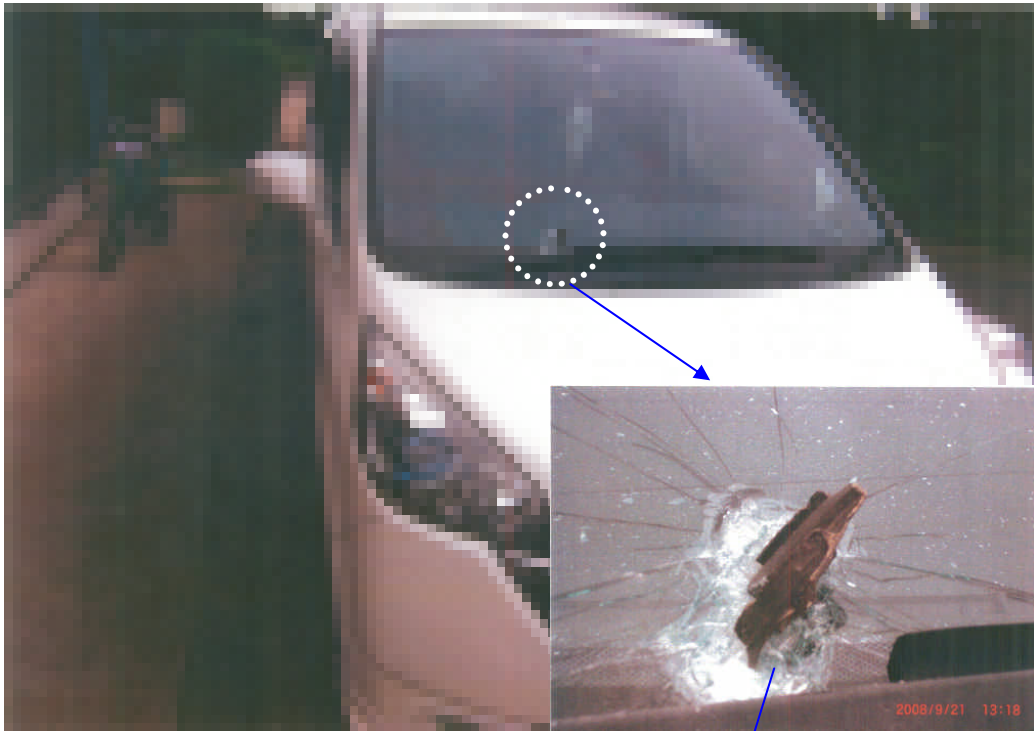
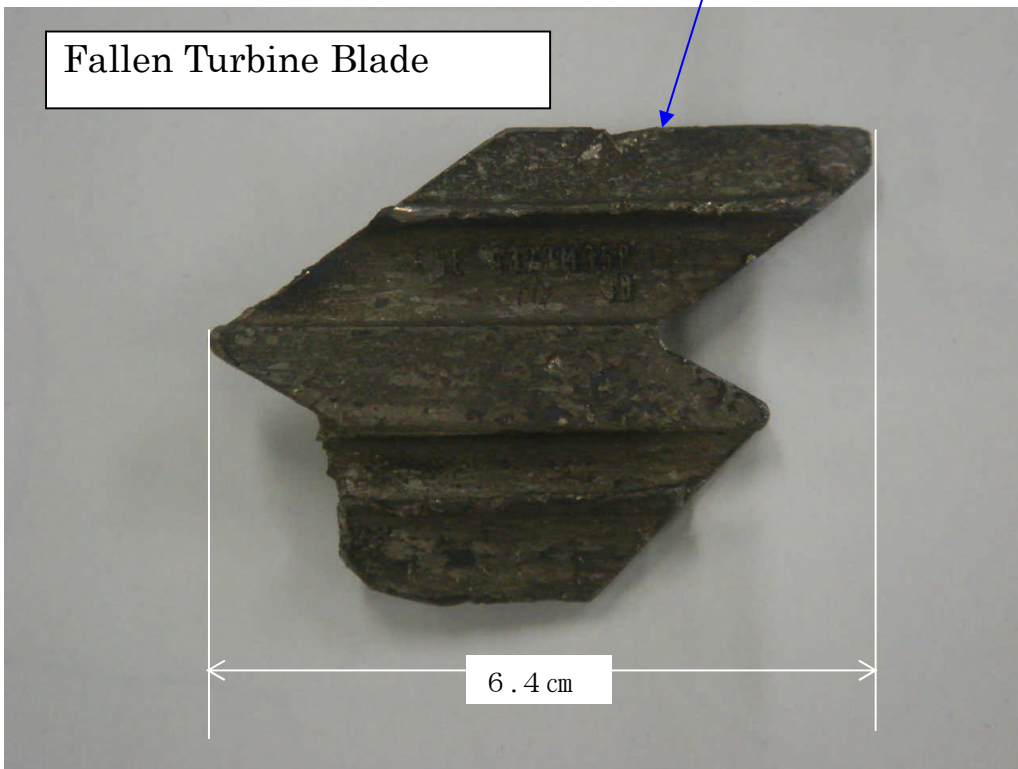
Fragments of LPT blades and nozzle guide vanes (hereinafter referred to as “NGV”^{*5}) fell onto three passenger cars parked directly beneath the Aircraft’s flight path, and some fragments stuck in the cars and damaged them.

It is considered highly probable that, as a result of the secondary breakage as described in 3.9, the fragments of the LPT blades and NGVs discharged from the engine exhaust outlet were scattered in the air. Then, as described in 2.4, some of the broken, falling pieces of turbine blades stuck in the passenger cars parked directly beneath the Aircraft's flight path and damaged them.

Photo 10 Damaged Car
