MA2011-4

**MARINE ACCIDENT
INVESTIGATION REPORT**

MARINE ACCIDENT INVESTIGATION REPORT

Vessel Type and name: Container ship “KUO CHANG”
IMO number: 9172313
Gross tonnage: 15,095 tons

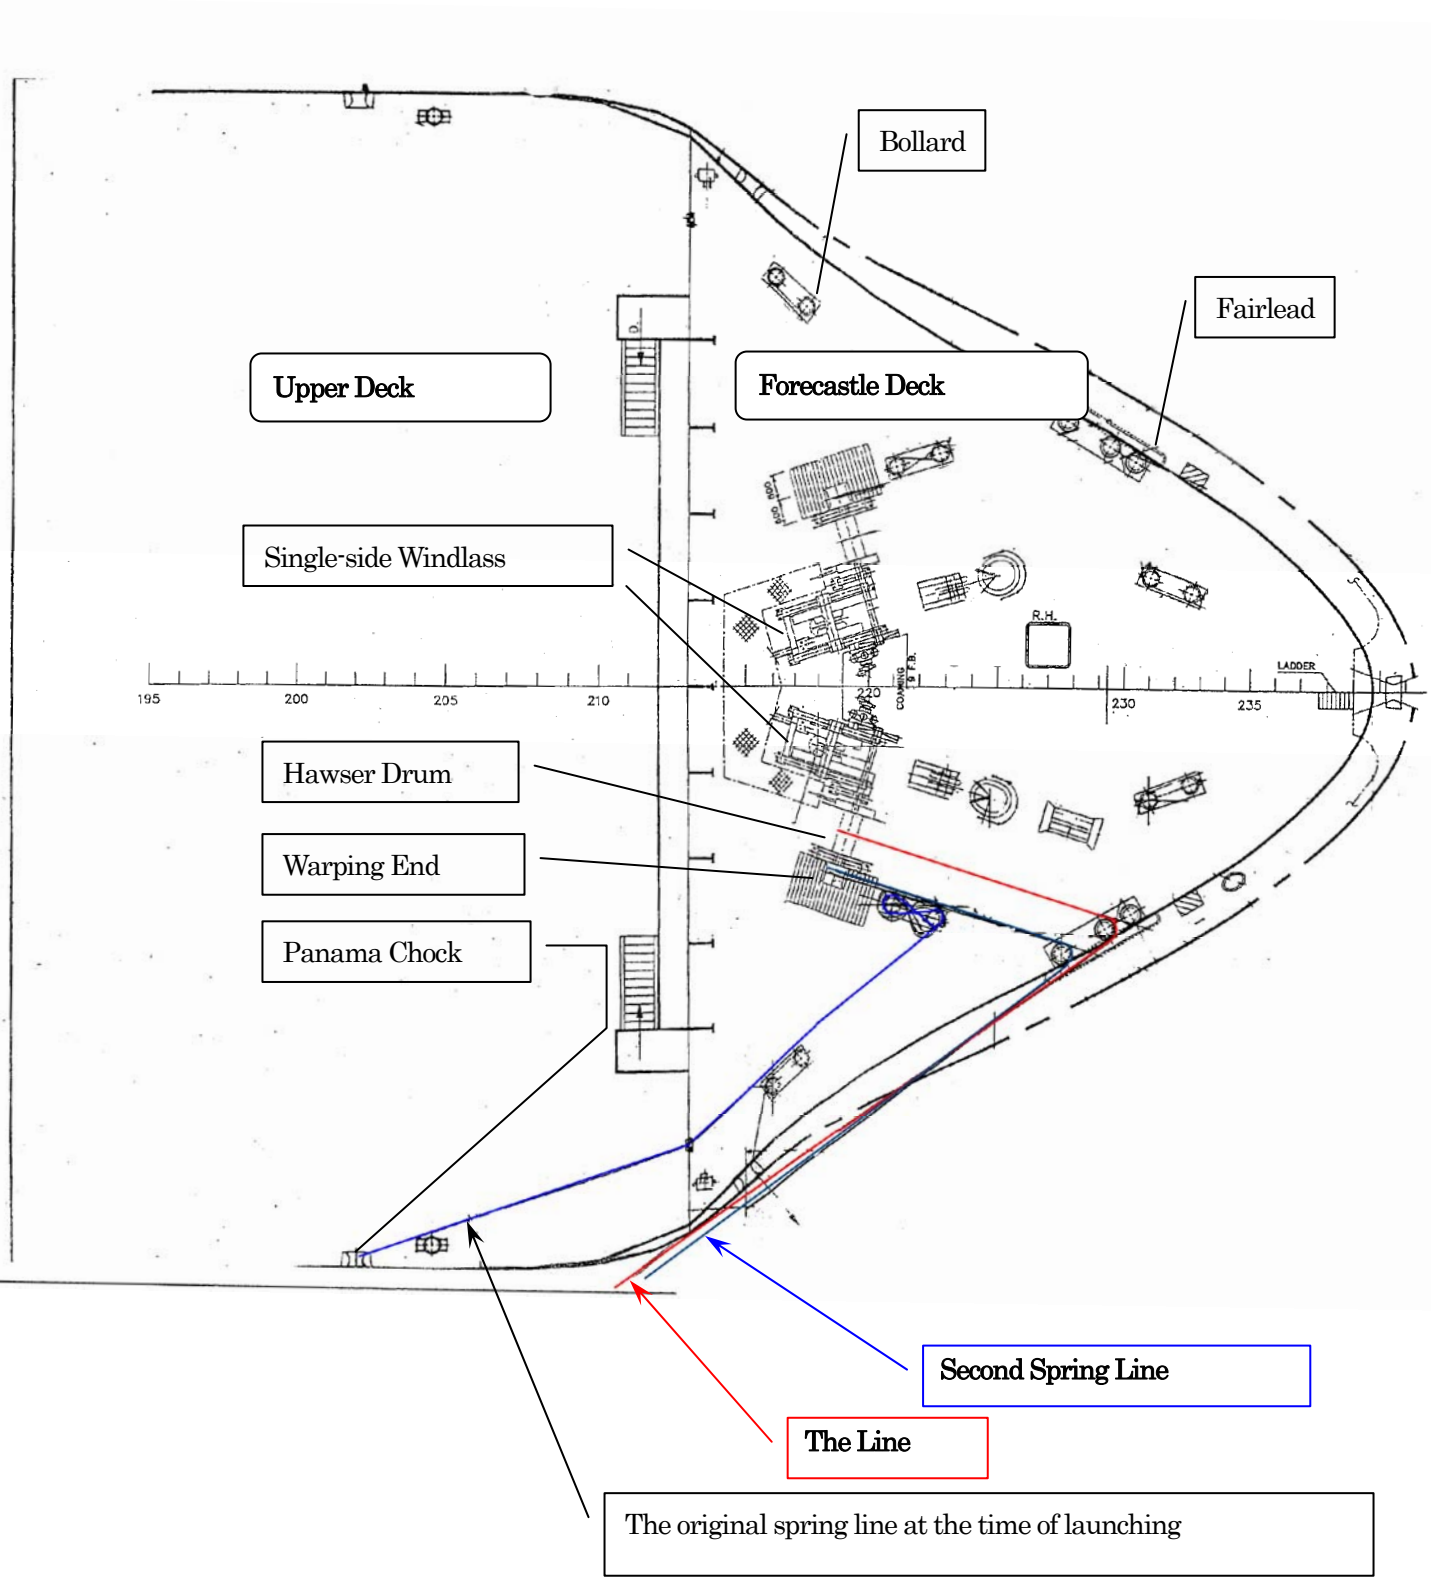
Attached Chart 5: Route of Forward Spring Line

In each case, the spring line of the Ship was found to be touching the Bend Point. Furthermore, on the starboard side of the Bend Point, abrasions and rust were found.

② It is considered probable that the Line’s strength had degraded upon damage caused by repetitively touching the Bend Point, such as yarns sticking-out and breaks and fluff in the portion of 20 m–34 m from the end of the eye.

It is considered probable that the Line was broken due to the wear it had incurred and by the additional tensions on the Line touching the Bend Point: the impulsive tension due to the winding moment in the hawser drum; the tensions due to the forward headway of the Ship; and the Wind Pressure.

Therefore, it is recommended to clearly state and require to pay attention to the route of mooring ropes and the bitts to moor the ropes onto in order to prevent mooring ropes from touching corners such as the Bend Point to the extent possible and obtain safe and effective mooring forces,

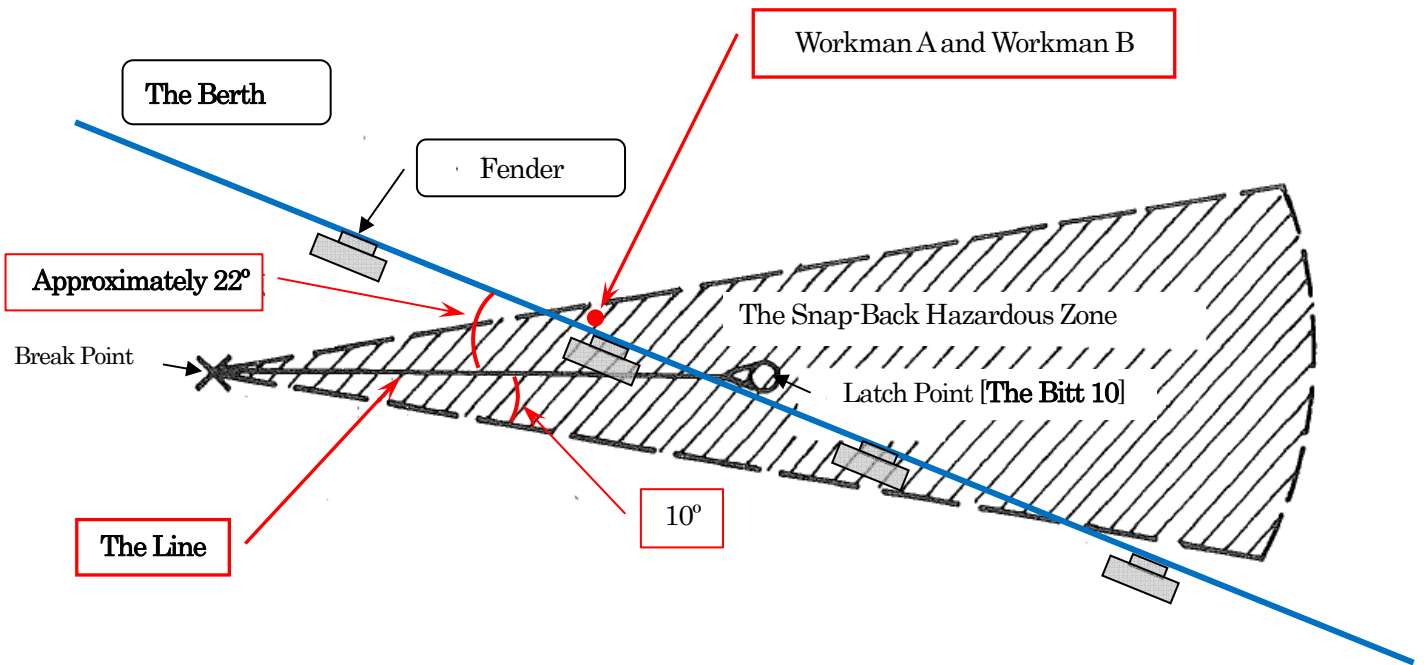
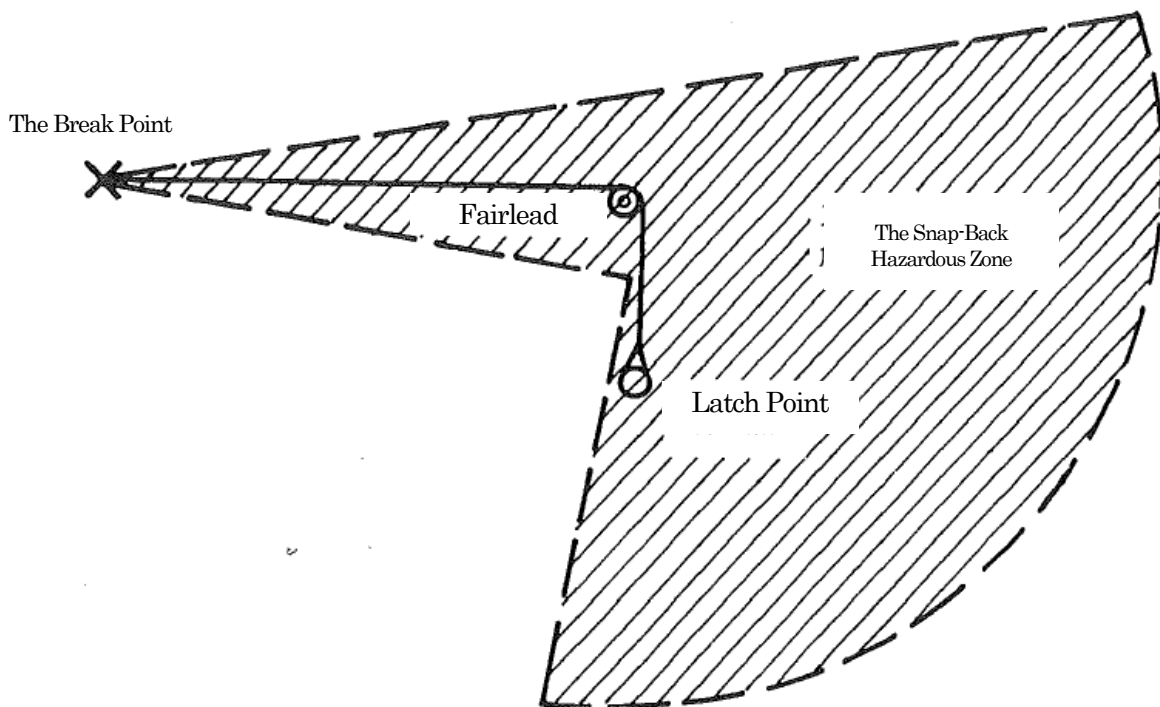
Attached Chart 6: The Situation of the Accident and the Snap-Back Hazardous Zone

As a general rule, any point within about a 10 degree cone around the line from any point at which the line may break is in danger. A broken line will snap back beyond the point at which it is secured, possibly to a distance almost as far as its own length.

(6) It is considered highly probable that Workman A and Workman B were hit, while working inside the hazardous zone of snap back, by the Line which had snapped-back at the moment of breaking.

It is considered probable that the accident occurred because the Line broke, snapped back and hit Workman A and Workman B, who were working inside the hazardous zone of snap-back.

It is desirable that line handling service providers provide their mooring workers with information on extension of the snap-back hazardous zones of ropes when broken under tension, and give them instructions such as to avoid working inside the zone unless necessary and to complete the work swiftly and leave from the snap-back hazardous zones as promptly as possible.

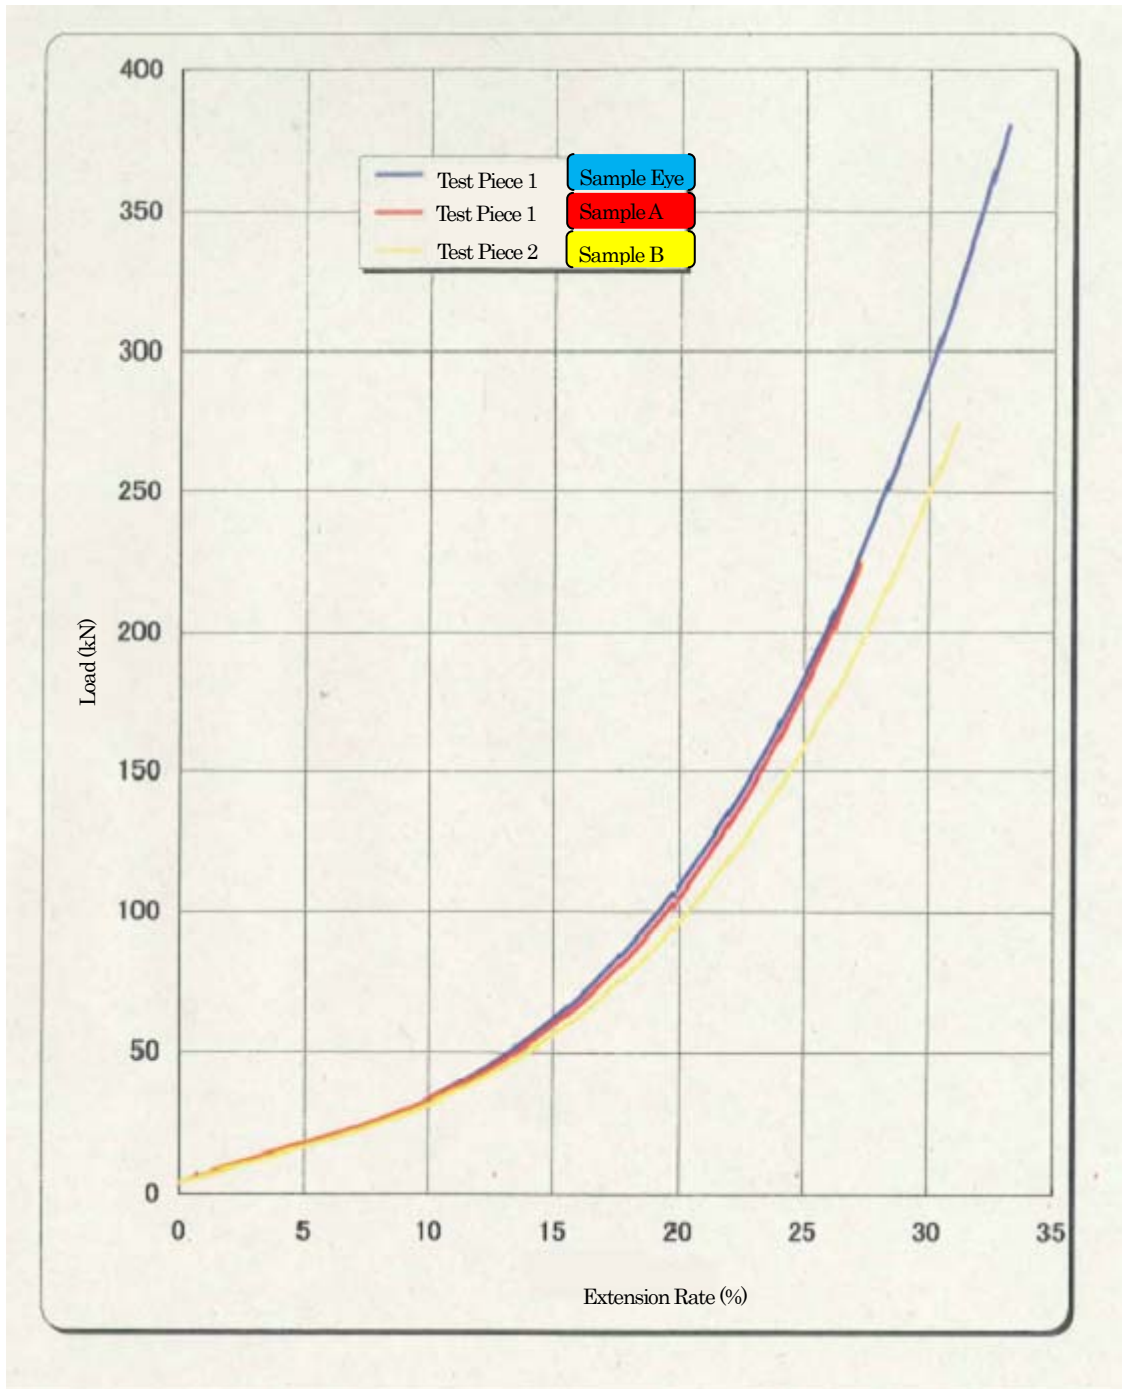
Attached Chart 9: Load-Extension Curve

The breaking load of Sample Eye is 380 kN, and the sample was broken at the eye-spliced portion. The breaking loads of Sample A and Sample B were 224 kN and 274 kN respectively, and each sample was broken near the middle of the abraded portion. (Refer to the Attached Chart 9: Load-Extension Curve).

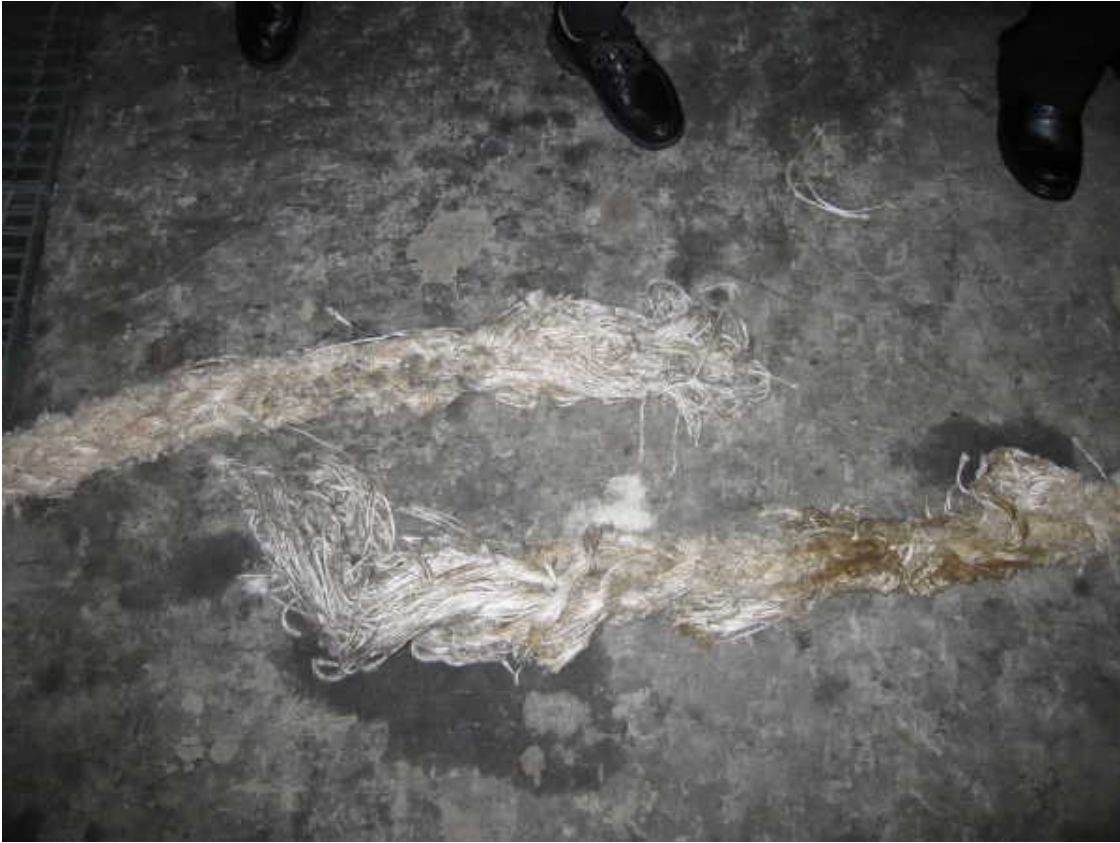
Photo 3: The Broken Part of the Rope

The portion of the rope about 10 m from the eye toward the breaking point showed a small amount of fluff, the portion between about 10 m to 20 m showed several breaks in yarns, and a portion about 20 m toward the breaking point showed fluff and wear.

The portion of the rope from the breaking point to about 5 m along toward the hawser drum showed fluff and wear, and the portion about 5 m to 16 m (the other end of the rope) showed fluff on the surface and several breaks in yarns.

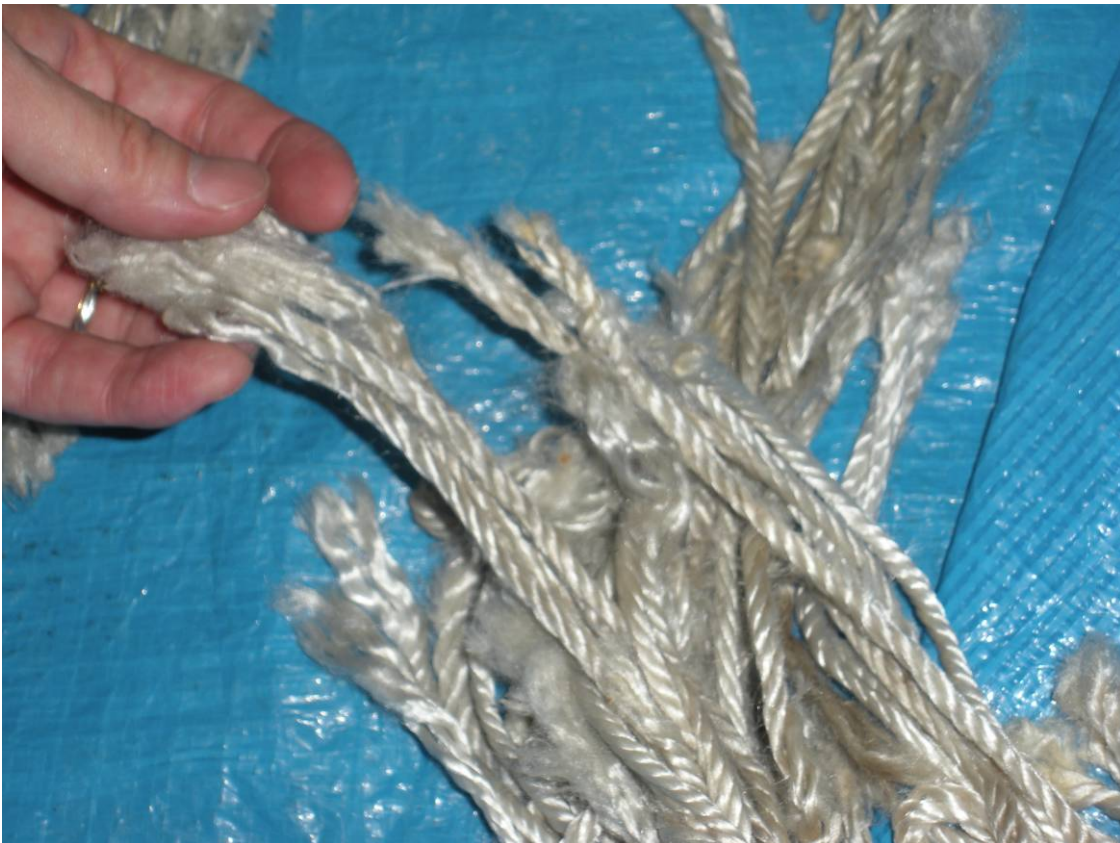
Photo 4: The Close-up of the Broken Part (Yarn)

According to the external inspections, the 6 m portion around the break point showed such severe damage, including expositions of yarns, breaks of yarns and fluff that the shape of the strands could not be identified.

Such symptoms are often observed in cases where a rope is scraped. Furthermore, the

damage was localized in a narrow portion of the rope, and also the damage here was much more severe than in the other portions. Therefore, it is considered that this section of the rope had been scraped.

Therefore, it is considered that the localized and repetitive scrapes had caused external damage, which in turn had decreased the strength of the rope to such an extent that the rope could not resist the tensile load and finally broke.

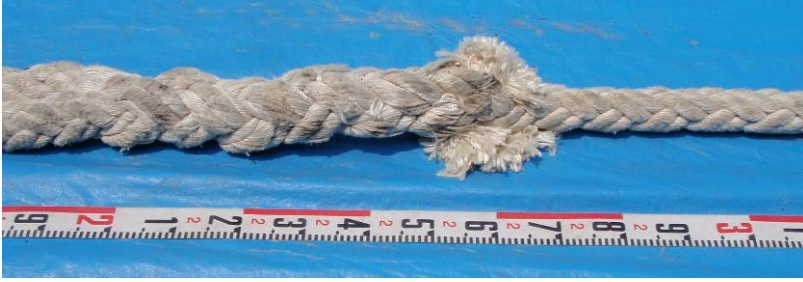
Photo 5: Eye-Splice of the Line

① The eye and the eye splice²⁷ showed no distinctive damage except small fluff.

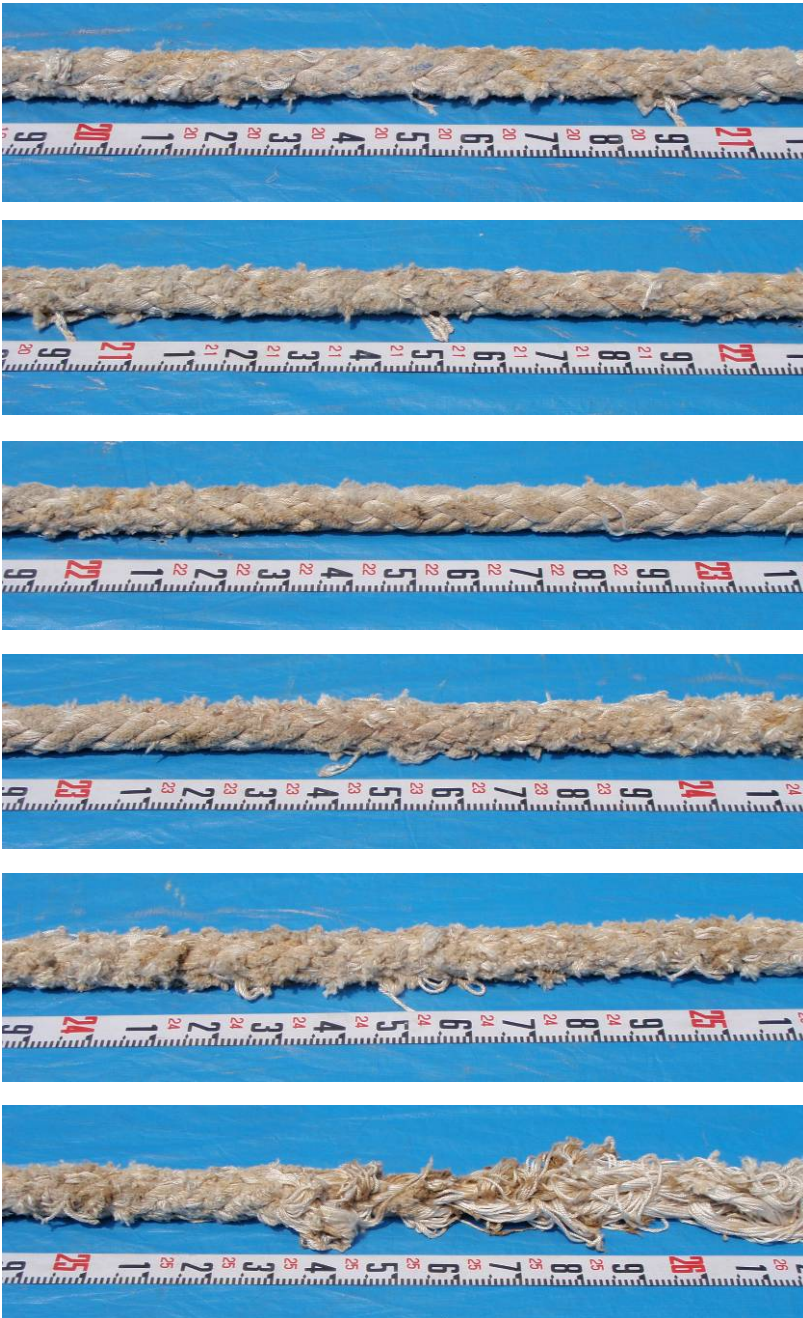
Photo 6: Close-up of the Line: 20 to 26m from the end of the eye

④ The whole portion between about 20 m to 23.5 m showed severe damage in the form of exposed yarns, breaks and fluff.

⑤ The whole portion between about 23.5 m to 25 m showed such severe damage in the form of

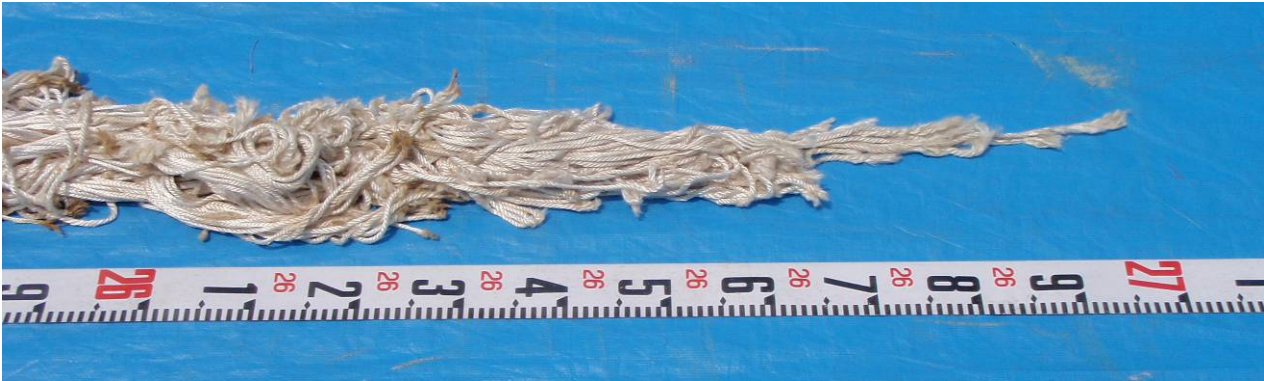
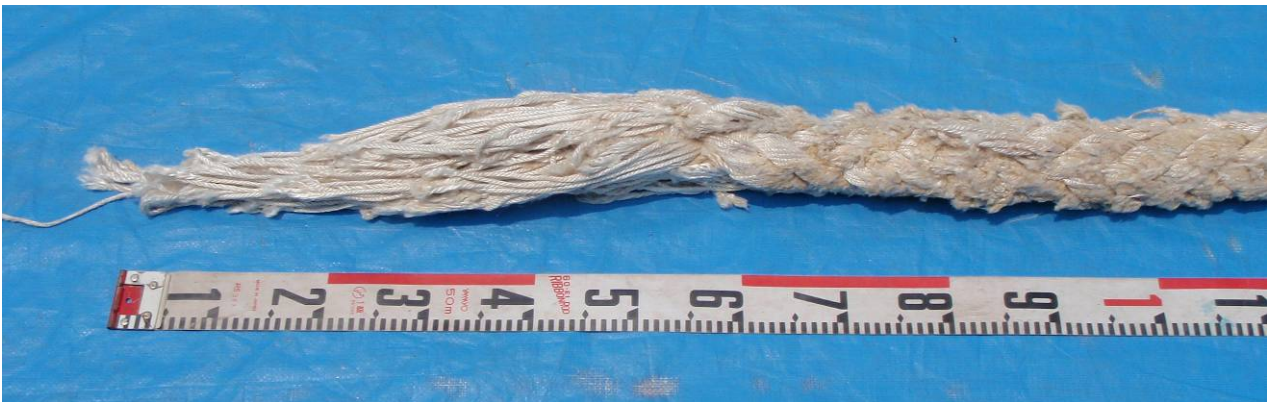
Photo 7: Close-up of the Break Point

⑥ At the break point (the end of the Line), strands did not keep their original shape. The lengths of the broken yarns were not uniform. (Refer to Photo 7: Close-up of the Break Point)

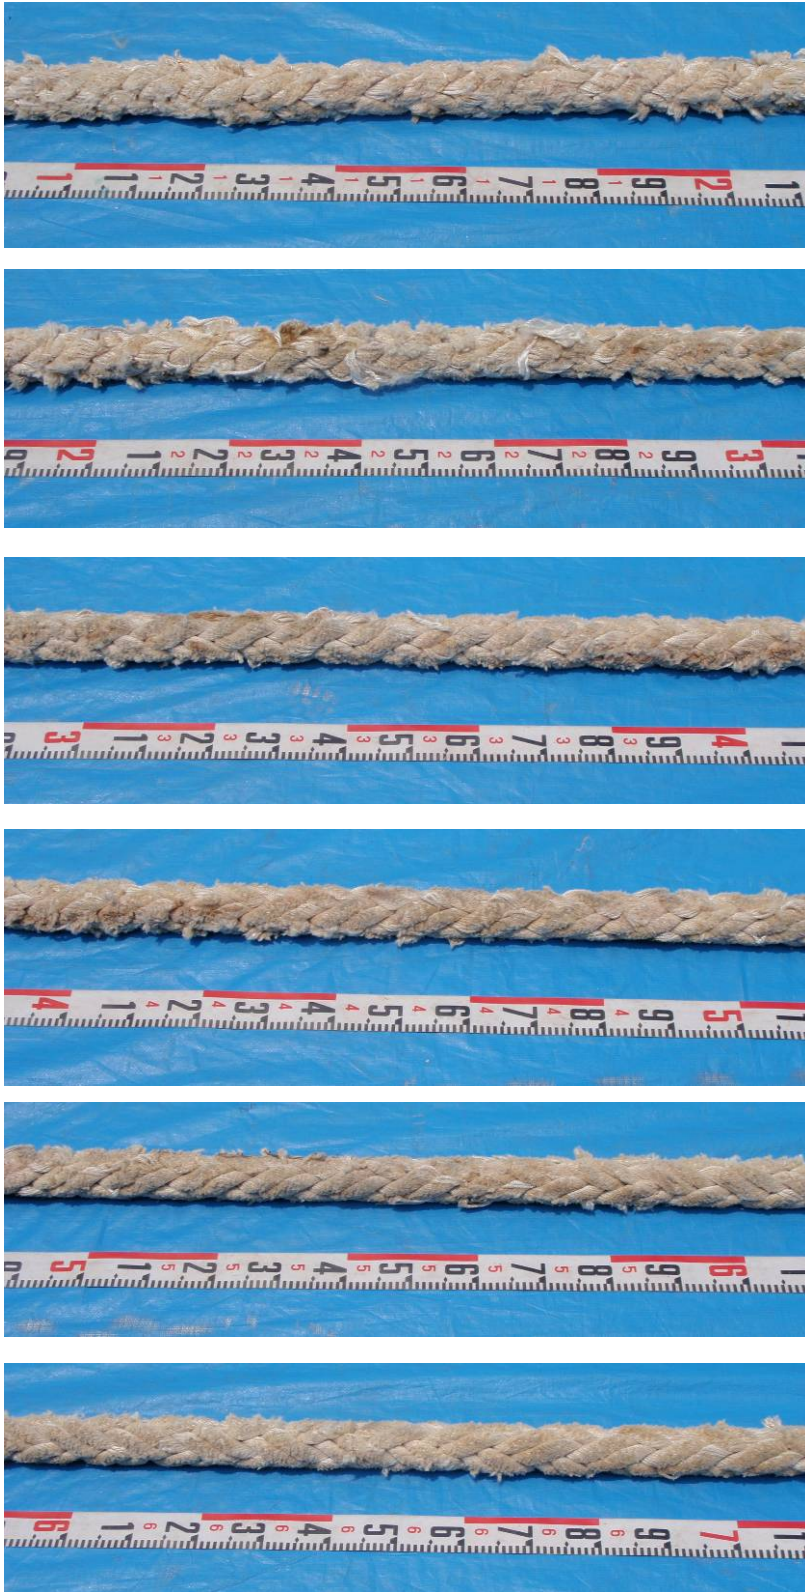
Photo 8: Close-up of the Line: 1 to 7m off the break point toward the hawser drum

⑦ The whole portion about 3 m off from the break point toward the hawser drum (the same shall apply hereinafter) showed such severe damage in the form of exposed yarns, breaks and fluff that the shape of the strands could not be identified.

⑧ The whole portion between about 3 m to 7 m from the break point showed severe damage in the form of exposed yarns, breaks, and fluff. (Refer to Photo 8: Close-up of the Line; 1 to 7m off the break point toward the hawser drum)
