MA2013-7

**MARINE ACCIDENT
INVESTIGATION REPORT**

Accident Type	Fatality of a crew member
Date and Time	About 01:05, June 7, 2012 (local time, UTC+9 hours)
Location	Fukuyama Port About 132° true, 2.6 nautical miles from JFE Steel Fukuyama Port Shingai leading light (front light), Fukuyama City, Hiroshima Prefecture (approximately 34° 25.8' N, 133° 26.8' E)
Process and Progress of the Investigation	<p>The Japan Transport Safety Board appointed an investigator-in-charge and a marine accident investigator to investigate this accident on June 7, 2012.</p> <p>Comments on the draft report were invited from parties relevant to the cause of the accident.</p> <p>Comments on the draft report were invited from the flag State of JUNIPER PIA.</p>
Factual Information	<p>Vessel type and name General cargo ship JUNIPER PIA</p> <p>Gross tonnage 4,382 tons</p> <p>IMO number 9016179</p> <p>Port of registry Jeju (Republic of Korea)</p> <p>Owner PIA SHIPPING CO., LTD. (Republic of Korea)</p> <p>Management company SEOK CHANG MARITIME CO., LTD. (Republic of Korea)</p> <p>Classification society KOREAN REGISTER OF SHIPPING (Republic of Korea)</p> <p>Lr × B × D 100.04 m × 17.60 m × 8.70 m</p> <p>Hull mate

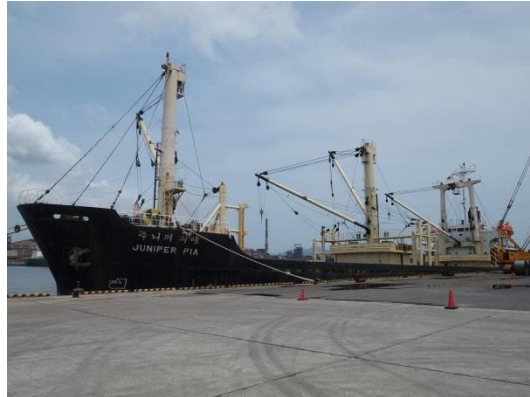
Photo 1: Overview of the Vessel

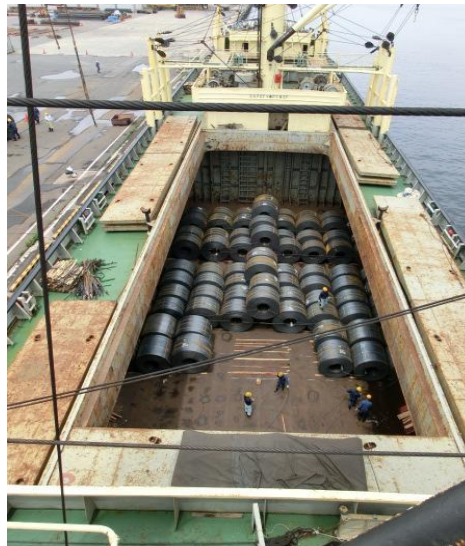
Photo 2: No. 2 Cargo Hold and Removed Hatch Covers

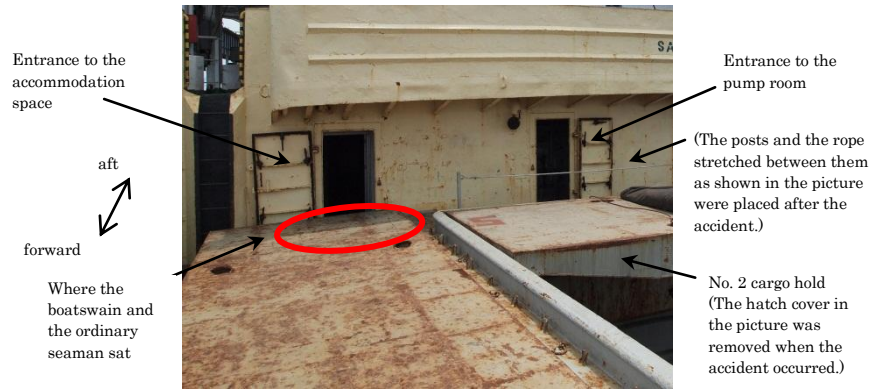
Photo 3: Entrance to Accommodation Space and Entrance to Pump Room

Probable Causes	<p>It is probable that the accident occurred when the second officer fell into No. 2 cargo hold because the hatch covers of the cargo holds were removed while the Vessel was proceeding to No. 2 Berth in Fukuyama Port at night.</p>
Actions Taken	<p>After the accident, a fall protection fence (three posts and a rope stretched between them) was set up on the Vessel on the stern side of the hatch coaming of No. 2 cargo hold (see Photo 3, Photo 6 and Photo 7). It was also decided that hatch covers should not be removed before berthing.</p>

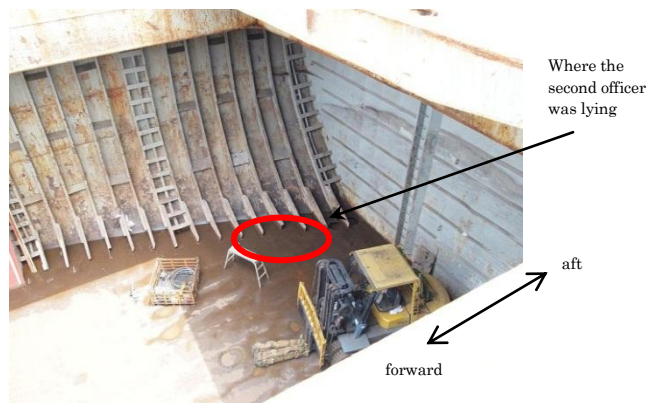
Injuries to Persons	Death: one person (the second officer)
Damage to Vessel	None
Events Leading to the Accident	<p>On June 4, the Vessel, boarded by the master and 14 other crew members, departed in ballast from Incheon Port, Republic of Korea for Fukuyama Port for the purpose of loading about 5,000 tons of steel coils. After letting go anchor at Fukuyama Port C-1 anchorage at about 18:05, June 6, the Vessel removed the hatch covers of the cargo holds while at anchor.</p> <p>At about 00:45, June 7, the master instructed the crew to stand by at their respective stations for entering port, when the second officer came on the bridge.</p> <p>Heaving up anchor at about 00:55, the Vessel started proceeding to JFE Steel No. 2 Export Berth in Fukuyama Port (hereinafter referred to as “No. 2 Berth”).</p> <p>A few minutes before the accident, the second officer reported to the master that he would stand by at the aft station from that time on, and went out of the bridge.</p> <p>Immediately before the accident, the boatswain and an ordinary seaman saw the second officer pass in front of them and enter the pump room on the stern side of No.2 cargo hold when they were sitting facing toward the stern on hatch covers near a starboard entrance to the accommodation space and were waiting for the chief officer to stand by at the forward station with them.</p> <p>Afterward, hearing a scream at about 01:05, the boatswain and the ordinary seaman thought that something had happened to the second officer although No. 2 cargo hold was too dark for them to know what had happened inside, and informed other crew members of it. After the inside of No.2 cargo hold was lit, the second officer was found lying and bleeding at the starboard aft end of No. 2 cargo hold.</p>

Photo 4: Accident Site
(The starboard aft end of No. 2 cargo hold)

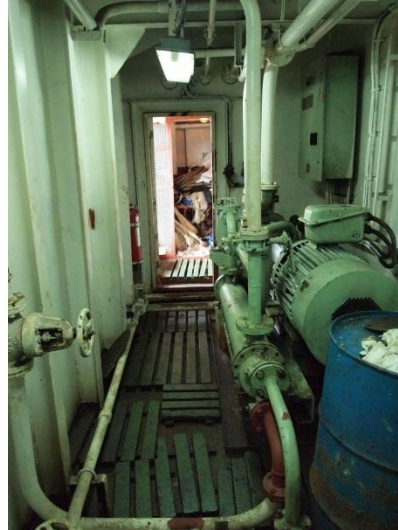
a hydraulic pump to drive a mooring winch placed on the poop deck as well as a switch for starting the pump. The hydraulic pump was usually started by an able seaman or an oiler.

Photo 5: Inside of Pump Room (Seen from the port side)

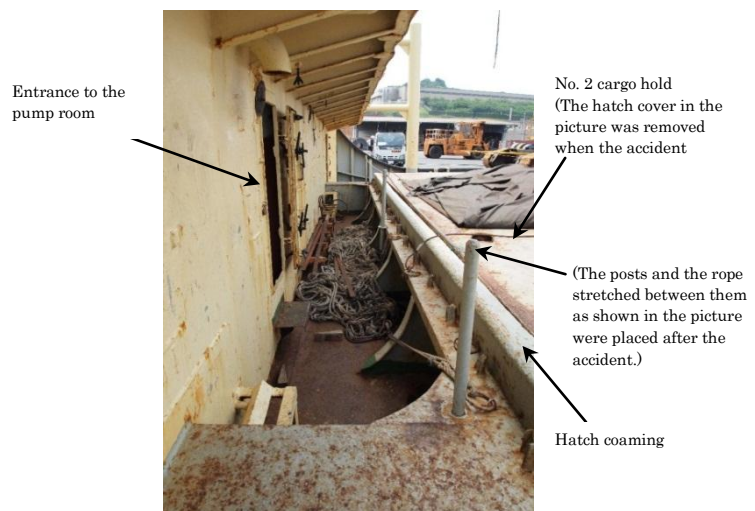
The width of the passageway between the pump room and No. 2 cargo hold was about 125 cm, and the height of the hatch coaming was about 100 cm. The height of the two hatch covers placed on top of each other on the upper deck was about 95 cm.

Photo 6: Passageway and Hatch Coaming

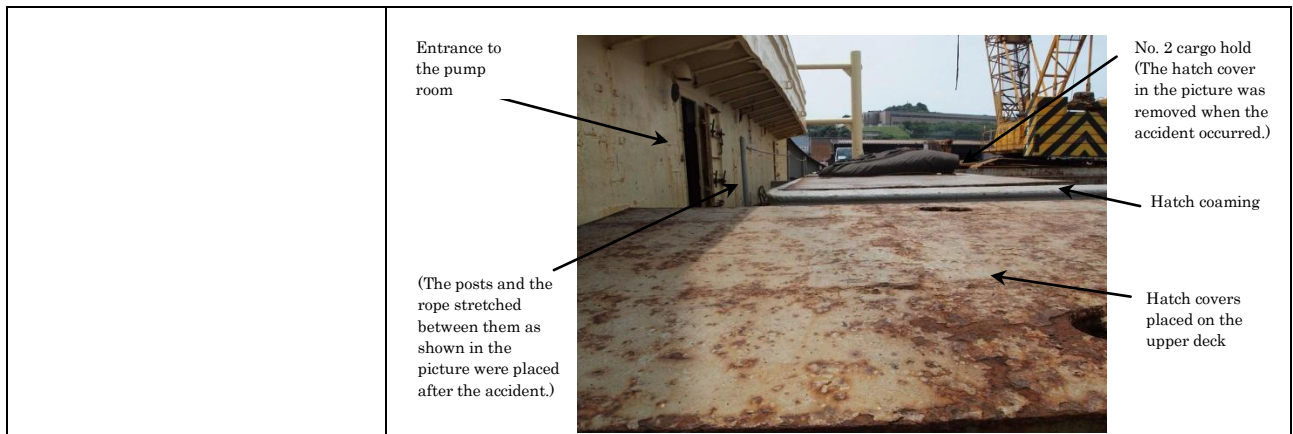
Photo 7: Hatch Coaming and Hatch Covers on the Upper Deck
