**MARINE INCIDENT
INVESTIGATION REPORT**

MARINE INCIDENT INVESTIGATION REPORT

Vessel type and name: LNG Tanker, "LNG ARIES"
Vessel number (IMO number): 7390193
Gross tonnage: 95, 084 tons

Incident type: Loss of control (blackout)
Date and time: Around 12:37, December 3, 2012 (Local time, UTC+9 hours)
Location: Off the Southeast of the Toden-Ogishima LNG Berth in Section 2 of Kawasaki Quarter, Keihin Port
120° true, 100 meters from the Toden-Ogishima LNG Berth Light in Kawasaki City, Kanagawa Prefecture
(approximately 35° 28.2'N, 139° 44.4'E)

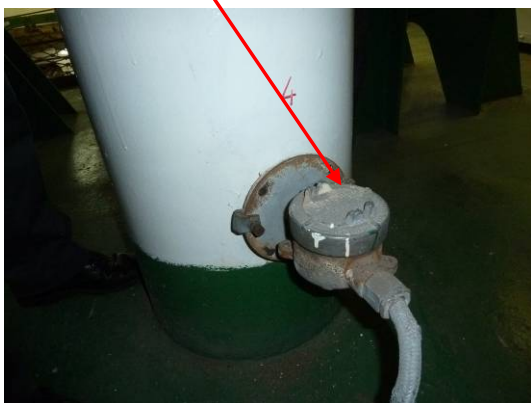
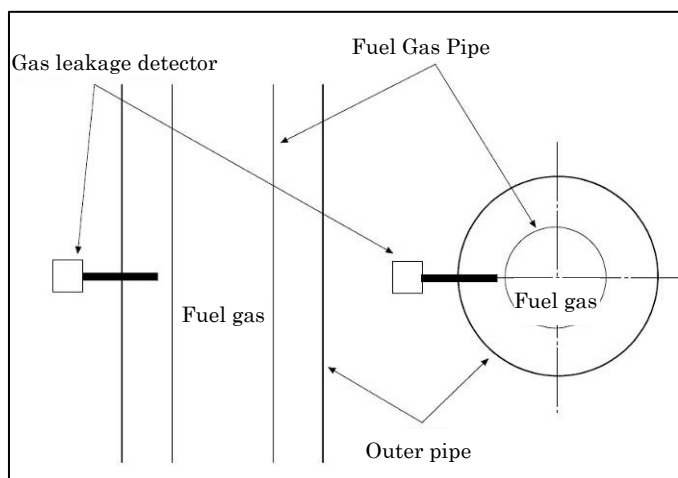
Gas Leakage Detector

Gas leakage detector

The inspection of the gas leakage detectors revealed that there was no damage to the fuel gas pipes. However, a failure was found at the base of the detection unit. An alarm error had activated the warning device (for the increase of gas concentration) and also stopped the burning of BOG in the main boilers to occur a flame failure.

According to Chapters 2.1, 2.5.5 (2), 2.8.1, and 2.9.1, gas leakage detectors are devices that detect the increase of gas concentration caused by BOG leakage due to factors such as damage to any fuel gas pipe, and emit a warning signal in response to the gas concentration. At the time of the incident, a gas leakage detector emitted a warning signal that indicated an increased gas concentration, and then the burning of BOG then stopped in the main boilers, indicating flame failure in the main boilers. However, in actuality, no fuel gas pipes were damaged, and the gas concentration had not increased. Therefore, it is probable that the base of the detection unit was defective, and that the warning signal was wrongly emitted because of the defect.

- Replacement of the broken gas leakage detector with a new one

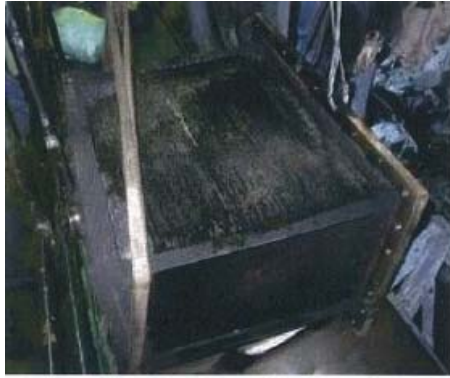
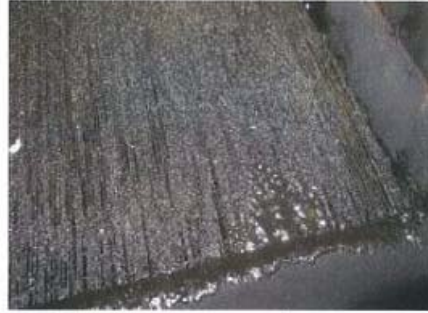
Soiling of the air side of the air condenser of the stand-by diesel generator

According to Chapters 2.1, 2.8.2, and 2.8.3, at the time of the incident, it is probable that the air side of the air inter cooler of the stand-by diesel generator was clogged; that a load which exceeds 380 kW could not be placed on the generator because the amount of air supply was insufficient when the generator was operated to increase the load; that a diode on an electric circuit on the main switchboard was loose; and that there was a problem with the ACB for the emergency diesel generator and it could not be closed.

- Replacement of the air inter cooler with a new one
- Inspection and overhaul of the supercharger
- Inspection and maintenance of the cooling fresh water system

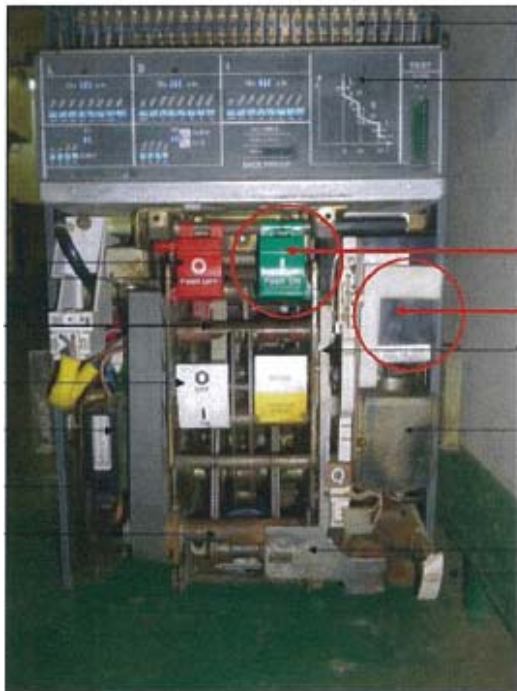
CLOSE button
Solenoid valve for closure operation

ACB for the emergency diesel generator
(The ACB is removed from the generator)

Damage to the ACB for the emergency diesel generator

generator was automatically started. However, due to damage to the ACB, the ACB could not be closed.

- Inspection, such as the switchboard
- Replacement of the ACB with new one

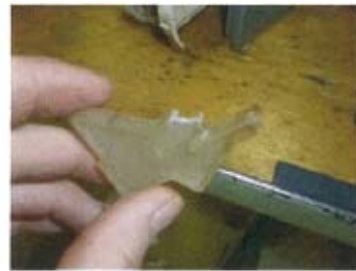
- (a) damage to a plastic part in the internal linkage mechanism behind the CLOSE button of the ACB,
- (b) operation failure of the spring as well as the solenoid valve for the closure operation, and
- (c) The melting of a fuse on the electric circuit in the emergency switchboard and the failure of a relay on the circuit.

Damage to a plastic part in the internal linkage mechanism

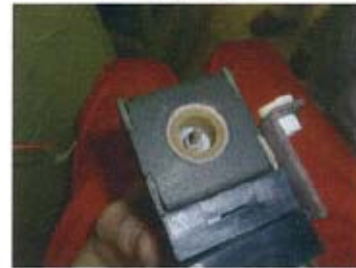
Damage to the solenoid valve for closure operation
