MA2012-12

**MARINE ACCIDENT
INVESTIGATION REPORT**

Vessel type and name: Chemical Tanker SEIYO
Vessel number: 137203
Gross tonnage: 499 tons

Accident type: Foundering
Date and time: Around 09:22 (Local time, UTC+9 hours), January 9, 2011,
Location: South-west off Sado Island, Sado City, Niigata Prefecture,
Around 216° true bearing, 16.0 km from Sawazakihana lighthouse
located at Sado City,
(approximately 37°42.5'N, 138°05.6'E)

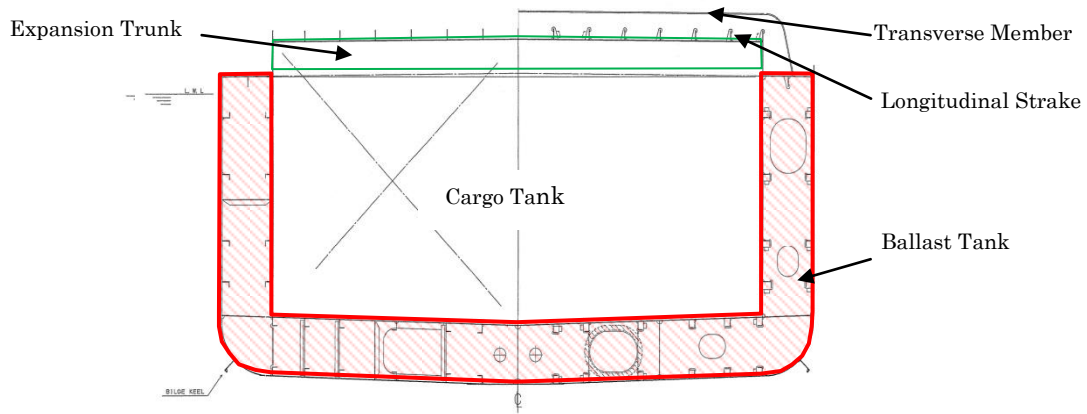
Figure 2-3 Arrangement of Expansion Trunks, Cargo Tanks and Ballast Tanks

Each cargo tank is provided with an expansion trunk on top of it, and the upper surface of cargo tank is higher than the upper deck by about 0.50m at the ship side and by about 0.55 in the center of the hull.

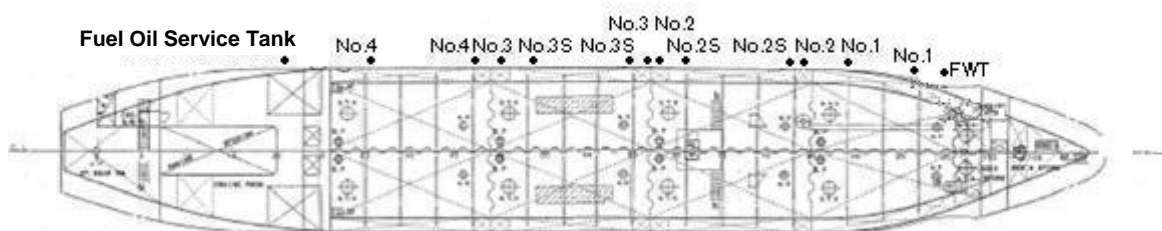
Figure 2-4 Air Vent Piping Arrangement on the Port Side
(Arrangement on the starboard side is same except fuel oil service tank)

- b) When the Vessel was built, water tightness against weather was required for the air vent pipe head but tightness against water pressure was not required.
- c) When the Vessel underwent a periodic inspection in February 2009, the inspection for air vent pipe was carried out and there was no problem found.

- a) When the Vessel docked at the ship repair company in February 2009, air vent pipes were removed at 24 points and the repair works were executed. However, this ship repair company filed an application for court-led rehabilitation proceedings and went bankrupt which made the information on the maintenance and inspection unavailable.
- b) When the Vessel poured sea water into ballast tank, they used to confirm that the ballast tank was filled with water by observing that the sea water came out of air vent pipe head.
- c) An overhaul of the air vent pipe head of the air vent pipes was not performed by the crew members on board and the pipe head was not furnished with a waterproof cover.

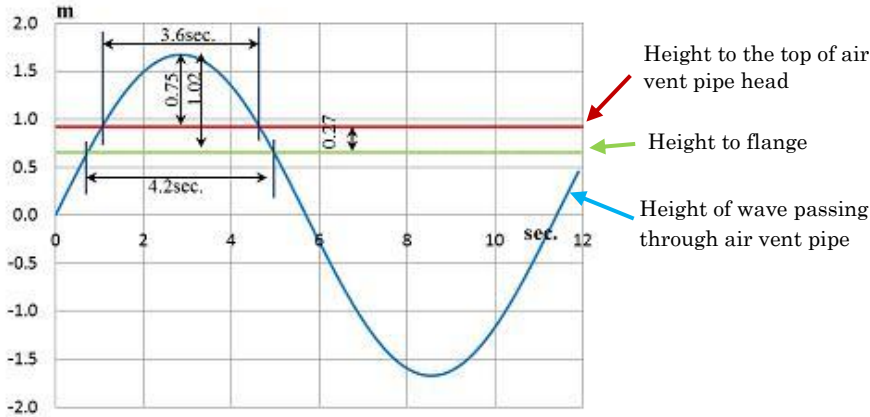
Figure 2-7 Situation of Wave Passing through Air Vent Pipe

When the rolling motion increased (at around 04:00) as described in the paragraph 2.8.3 (2) below, the disc float type air vent pipe head of inner diameter 100 mm was in such a situation where sea water remained on the port side upper deck and the port side expansion trunks, the heel of the Vessel to port increased and caused the air vent pipe heads repeatedly to submerge in the water due to the waves. Therefore, in order to simulate the same situation, an air vent pipe

The depth from the water surface to the flange was 1.02 m.
 Submerging period was 4.2 seconds.

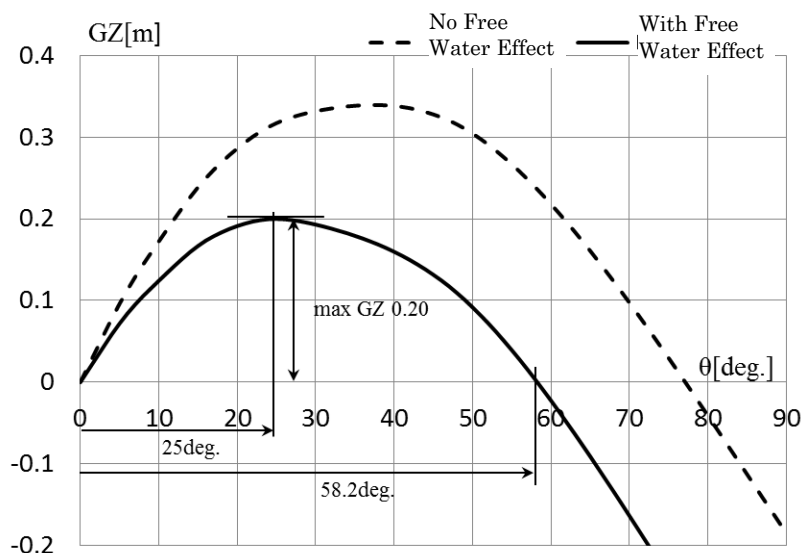
Figure 2-10 Stability Curve in Case of No Water Inflow from Air Vent Pipe

By using the factors such as the Vessel's departure draft, stability data prepared for a master according to the provisions of the Ship Safety Act (hereinafter referred to as "Stability Data"), cargo loading conditions and fuel oil quantity at her departure, the displacement (W) was estimated to be 1,751.55 t, the metacentric height (G₀M), after taking the free water effect into consideration, to be 0.839 m, natural period of rolling to be 8.76 seconds, and the stability curve for the Vessel was estimated as per the following figure.

Based on the above, the verification of whether or not the Vessel complies with the Ship Stability Rule under the conditions mentioned in above paragraph (1) resulted in ascertaining that whereas the rules provide that a ship should have righting lever*23 bigger than 0.2 m at a heel angle bigger than 30°, the Vessel has righting lever of 0.19 m at a heel angle of 30° which is lower by 0.01 m.

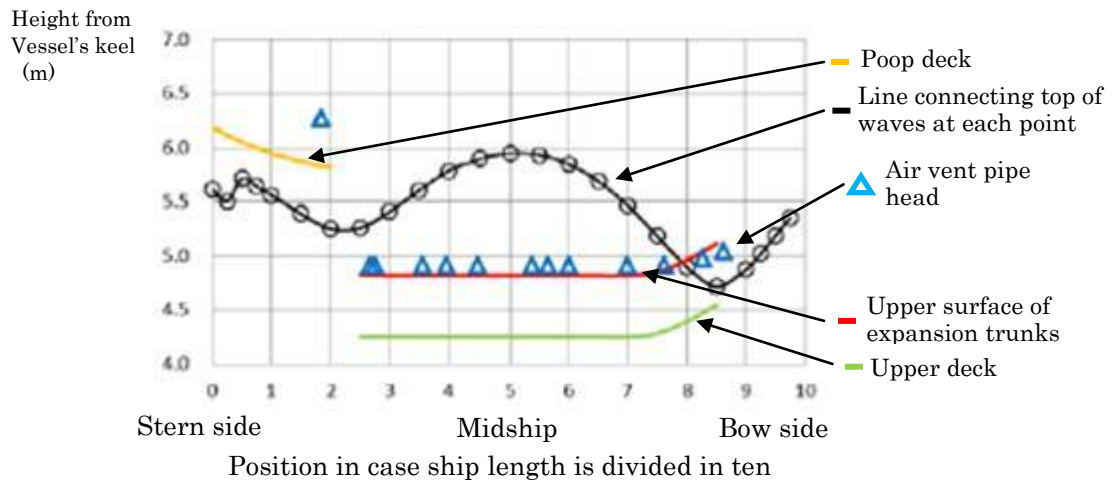
Figure 2-12 Calculation Results when Vessel has Steady Heel to Port at an Angle of about 4.5°
2) Point II

Based on the assumption that the Vessel had a steady heel to port at an angle of about 4.5° at Point I, it is probable that about 24.8 tons of sea water washed on the port side of the upper deck and the expansion trunks to remain there causing about 15 tons of sea water to flow into the port side ballast tanks, and that, as shown in the following figure, the waves coming from the port side reached over the expansion trunks and the air vent pipes of the port side ballast tanks and allowed to submerge the air vent pipe heads in the water.

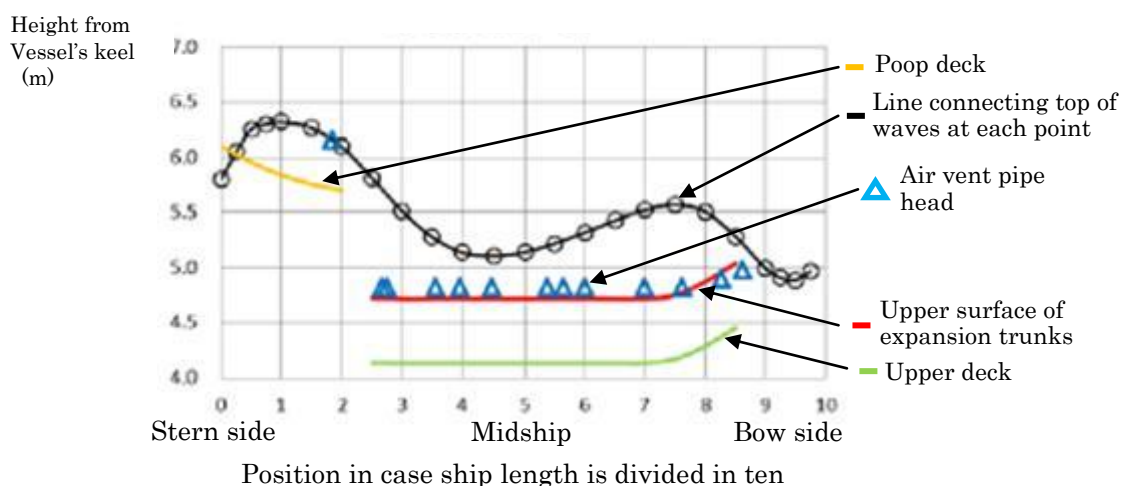
Figure 2-13 Calculation Results when Vessel has Steady Heel to Port at an Angle of about 5.8°

Based on the assumption that the Vessel had a steady heel to port at an angle of about 5.8° at Point II, it is probable that about 24.8 tons of sea water washed on the port side of the upper deck and the expansion trunks to remain there causing about 17.1 tons of sea water to flow into the port side ballast tanks, and that, as shown in the following figure, the waves coming from the port side reached over the air vent pipes of the port side ballast tanks and the air vent pipes of the fuel oil service tank on the poop deck and allowed to submerge respective air vent pipe heads in the water.

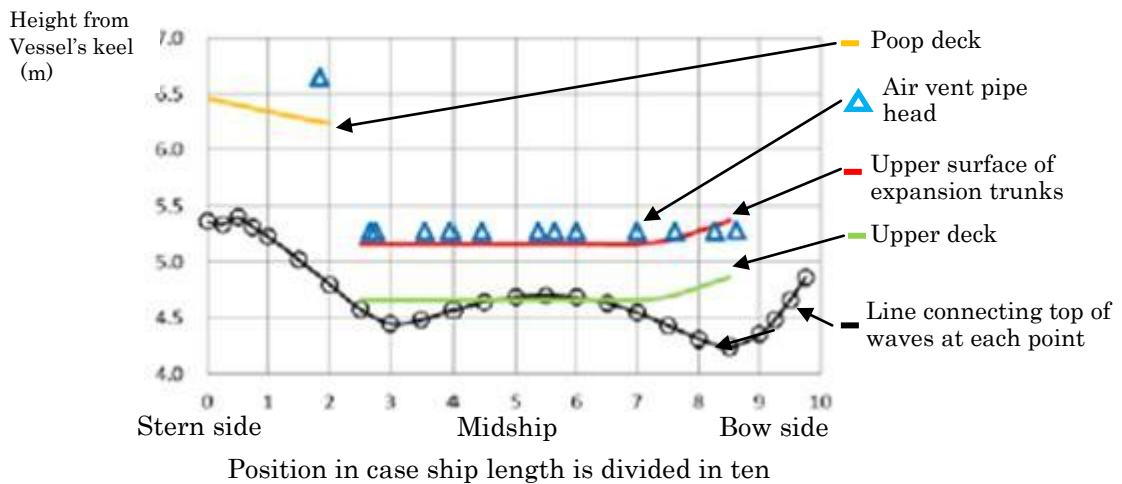
Figure 2-14 Calculation Results when Vessel has Steady Heel 0°

However, in case that water did not flow in the port side ballast tanks, the waves coming from the port side did not reach the air vent pipes of the ballast tanks and service tanks as shown in the following figure.

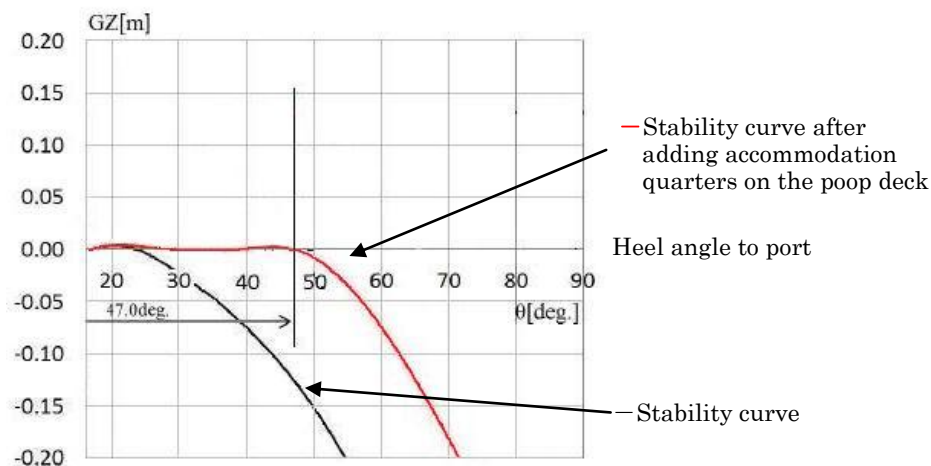
Figure 2-15 Vessel's Stability Curve with Steady Heel at an Angle of 16.5°

The Vessel's stability curve, as shown in the figure 2-10, when the steady heel increases, turns out to be the one having an intersection of a heel angle and the stability curve as a coordinate origin and the righting lever decreases as the steady heel increases.

The Vessel was in the situation where her righting lever diminished to nearly zero, when the angle of steady heel to port was about 16.5°, as shown with black stability curve. However, since the entrance on the poop deck kept closed, the calculation of her righting lever was done by adding the buoyancy of the accommodation quarters on the poop deck to find that she was in the situation where, as shown by red stability curve, with the heel angle of between about 16.5° and about 47.0°, her righting lever became almost zero and stabilized, and that she could be settled in a position with a steady heel at any angle within this range. The Vessel had the risk of capsizing by losing stability when her steady heel angle exceeded about 47.0°.

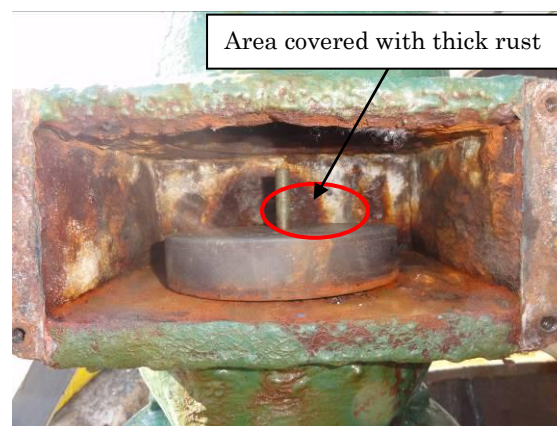
As a result of research on air vent pipe heads for other ships, there was an air vent pipe head found in which the casting section to cover a disc float was rusty as shown in the following photo, and particularly the thick rust generated inside the pipe head interrupted the movement of the disc float and rendered the disc float incapable of moving up to the highest point to shut the opening of the air vent pipe head.

In this respect, it would be appreciated if you could advise members of your organization to thoroughly perform maintenance of the air vent pipe heads of the air vent pipes.
