MA2014-8

**MARINE ACCIDENT
INVESTIGATION REPORT**

Vessel Type and Name: Cargo Ship YUSHO SEVEN

Accident Type: Fatality of a stevedore

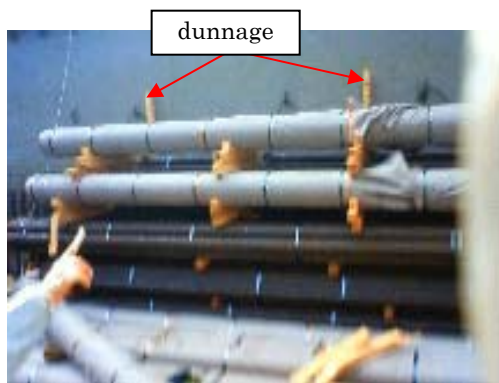
Photo 2.1-2 Laying of dunnage 1

Stevedores planned to insert wedges after the Kaohsiung Cargo had been stacked on both sides and they did not insert wedges on all tiers due to the fact that there was a mixture of pairs of Bundled Pipes and Wrapped Pipes that could not tumble down although there were still some Wrapped Pipes consisting of single pipes. (See Photo 2.1-2, Photo 2.1-3)

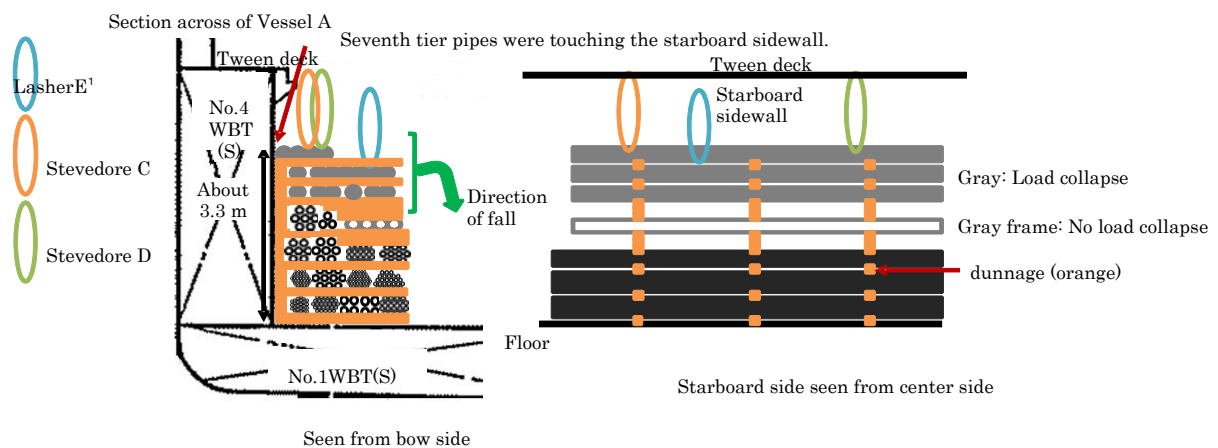
Figure 2.1-2 Positions of Lasher and Stevedores

In accordance with the instruction from No. 1 cargo hold supervisor to try to move the Pipe, Stevedore C and Stevedore D inserted a turnbuckle between the sidewall and the Pipe, and moved it right and left, but they could not move the Pipe. Stevedore C had never used a turnbuckle to move pipes before.

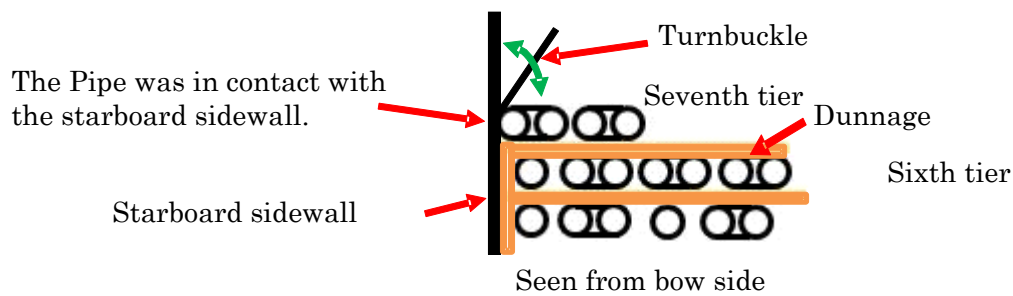
Figure 2.1-3 Use of the Turnbuckle

After moving the turnbuckle from side to side many times on the aft end, Stevedore C and Stevedore D managed to create a clearance gap to pull out the wire rope. They did the same on the fore end and created a clearance gap about 10 cm wide on the fore end to pull out the wire rope. Stevedore C was told by Lasher E₁ that the wire rope could be pulled out.

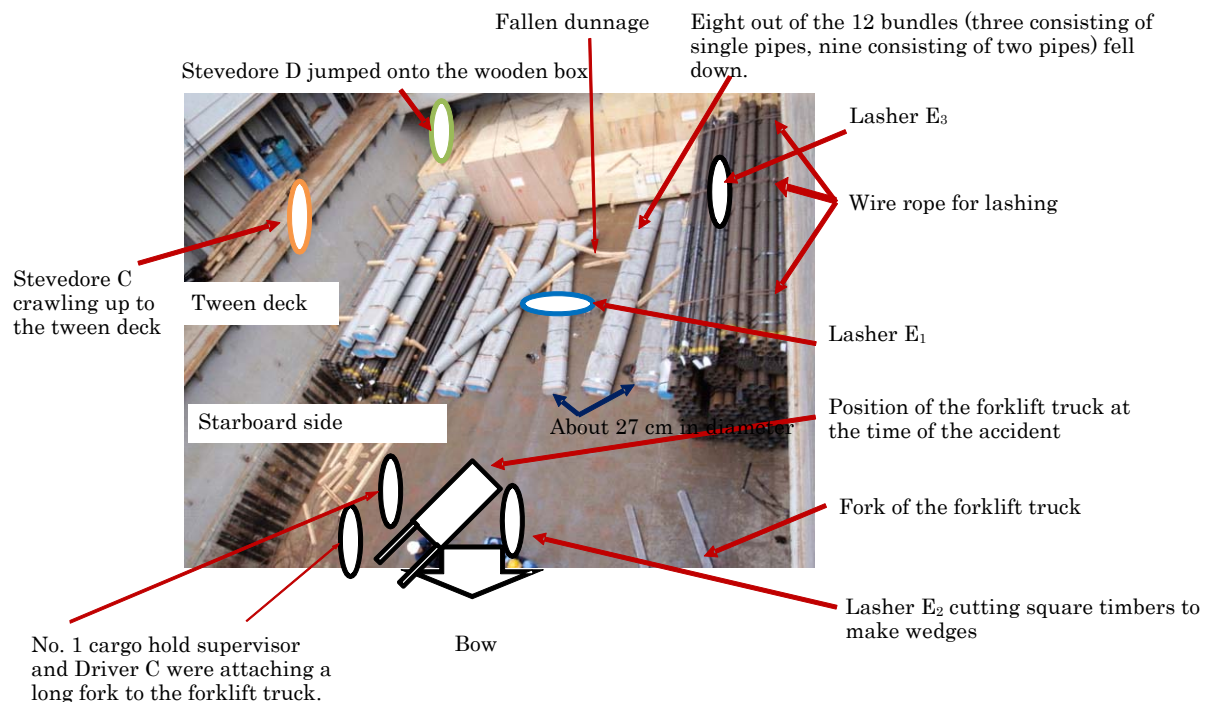
Photo 2.1-8 Situation on the Lower Deck of No. 1 Cargo Hold after the Cargo Collapsed

At around 15:45, Lasher E₁ started walking from fore to aft on the port side of the Wrapped Pipes on the sixth tier, stopped in the middle of the pipes and turned around to starboard, but could not step over the Pipe and fell down onto the lower deck with the Wrapped Pipes, which fell on top of him.
