MA2014-6

**MARINE ACCIDENT
INVESTIGATION REPORT**

MARINE ACCIDENT INVESTIGATION REPORT

Accident type	Fatality of crew members
Date and time	Around 14:20 on July 2nd, 2012 (local time, UTC+9 hours)
Location	Heigun-suido Channel, Yamaguchi Prefecture Around 119° true bearing, 2.3 nautical miles (M) from Shimoninai Island Lighthouse located in the town of Suo-oshima, Yamaguchi Prefecture (approximately 33°49.7'N,132°13.4'E)
Summary of the Accident	While the chemical tanker CHEM HANA was proceeding in the Heigun-suido Channel off the south of Yashiro Island in the town of Suo-oshima after unloading around 960 tons of acetone at Kanmon Port, two of the crew members who were cleaning cargo tanks fell into cardiopulmonary arrest at around 14:20 on July 2nd, 2012, and were confirmed dead at the hospital they were taken to.
Process and Progress of the Investigation	(1) Setup of the Investigation The Japan Transport Safety Board appointed an investigator-in-charge and a marine accident investigator to investigate this accident on July 2nd, 2012. (2) Comments from Parties Relevant to the Cause Comments on the draft report were invited from parties relevant to the cause of accident. (3) Com

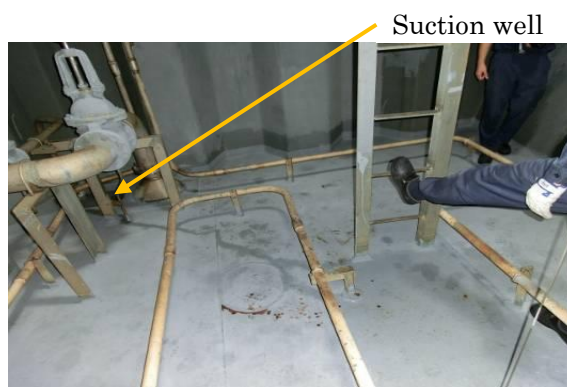
Photo 2: Bottom of No.2 cargo tank (port side)

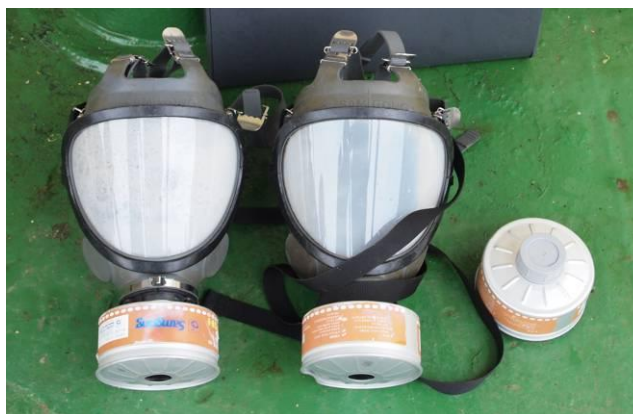
When the chief officer and AB-A wore their gas masks to enter No.1 cargo tank (port side), they loaded them with a new canister. The canister, filled with an intermediate concentration organic compound, had usage instructions on its surface reading “Must be used in the presence of gas concentration of less than 1% and oxygen concentration of more than 18%.”

Photo 3: Canister-type gas masks
