MA2014-6

**MARINE ACCIDENT
INVESTIGATION REPORT**

Vessel type and name: Bulk Carrier NIKKEI TIGER
IMO number: 9159438
Gross tonnage: 25,074 tons

Vessel type and name: Fishing Vessel HORIEI-MARU
Fishing vessel registration number: ME1-937
Gross tonnage: 119 tons

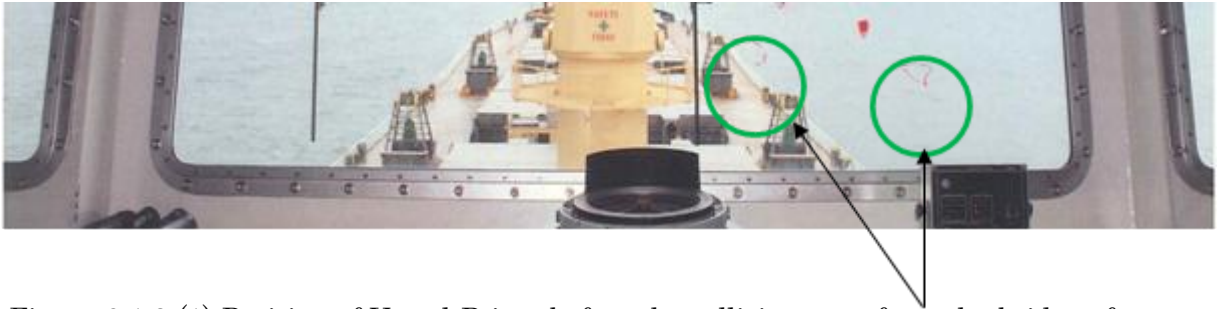
Figure 2.1.3 (1) Position of Vessel B just before the collision seen from the bridge of Vessel A

Helmsman A, after Vessel B hid in the starboard bow blind zone of Vessel A (in a situation of limited range of view) and became invisible from the bridge, felt slight hull vibrations before 01:56:07 on September 24. (See Figure 2.1.3 (1))

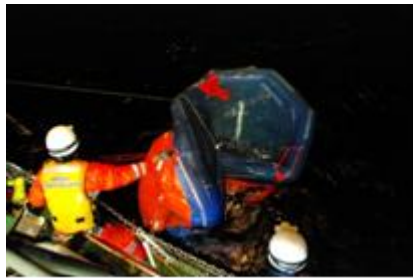
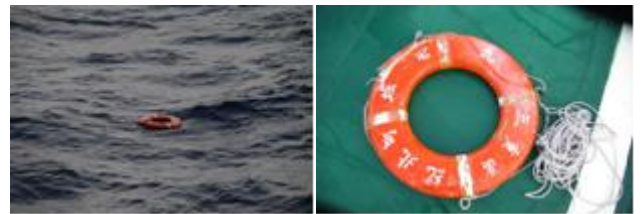
Photo 2.1.4 (2)-1: Recovered Vessel B's Liferaft and Others (courtesy of the Japan Coast Guard)

Liferaft

Lifebuoy

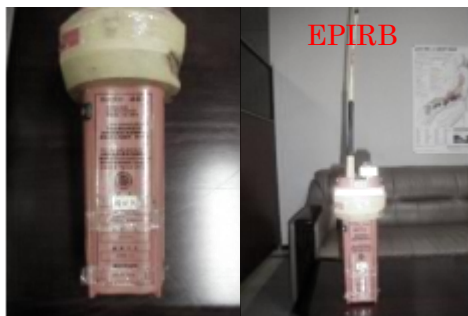
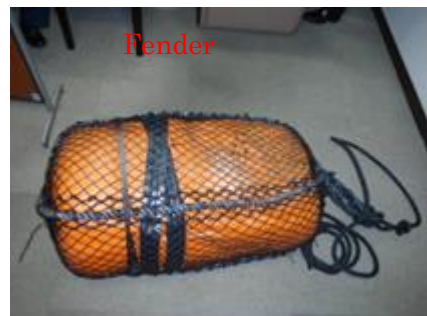
Photo 2.1.4 (2)-2: Recovered Vessel B's EPIRB and Fender Held by Group 1 during Their Drift

EPIRB

Fender

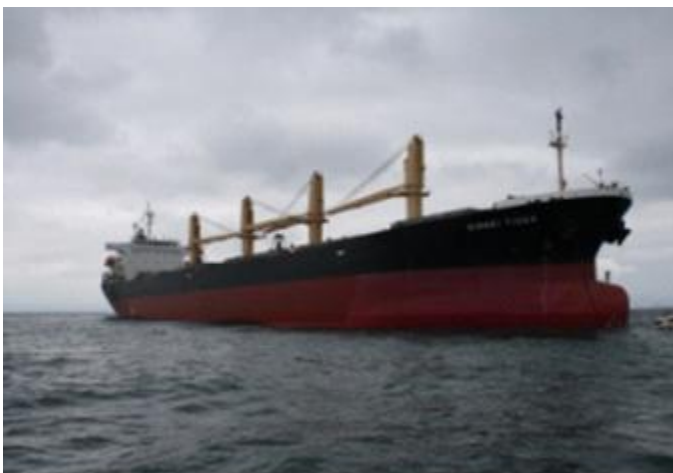
Photo 2.5.1 (1): Photo of Vessel A

Vessel A suffered abrasive damage to the bow, but received no significant damage that affected its seaworthiness.
