**MARINE ACCIDENT
INVESTIGATION REPORT**

Vessel type and name: Container ship BAI CHAY BRIDGE

Vessel type and name: Fishing vessel SEIHOU MARU No. 18

Accident type: Collision

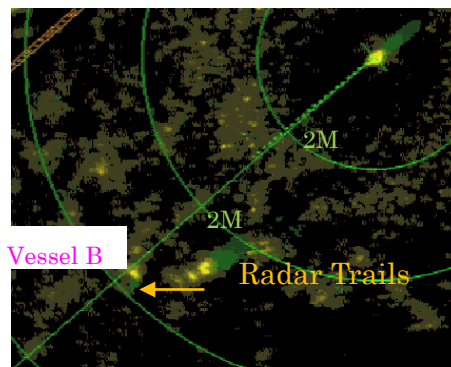
Photo 2.1-1 Echo and Radar Trails of Vessel B

The echo of Vessel B appeared on the radar screen at around 22:58 and stayed there.

1. The radar trails are Vessel B's true headings.
2. The radar trails were displayed starting at around 22:58:12, showing Vessel B at about 5.7 M from Vessel A. (See Photo 2.1-1.)

3. The radar trails were displayed on the screen in the direction of about 023° (true bearing; hereafter the same) from around 23:02:12 to around 23:08:12.
4. The radar trails were displayed on the screen in the direction of about 090° from around 23:08:12 to around 23:10:57.
5. The radar trails were displayed on the screen in the direction of about 155° from around 23:10:57 to around 23:12:12.

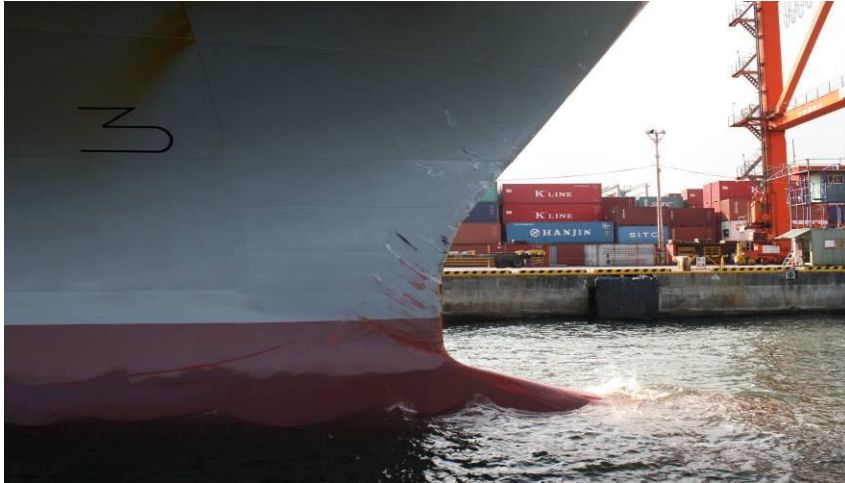
Photo 4 Damage to Vessel A's Starboard Side

The statements of Master A and the photographs showing damage to Vessel A indicate that Vessel A sustained scratches to its bow.

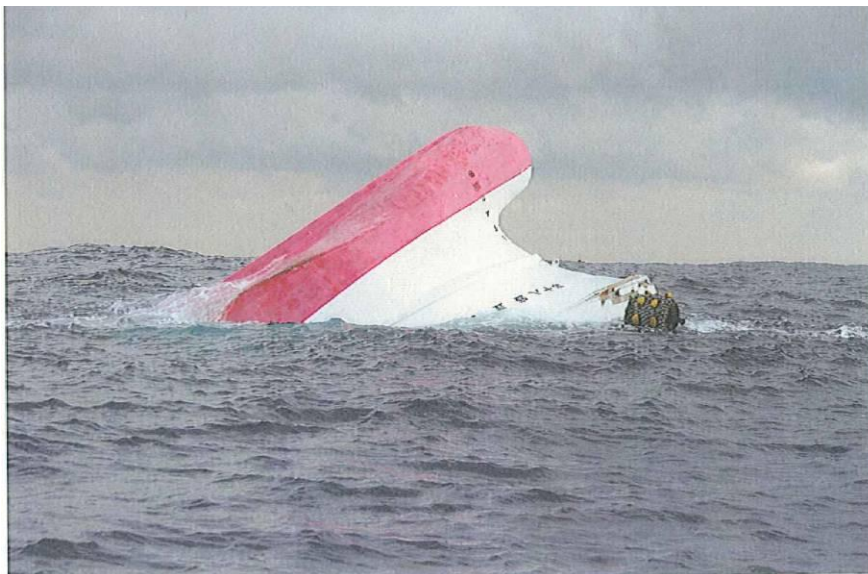
Photo 6 Vessel B Left Adrift – Around 13:30, January 24, 2013

Based on the statements of Skipper B and the photograph showing it drifting, Vessel B is thought to have broken apart at around the middle of the hull. As Vessel B was subsequently left adrift before sinking, details of the damage caused in the collision could not be ascertained.
