MA2014-12

**MARINE ACCIDENT
INVESTIGATION REPORT**

Marine Accident Investigation Report

Accident type	Capsize
Date and time	Around 15:44 on April 9, 2013 (local time, UTC+9 hours)
Location	Off Fukui #4 Berth, Hamada Port, Hamada City, Shimane Prefecture Around 070° true bearing, 600m from Hamada Port West Breakwater Lighthouse (approximately 34°52.9' N, 132°03.2' E)
Summary of the Accident	During its service to help unberth container ship MERRY STAR at Hamada Port, Hamada City, Shimane Prefecture, work boat Koun Maru No. 58, with a captain and one worker on board, capsized around 15:44 on April 9, 2013. The captain died.
Process and Progress of the Investigation	<p>(1) Setup of the Investigation On April 10, 2013, the Japan Transport Safety Board appointed an investigator-in-charge and two marine accident investigators to investigate this accident.</p> <p>(2) Collection of Evidence On-site investigation and interviews on April 11 and 12, 2013; interviews and collection of written replies to the questionnaires on April 16, 18, and 30, 2013; interviews on April 24, June 4, 5, 10, and 13, 2013, and February 27, June 17, July 7, August 5, and September 1, 2014</p> <p>(3) Comments on

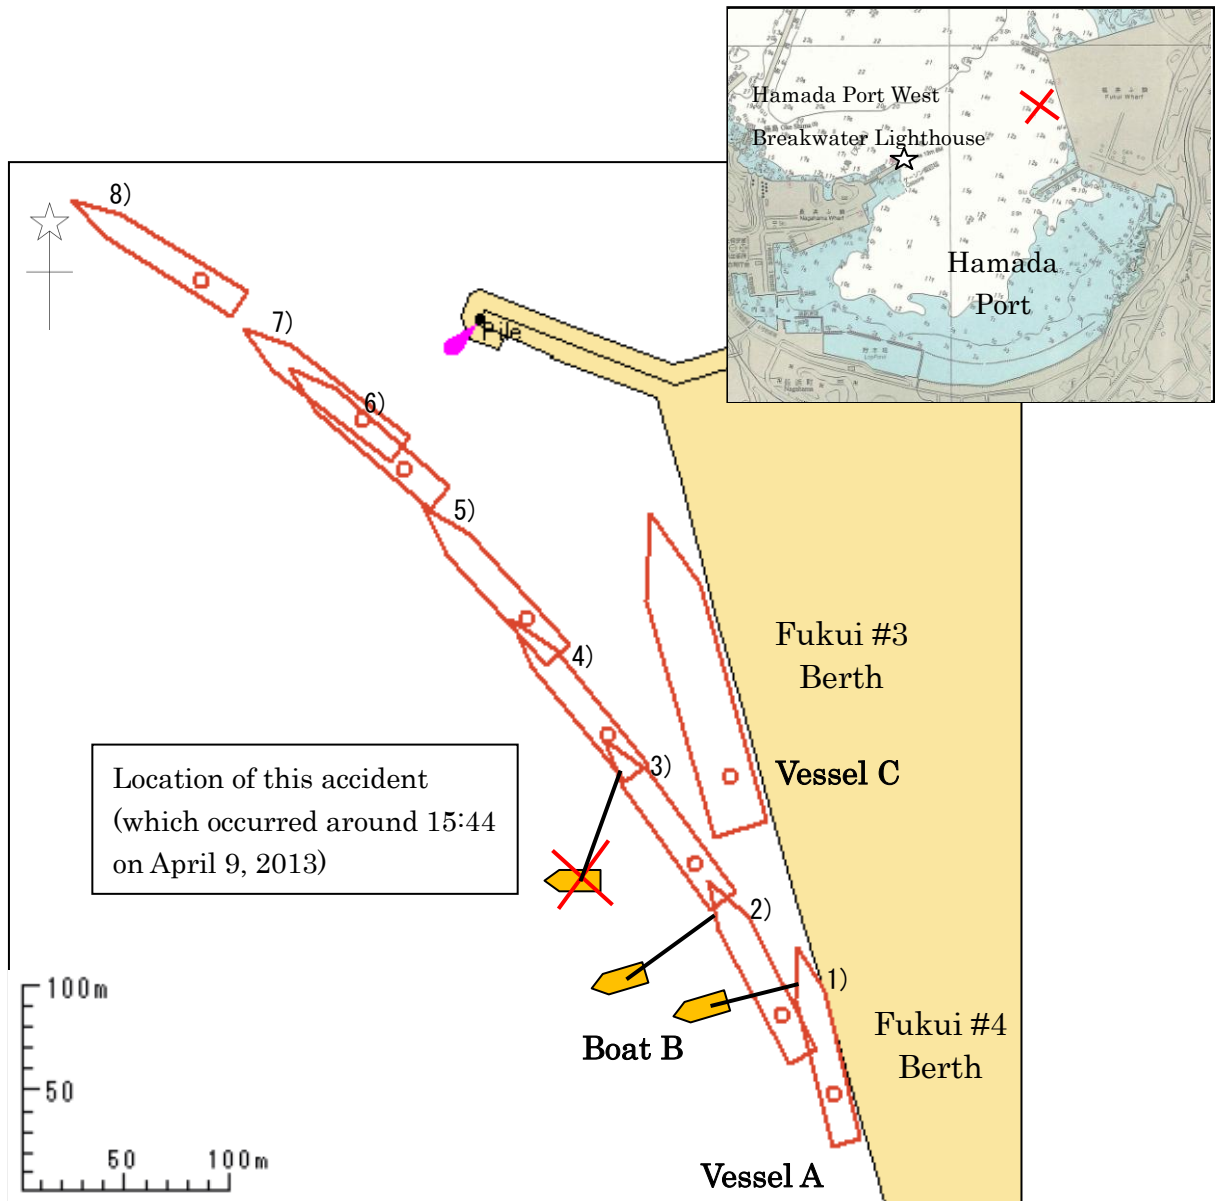
Appended Figure 1: Schematic View of How this Accident Occurred

<p>(8) It is probable that the following things occurred. Because Vessel A increased its speed, Boat B moved from the 8 o'clock position further to the stern direction of Vessel A. Around 15:44, Boat B was pulled abeam and capsized.</p> <p>(9) It is probable that the following things occurred. Captain A did not inform Boat B that Vessel A would be increasing its speed. Although having increased its speed, Captain A paid more attention to preventing Vessel A from being drifted toward Vessel C, without checking the status of Boat B. Vessel A pulled abeam Boat B as a result.</p> <p>(10) It is somewhat likely that the following things occurred. If Captain A had informed Boat B ahead of time that Vessel A would be increasing its speed, by means of direct communication such as transceivers, the boat could have understood the intent of Vessel A and removed the tow line from the hook, and Vessel A could have prevented pulling the boat abeam.</p> <p>(11) It is somewhat likely that the following things occurred. Captain B floated on the sea surface, with a lifejacket on, but the captain's consciousness deteriorated with time. The captain's lifejacket was caught by something in vessel structure, which produced a split on the back, and the captain was no longer able to wear the lifejacket adequately. Because Captain B had died, the situation could not be determined.</p> <p>(12) The direct cause of Captain B's death was suffocation by seawater inhalation induced by subarachnoid hemorrhage.</p>

<p>Probable Causes</p>	<p>It is probable that this accident occurred as follows. When unberthing from the quay to depart from Hamada Port, Vessel A veered out its mooring line as a tow line to Boat B, now positioned in the port bow direction, and had Boat B tow Vessel A to the port beam direction. When Captain A increased speed to prevent Vessel A from being drifted toward Vessel C, Boat B moved to the stern direction of Vessel A. Vessel A tried to cast off the tow line but could not, and as a result, Boat B was pulled abeam by Vessel A and capsized.</p> <p>It is probable that Vessel A pulled abeam Boat B, because Captain A did not inform Boat B that Vessel A would be increasing its speed, and because after increasing its speed, Captain A paid more attention to preventing Vessel A from being drifted toward Vessel C, without checking the status of the boat.</p>
<p>Safety Actions</p>	<p>After this accident, Company B came up with safety actions and decided to implement the following measures.</p> <p>(1) Boat B should not be used for vessel unberthing assistance operations in the future.</p> <p>(2) The existing hook on Boat B was replaced with one equipped with an emergency breakaway device. (See Photo 7)</p> <p>(3) The existing lifejackets were replaced with long-johns type lifejackets.</p>

To prevent recurrence of similar accidents in the future, the following things are considered useful:

1) When the vessel uses a boat for berthing or unberthing support, the vessel should understand the important features of the boat and should not increase its speed in a way that pulls the boat abeam.

2) When the vessel uses a boat for berthing or unberthing support, the vessel should use transceivers that would allow for direct communication.
