**MARINE ACCIDENT
INVESTIGATION REPORT**

Vessel type and name: Chemical tanker Nisshomaru

Accident Type: Fatality and injury of crew

Date and time: Around 11:27, June 28, 2011

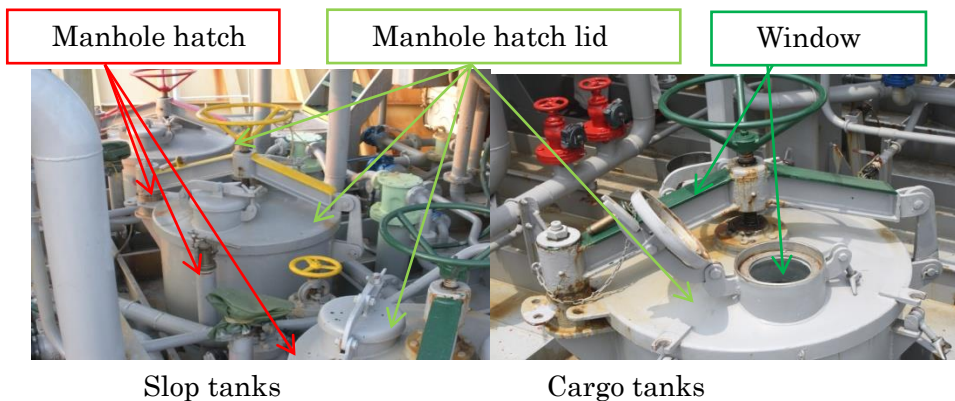
(Photo 2.5-1 Manhole hatches for slop tanks and cargo tanks)

The diameter of the manhole hatch was approximately 72cm for slop tanks and approximately 75cm for cargo tanks. The height of the manhole hatch opening from the expansion trunk was approximately 59cm for slop tanks and approximately 62cm for cargo tanks.

There were 2 windows with approximately 15cm diameter glass on the lid of the manhole hatches, enabling monitoring of cargo liquid surface, etc. within the tanks.

- (6) It is probable that the Vessel crew members usually opened the manhole hatch lids for slop tanks in case tank wash water leaked from the slop tank exhaust pipe outlet in order to stop the leak because they were concerned about the effect of tank wash water on the human body.

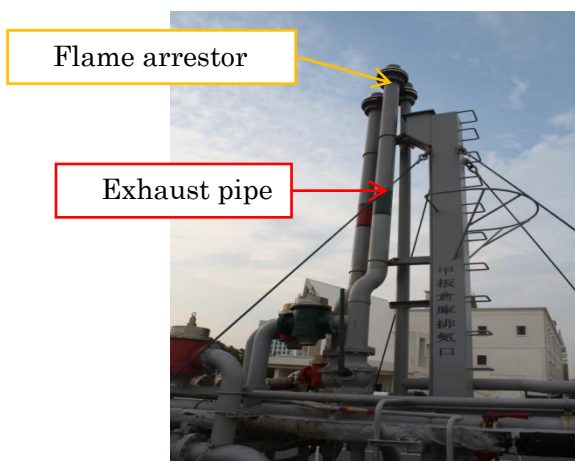
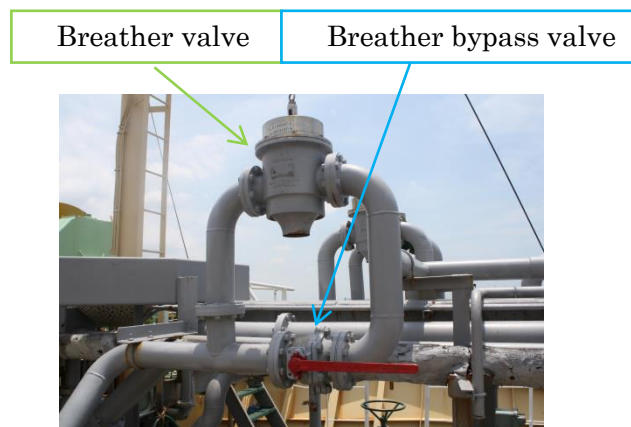
(Photo 2.5-3 Exhaust pipe, etc.) (Photo 2.5-4 Breather bypass valve , etc.)

Exhaust pipes were installed on slop tanks (starboard/center/port) as well as cargo tanks (starboard/port). Pipes coming out of the manhole hatch of each slop tank were integrated into one, pipes coming out of the air hatch of each of the No.1 and No.3 cargo tanks (starboard/port) were integrated into one, and pipes coming out of the air hatch of each of the No.2 and No.4 cargo tanks (starboard/port) were integrated into one. The tips were approximately 6.5m above the expansion trunk near the center of the No.2 cargo tanks toward the front.

A breather valve*⁹ and a breather bypass valve were installed on the exhaust pipe, and a flame arrestor*¹⁰ was installed at the tip as an outlet.

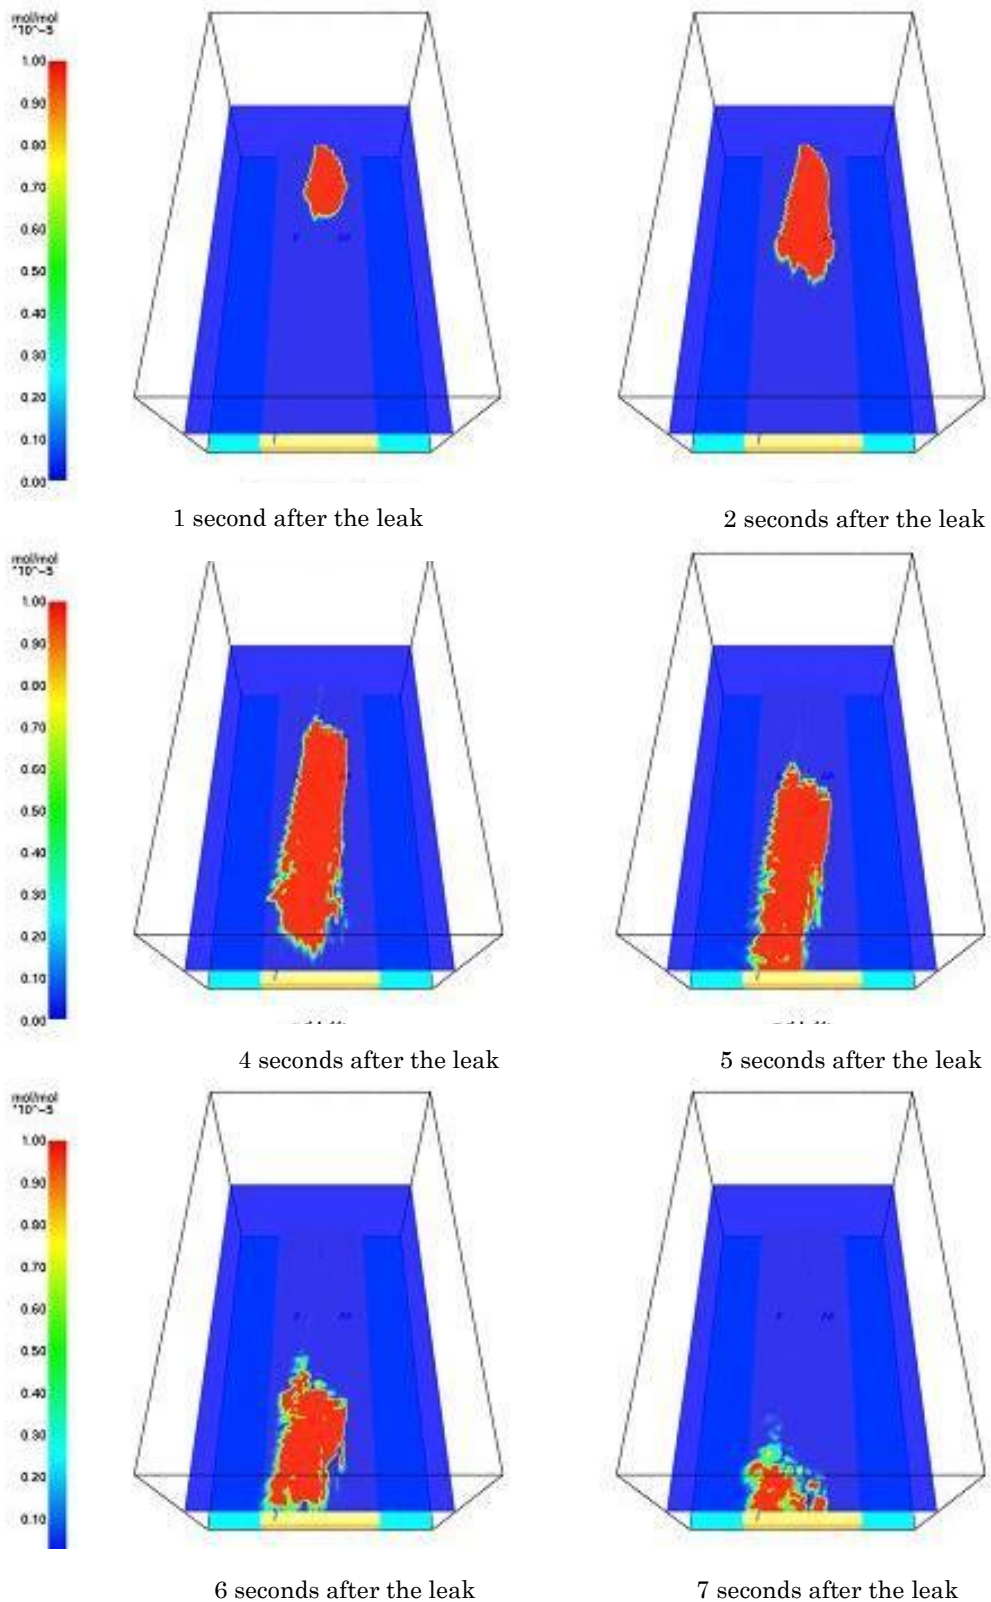
Figure 2.15-3 Hydrogen sulfide gas concentration distribution in horizontal cross-section, including the slop tank exhaust pipe outlet

Hydrogen sulfide gas concentration distribution in horizontal cross-section, including the slop tank exhaust pipe outlet, is shown in Figure 2.15-3. This shows the concentration distribution of every second up to 7 seconds after the beginning of the leak of hydrogen sulfide gas, excluding the result from 3 seconds after the leak. We have utilized the controlled concentration of 10ppm, which is regulated by the Industrial Safety and Health Law, as one of the indexes to determine the effect of hydrogen sulfide gas on people. The entire high concentration area with over 10ppm is shown in red. We can observe that the distribution form is disrupted due to mixture with surrounding air as the leaked hydrogen sulfide gas proceeds towards the stern and that the range of the high concentration area (red) increases.

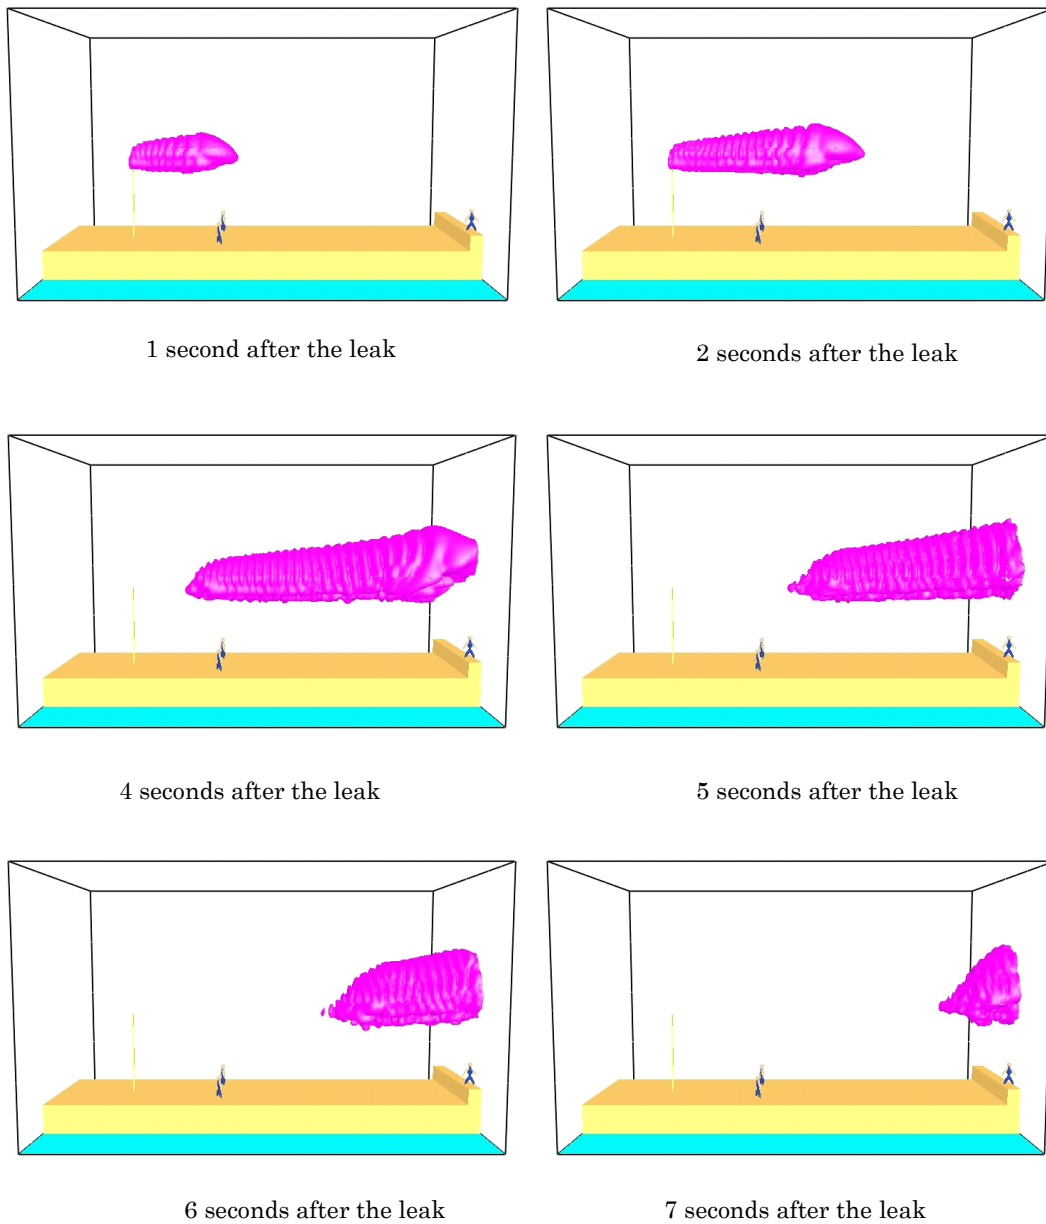
Figure 2.15-4 Change in the isosurface with the 10ppm concentration hydrogen sulfide gas over time

Change in the isosurface with the controlled concentration of 10ppm over time is shown in Figure 2.15-4 in order to confirm the spatial range of high concentration hydrogen sulfide gas in a three-dimensional manner. This shows that the hydrogen sulfide gas, which sprayed out

of the slop tank exhaust pipe outlet, is carried toward the leeward side, where the navigation bridge, etc. is located, while making a thin and long gas cloud. A bore*¹⁴ has been formed at the tip of this gas cloud, and it matches the phenomenon generally seen in gravity flows*¹⁵ of high density gas, which is heavier than air.

10ppm diffuses as far as the deck vicinity is not reproduced. Even if we consider that the numerical simulation in this analysis investigation is based on many hypotheses, it is extremely unlikely that the 3 crew members, who were located relatively close to the slop tank exhaust pipe outlet, would have been affected even if each of these people remained in the same position without evacuating. Therefore, it is valid to consider that this accident involving death and injury was due to a different cause. However, regarding the one crew member toward the stern from the slop tank exhaust pipe outlet, due to the facts that the disturbance effect is increased toward the back of the vessel, that he was positioned higher than the 3 crew members toward the front, and the fact that there were structures with complex forms around such as the cargo pump room companion, we cannot completely deny the possibility that part of the hydrogen sulfide gas that sprayed out of the slop tank exhaust pipe outlet had reached him.

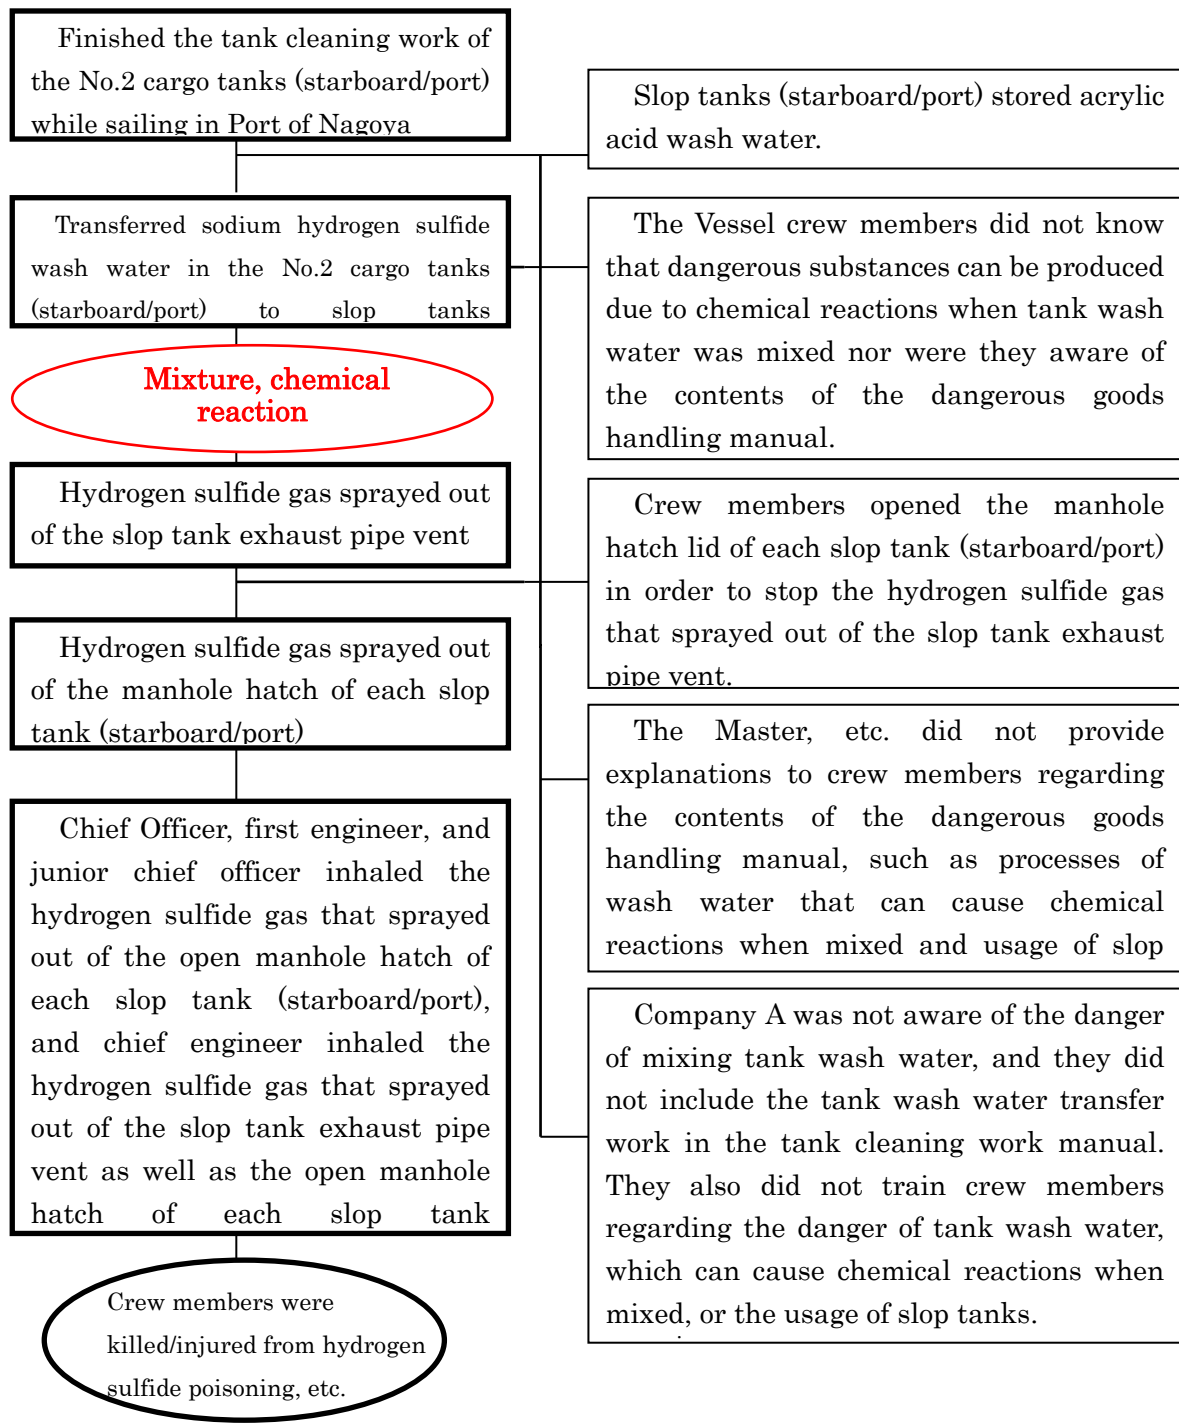
Figure 1 Factors leading to death and injury of crew members (summary)

It is probable that the chief officer, first engineer, and junior chief officer inhaled the hydrogen sulfide gas that sprayed out of manhole hatches and suffered from hydrogen sulfide poisoning due to the fact that they recognized white smoke from the slop tank exhaust pipe outlet and opened the each manhole hatch lid for the slop tanks (starboard/port) while evacuating toward the starboard side of the forecastle deck, which was on the windward side, in order to stop the leak due to the fact that they were concerned about the effect of tank wash water on the human body. However, it is probable that they could have avoided suffering from the poisoning if they had not opened the lid for each manhole hatch due to the fact that the gas would not have diffused toward the windward side of the slop tank exhaust pipe outlet.

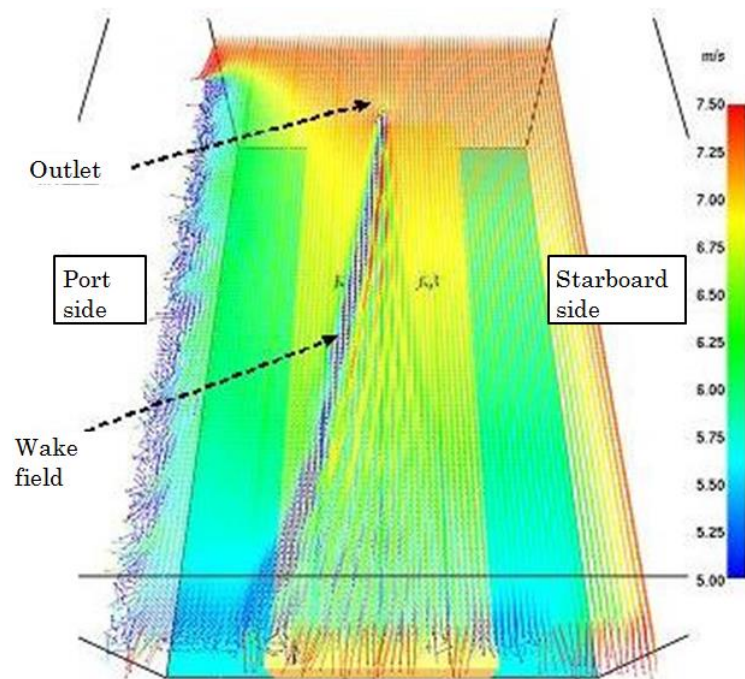
Attached Figure 2-3 Speed distribution in horizontal cross-section 8.5m above the sea surface (This shows the fully-developed gas flow field (momentary value) 15 seconds after the start of the calculation)

Attached Figure 2-3 shows the speed distribution in horizontal cross-section 8.5m above the sea surface as an example of a gas flow field within the calculation range. This shows the

fully-developed gas flow field (momentary value) 15 seconds after the start of the calculation. Since this is the speed distribution 0.3m below the exhaust pipe outlet, we can see that a low speed wake field is formed behind the exhaust pipe due to it affecting the gas flow field as an obstacle. Since the boundary condition is set with the wind direction of starboard bow 5°, we can observe that the wake is leaning toward the port side. In addition, the estimation for the flow speed in this cross-section according to the power law mentioned in the previous clause is $7.4 \times (8.5/9.5)^{0.15} \approx 7.28$ [m/s], indicating that the same level of flow speed is gained around the exhaust pipe outlet shown in Attached Figure 2-3. However, the speed is slower than the expected flow speed on the leeward side of the outlet speed due to the boundary condition effect. The advection diffusion analysis of leaked gas using this gas flow field would evaluate the safety aspect, so we conducted the following simulation based on the judgment that the necessary gas flow field for this analytical investigation is recreated for the most part.

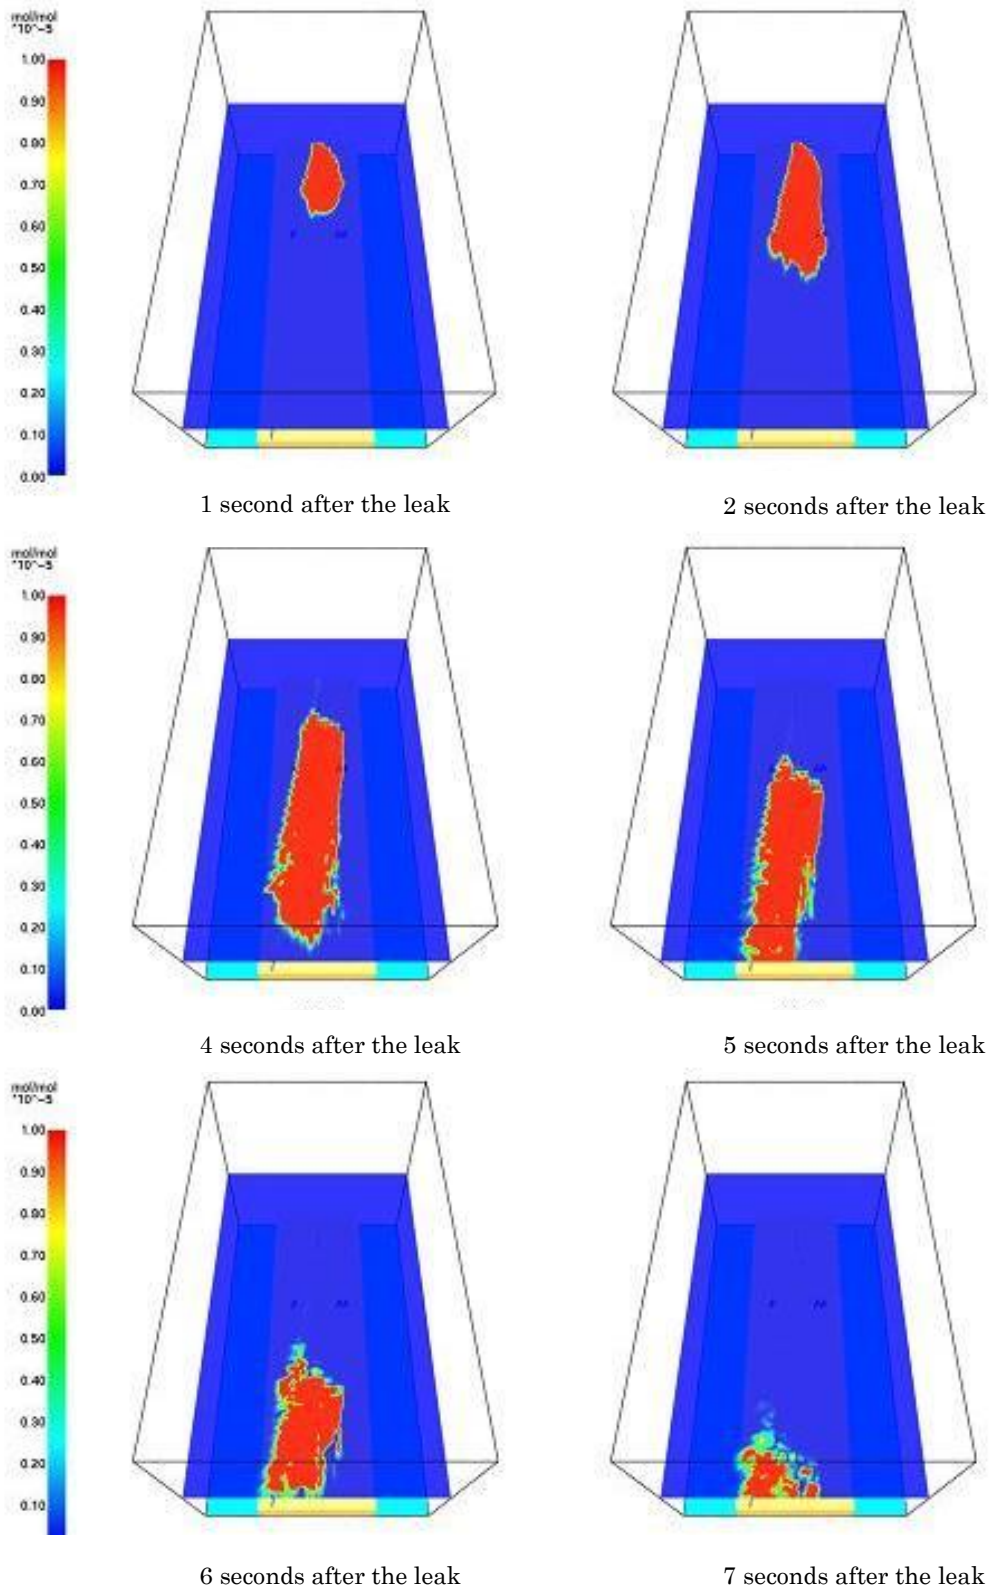
Attached Figure 2-4 Hydrogen sulfide gas concentration distribution in horizontal cross-section, including the exhaust pipe outlet

First, hydrogen sulfide gas concentration distribution in horizontal cross-section, including the slop tank exhaust pipe outlet, is shown in Attached Figure 2-4. This shows the concentration distribution of every second up to 7 seconds after the beginning of the leak of hydrogen sulfide gas, excluding the result from 3 seconds after the leak. We have utilized the controlled concentration of 10ppm, which is regulated by the Industrial Safety and Health Law, as one of the indexes to determine the effect of hydrogen sulfide gas on people. The entire high concentration area with over 10ppm is shown in red. We can observe that the distribution form is disrupted due to mixture with surrounding air as the leaked hydrogen sulfide gas proceeds towards the leeward side and that the width of the high concentration area (red) increases.

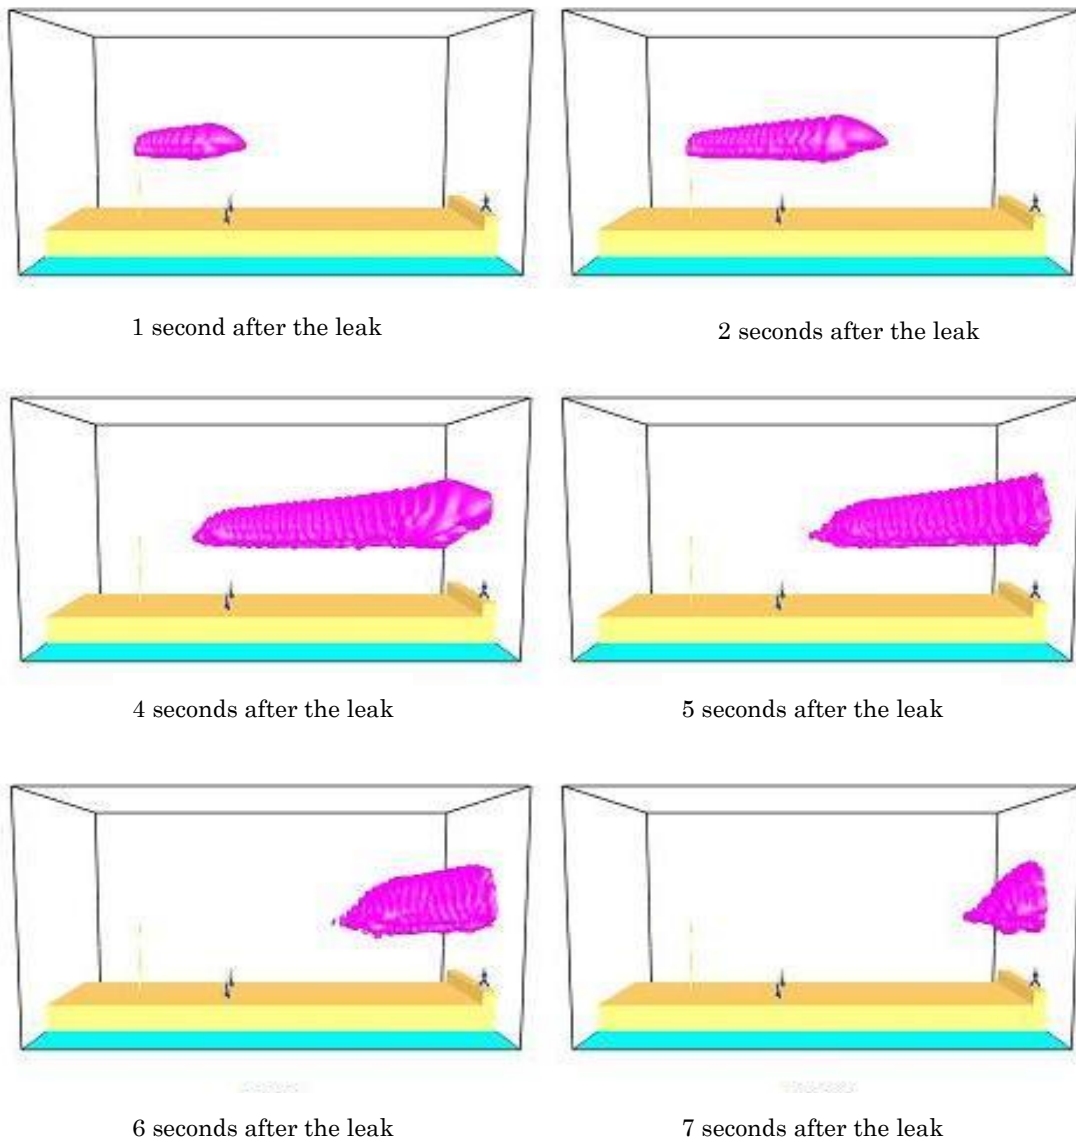
Attached Figure 2-5 Change in the isosurface with the 10ppm concentration hydrogen sulfide gas over time

Next, change in the isosurface with the controlled concentration of 10ppm over time is shown in Attached Figure 2-5 in order to confirm the spatial range of high concentration hydrogen sulfide gas in a three-dimensional manner. This shows that the hydrogen sulfide gas, which sprayed out of the slop tank exhaust pipe outlet, is carried toward the leeward side, where the navigation bridge, etc. is located, while making a thin and long gas cloud. A bore has been formed at the tip of this gas cloud, and it matches the phenomenon generally seen in gravity flows of high density gas, which is heavier than air. Therefore, it is probable that the concentration distribution indicated in Attached Figures 2-4 and 2-5 is a valid calculation result at least from a qualitative perspective.
