MA2015-7

**MARINE ACCIDENT
INVESTIGATION REPORT**

Accident type	Fatality of a crew member
Date and time	Between 03:45 to 03:55 on December 17th, 2013 (local time, UTC-8 hours)
Location	On the Pier of the Morro Redondo Port in the Cedros Island, Baja California State, United States of Mexico (approximately 28° 02.6'N, 115° 10.7'W)
Summary of the Accident	While the Cargo ship ONOE with twenty crew, including the Master and the second officer, was under the cargo handling load of the sea salt at the pier of the Morro Redondo Port in the Cedros Island, Baja California State, United States of Mexico on December 17th, 2013, and between 03:45 and 03:55, the second officer fell from the gangway of the land boarding facility to the pier underneath, which is about 5 to 6 meters in height, and died.
Process and Progress of the Investigation	<p>(1) Setup of the Investigation The Japan Transport Safety Board appointed an investigator to investigate this accident on February 17th, 2014.</p> <p>(2) Collection of Evidence Collection of questionnaire on February 18, 26, and 27; March 7, 11, and 25; July 10; August 14; September 3, 8, 11, 16, 24, and 29, 2014.</p> <p>(3) Comments from Parties Rele

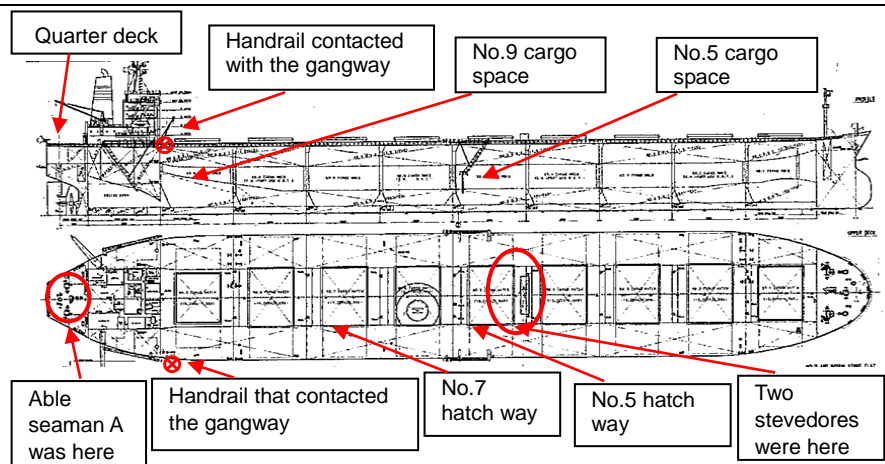
The work barge operator, while waiting on the sea near the gangway, saw that the wire rope was broken immediately after the handrail pushed the tip of the gangway toward the shore side, and the second officer, who was rushing toward the vessel, fell down from the gangway. (See Figure 3 and Photos 3-5)

Figure 3: The situation on the deck of the vessel

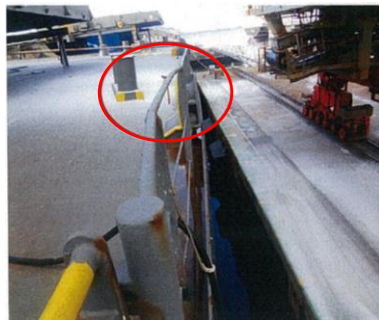
<p>Injuries to Persons</p>	<p>The death of one person (Second officer)</p>
<p>Damage to Vessel (or Other Facilities)</p>	<p>The vessel: Cracks and bent damage occurrence to the handrail of the starboard rear.</p> <p>This land getting on and off facilities: Break of this wire rope and bent damage occurred to the top part of the gangway.</p>
<p>Events Leading to the Accident</p>	<p>The questionnaire collected from Company A listed as follows.</p> <p>(1) Movements of the vessel</p> <p>The vessel, including twenty crew (all of them are the Philippine nationals) the Master and the second officer got on board, came alongside on the starboard side to the pier of the</p>

Photo 3: Damage to the handrail

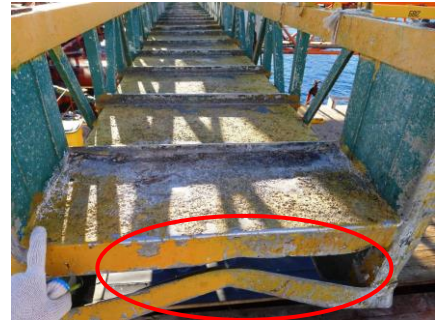
Photo 4: Damage to the gangway

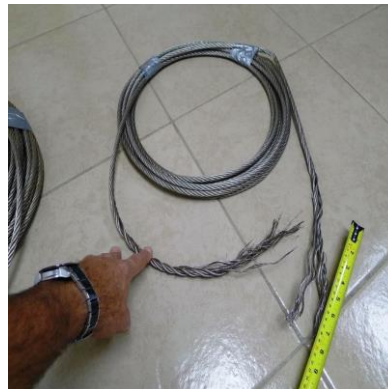
Photo 5: Broken state of this wire rope

- (8) It is considered probable that the reason the second officer, who had been walking toward the shore side on the gangway, moved toward the vessel, was because he knew that the handrail contacted the tip of the gangway.
- (9) It is considered probable that as the ordinary seaman A carried-out the mooring operation, after obtaining the permission from the second officer, this vessel was drawn to the pier while being moved toward the stern direction, and the handrail was in contact with the tip of the gangway; thus, the gangway was pushed toward the shore direction, a tensile stress exceeding the strength of this wire rope, which therefore, caused the wire rope to break. (See Photo 6)

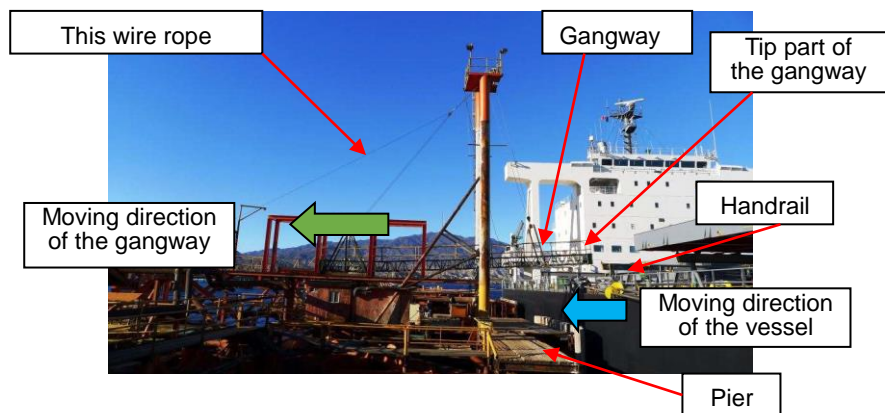
Photo 6: Moving situation of the vessel and the gangway after starting of this mooring operation

- (10) It is considered probable that the second officer fell down from the gangway to the pier, as the gangway moved toward the shore direction because this wire rope was broken when he was returning back to the vessel on the gangway. However, it was not possible to determine the situation that led him to fall.
- (11) In Company A, as the mooring operation gives a serious risk to the crew, it had been so determined that the mooring winch operation is recommended to be conducted in accordance with the "Safe Mooring Practices and their Guidelines", so that the crew members involved in the mooring operation are trained to
