MA2016-8

**MARINE ACCIDENT
INVESTIGATION REPORT**

MARINE ACCIDENT INVESTIGATION REPORT

Vessel type and name: Cargo Ship MING GUANG
IMO number: 8513456
Gross tonnage: 1,915 tons

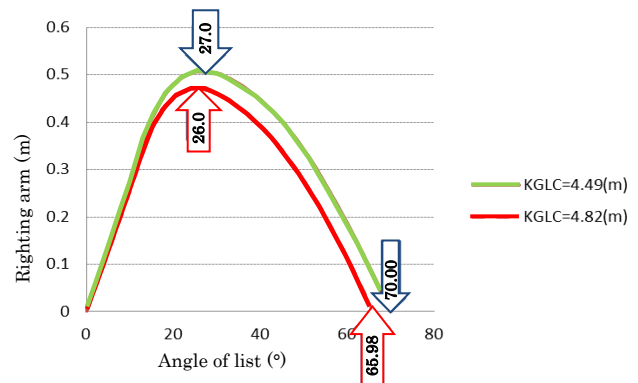
Figure 2.10-1 Stability Curve at Departure

KGLC (m)	4.49	4.82
Bow draft (m)	5.20	
Stern draft (m)	5.30	
Mean draft (m)	5.25	
Displacement (t)	4,407.90	
Height of center of gravity (m)	3.71	3.79
Metacentric height ^{*24} (GoM) (m)	1.51	1.43
Angle of list (°)	0.00

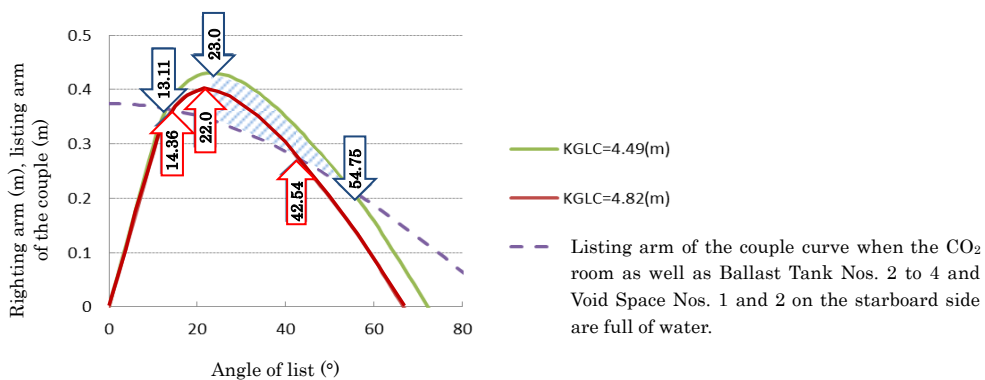
Figure 2.10-3 Stability Curve when the CO₂ Room as well as Ballast Tank Nos. 2 to 4 and Void Space Nos. 1 and 2 on the Starboard Side are Full of Water

*The amounts of seawater needed to fill the starboard Ballast Tank Nos. 2 to 4 are 55.3 tons, 58.4 tons, and 49.2 tons, respectively, and to fill the starboard Void Space Nos. 1 and 2 are 72.9 tons and 92.0 tons, respectively. Ballast Tank No. 1 was nearly full of water when the Vessel departed Hakodate Port.

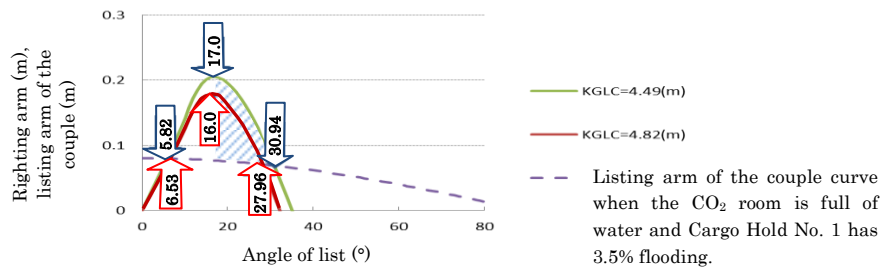
Figure 2.10-4 Stability Curve when the CO₂ Room is Full of Water and Cargo Hold No. 1 has 3.5% Flooding

listing increase and the list rate exceeds 17°, where the righting arm is largest, it is thought that wind and waves would cause capsizing in a relatively short period of time, a situation that is unlike the listing circumstances at the time of the accident.

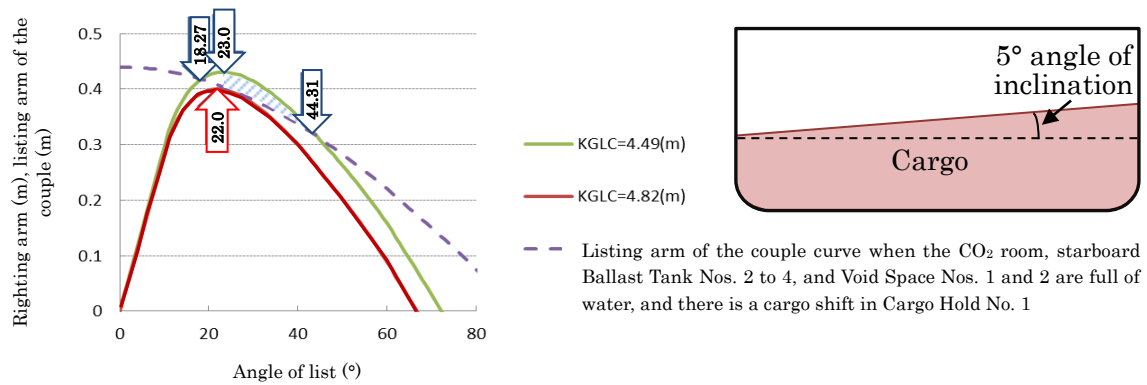
Figure 2.10-5 Stability Curve when the CO₂ Room, Starboard Ballast Tank Nos. 2 to 4, and Void Space Nos. 1 and 2 are Full of Water, and there is a Cargo Shift in Cargo Hold No. 1

KGLC (m)	4.49	4.82
Bow draft (m)	5.87	
Stern draft (m)	5.46	
Mean draft (m)	5.67	
Displacement (t)	4,800.74	
Height of center of gravity (m)	3.69	3.77
Metacentric height (GoM) (m)	1.70	1.62
Angle of list (°)	18.27	-
Listing arm of the couple (m)	0.42	-

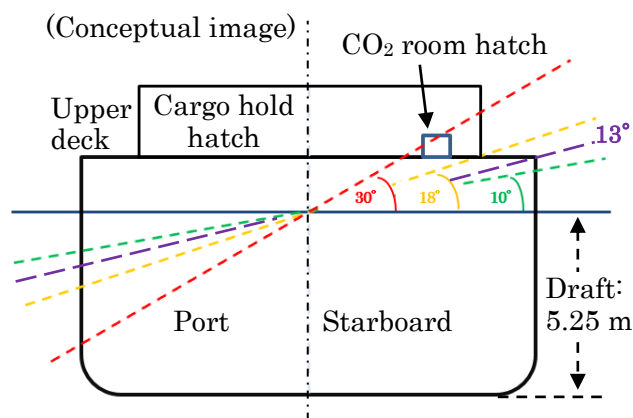
Figure 3.1 Water Line Situation at Time of List (State of Loading at Departure from Hakodate Port)

Time and date		Starboard angle of list
December 24	Around 16:00	No list
December 25	Around 05:00 to 09:00	Angle of list unknown
	Around 12:00	Approx. 4° - 5°
	Around 15:30	Approx. 7° - 10°
December 26	Around 03:00	Approx. 18°
	Around 04:55	Approx. 30°
	Around 05:45	Approx. 30° - 40°
