MA2016-10

**MARINE ACCIDENT
INVESTIGATION REPORT**

Accident type	Fatality of a grain inspector
Date and time	Around 08:50 on October 19, 2015 (local time, UTC+9 hours)
Location	Kobe Section 2 Grain Wharf, Hanshin Port Around 050° true bearing, 2,610m from Kobe No.5 Breakwater East Lighthouse (approximately 34° 42.10' N, 135° 15.70' E)
Summary of the Accident	At around 08:50 on October 19, 2015, while the cargo ship TRITON SWAN was engaged in cargo handling work at Kobe Section 2 Grain Wharf, Hanshin Port, a grain inspector died inside the No. 3 cargo hold where there was an oxygen deficiency hazard.
Process and Progress of the Investigation	(1) Set up of the Investigation The Japan Transport Safety Board appointed an investigator-in-charge and one other marine accident investigator to investigate this accident on October 19, 2015. Three accident investigators from the Kobe Office also took part in the investigation of this accident. (2) Collection of Evidence October 19 and 20: On-site investigations and interviews October 21 and 22, December 25, 2015, February 19 and 23, April 27, 2016: Interviews December 20 and 21, 2015, January 7 and April 7, 2016: Collection of questionnaire

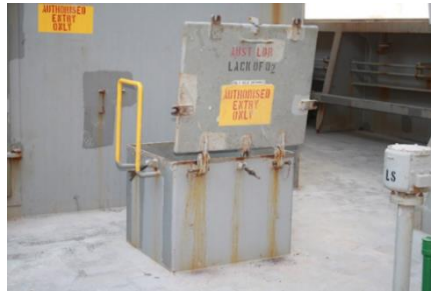
Photo 2 This hatch

- (7) After this accident, the cargo handling manager acknowledged that this hatch had been opened. Moreover, crew members discovered that the security tag had been cut and had fallen on the deck beside this hatch.
- (8) The chief officer had not instructed crew members to unseal the security tag of this hatch, because entry into the No. 3 cargo hold was not yet scheduled at that time of this accident.
- (9) Places with an oxygen deficiency hazard are designated as follows in the Order for Enforcement of Industrial Safety and Health Act (related to Articles 6 and 21).

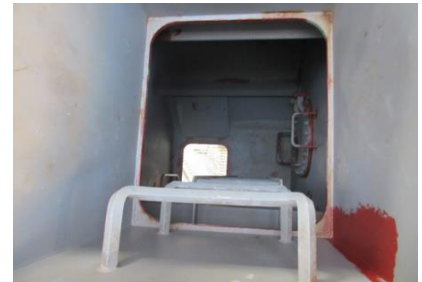
Photo 3 Vertical ladder

At around 09:00, the cargo handling manager measured the oxygen concentration near the bottom of the vertical ladder of this hatch and confirmed that it was about 11–12%.

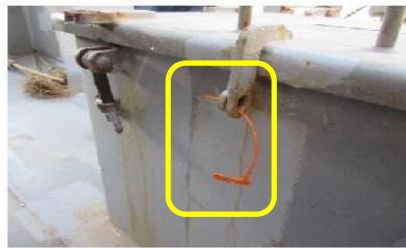
Photo 6 Security tag

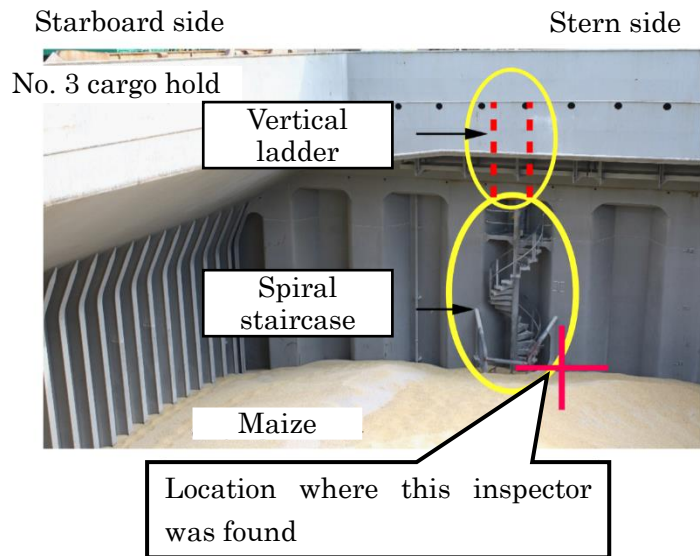
At around 08:50 to 08:55, while one of the cargo handlers was engaged in remote control of the cargo handling equipment near the port side center of the hatch of the No. 3 cargo hold, he noticed this inspector lying prone on top of the maize at the bottom of the starboard stern side spiral staircase of the No. 3 cargo hold. (See Photo 7)

Photo 7 Situation of the No. 3 cargo hold at that time of this accident

- 4) It is probable that the No. 3 cargo hold had fallen into a state of oxygen deficiency, because it had remained closed for about 1.5 months after the vessel was loaded with maize.

Considering from (2) 3) above, the fact that the security tag of this hatch had been cut, and the fact that the oxygen concentration at the bottom of the vertical ladder of this hatch was about 11-12% when the cargo handling manager measured it at around 09:00, it is probable that this inspector entered the No. 3 cargo hold before the oxygen concentration had been confirmed, but it has not been possible to clarify the circumstances of this.

<p>Safety Actions</p>	<p>The following measures are possible to prevent recurrence of similar accidents:</p> <p>(1) After this accident, Association A studied safety actions and took the following measures.</p> <p>1) Association A produced a draft “Basic Manual on Preventing Anoxia” (hereinafter referred to as “Manual”) and distributed it to the various branches, each branch then produced the Manual to suit its own local circumstances, and after reporting to the headquarters, immediately put it into practice.</p> <p>2) The Kansai Kobe Branch of Association A, in its Manual, specified the following procedure for cases when inspectors need to enter cargo holds and other hazardous locations where there is a risk of oxygen deficiency in order to confirm quality, such as when a hold has remained closed after being loaded with grain.</p> <p>a Check with the cargo handling manager whether the oxygen concentration has been measured, the result of the oxygen</p>

<p>concentration measurement, and whether or not entry is possible.</p> <ul style="list-style-type: none">b Notify the cargo handling manager or other operators of the intention to enter.c Carry an oxygen concentration detector.d Prepare oxygen respirators. <ul style="list-style-type: none">3) Each branch of Association A familiarized all of its employees with the content of the Manual.4) Association A decided to have its office managers and employees who were engaged in port and harbor duties attend a skill training course for oxygen deficiency hazardous operations chiefs, appoint operations chiefs from amongst them, and have these continuously give guidance on oxygen deficiency to the employees under their authority.5) Association A decided to have the managers of its branches report to headquarters on the status of guidance on preventing oxygen deficiency accidents in each branch, and to instruct improvements if problems arose.6) Association A conducted a revision of the provisions related to health and safety. <p>(2) The following measures are possible to prevent recurrence of similar accidents:</p> <ul style="list-style-type: none">1) Association A should familiarize grain inspectors with the content of the Manual and rigorously enforce their compliance with it.2) The procedure mentioned above and a system of planned and sustainable guidance designed to prevent oxygen deficiency accidents should be created for grain inspectors, and steps should be taken to improve the awareness of grain inspectors.

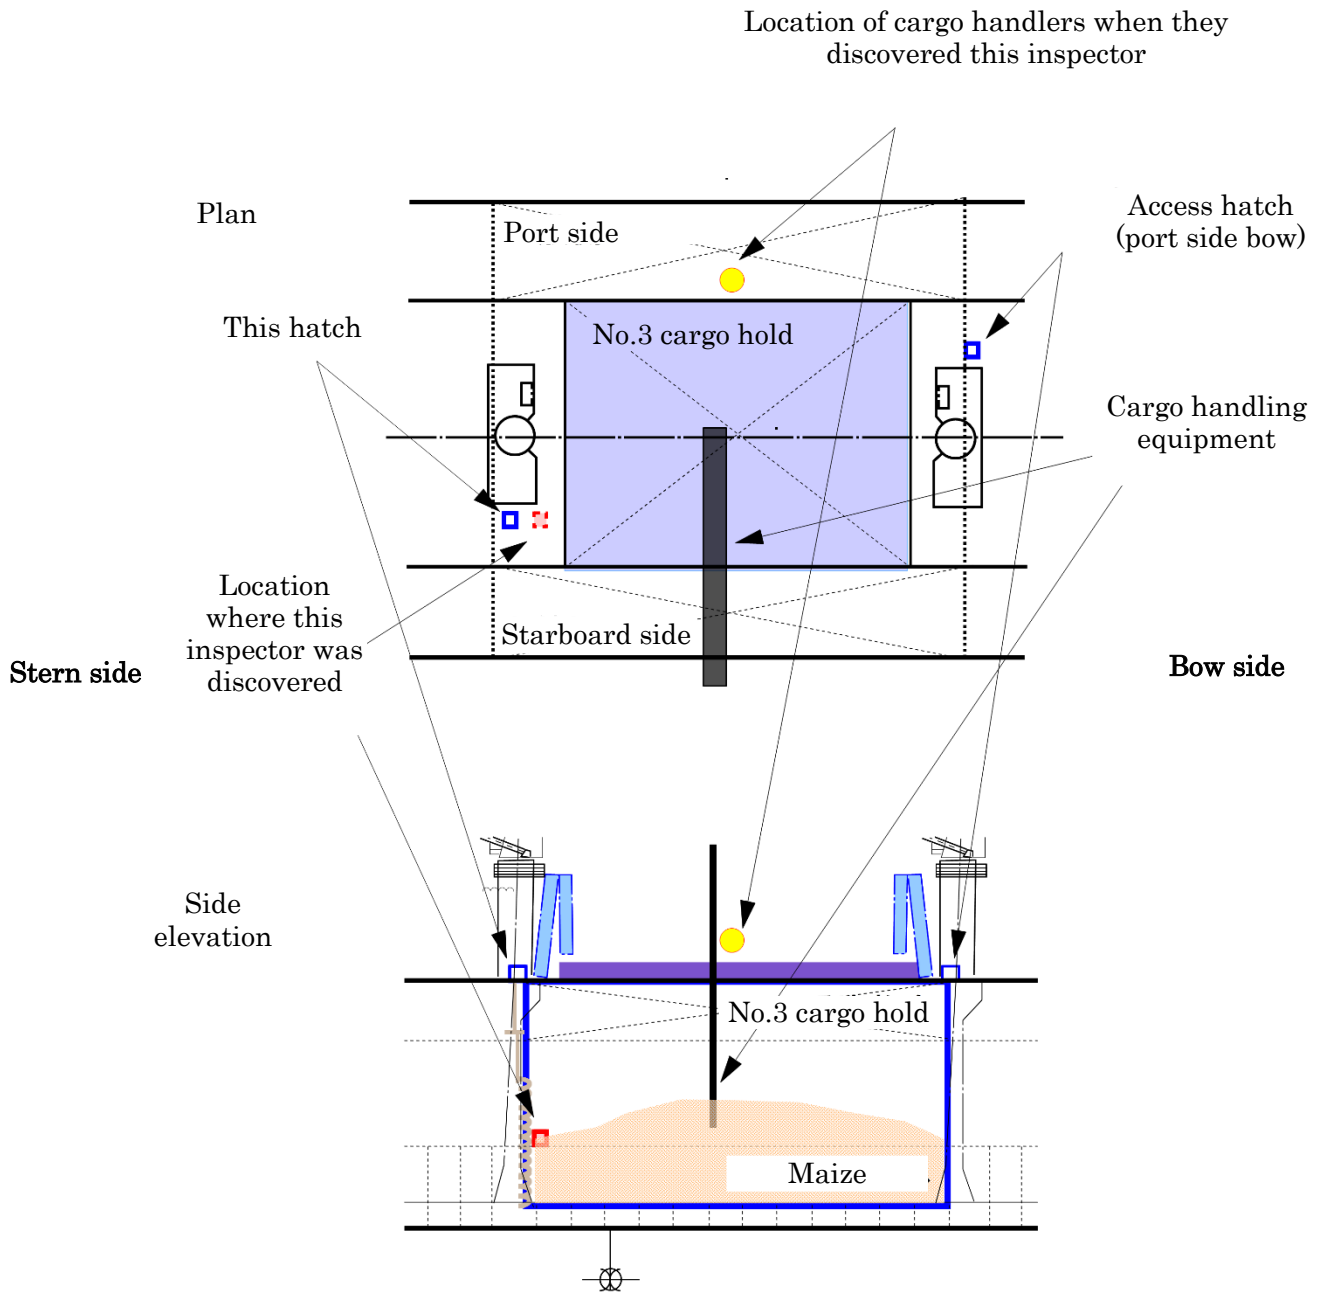
Fig. 2 Sketch of the accident situation

<p>day, the cause of death was certified as asphyxiation due to oxygen deficiency (tentative) and the time of death as 08:50 (tentative). (See Fig. 1 Sketch map of the accident location, Fig. 2 Sketch of the accident situation)</p>
<p>Other Matters</p>	<p>(1) The No. 3 cargo hold had been locked and this hatch had been sealed using a security tag from the time when the vessel left port in the USA until it docked at this wharf and the hatch was opened.</p> <p>(2) Upon request from the cargo owner, Association A was planning to have this inspector, Inspector A and Inspector B inspect the maize loaded on the vessel from the morning of October 19.</p> <p>(3) Although inspection work is normally carried out after staff of the Ministry of Agriculture, Forestry and Fisheries have undertaken plant quarantine, Association A sometimes carried out quality checks to confirm that there was no damage or other defect in the grain before plant quarantine, as part of this inspection work.</p> <p>(4) When its employees were to enter hazardous locations where there was a risk of oxygen deficiency when carrying out inspection work such as gauging grain temperature or sampling, Association A required them to enter only after asking the cargo handling manager for the result of oxygen concentration measurement and confirming safety, irrespective of whether before or after plant quarantine had been carried out.</p> <p>(5) Caution notices announcing “AUTHORISED ENTRY ONLY” (in English, red letters on a yellow background)” and “LACK OF O₂ (in English, black letters)” were permanently displayed on the top of the access hatch of the vessel.</p> <p>(6) If, after opening the access hatch and measuring the oxygen concentration in the cargo hold, it was judged safe to enter the hold, the cargo handling manager would display a sign marked “検査済み OK” (“Inspected OK”) in Japanese, and if the oxygen concentration was low, the sign would read “酸欠” (“Oxygen low”). (See Photos 8 and 9)</p> <div style="display: flex; justify-content: space-around; align-items: center;">     </div> <p style="text-align: center;">Photo 8 Caution notice on the top Photo 9 Sign permitting hold entry</p>

- 5) It is probable that this inspector was witnessed going to the vessel by ascending the stairs attached the terrestrial cargo handling equipment at around 08:40, and was discovered lying prone on top of the maize at the bottom of the stern side spiral staircase of the No. 3 cargo hold at around 08:50 to 08:55.
