**MARINE ACCIDENT  
INVESTIGATION REPORT**

Vessel type and name: Cargo Ship TAI YUAN

Accident type: Fire

Date and time: Around 13:20, April 24, 2017 (local time, UTC +9 hours)

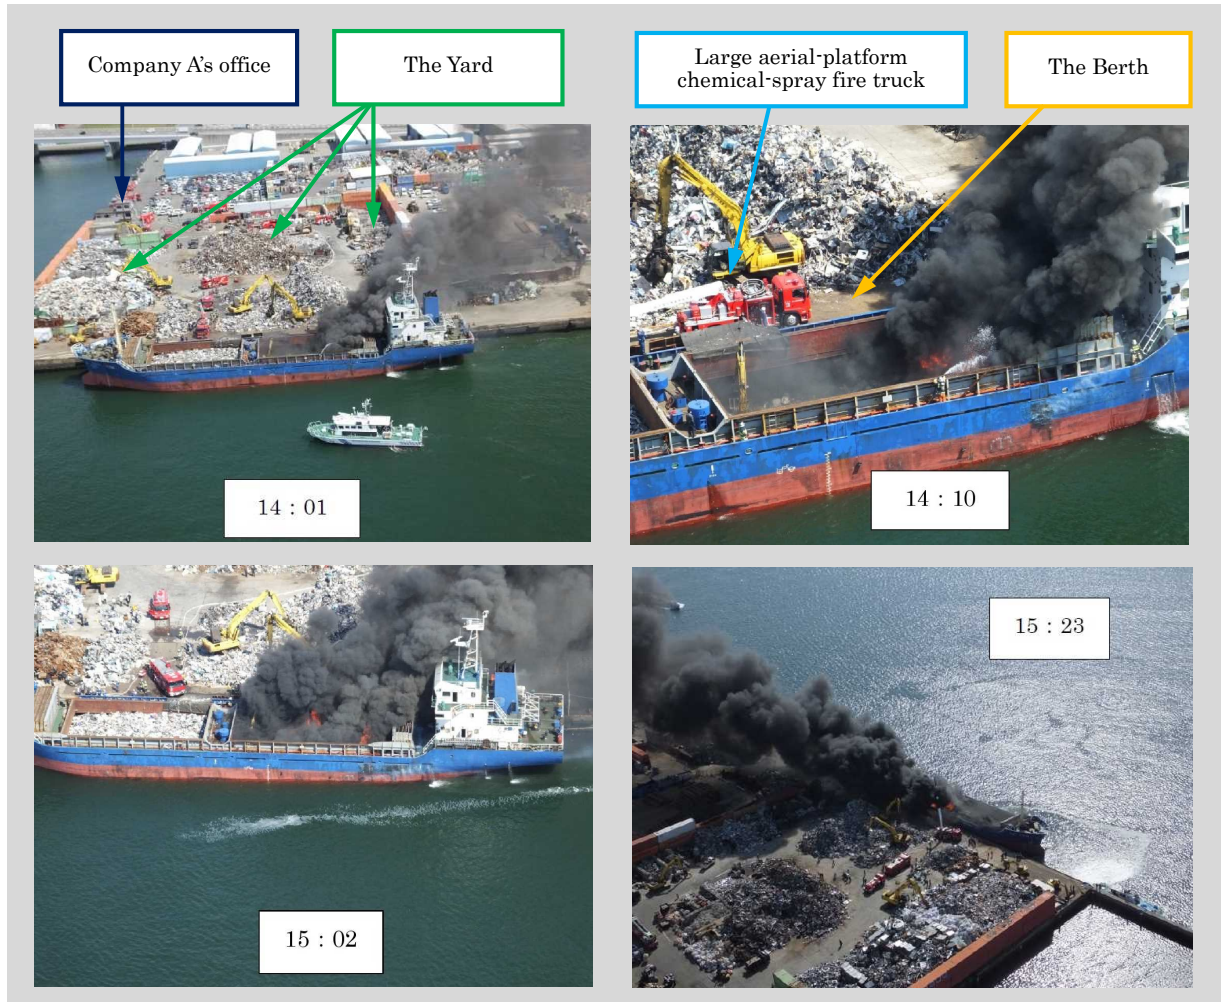
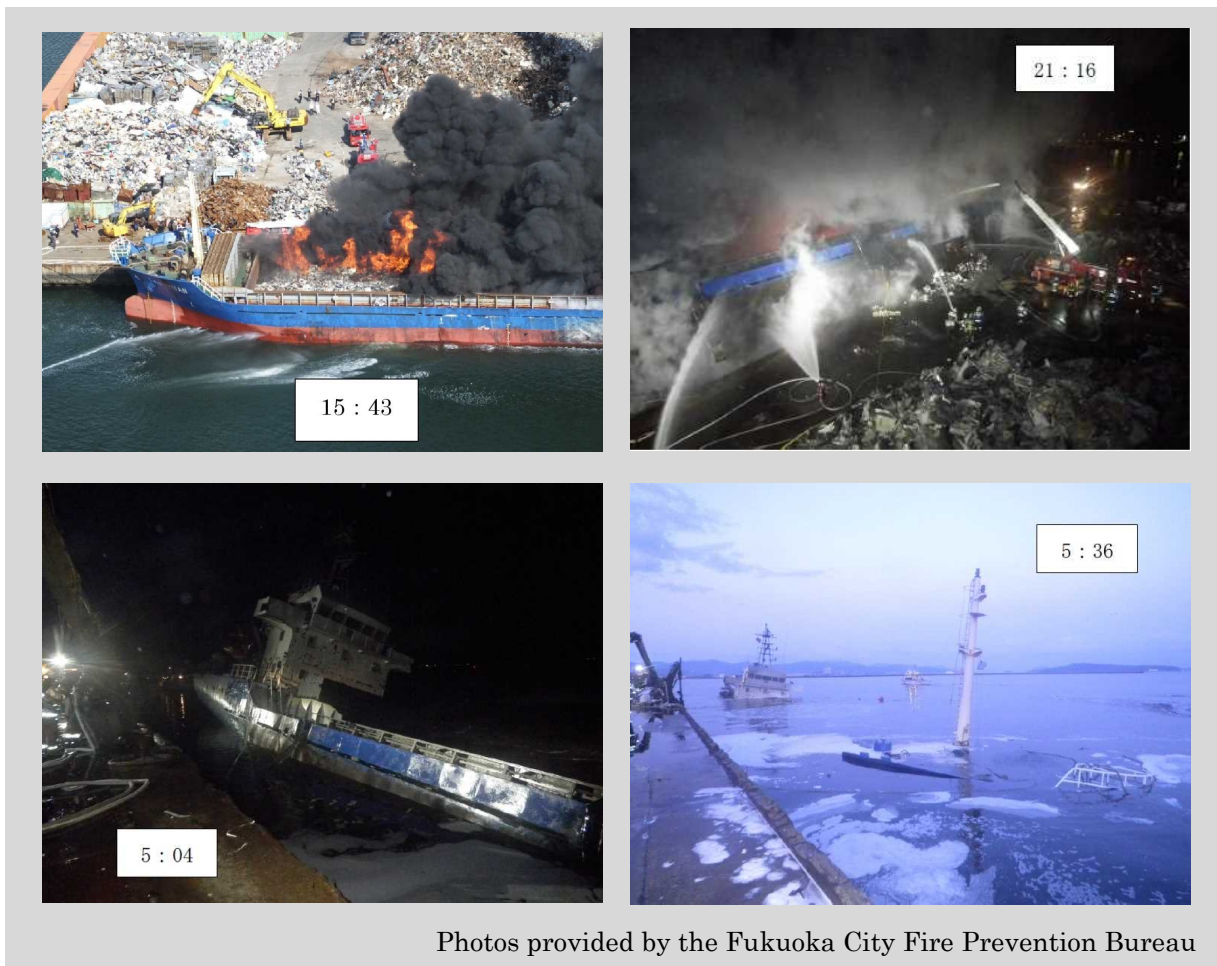
Figure 1 Circumstances of the Vessel's Fire and Foundering

The Vessel continually underwent firefighting by the Fire Company but, at around 04:45, foundered from her port bow side. She settled on the bottom with only her wheel house above the water. The fire was extinguished.

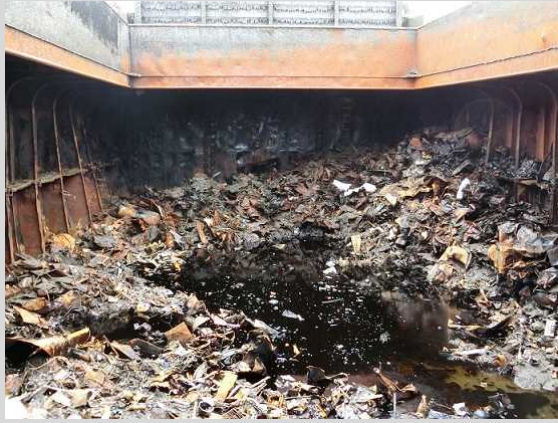
Aft side of the Cargo Hold

According to the onsite investigations and statement of the person in charge at the ship-breaking company, the Vessel had paint burn damage and heat deformation to her cargo holds' walls, pipes, and plating shell, but there were no breaches, cracks, or other such damage to the Vessel's plating shell.

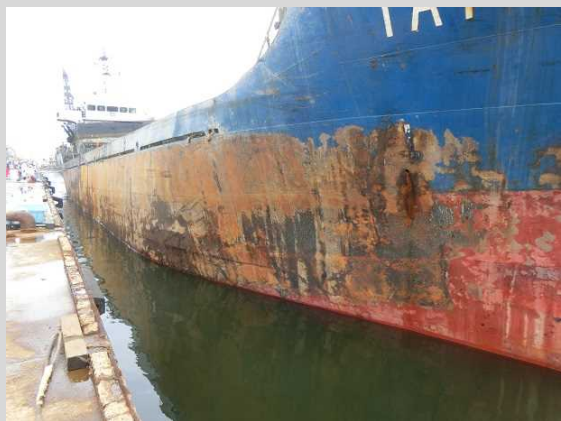
Starboard plating shell

pipes, and plating shell; however, it is probable that there was no damage such as breaches or cracking of the Vessel's plating shell that would cause flooding.

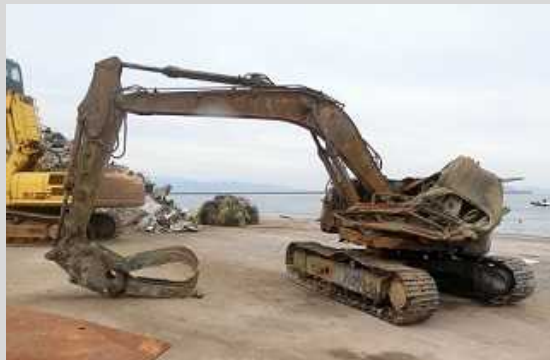
The Hydraulic Excavator

Additionally, the Hydraulic Excavator had burn damage and heat deformation.

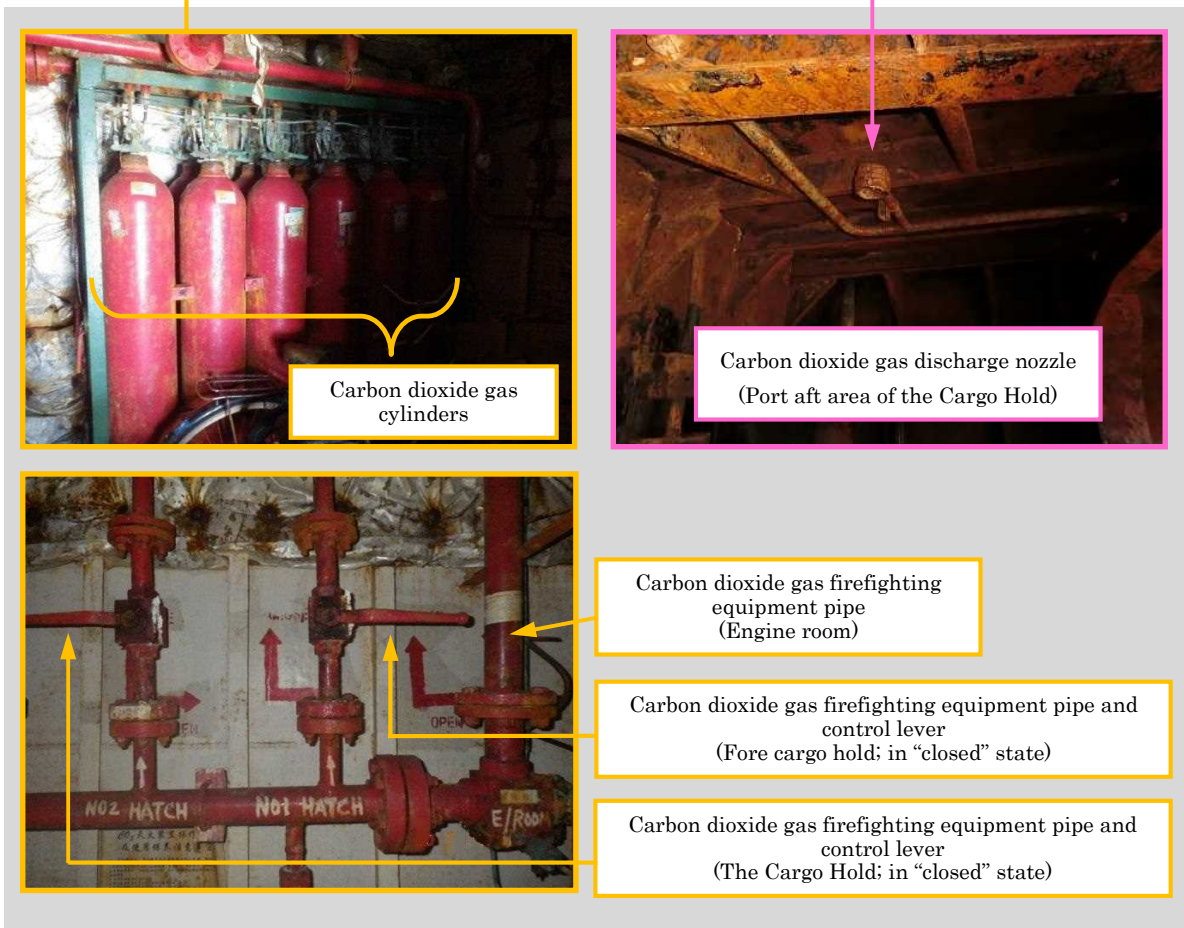
Figure 4 State of the Carbon Dioxide Gas Firefighting Equipment

After the accident, the operating levers for the carbon dioxide gas firefighting equipment were found to be in the "closed" state for both the fore cargo hold and the aft cargo hold on the raised Vessel.

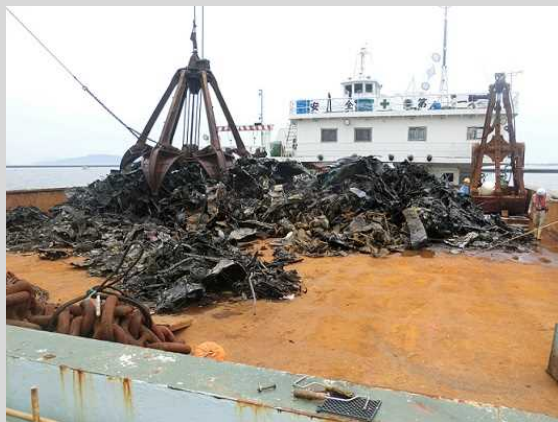
Raised Scrap from the Cargo Hold

The scrap in the aft cargo hold that was raised from the foundered Vessel was found to contain waste metal as well as a mix of dry cell batteries, lithium batteries, button cells, kerosene cans, and other items. It also contained a large mixture of insulation material, plastic products, rubber products, vinyl products, wood chips, pieces of paper, and other items.

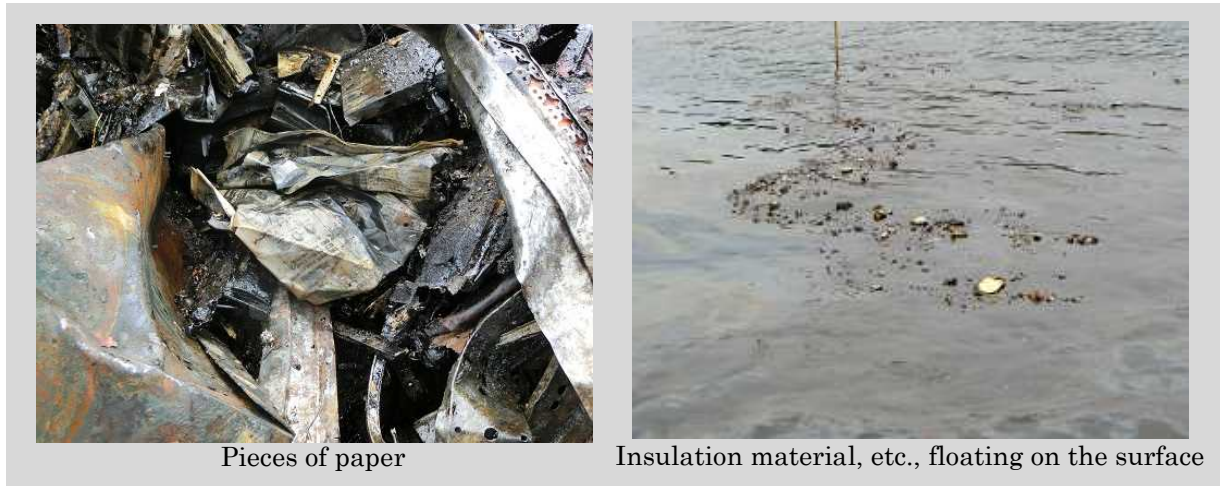
Figure 5 Cargo Raised from the aft cargo hold

In addition, a large quantity of floating insulation material and other items was observed on the ocean's surface after the scrap was raised.

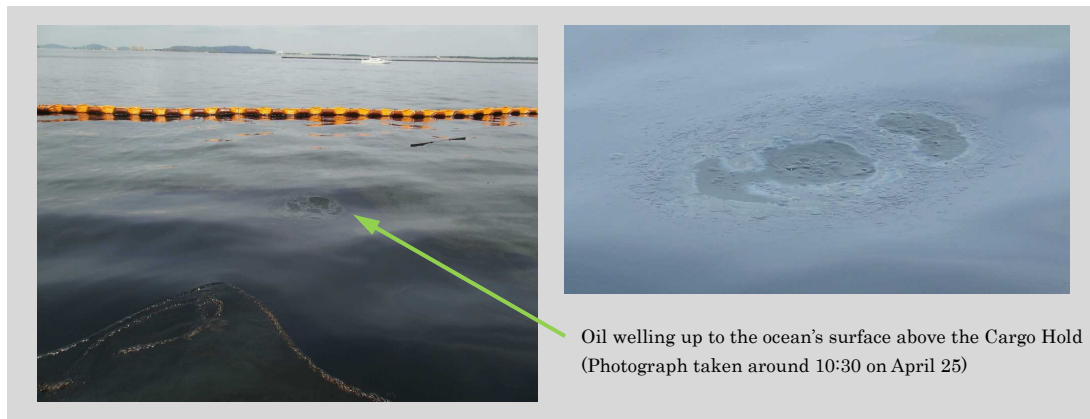
Figure 9 Circumstances of the Oil Spill from the Vessel

Spilling oil was observed following the Vessel's foundering. According to the salvage company, the air vent pipe of the fuel tank was closed at around 17:25 on April 25. (See Figure 9)

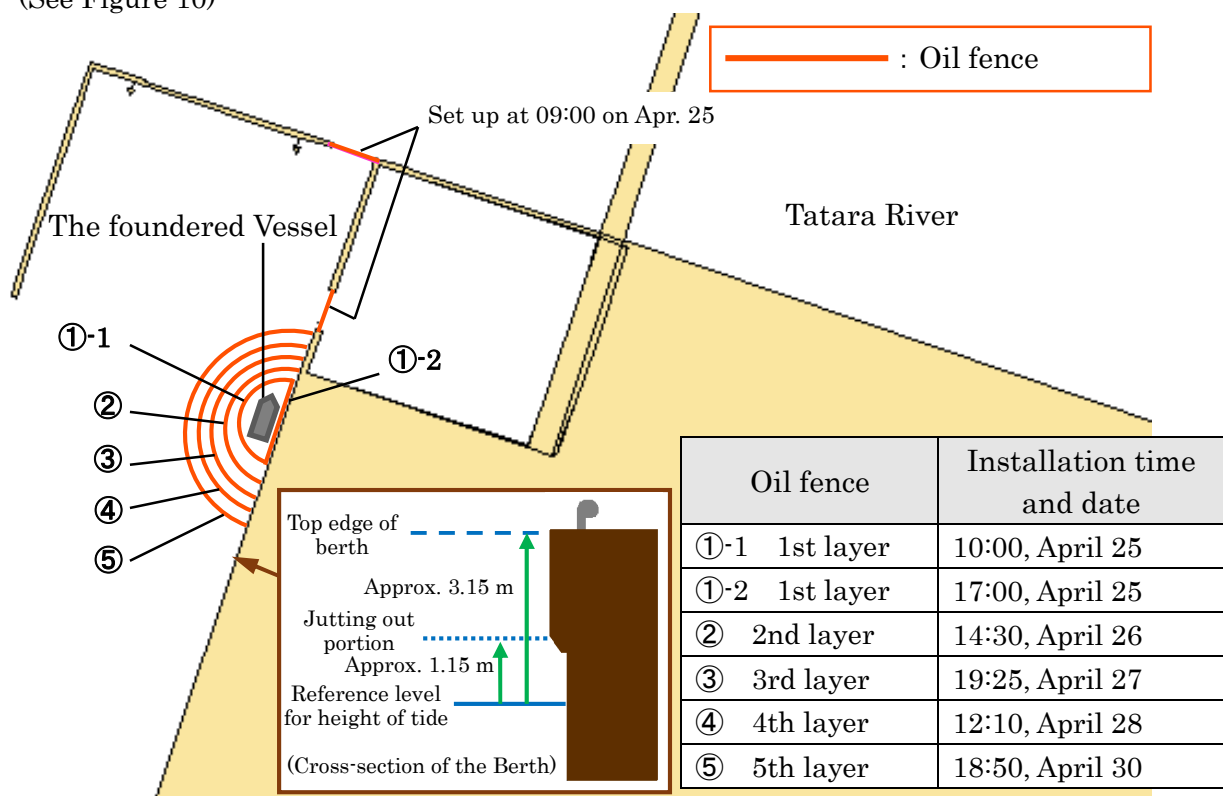
Figure 10 Circumstances of the Installation of the Oil Fences and Berth

Although an oil fence encircling the Vessel's seaward side was set up by the oil fence installation company at around 10:00, oil was observed flowing out from point of contact between the oil fence and the Berth. Therefore, at around 15:00, Company B requested the oil fence installation company to set up an oil fence on the Vessel's berth side, which was done at around 17:00. Subsequently a total of four additional oil fences encircling the Vessel's seaward side were set up.

It should be noted that the Berth's height was approximately 3.15 m above the reference level for height of tide, and that the Berth had a shape that jutted out toward the sea for approximately 2 m below its upper edge (approximately 1.15 m above the reference level for height of tide). The sea area in front of the Berth had been dug down to a depth of approximately 10 m (below the reference level for height of tide).

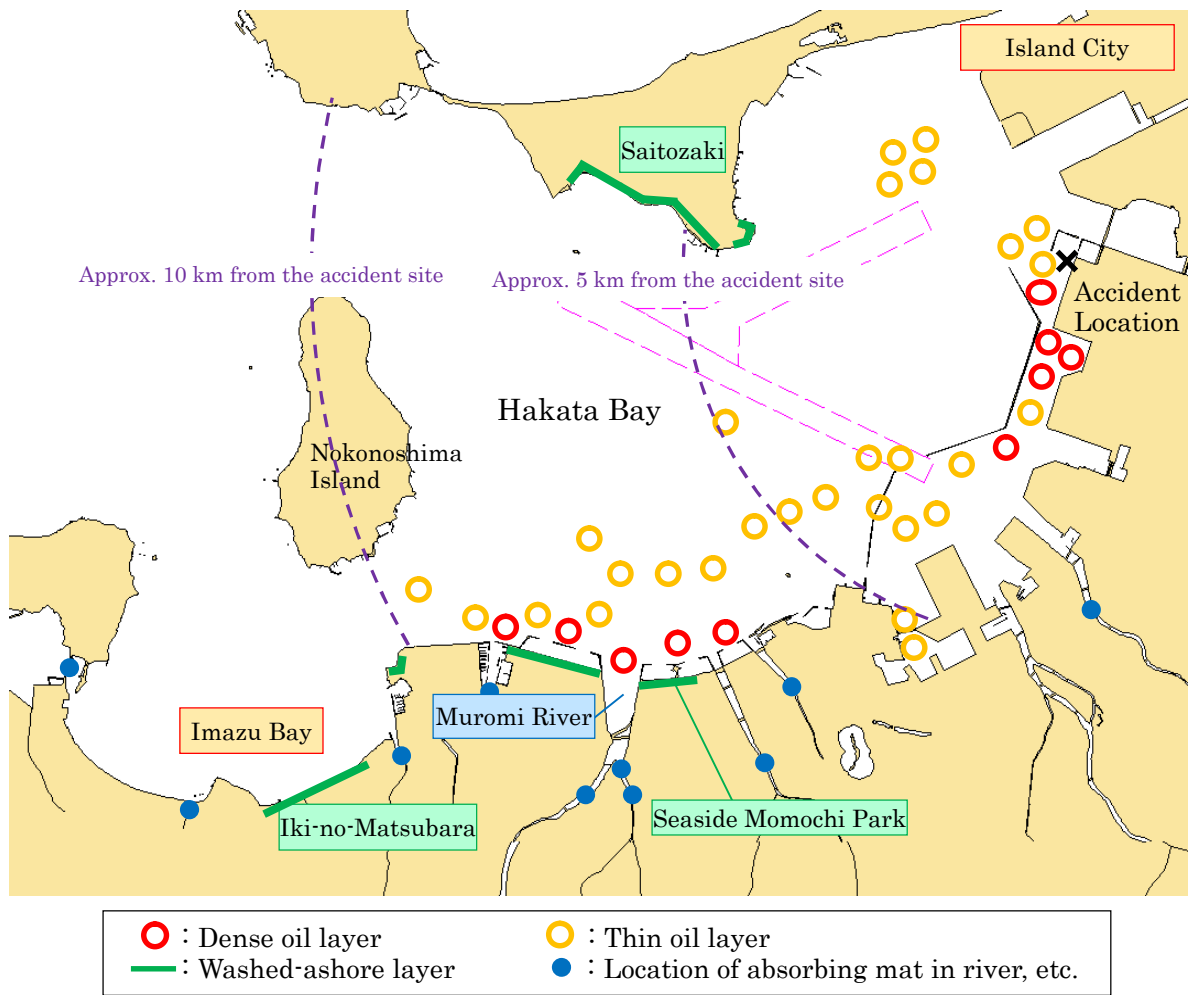
Figure 11 The Oil's Spread

Floating oil was observed extending from the sea area in front of the accident site to the sea area on the western side of Island City, Fukuoka City, Fukuoka Prefecture, to the north and near Imazu Bay in Fukuoka City to the southwest. (As of April 27)

Oil was observed being washed ashore from Seaside Momochi Park in Fukuoka City, Fukuoka Prefecture to Iki-no-Matsubara in Fukuoka City and near Saitozaki in Fukuoka City.

Oil was observed being washed ashore in the western areas of the Muromi River and other rivers that drain into the southern part of Hakata Bay and attached to absorbing mats within a range of between approximately 100 m and 1.9 km from each of the rivers.

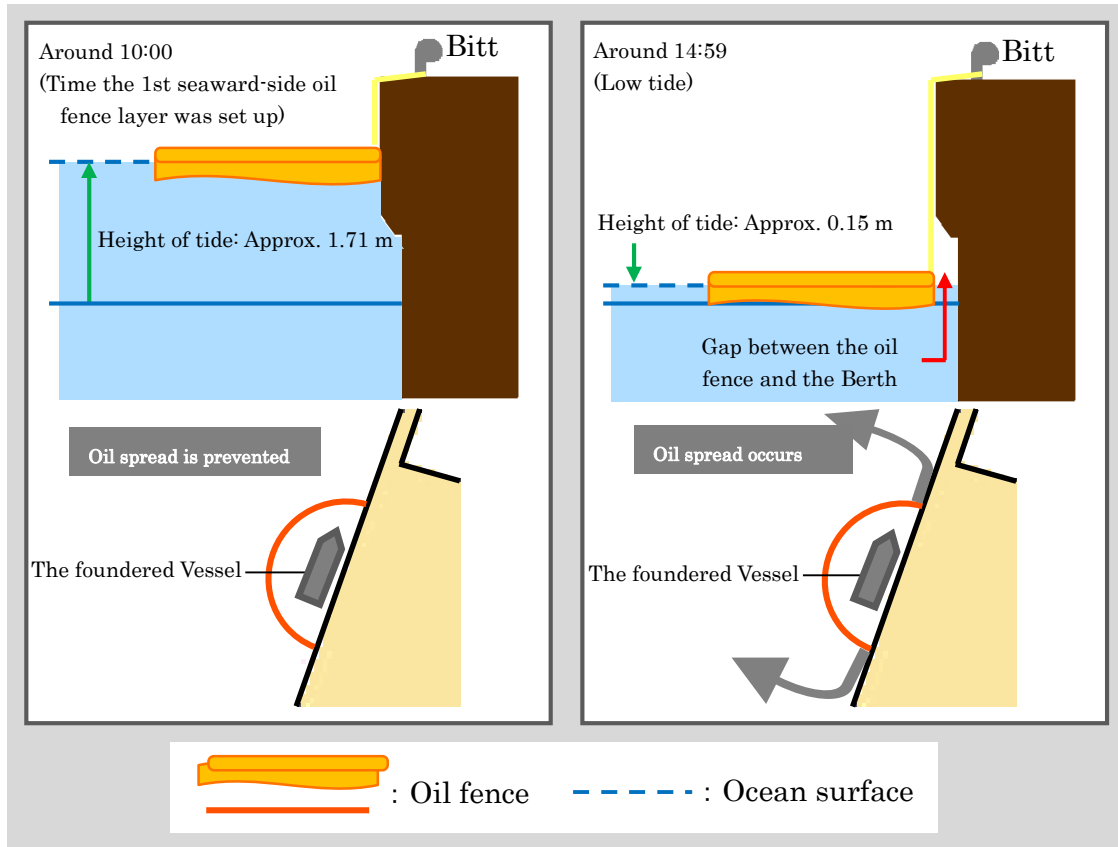
Figure 12 Conceptual Image of the Oil Fence's Setup and the Oil's Spread

- (2) From 2.10.2, 2.11.1 (2), and 3.3.1, it is somewhat likely that, from around 12:00, when the height of tide was lower than the height of the lower edge of the jutting out portion of the Berth (approximately 1.15 m), and around 17:00, when the oil fence encircling the berth side of the Vessel was set up, the spread of oil continued from the gap that formed between the Berth and the oil fence. (See Figure 12)
